(E83-10258) THEMATIC MAPPER FLIGHT MODEL
PRESHIPMENT REVIEW DATA PACKAGE, VOLUME 2,
PART A: SUBSYSTEM DATA Final Report
(Hughes Aircraft Co.) 276 p HC A13/MF A01

Prepared for
GODDARD SPACE FLIGHT CENTER
Greenbelt, Maryland 20771
CONTRACT NAS 5-24200

FLIGHT MODEL
PRESHIPMENT REVIEW
DATA PACKAGE
VOLUME II - SUBSYSTEM DATA
PART A

THEMATIC MAPPER
FLIGHT MODEL
PRESHIPMENT REVIEW
VOLUME II
SUBSYSTEMS
TABLE OF CONTENTS

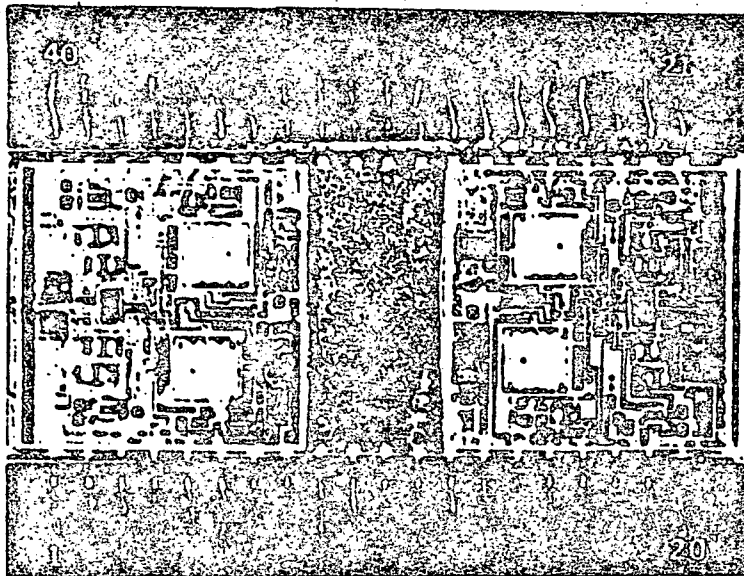
Figure No. 2
Sample No. Q3

Overall view of Q3 transistor
Arrows point to the scratches
on the chip.

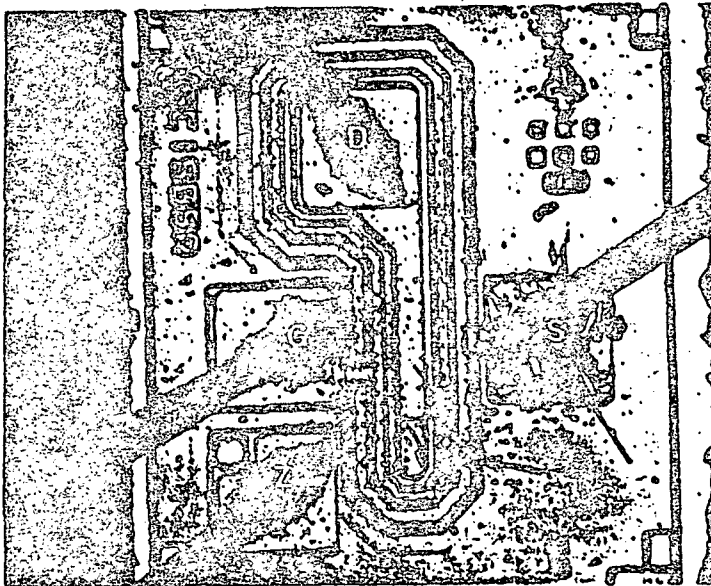
Figure No. 3
Sample No. Q3

Magnified view of the anomaly
shown in Figure 2.

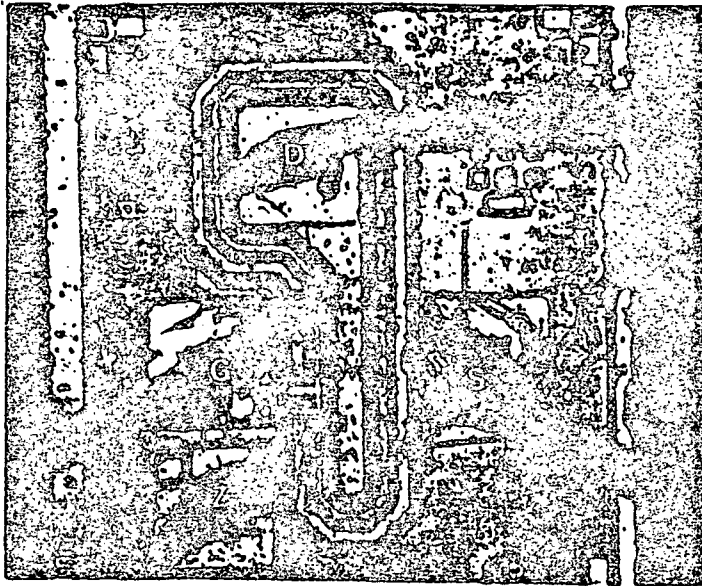
Figure No. 4
Sample No. Q4

Overall view of Q4 transistor.
Arrows point to the scratches
on the chip.

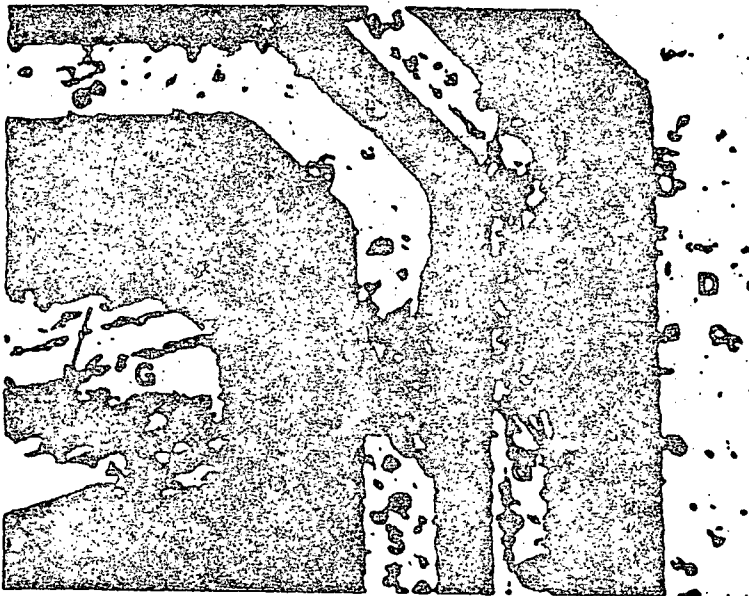
Figure No. 5
Sample No. Q4

Magnified view of the anomaly
shown in Figure 4.

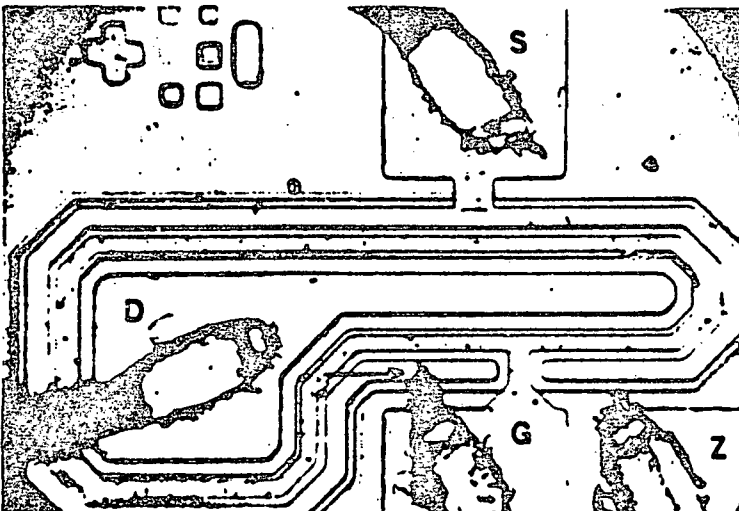
Figure No. 6
Sample No. Q1

Overall view of Q1 transistor chip
Arrow points to lead bond
anomaly.

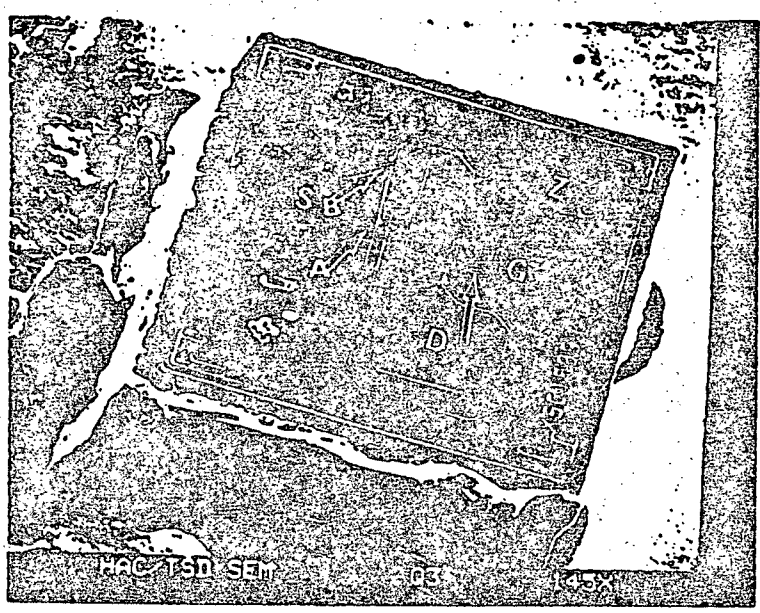
Figure No. 7
Sample No. Q3

SEM view of Q3 after metal
removal with pinholes indicated
(145X)

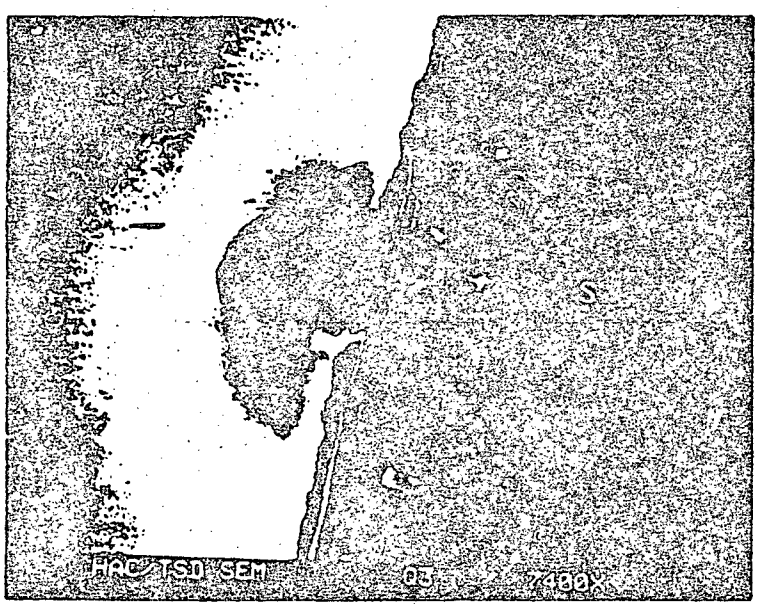
Figure No. 8
Sample No. Q3

Magnified view of pinhole
shown in Figure 7 Arrow B.
(7400X)

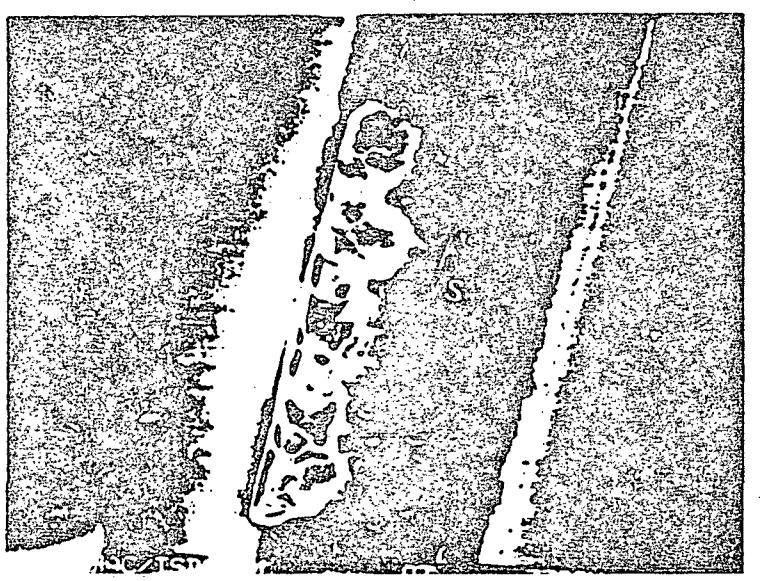
Figure No. 9
Sample No. Q3

Magnified view of the pinhole
shown in Figure 7, Arrow A.
(3700X)

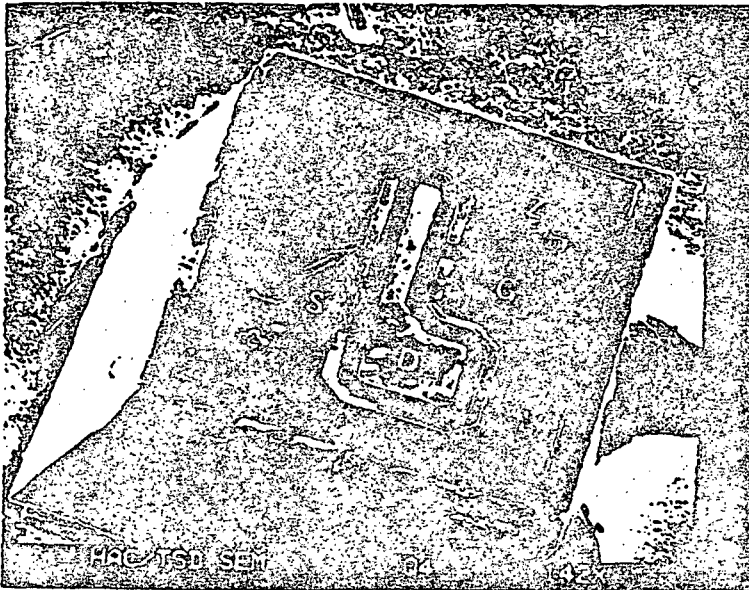
Figure No. 10
Sample No. Q4

SEM view of Q4 transistor after
metalization removal with pin-
hole indicated.

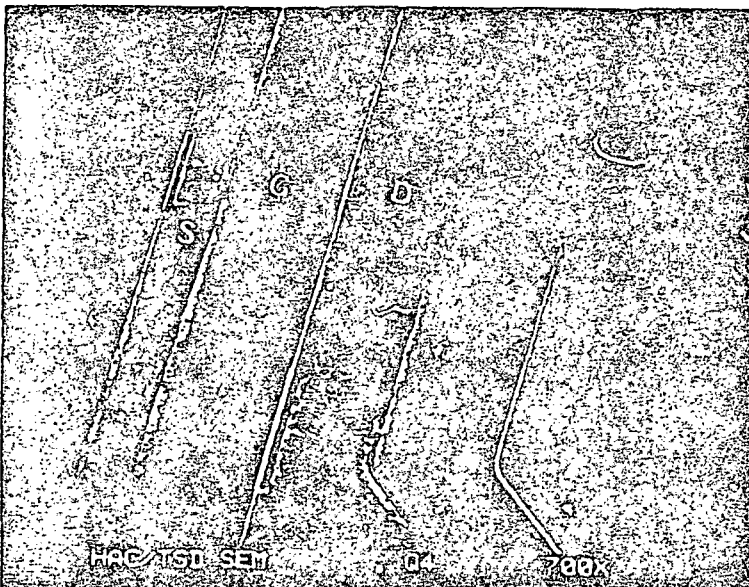
Figure No. 11
Sample No. Q4

Magnified view of the pinhole
shown in Figure 10.

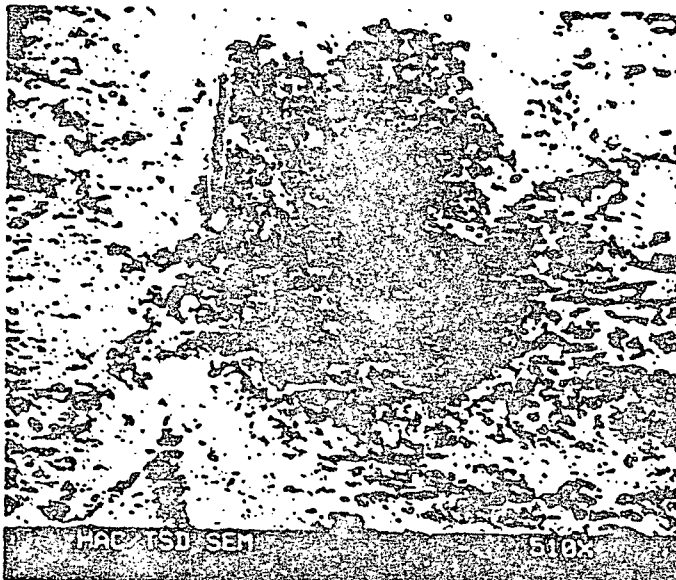
SUBJECT: Failure Report F3657

The Failure mode reported on subject Failure Report was traced to a defective output driver (P/N 911958-001). Reliability cannot submit the defective part to TSD (Technology Services Division) for Failure Analysis because the responsible Multiplexer personnel cannot locate the part.

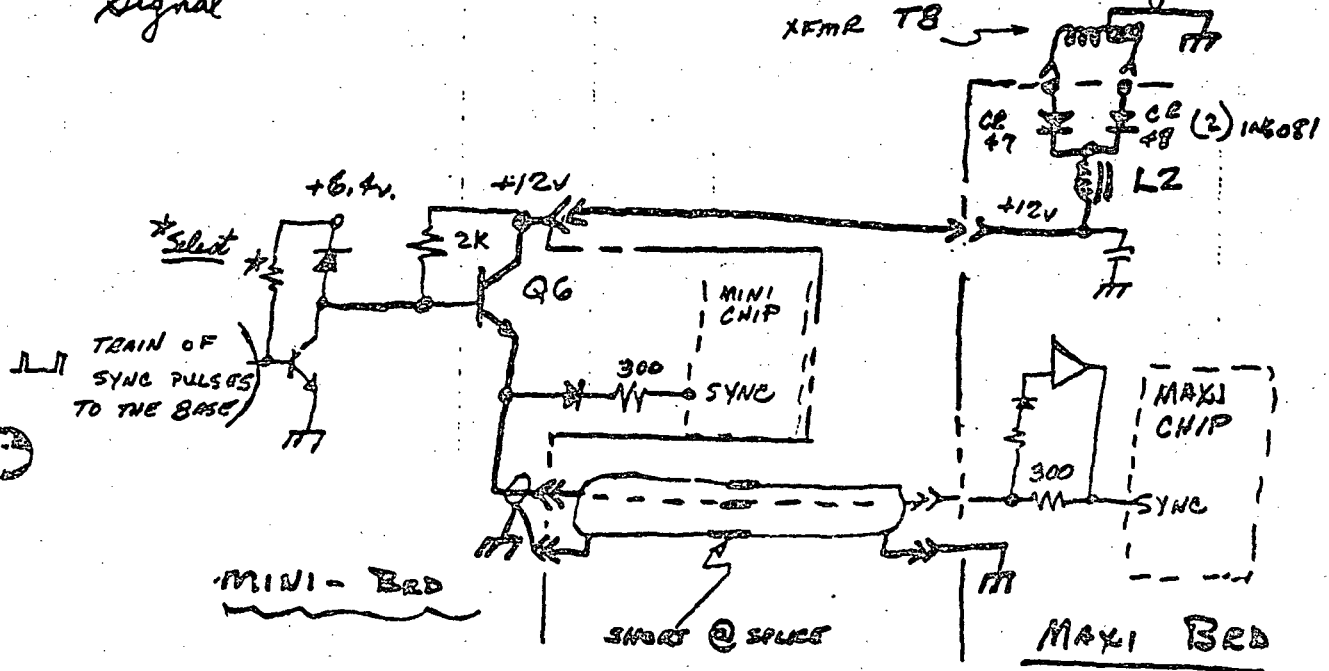
There was a shielded wire short, which put the center conductor at return ground potential. This short was in the inter-connecting harness, from MINI-Sw. to the MAXI-Sw. that carries the "sync signal"
