## SERVICE INFORMATION BULLETIN

**SURGE WHILE DRIVING DURING AUTO REGENERATION**

This bulletin provides a procedure to modify the Intake Throttle Valve.

2008-2010 North American Production Vehicles equipped with the J08E engine.

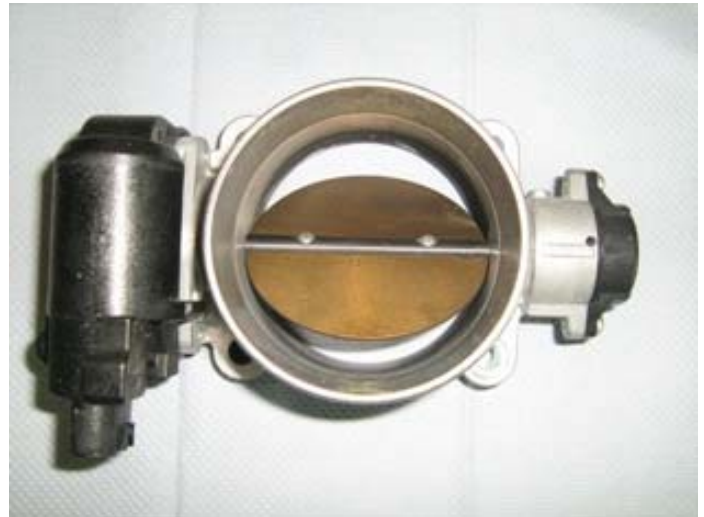
- d) Remove the Intake Throttle Valve from the vehicle. Cover the Intake Manifold opening to prevent dirt from entering Intake Manifold. Check and wiggle the throttle blade. If any movement is detected between the throttle blade and throttle shaft the Throttle Valve assembly must be replaced.
