Technical Service Bulletin

GROUP DRIVESHAFT AND AXLE	NUMBER 19-DS-001H-1
DATE FEBRUARY, 2019	MODEL(S) ALL

SUBJECT: WHEEL BEARING NOISE INSPECTION

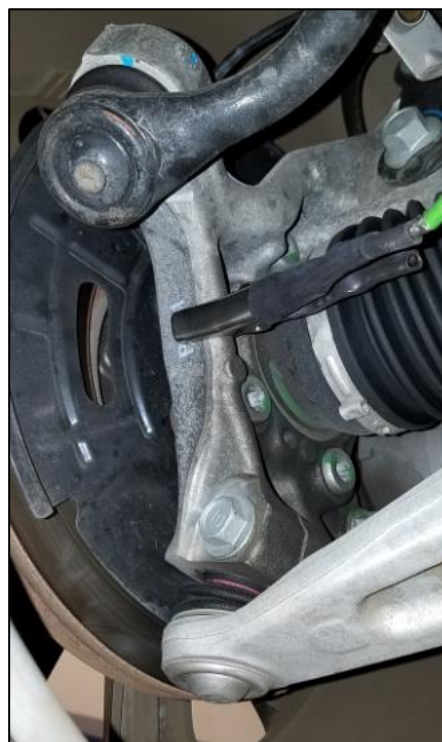
1. Confirm the noise by performing a test drive. If no noise is heard, no further repair is necessary.
2. If the noise is confirmed, attach chassis ears to the following locations:
 - The knuckle where the source of the noise is.
 - The opposite side knuckle to compare left and right wheel bearing condition.
 - Other areas suspected of causing the noise to compare the sound coming from the knuckle to other sources.

Be sure to route the wires for the chassis ears away from any moving components (CV shaft, suspension components, etc.).

Secure the wires using cable ties, or similar. Leave enough slack for suspension and steering movement.

3. Test drive again while listening to the chassis ears.
 - If the noise is confirmed to be coming from the knuckle, **replace the wheel bearing hub assembly on the side consistent with the noise.** Refer to the applicable shop manual for replacement procedures.
 - If the noise is confirmed to be coming from another source, continue evaluating different sources of the noise until it is found, and repair as necessary.
4. After completing the repair, test drive again to confirm the noise has been resolved.
