NONCONFORMANCE-REPORT LOG & STATUS BOOK

PROJECT NO. 7220

SUBJECT: CONSUMERS POWER COMPANY
MIDLAND PLANT - UNITS 1 & 2
JOB NO. 7220
MISCELLANEOUS METAL
FILE: 0274, C-33

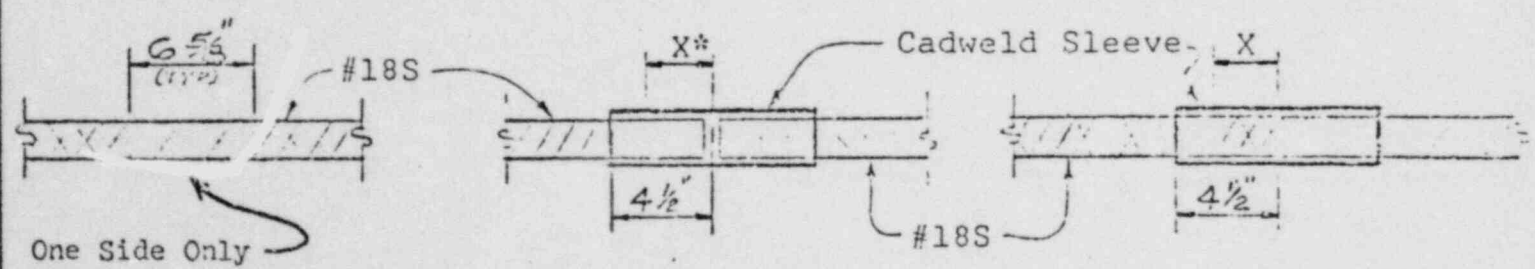
10. No. 11. NONCONFORMANCE (DISCREPANCY) DESCRIPTION: ASME YES NO
 1 Spec. C-55 Rev. 1 Sect. 4.3.1 States, "The bar ends to be spliced shall be in good condition with full size undamaged deformations." A reinspection of all reinforcing steel Cadweld splices found interrupted deformations within the splice sleeve on the following splices in Containment #1. See sheet 2 of 3.

Splice No.	Splice End	Dimension "X"
32/3R16	East	4"
27/3R19	East	4 1/2"
29/3R20	East	3 1/4"
34/3R22B	East	4 1/2"
18/3R23	East	1 1/2"
19/3R25	East	3 1/4"
13/3R30	East	2 1/2"
46/3R49	East	4 1/2"
42/3R50	East	2"
65/3R55	East	1 3/4"
70/3R60	East	2 3/4"
54/3R68	East	3 1/4"
117/3R95	East	3"
79/3R131	East	1 1/2"
136/4R40	South	3 1/4"
129/4R47	South	3 3/4"
133/4R48	South	4 1/2" *
132/4R62	South	4 1/4"
⁶² 29/3R53	East	3" *
120/3R93	East	3 1/2" *
131/4R54	South	2 1/2" * ^{AS 3 1/2" *}
128/4R68 4R64 ^{AS}	South	2 1/2" * ^{AS 3" *}

Interrupted Deformations (Typical)	Interrupted Deformations Totally Enclosed Within Cadweld Sleeve *	Interrupted Deformations Partially Enclosed Within Cadweld Sleeve
------------------------------------	---	---

Project Engineering should investigate the possibility of accepting the bar placed in Containment #1 Base slab "as is". On the bar remaining to be placed, ends where interrupted deformations exist will be cut back to a point where the splice can be made on uninterrupted deformations and the subsequent missing bar length replaced using another Cadweld splice

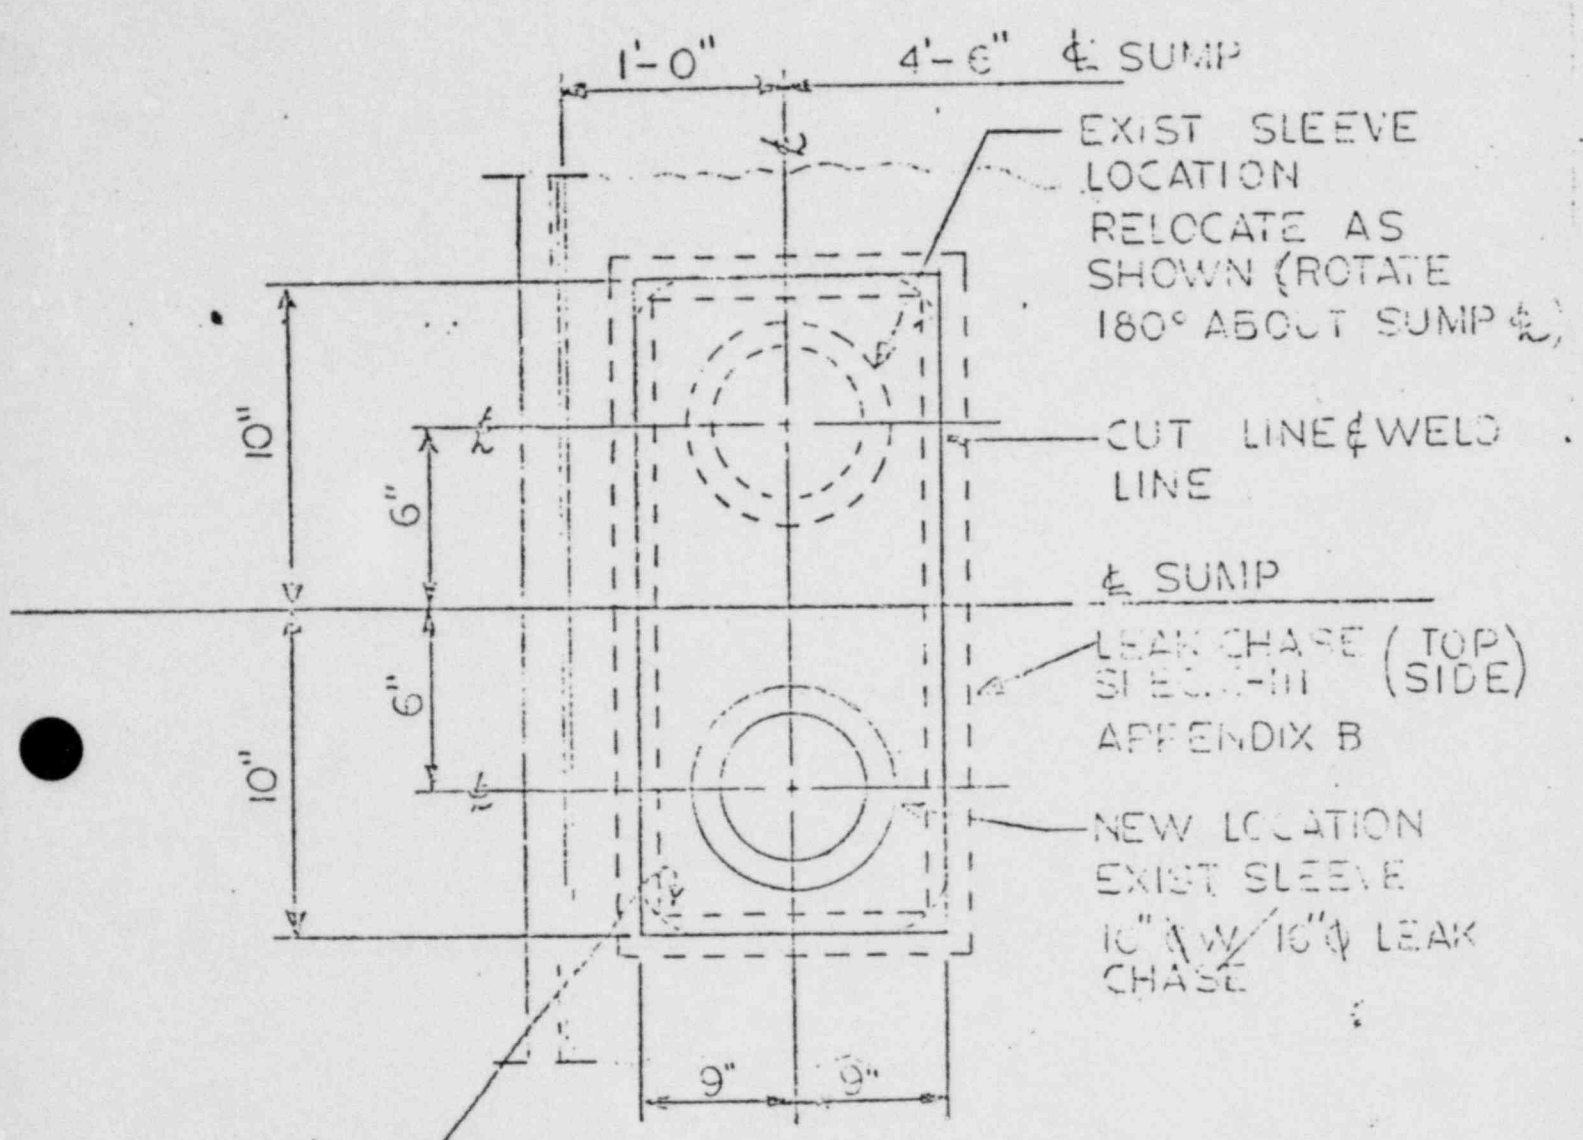
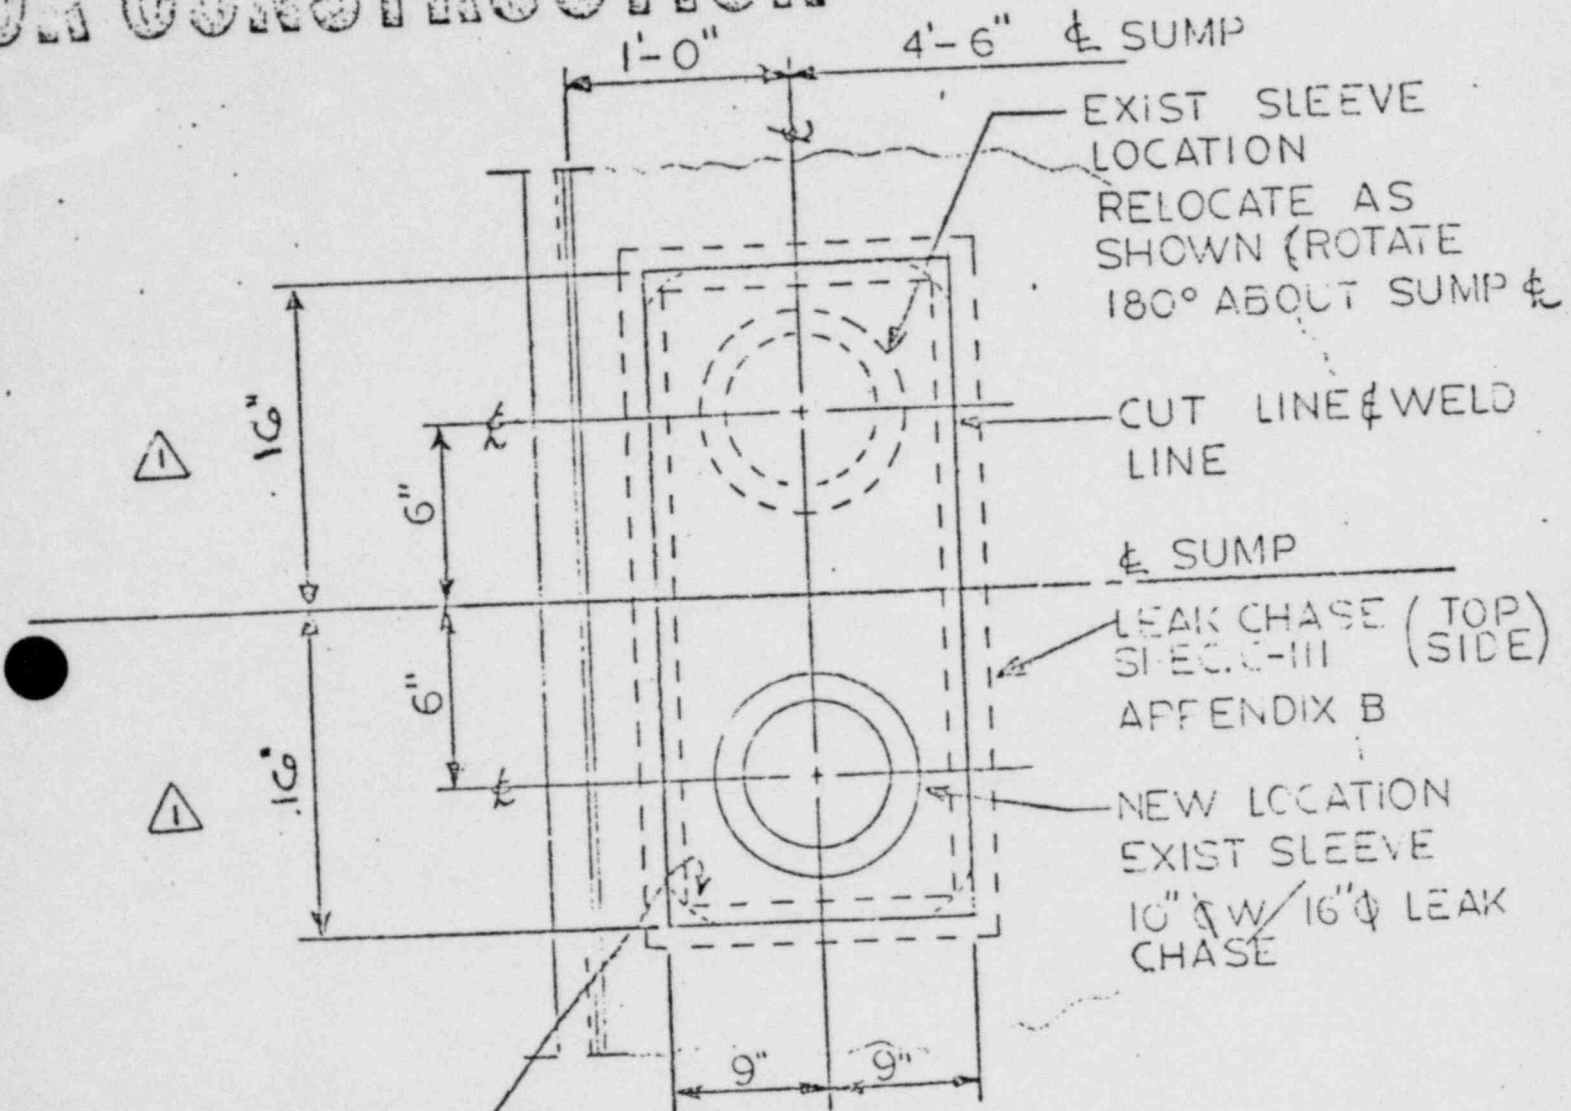
DR. ED	CHK. R.E.S.	DATE 2-15-74
BECHTEL POWER CORP. MIDLAND PLANT 112		
UNIT "2" SUMP 10" DIA. SLEEVE RELOCATION		
JOB NO.	DRAWING NO.	
7210	ESK C-03

59	2-13-74	L. R. Albert	C-111. No procedure for removal of "B" series sleeves from thickened liner plate in C-111 Rev. 2	Field	Not Applicable	2-22-74	3-6-74	L. R. Albert
60	2-14-74	S. S. Grant	C-50A. Sump liner plate fabricated incorrectly.	Field	2-18-74	2-18-74		
				2-15-74	Info.			
61	2-14-74	G. W. Knoll	C-230. Time of set test for cement not in conformance with ASTM C-150 & Spec. C-230.	Not Applicable	2-19-74	2-27-74	2-27-74	L. R. Albert
62	2-14-74	G. W. Knoll	C-230. Liquid admixtures for concrete placed to date in violation of Spec. C-230 (contain Chloride)	Not Applicable	2-19-74	2-27-74	2-27-74	L. R. Albert
63	2-14-74	A. L. Boulden	C-111. Plate S1-3-II-2 Elev. 609' bend greater than 1/8" measured w/ 24" straight edge.	Field	Not Applicable	3-5-74		
				2-14-74				
51 Rev. 1	2-8-74	P. T. Carpenter	C-230. Placements CC(582.25)a, A(578.67)a&b, CC(580)a, A(573)a. Air test data.	Not Applicable	2-18-74

EXIST SLEEVE LOCATION
 RELOCATE AS SHOWN (ROTATE 180° ABOUT SUMP &)

CUT LINE & WELD LINE
