Xerox & Third-Party Toners – Reliability Test Report

Xerox Phaser 6360 Color Laser Printer

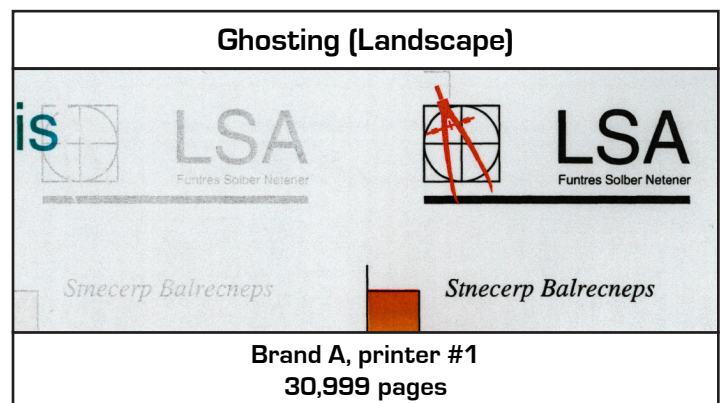
A second print quality issue – ghosting, the faint copying of parts of the print image on additional areas of the page – began to be barely discernible on one of the printers using Brand A toner at 10,000 prints, and by 16,000 prints, ghosting could clearly be seen on output from all three printers.

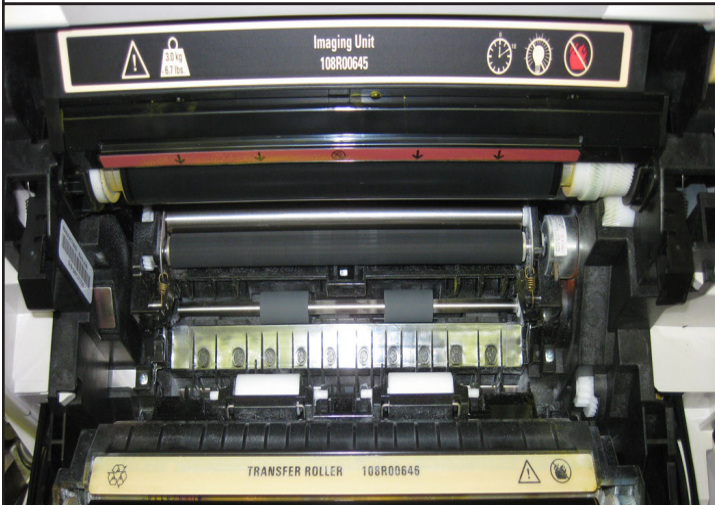
Xerox OEM Cartridges - Minor Accumulation
78,899 pages, printer #3

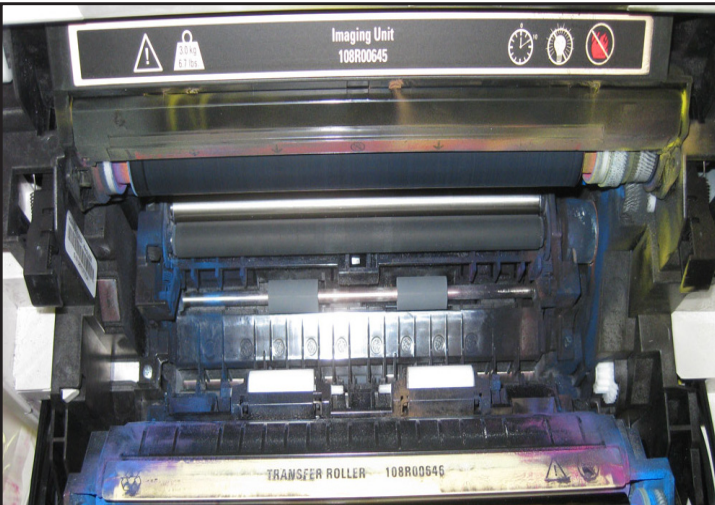
Brand A toner cartridges experienced excessive toner leakage. Black and Magenta toner were the most frequent to leak, for unknown reasons. Black Toner was leaking so excessively that toner emerged from the Manual Tray on printer #1 causing it to be unusable – clean paper would become covered with Black toner before printing. Toner leaked into the printers themselves causing print quality issues, paper jams, and even printer failures. An exception was printer #3 in which only Black toner leaked so much as to infiltrate the Imaging Units; no Magenta toner was found as noticed in printer #1 and #2 Imaging Units. While printing continued, Black and Magenta toner usage increased rapidly. Yellow and Cyan had visible leakage, but it was not as drastic as with Magenta and Black Toners. Toner cartridge leakage also caused the Imaging Units and Transfer Rollers used with Brand A to be damaged well before their rated life of up to 35,000 pages.

Brand A - Significant Toner Leakage
66,039 pages, printer #3

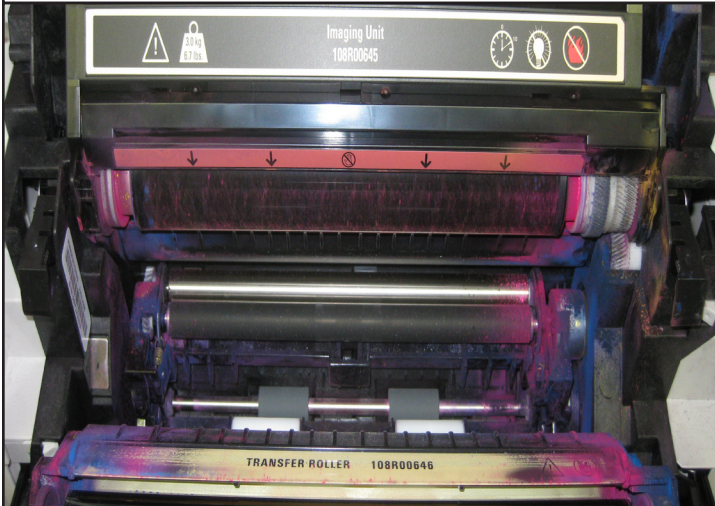
Brand B - Significant Toner Leakage
38,337 pages, printer #2

Brand B toner cartridges also experienced excessive toner leakage. All three printers dedicated to Brand B testing had Magenta toner cartridge leakage; printer #1 also had Yellow toner leakage. Again on all three printers, loose toner was observed on Manual Tray 1, Imaging Unit gears were stripped, and Transfer Roller life declined by about half.

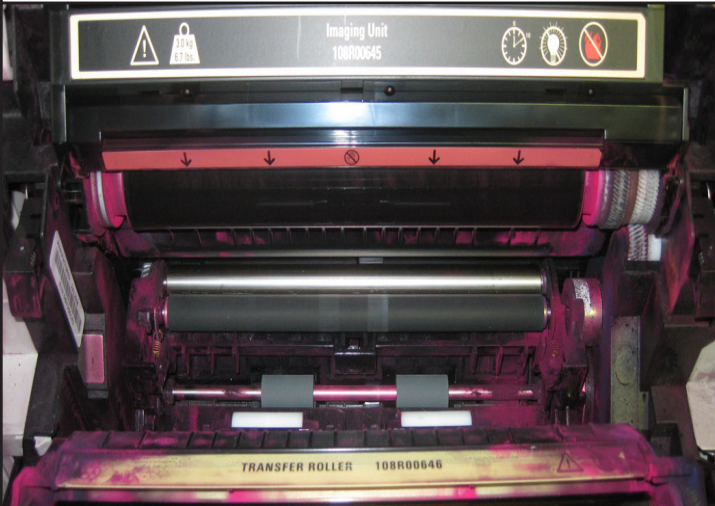
Brand C - Significant Toner Leakage
41,503 pages, printer #2

Brand C toner cartridges had excessive toner leakage in their dedicated printers, resembling those of Brand A and Brand B. Toner leakage was primarily from Black cartridges, but printer #2 also had loose Magenta Toner. All three printers had toner appear in Manual Tray 1 and Imaging Unit gears were stripped.

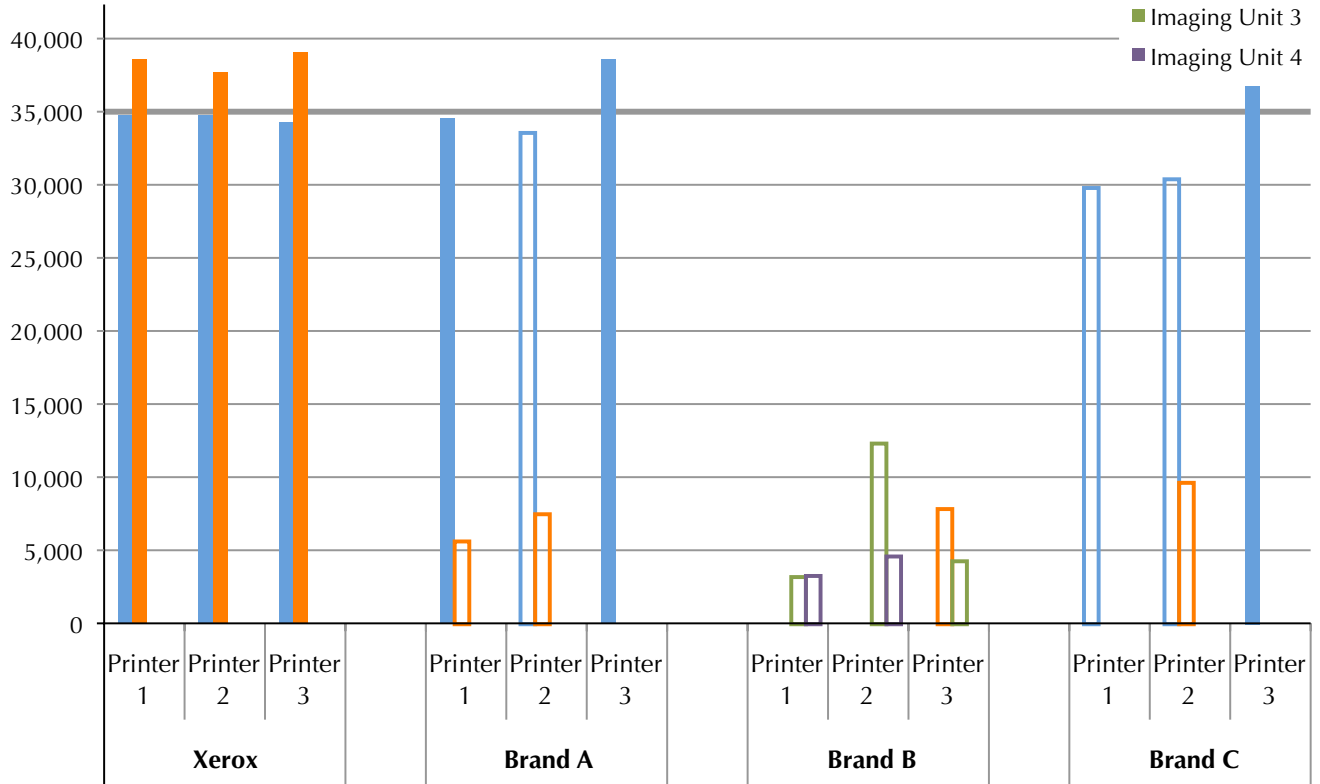
Imaging Unit Life

its gear had worn down. Gears in both Imaging Units used in printer #2 wore down, the first managing 33,500 pages while only 7500 pages for the second. Printer #3 did not have a failed Imaging Unit; perhaps significantly, only Black toner leaked as noted above. Since printer #1 and #2 Imaging Units' gears were permanently damaged by the toner, vacuuming the loose toner out of the printer was to no avail.

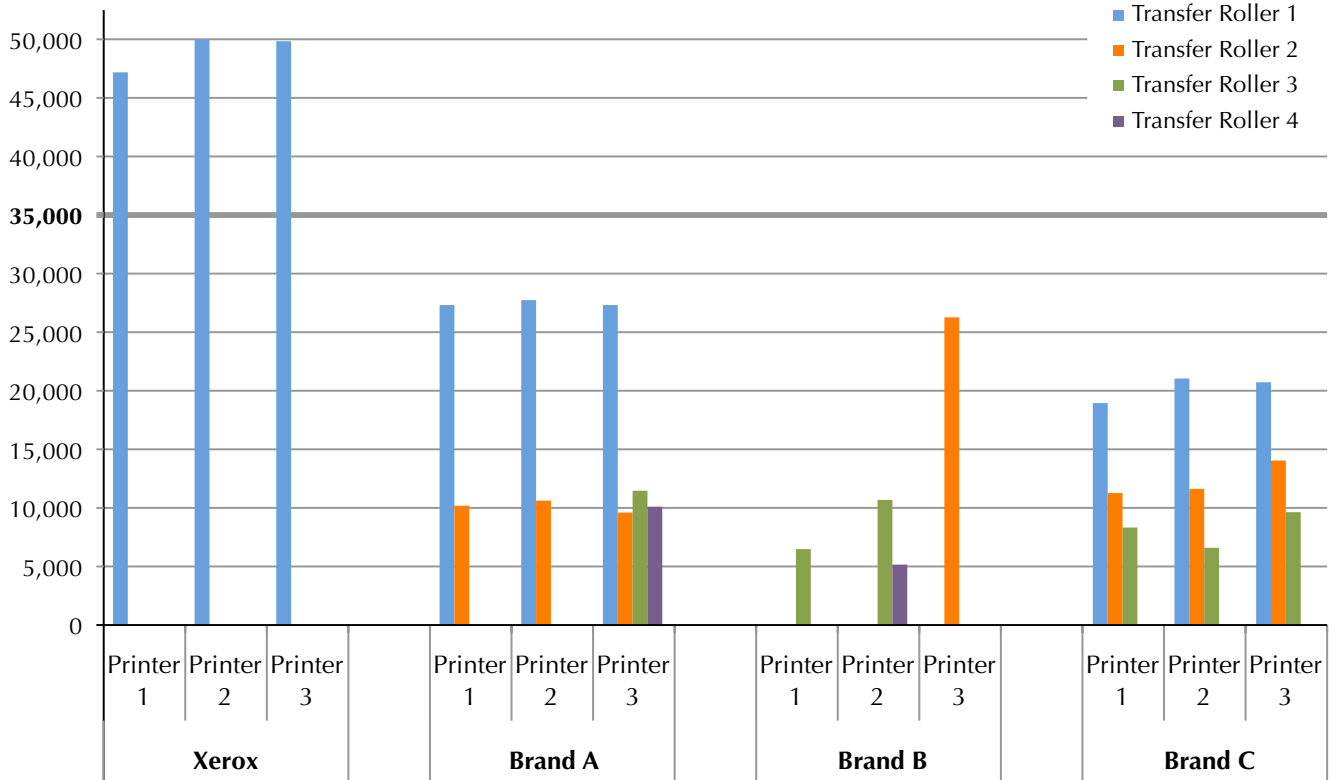
Transfer Roller Life

Transfer Rollers became covered with toner from leaking cartridges, shortening their life. First Transfer Rollers printed 27,292, 27,715, and 27,295 pages for each of the three printers, respectively, while the second Transfer Rollers only printed 10,203, 10,637, and 9621 pages for each of the three printers, respectively; toner leakage cut Transfer Roller life by about half.

Transfer Roller life declined rapidly, as with Brand A and Brand B toner cartridges. Printer #1 used three Transfer Rollers which reached 18,942 pages, then 11,283 pages, and finally 8345 pages. Transfer Rollers from printer #2 had descending yields as well; 21,035, 11,637, and 6621 pages. Printer #3 also used three Transfer Rollers; 20,716, 14,052, and the last with 9653 pages.

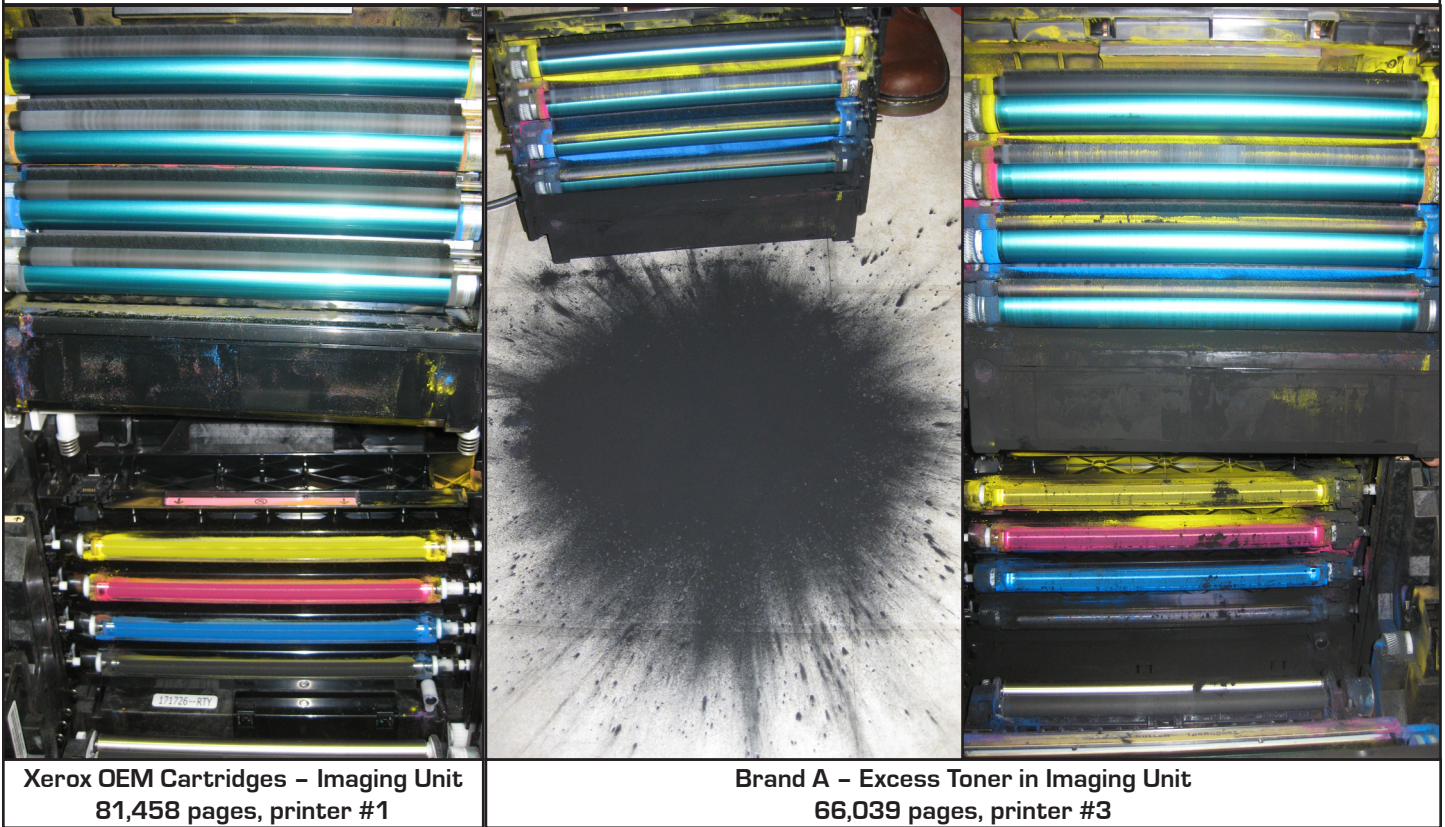
Replacing Imaging Unit

Xerox OEM Cartridges - Imaging Unit
81,458 pages, printer #1

Brand A - Excess Toner in Imaging Unit
66,039 pages, printer #3

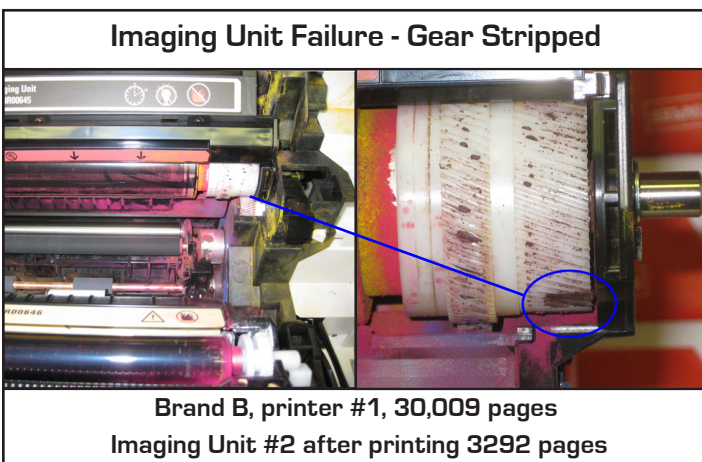
Brand B, printer #1, 30,009 pages
Imaging Unit #2 after printing 3292 pages

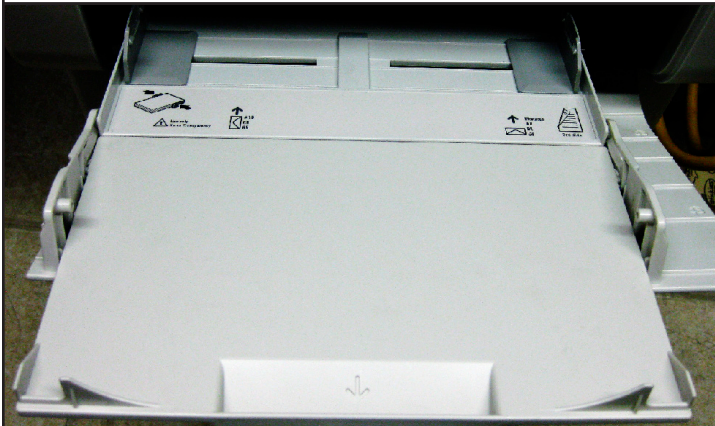
Xerox OEM Cartridges, printer #2
84,290 pages

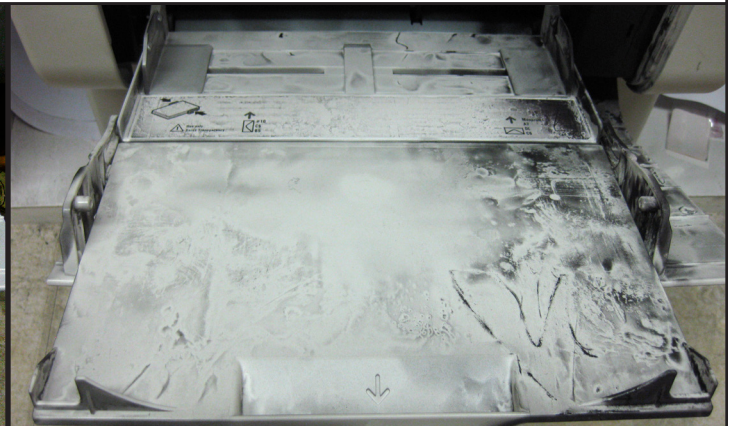
Brand A, printer #2
41,000 pages

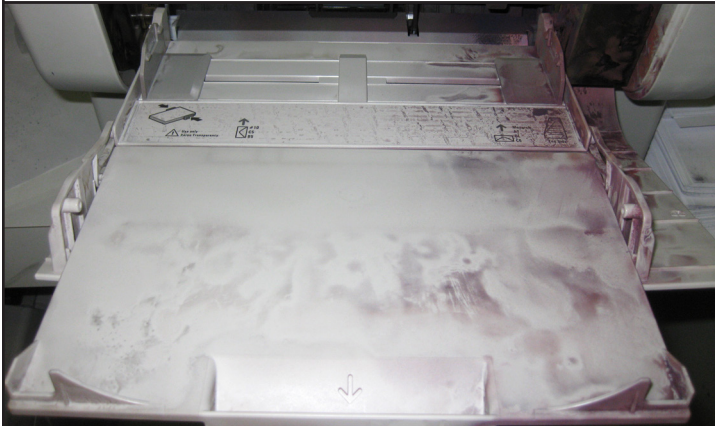
Brand B, printer #3
28,385 pages

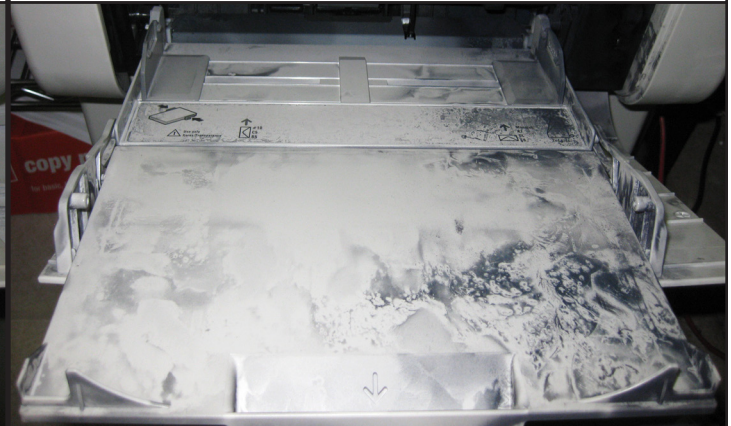
Brand C, printer #1
38,848 pages
