**HONDA**

AMERICAN HONDA MOTOR CO., INC.

**600 SEDAN – WHEEL SETTING (LUG) NUT TORQUE  
SPECIFICATION AND TIGHTENING PROCEDURE**

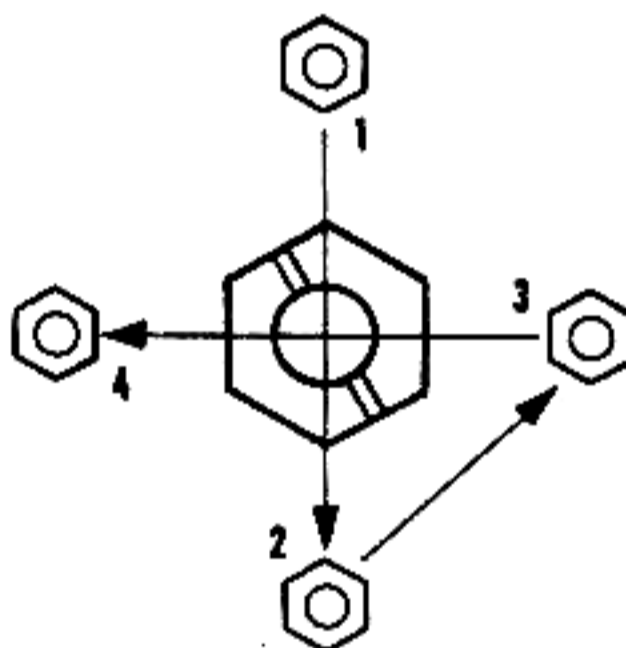
TORQUE SPECIFICATION: 4.0-4.8 KgM (28.9-34.7 lb-ft)

Whenever a wheel is removed and remounted, the wheel setting (lug) nuts should be tightened in the sequence shown below.

**CAUTION: DO NOT TIGHTEN THE NUTS TO MORE THAN 4.8 KgM (34.7 lb-ft)**AMERICAN HONDA MOTOR CO., INC.  
AUTOMOBILE SERVICE DEPARTMENT

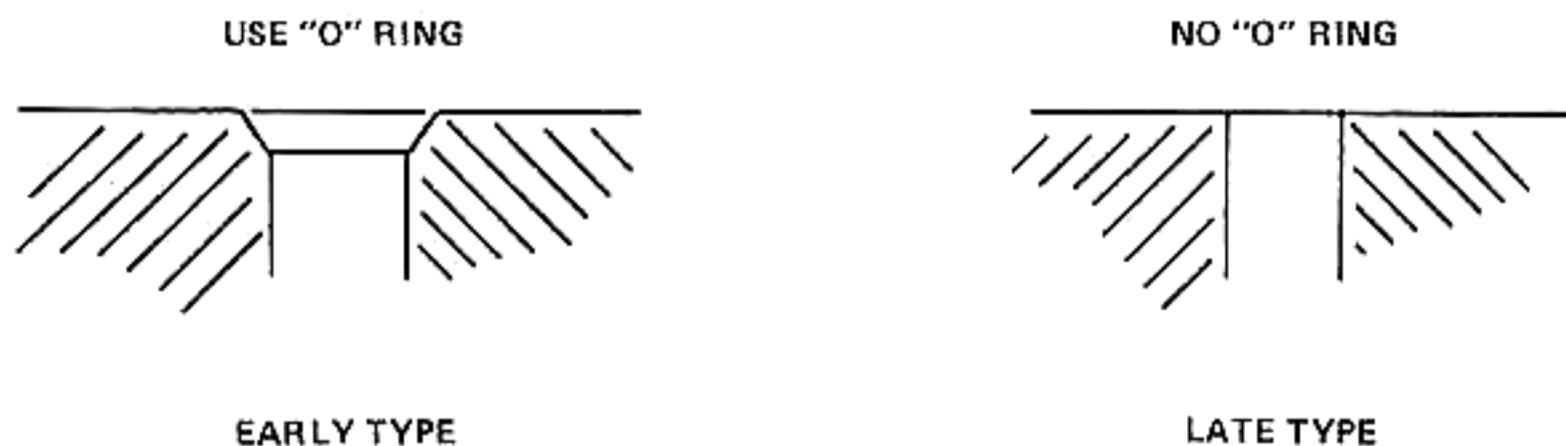
**CYLINDER BARREL**

Beginning with engine number N600E-1025937, the cylinder barrel has been modified to eliminate the use of "O" rings P/N 91326-568-003 on cylinder stud "A" between the cylinder barrel and the upper crankcase. These "O" rings must not be used when installing the new type cylinder barrel P/N 12100-568-682 on either the early or late type engines. The "O" rings should still be used with the early type cylinder barrel P/N 12100-568-680 or 12100-568-681.

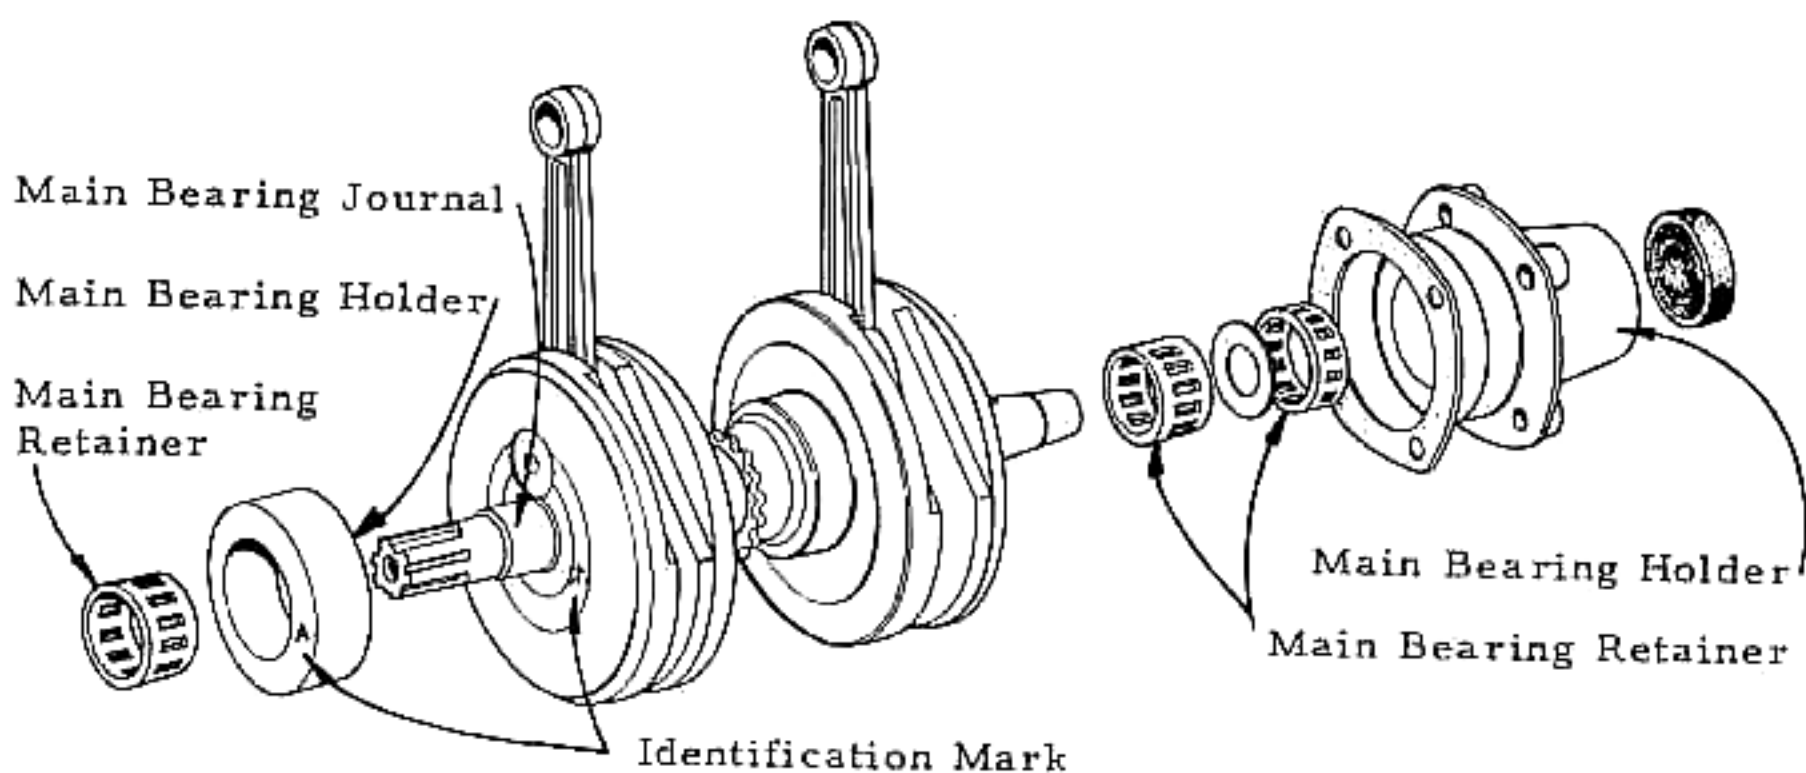
HONDA 600  
CRANKSHAFT MAIN BEARING ROLLER SELECTION CHART

The total clearance between the main bearing journal, roller and holder is 0.016 - 0.026 mm (0.00063 - 0.00102 in.) To make proper roller selection possible, the diameters of the crankshaft main bearing journal and holders are determined at the time of manufacture and inscribed on the respective part as indicated in the drawing below. If the crankshaft counterweight is marked either "C" or " / \ ", and the bearing holder is marked "F", find the "C" on the crankshaft main journal list and then move across the chart to the "F" column under the outer main bearing holder group - in this case -0.008 to -0.010. Then choose the appropriate part numbers from the chart on page 2. Whenever two marks are given on the bearing holder or crankshaft, choose the larger undersize roller. For example, if the crankshaft is marked "BC" or " □ / \ ", and the bearing holder is marked "E", use the -0.008 to -0.010 rollers rather than the -0.006 to -0.008 rollers.

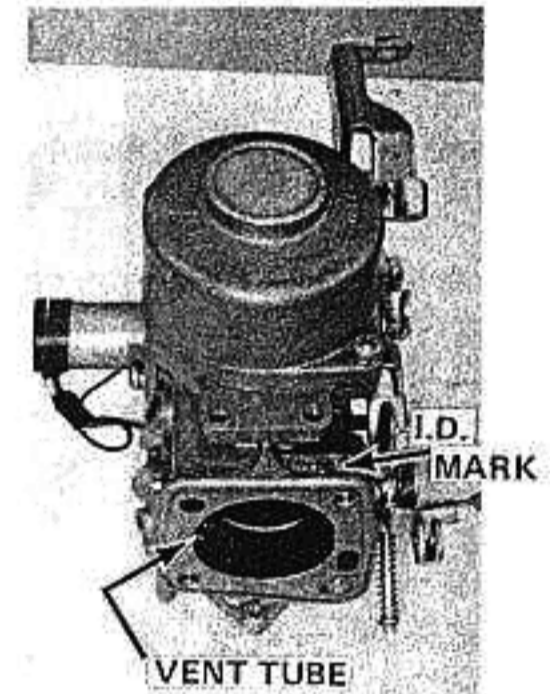
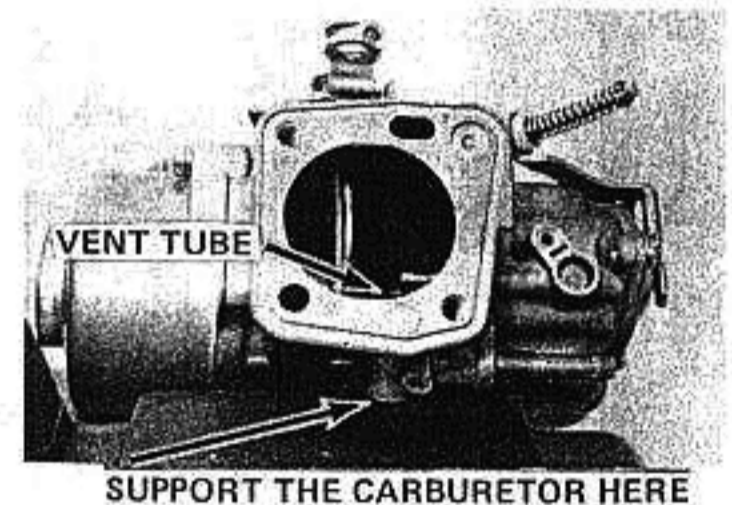
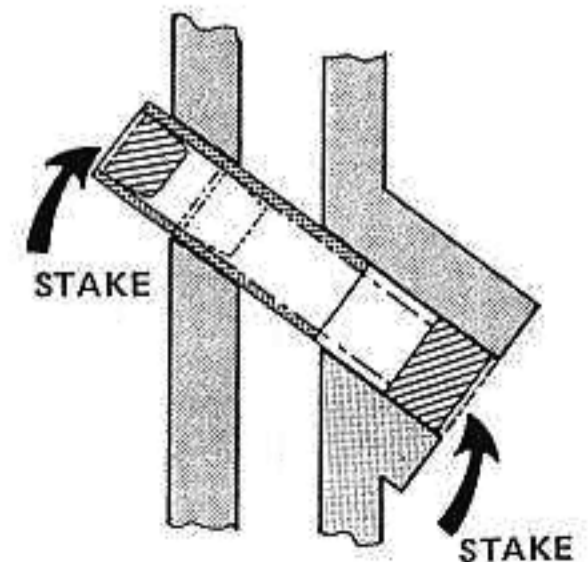
Under certain atmospheric conditions, some 600 Sedans and Coupes equipped with the 718A carburetor may experience a slight flat spot during rapid acceleration through a narrow band in the 4,000-4,500 rpm range. This condition can be corrected by installing a plug in the float chamber vent tube which extends into the left side of the choke bore and a No. 150 secondary main jet.

Remove the carburetor, then remove the carburetor air funnel and the air cleaner to carburetor bellows. Place the carburetor on a vise in such a way that the plug located on the external side of the vent is supported (see photograph). Place the small end of the plug into the vent tube and tap it in carefully with a drift punch. **DO NOT USE A CENTER PUNCH OR PIN PUNCH.** Drive the plug 0.5mm below the edge of the tube and stake the edge of the tube to secure the plug. The tube may move in as indicated in the drawing, but this will not affect carburetor performance. Turn the carburetor over and rest the air funnel mating surface on a wooden block, drive the external plug 0.5mm below the edge of the boss and stake the edge over it.

Remove the carburetor float chamber body. Remove the primary and secondary main jets by rocking the clip plate back and forth while pulling it up. Replace the secondary jet and then reinstall both jets by positioning them in the clip plate and pressing the clip plate into the carburetor. Remount the float body.

After the carburetor has been installed, the car should be road tested to insure proper performance.

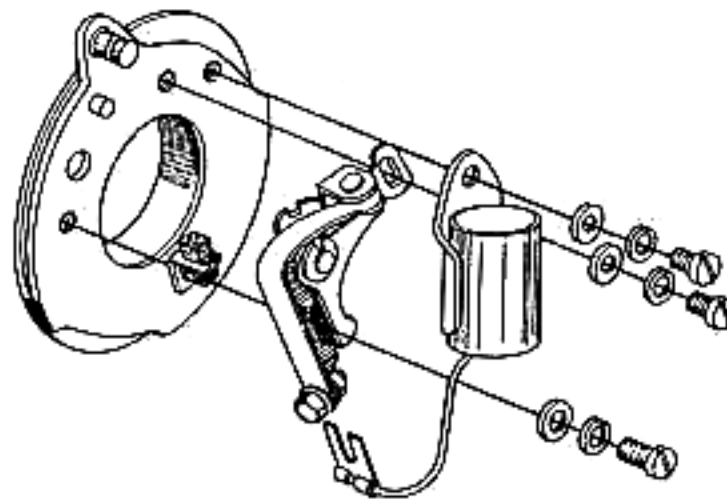
Whenever the screws used to secure the contact breaker point unit and condenser to the breaker plate are removed, they must be reinstalled with their lock washers and flat washers. If these washers are not mounted, the screws will extend through the upper portion of the breaker plate and cause it to bind. If the breaker plate binds, the action of the vacuum advance mechanism will be severely restricted, if not eliminated. Should you find a breaker plate where these washers have been removed, replace the washers on the condenser mounting screw. If this clamp is missing, it may be replaced with a 4mm flat washer (P/N 94101-04000).

After installing the washers, check the action of the vacuum advance mechanism. Start the engine and watch the contact breaker plate. If the plate moves counter-clockwise when the engine speed is increased to 4,000 rpm and clockwise when the speed is reduced, it is functioning properly. If the plate does not move, it has been damaged and must be replaced. The breaker plate should not be disassembled as no service is required and repair is not practical.

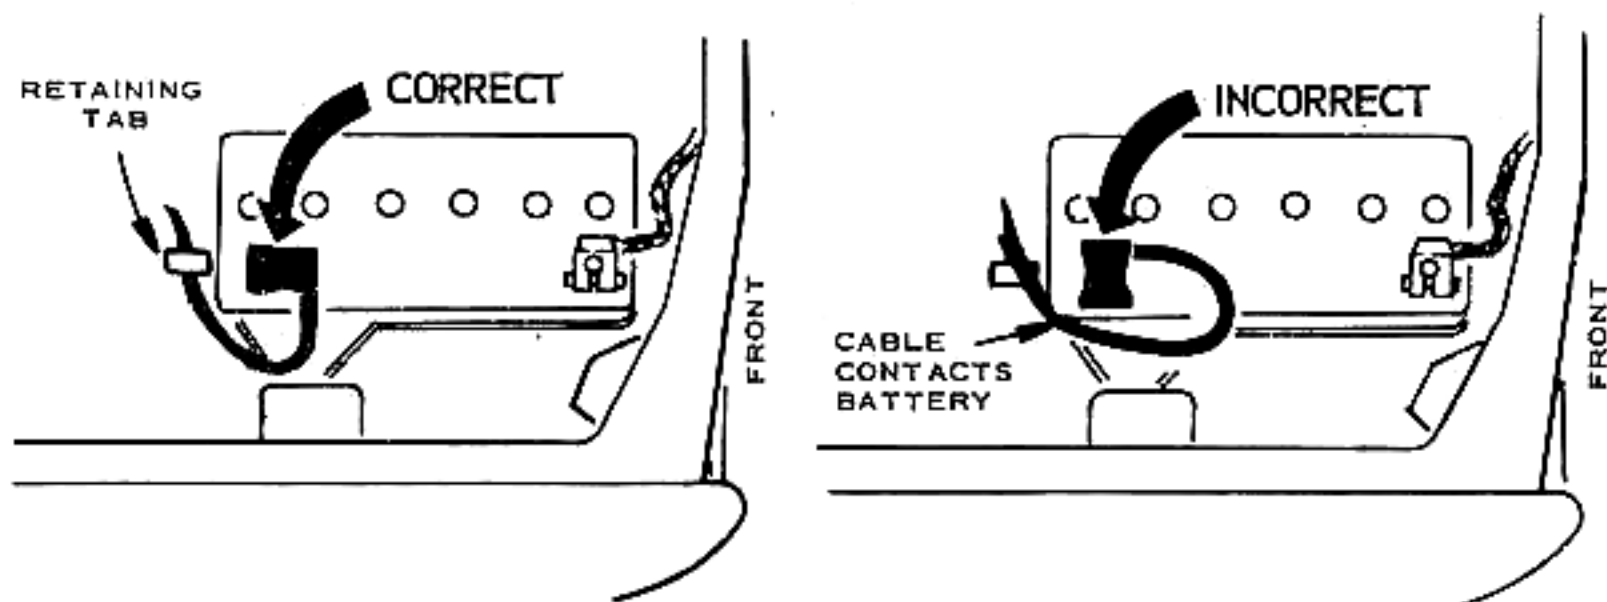
Whenever the Honda 600 Coupe's positive battery cable is disconnected, it must be remounted as shown in the illustration on the left. DO NOT mount the cable as shown on the right as it may cause it to rub against the battery case. After remounting the cable, check to be sure that it is being held away from the battery case by the retaining tab directly below the brake pipe grommet.

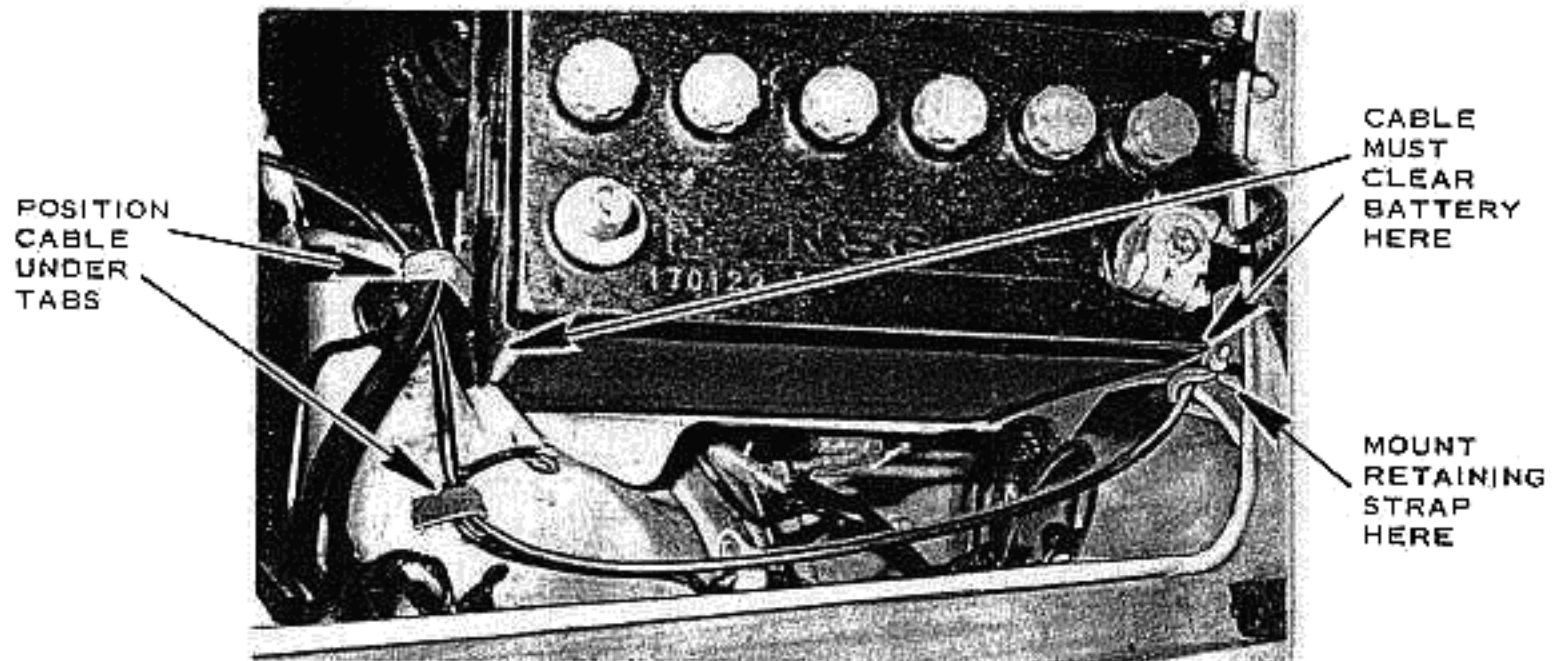
The Honda 600 Coupe hood latch release cable housing may rub against and damage the right front and rear corners of the battery. This condition can be prevented by the installation of a retaining strap to hold the cable away from the front edge of the battery case and by routing the cable through the retainer tabs in the engine compartment as shown in the photograph.

The hood latch release cable retaining strap must be installed and the cable must be routed under the tabs on all Honda 600 Coupes in your stock. All 600 Coupe Owners will be notified by mail to return to their dealers to have these services performed free of charge.

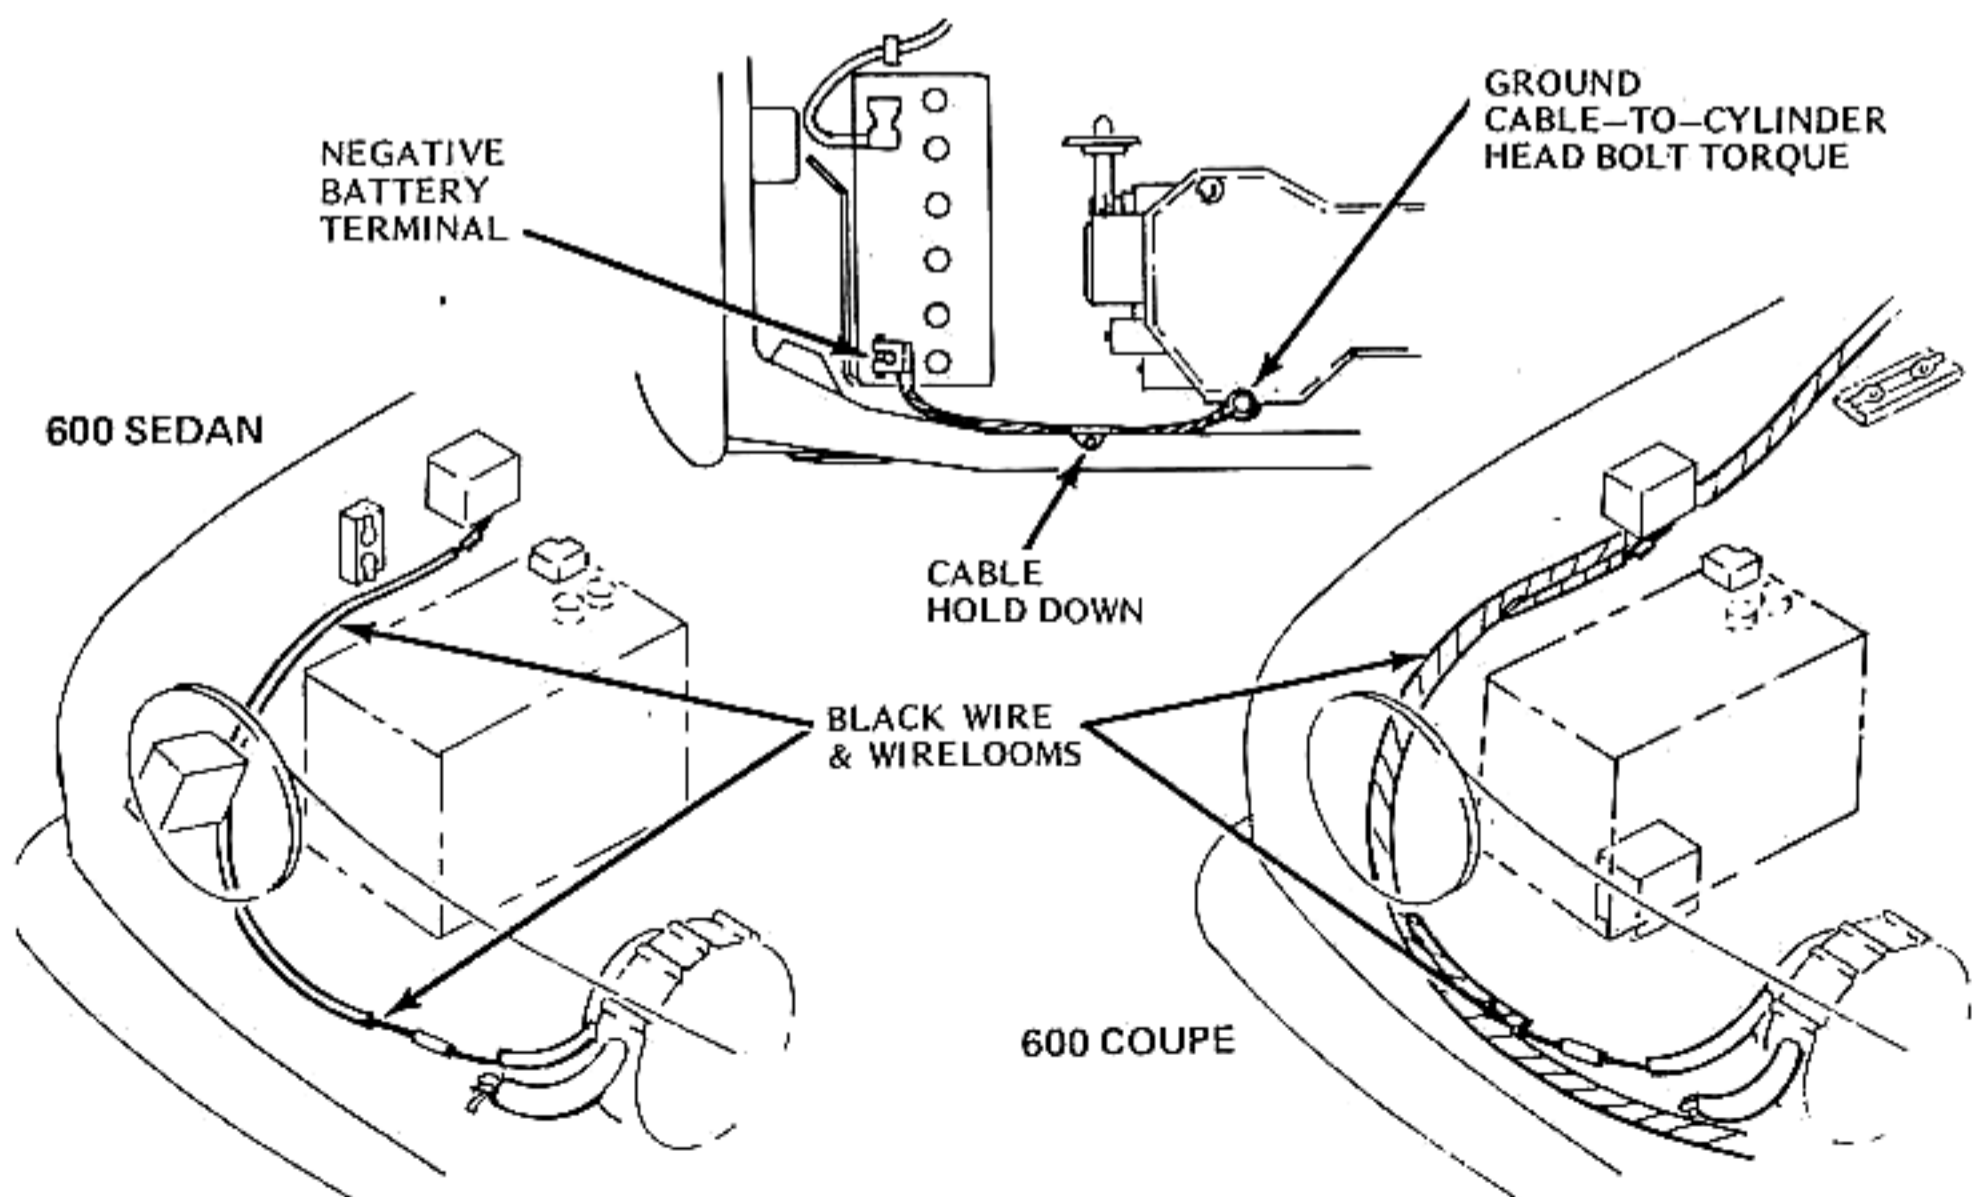
**GROUND CABLE TO ENGINE BOLT  
1.0-1.4 Kg-M (7-10 ft/lbs.)**

**SYMPTOMS:** Overheating or burning of the ground wire (black) from the voltage regulator to the alternator.

**DIAGNOSIS:** If the ground connection on the cylinder head is loose, the current that would normally flow through this cable is diverted through the black wire connecting the voltage regulator to the alternator. This wire is not designed to carry the heavy current loads and it will overheat. Damage to parts other than the ground wire (black) or its loom is unlikely but replacement of the wire may require a new set of alternator brushes and/or a new voltage regulator.

**CORRECTIVE ACTION:** The ground cables on all cars should be checked during routine servicing. Check for a loose ground cable-to-cylinder head bolt and check the cable for broken or frayed strands.

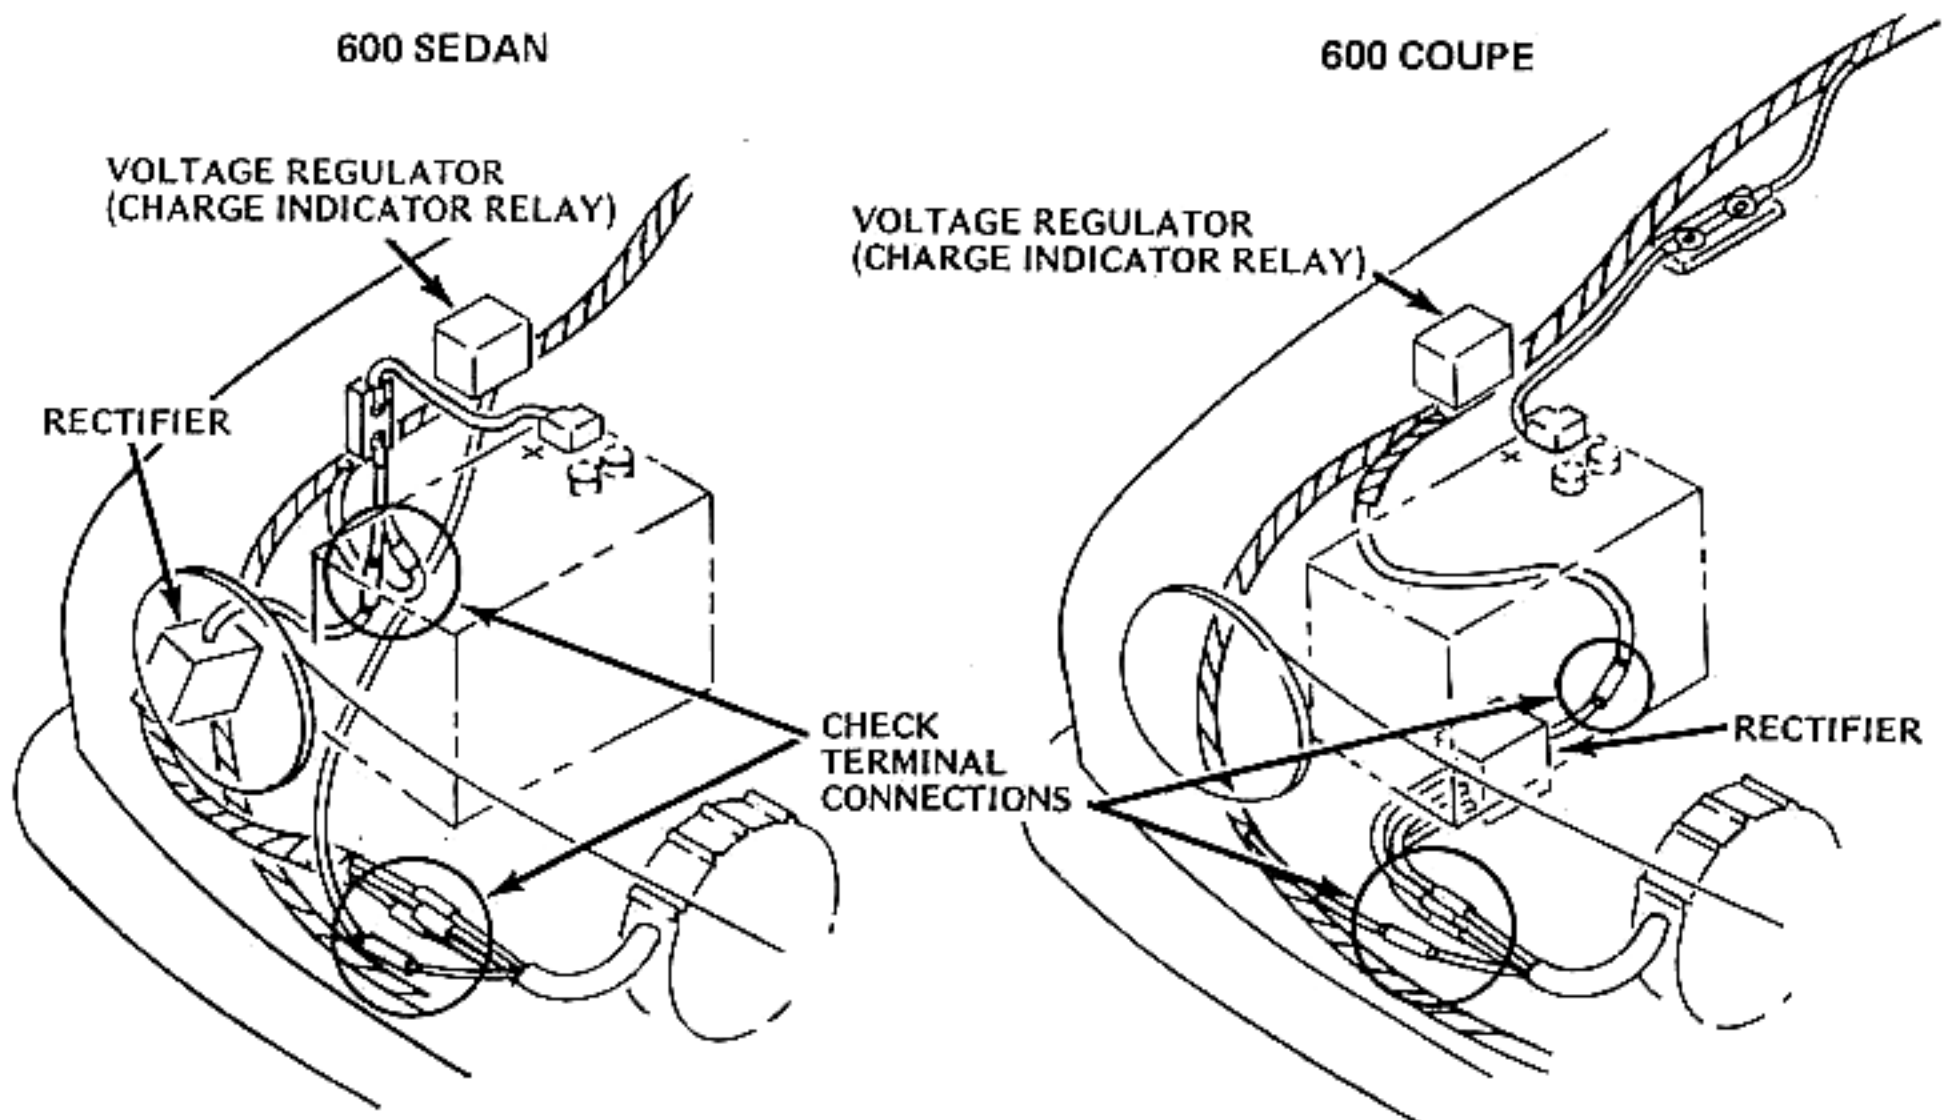
**SYMPTOMS:** Discoloration and possible melting of the charge indicator relay in the voltage regulator.

**DIAGNOSIS:** A poor connection at the rectifier output wire terminal will reduce current through the rectifier. This forces additional current through the wire (W/BL) between the stator and the voltage regulator and overheats the voltage regulator (charge indicator relay).

- Check the rectifier output wire terminal and the rectifier input terminals for loose or damaged connections.
- Start the engine and see if the charge indicator light goes out. If not, check the operation of the charge indicator relay.
- Check the amperage output and the no-load voltage to determine overall condition of charging system.

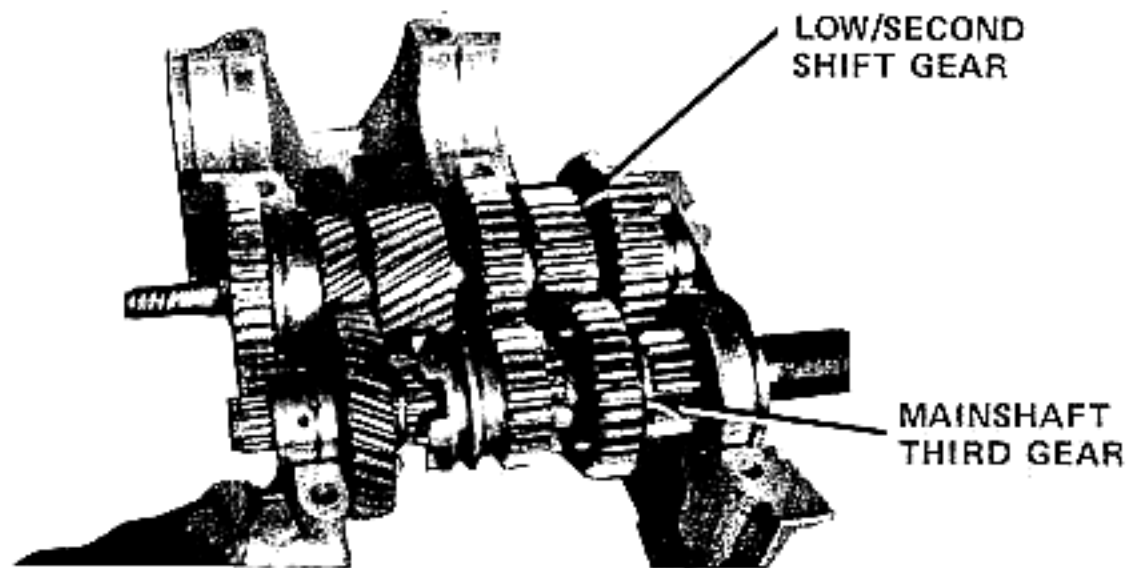
LOW/SECOND SHIFT  
 PN 23441-551-060  
 (DIA. 63.2MM)

MATES ONLY WITH

MAINSHAFT THIRD GEAR  
 PN 23470-568-030  
 (DIA. 64.6MM)

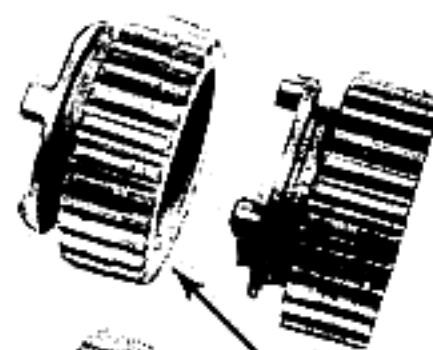
LOW/SECOND SHIFT GEAR  
 PN 23441-551-040  
 (DIA. 64MM)

MATES ONLY WITH

MAINSHAFT THIRD GEAR  
 PN 23470-568-020  
 (DIA. 64.1MM)
