# Historic Structures Report

## Olympia Brewery

Prepared by Chrisanne Beckner  
In Association with Artifacts Consulting, Inc.  
On Behalf of Old Brewhouse, LLC  
April 2011

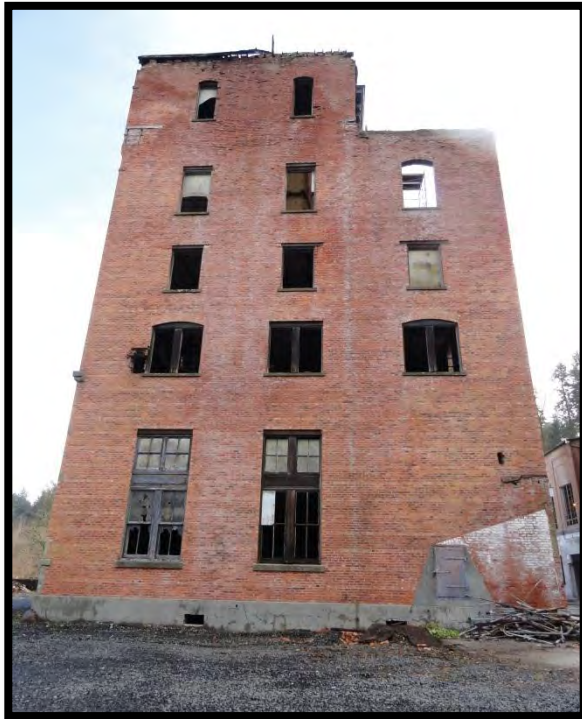
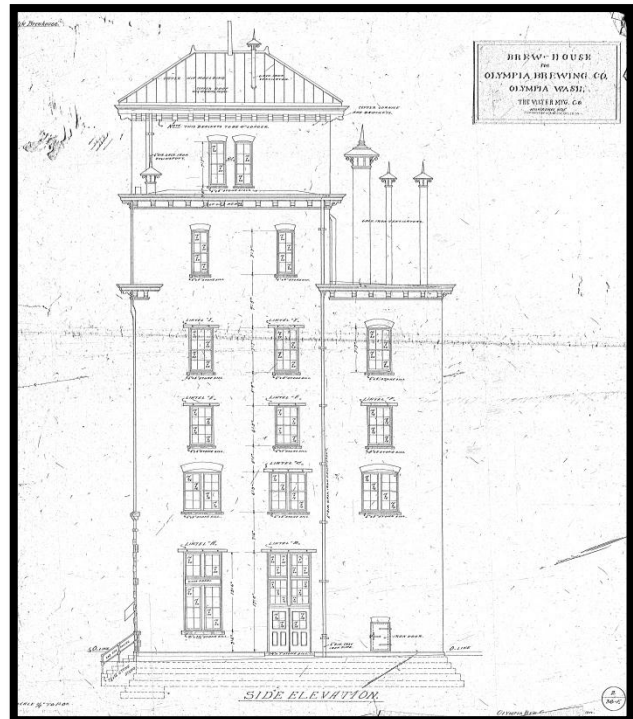
## West Elevation

The Brouwer House, heavily ornamented on the north façade, received less decorative treatment on the west façade. This elevation features three bays of various window types.

Here, damage to the roofs and cornices is extensive.

The western elevation faces the river and is perhaps the least visible of the building's four sides. Note that the steps and the door in the central bay were apparently not built as designed.

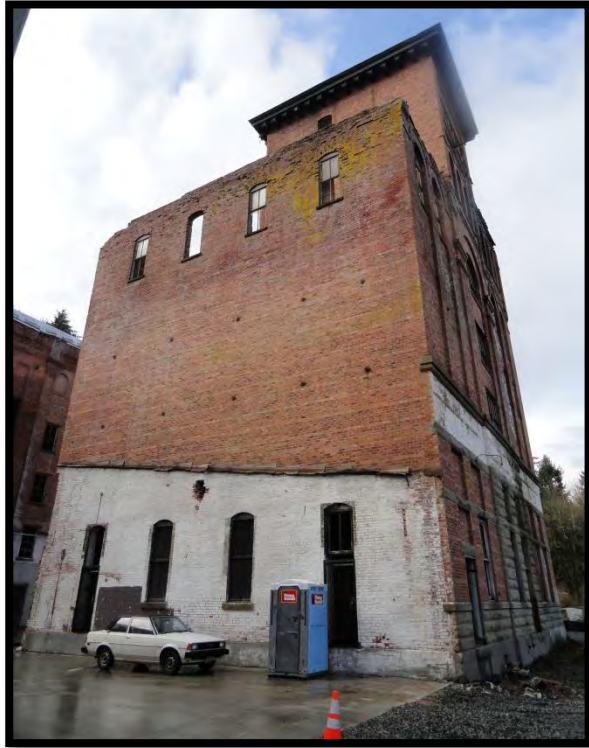
## East Elevation

The East elevation faces a storage building, just out of view. From the angle, the missing secondary roof is most obvious. This elevation is unusual in that it includes two exterior door and no windows on the second through fourth floors. This section of the building was used for grain storage and included large bins for malt, rice and grits, according to early plans.

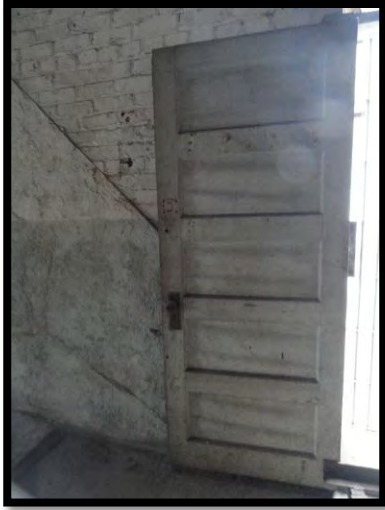
### First Floor Wooden Door

Material: Wood  
Condition: Good  
Significance: Primary

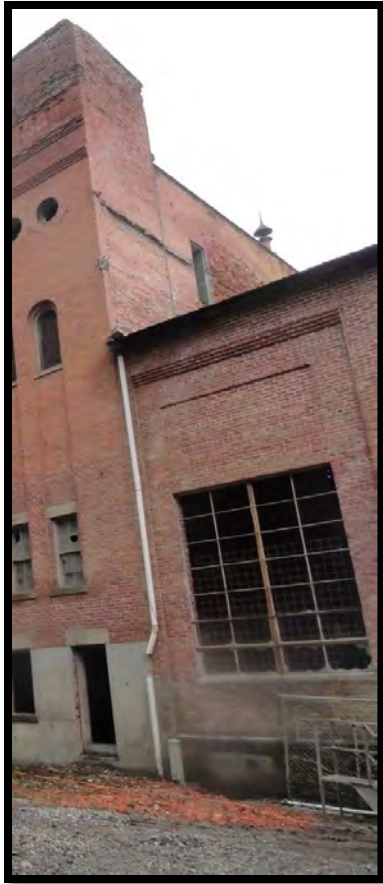
## South Elevation

Materials: Chehalis Brick  
American Bond: 6 stretcher courses per header  
Approximate size: 8 ¼" x 2 ½" x 4"  
Condition: Variable  
Significance: Primary

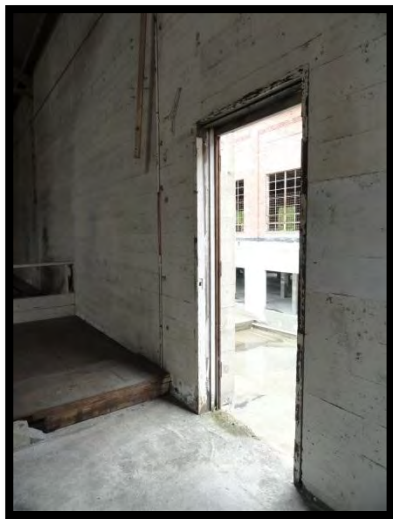
Materials: Missing  
Condition: Missing  
Significance: Secondary

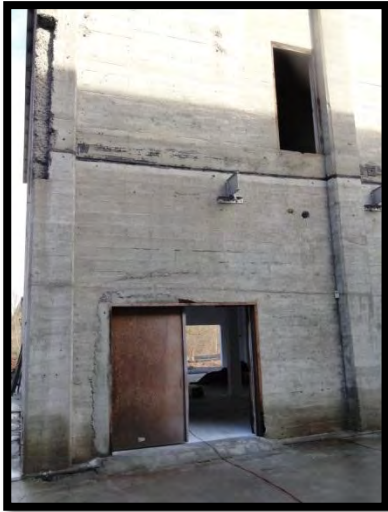
Materials: Wood Door and Casing  
Condition: Good/Missing  
Significance: Secondary

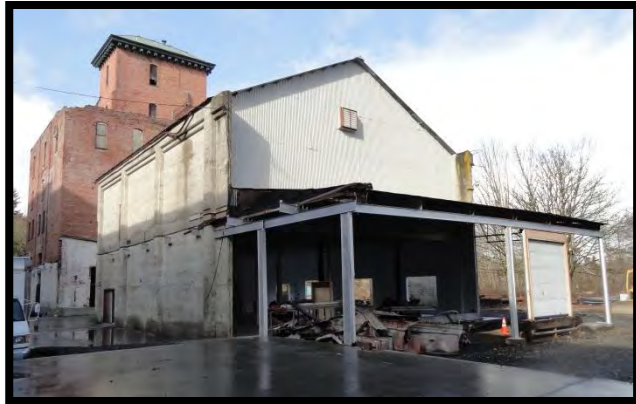
The east elevation is the most altered elevation on the North Storage Building. It is also the most mysterious. Instead of being made of concrete, the top floor is enclosed with sheet metal and the bottom floor is no longer enclosed at all, though the supports from a former single story addition remain. Rebar projects from the ends of the southern and northern concrete walls, suggesting that the building was never finished with a fourth concrete wall. The reasons for leaving the building unfinished are unknown, but a corrugated steel wall on the east elevation also appears in historic mid-century photos, along with the missing addition.

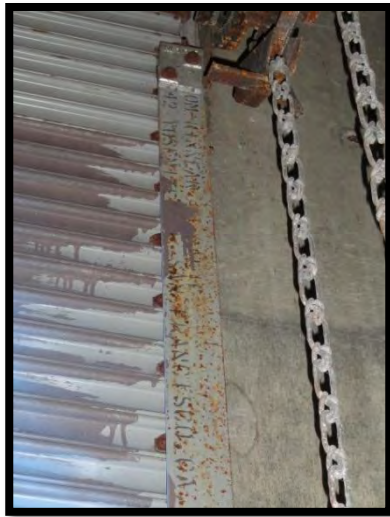
Materials: Steel  
Condition: Good  
Significance: Secondary
