HIGHWAY ACCIDENT REPORT

COLLISION BETWEEN METROLINK TRAIN 901 AND
MERCURY TRANSPORTATION, INC., TRACTOR-COMBINATION
VEHICLE AT HIGHWAY-RAILROAD GRADE CROSSING
IN GLENDALE, CALIFORNIA
ON JANUARY 28, 2000

**NTSB/HAR-01/02
PB2001-916202
Notation 7410
Adopted November 27, 2001**

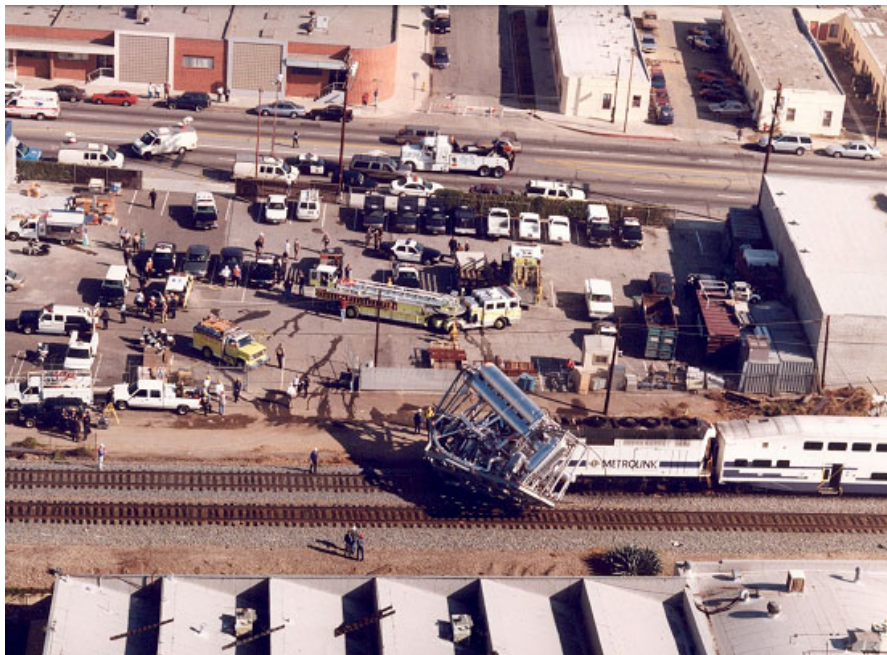
On January 28, 2000, about 5:56 a.m. (Pacific standard time) in Glendale, California, a tractor-combination vehicle, operated by Mercury Transportation, Inc., (Mercury) was transporting an oil refinery condenser unit, manufactured by Toromont Process Systems. The vehicle missed a turn in its planned route, traversed a highway-railroad grade crossing, turned around, and was attempting to retrace the crossing when it became lodged on the railroad tracks. About 90 seconds later, westbound Metrolink commuter train 901, operated by the Southern California Regional Rail Authority, collided with the vehicle. (See figure 1.) The Metrolink train had been traveling about 70 mph at the time of the collision. The engineer, conductor, and four passengers received minor injuries.

Figure 1. Final rest positions of train and vehicle. (Photograph source: Glendale, California, Police Department.)

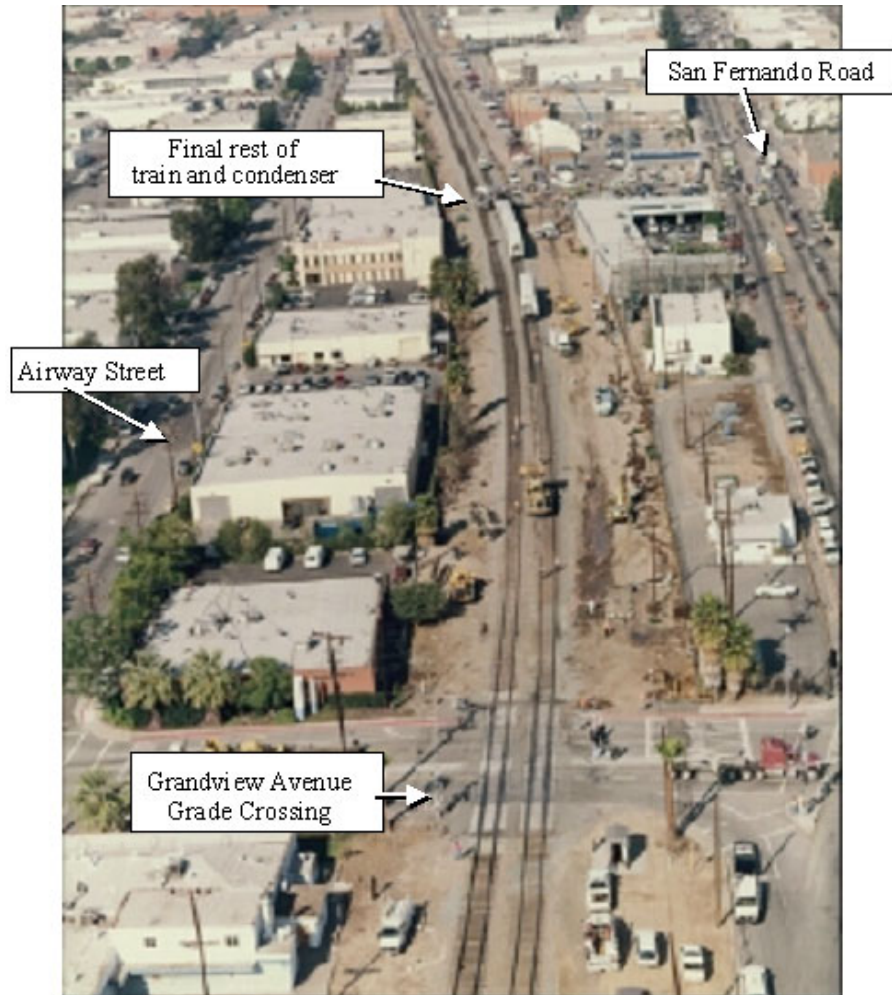
The truckdriver, seeing the approaching westbound train, ran back to the tractor and began to drive forward. He was able to move the tractor forward a few inches when the train struck the load. Two CHP officers said they saw the truck moving forward before the collision. The truckdriver said he was just starting to move off the tracks when the train hit the vehicle. The impact broke the semitrailer and rear “jeep”¹⁶ off the leading jeep. The train propelled the rear jeep about 101 feet west of the crossing where it came to rest along the south side of the tracks. The train carried the load about 1,100 feet west on

the tracks before coming to a stop on the tracks. (See figure 10.) Witnesses estimated the total time from the truck stopping on the tracks to impact was less than 90 seconds.

Figure 10. Aerial view of accident site. (Photograph source: Glendale, California, Police Department.)

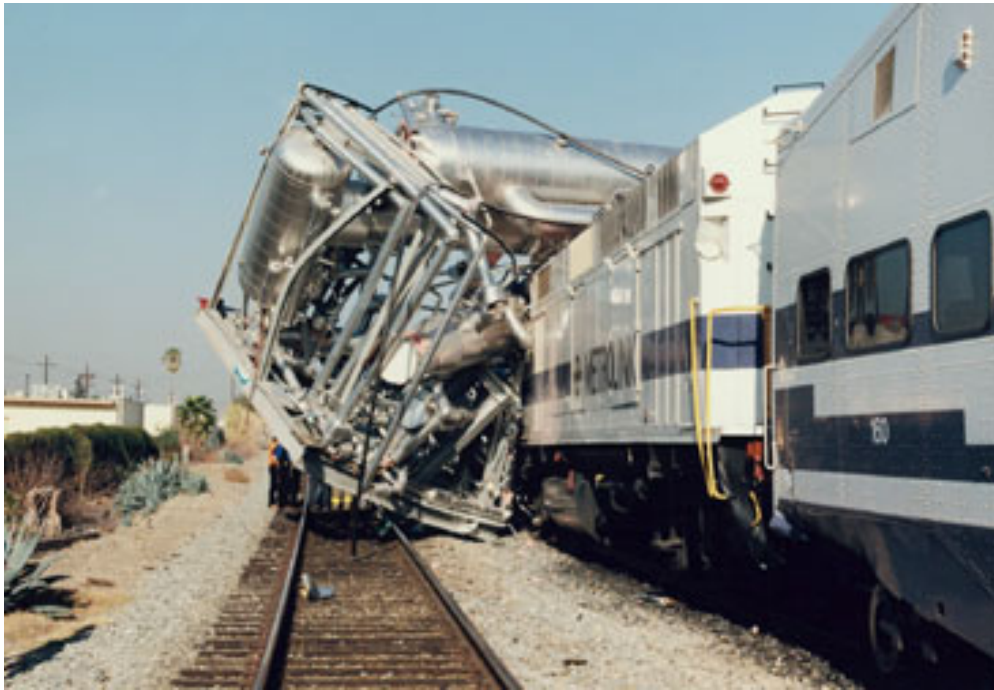
Figure 11. Postcollision view of condenser and train. (Photograph source: Glendale, California, Police Department.)

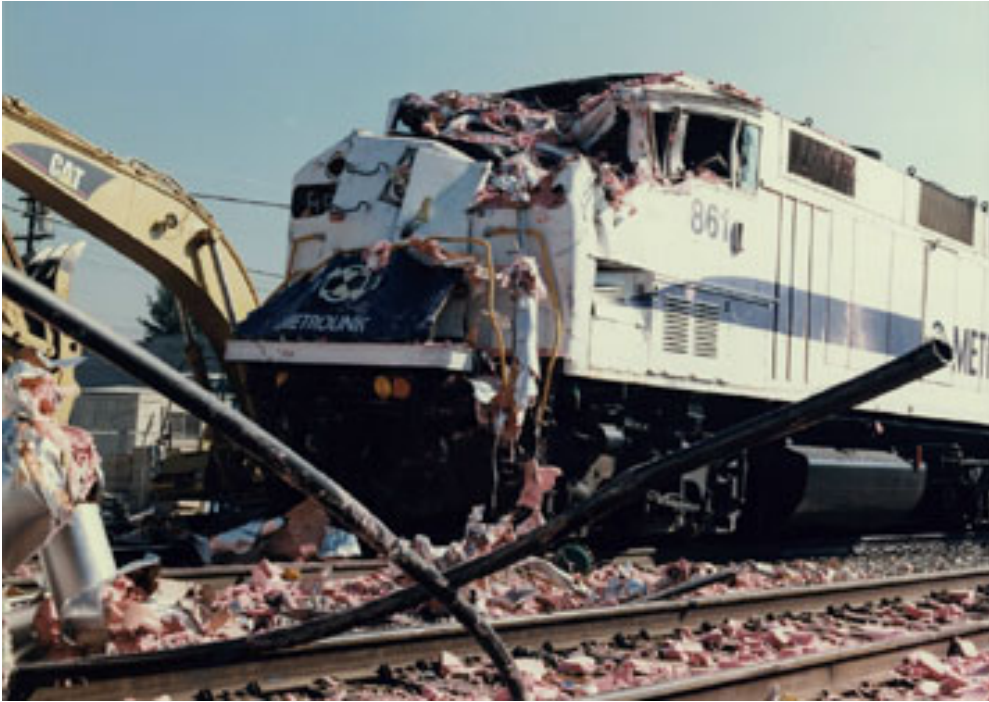
The collision resulted in severe damage to the locomotive (see figure 12) and minor exterior sheet metal damage to two coaches. The signal mast, lights, bells, and gate on the north side of the crossing were removed in the collision. No significant track damage occurred. The tractor was not damaged. The vehicle separated into three parts, and the oil refinery condenser was destroyed. (See table 2.)

Figure 12. Postcollision view of locomotive. (Photograph source: Glendale, California, Police Department.)
