Re: Third Five-Year Review, Luke Air Force Base, Arizona, July 2012

Final Third Five-Year Review Report

Luke Air Force Base, Arizona

July 2012

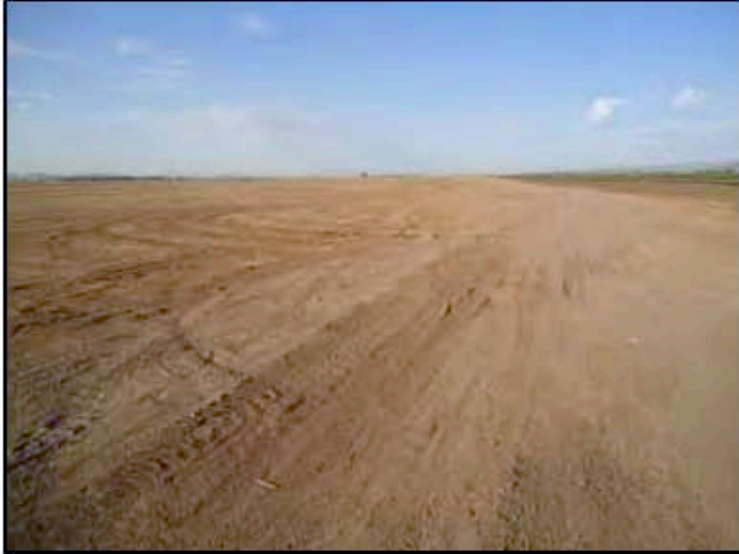
6. GENERAL SITE CONDITIONS	
Site is partially covered by runway.	
7. LANDFILL COVERS	
Not applicable	
8. VERTICAL BARRIER WALLS	
Not applicable	
9. GROUNDWATER/SURFACE WATER REMEDIES	
Not applicable

LF-03: Runway covers part of site,
no clear indication/delineation of
site boundaries.

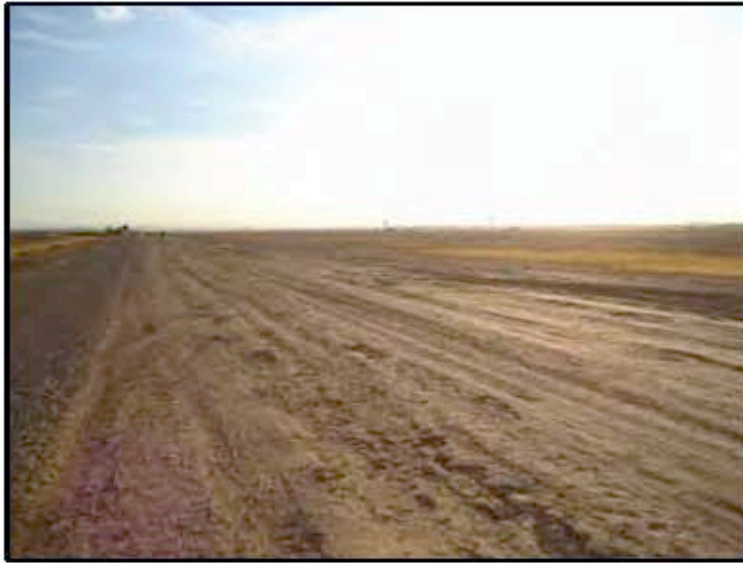
6. GENERAL SITE CONDITIONS	
Site is adjacent to active Base Skeet Shooting Range; some debris from range was observed during site inspection.	
7. LANDFILL COVERS	
Not applicable

LF-25: Looking northeast, site access road has been recently repaved

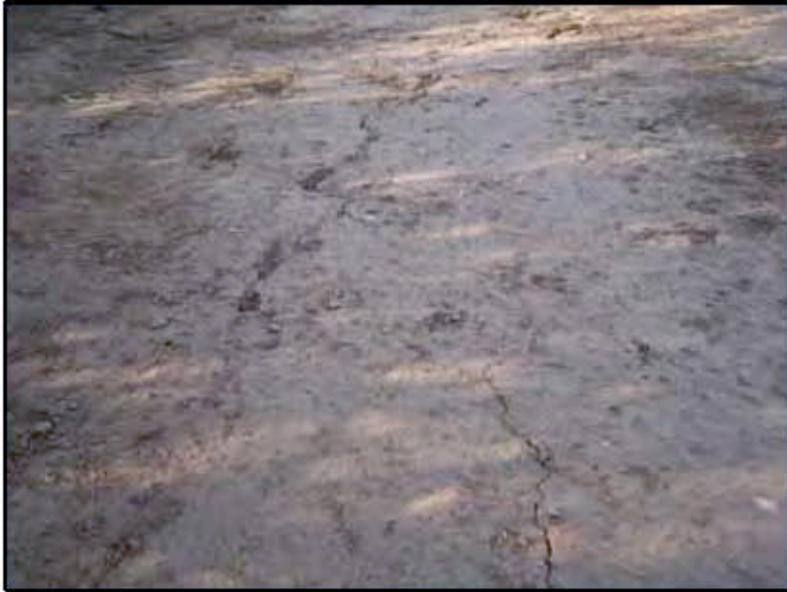
SD-20: Example of cracks in hardpan

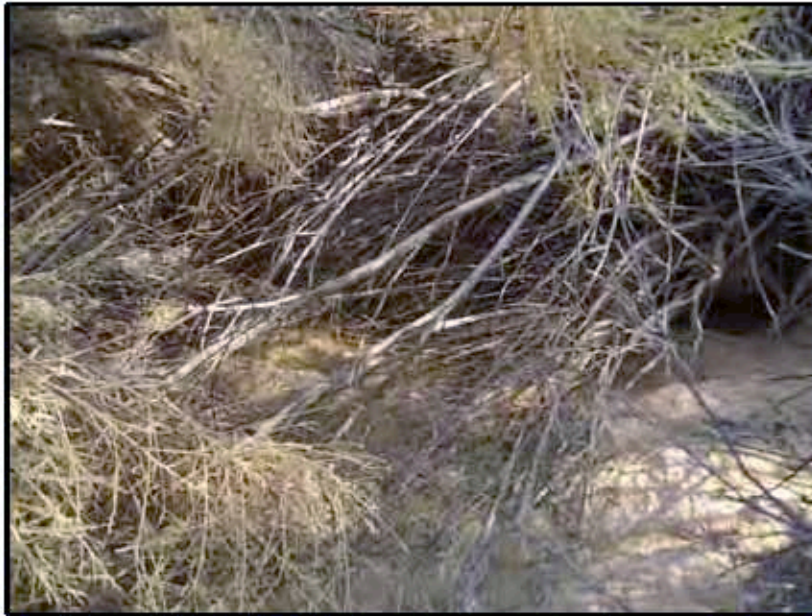
SD-20: Earth fissure located at south end of drainage channel

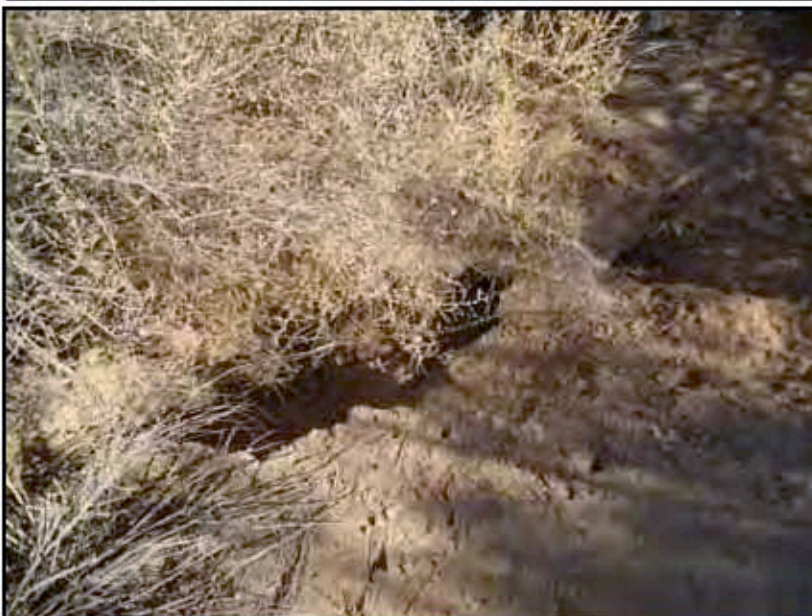
SD-20: Earth fissure located at south end of drainage channel

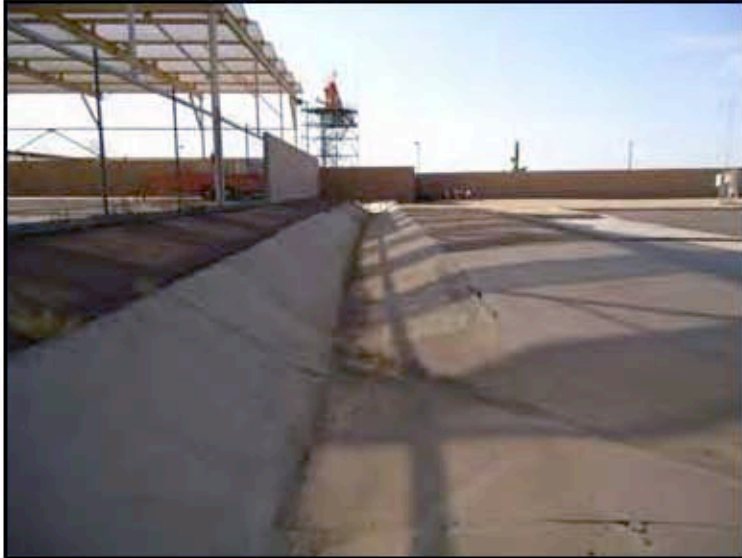
6. GENERAL SITE CONDITIONS	
Concrete drainage culvert by ST-18; contained minimal debris	
7. LANDFILL COVERS	
Not applicable	
8. VERTICAL BARRIER WALLS	
Not applicable

DP-23: Drainage channel near DP-13 area.

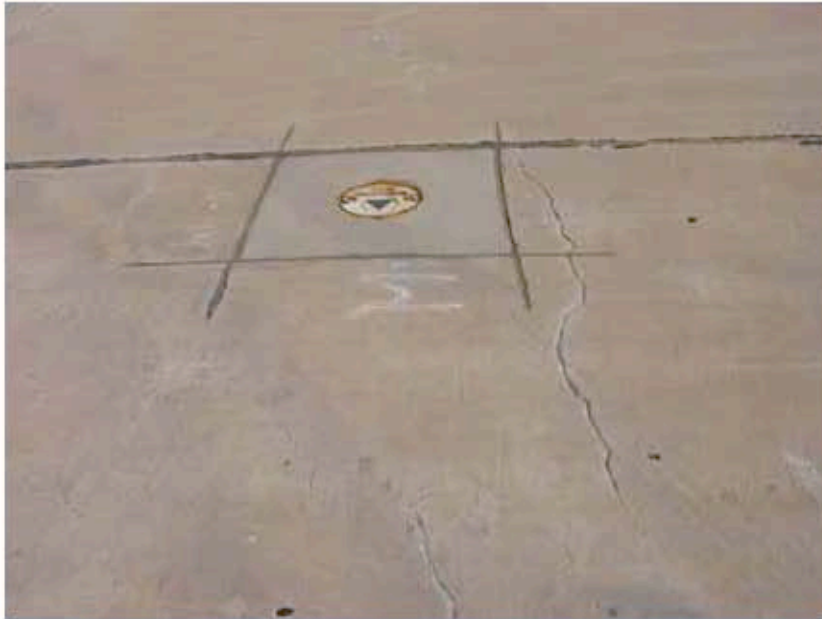
Photograph 2: January 2009 repair of concrete cuts around well completion, repairs performed by Tierra Dynamic.

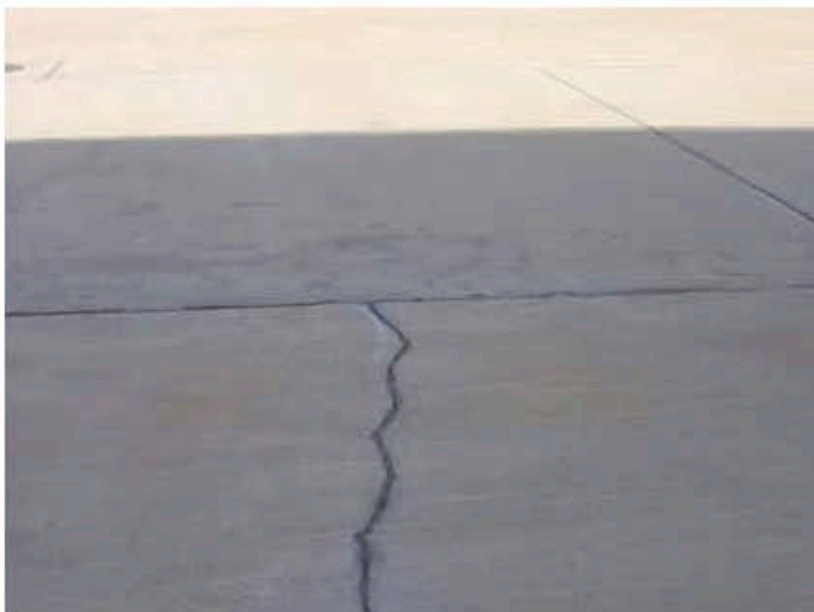
Photograph 3: Example of previous crack repair in good condition.

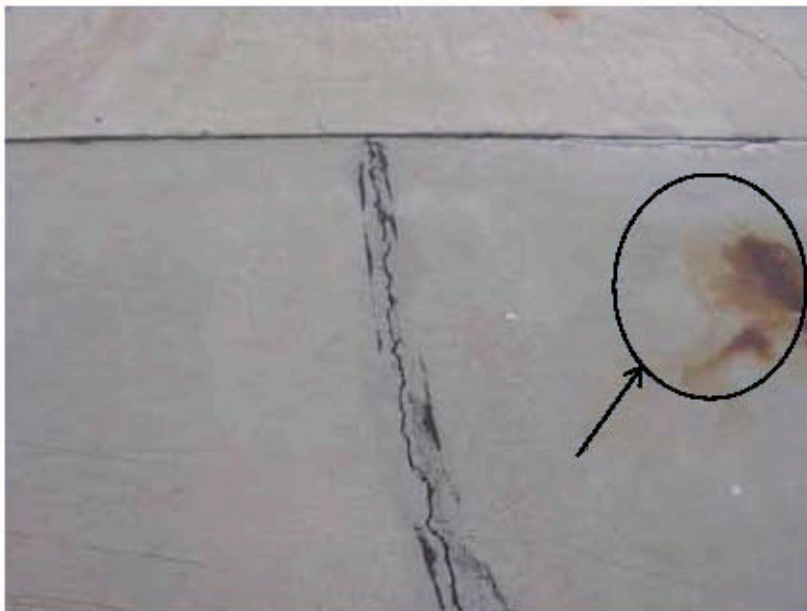
Photograph 4: A previous repair, thought to be 1st generation, in good condition. Small rust stain present of unknown origin.

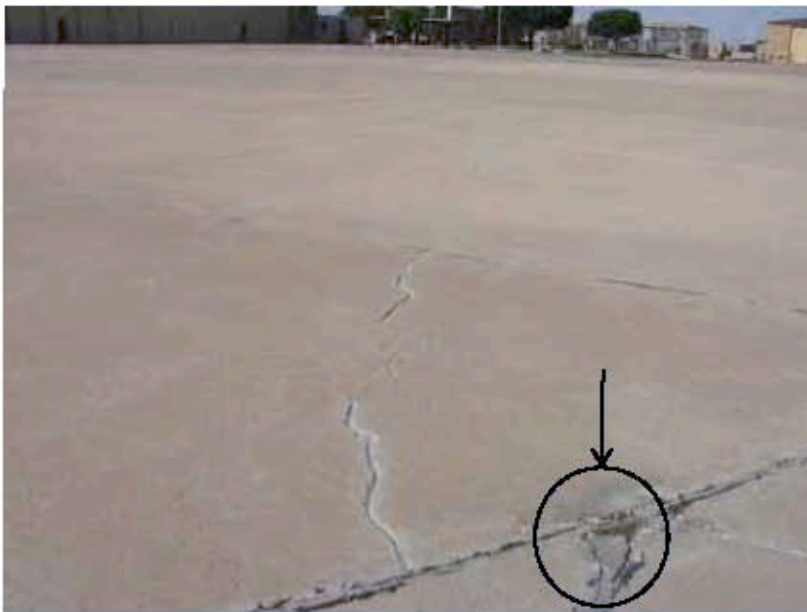
Photograph 5: A previous repair that may warrant additional repairs due to additional cracking and spalling present adjacent to the repair.

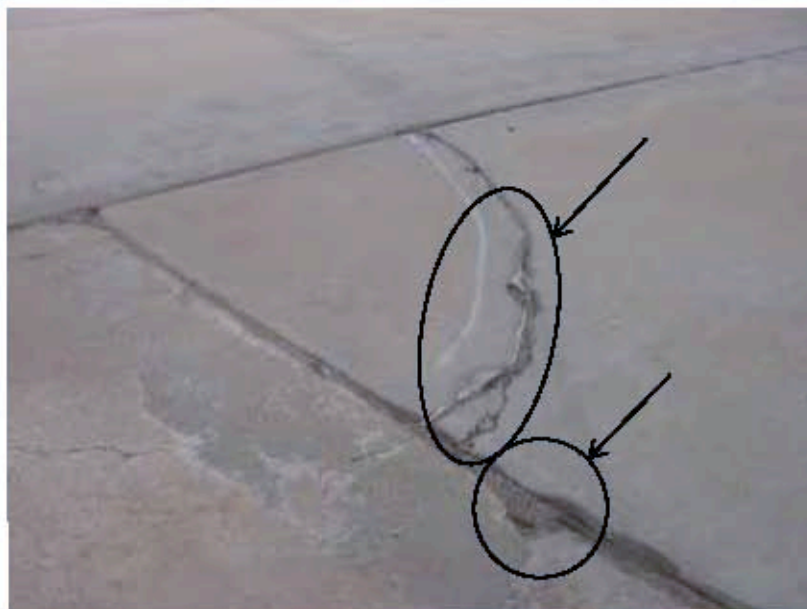
Photograph 6: A previous repair that may warrant additional repairs due to additional cracking and spalling present adjacent to the repair.

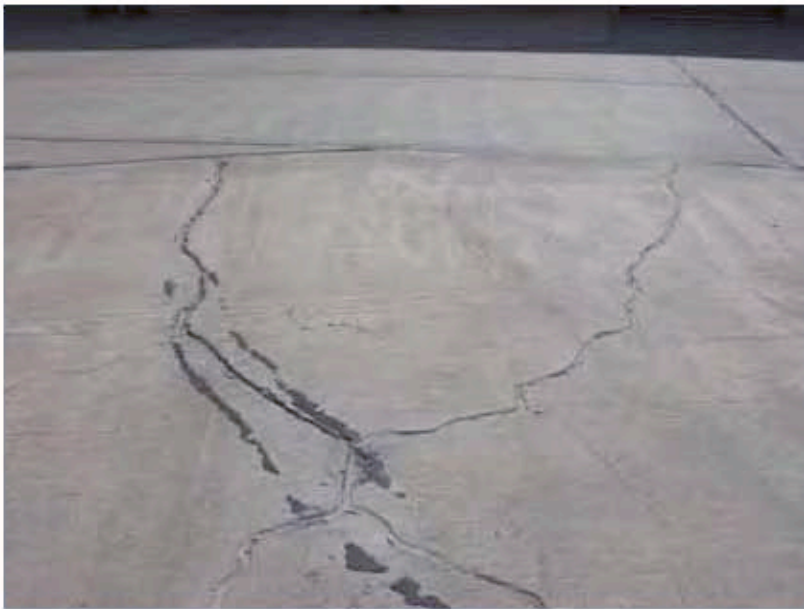
Photograph 7: A previous repair that may warrant additional repairs due to additional cracking and lack of repair material within the repair.

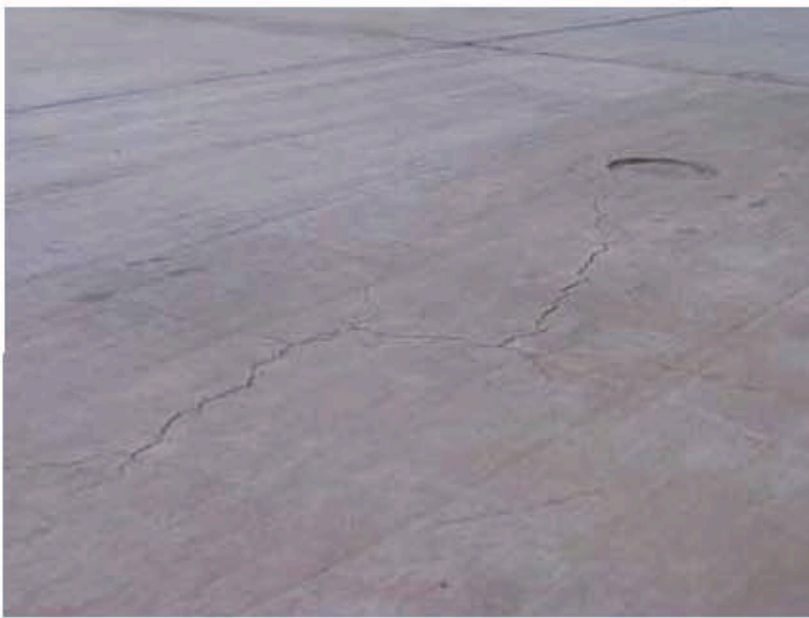
Photograph 8: Example of shallow surface cracking. Cracking with vertical or horizontal displacement are considered to penetrate the full depth of the concrete thickness.

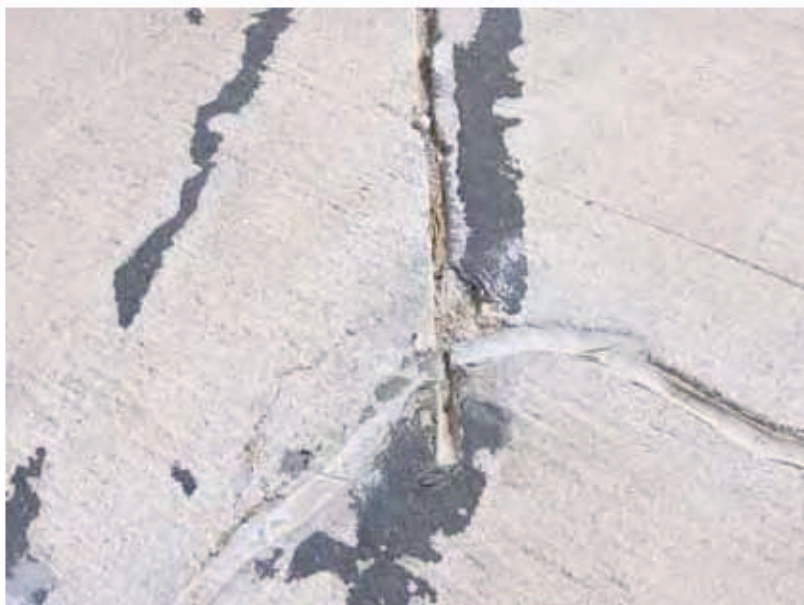
Photograph 9: A previous repair that may warrant additional repairs due to additional cracking and spalling present adjacent to the repair.

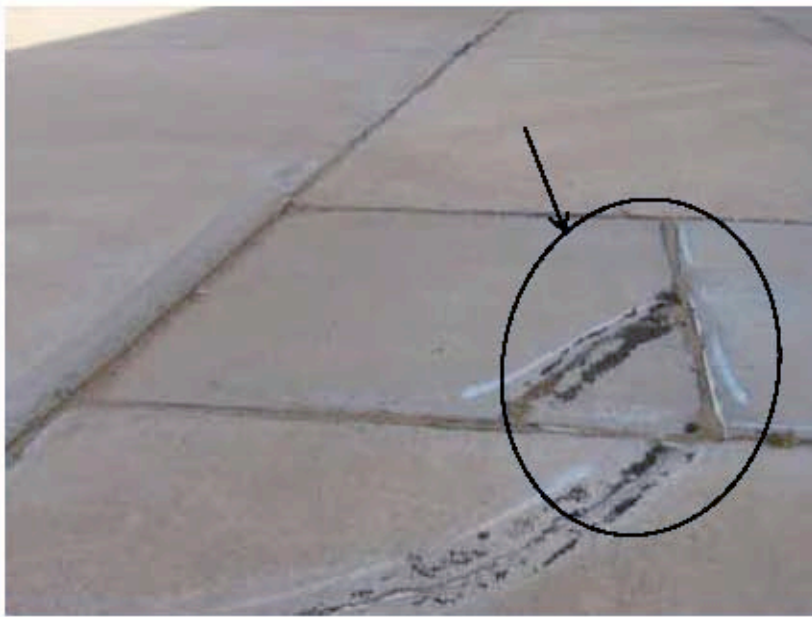
Photograph 10: A previous repair, that may warrant additional repairs due to additional cracking, the presence of spalling, and lack of repair material within the repair.

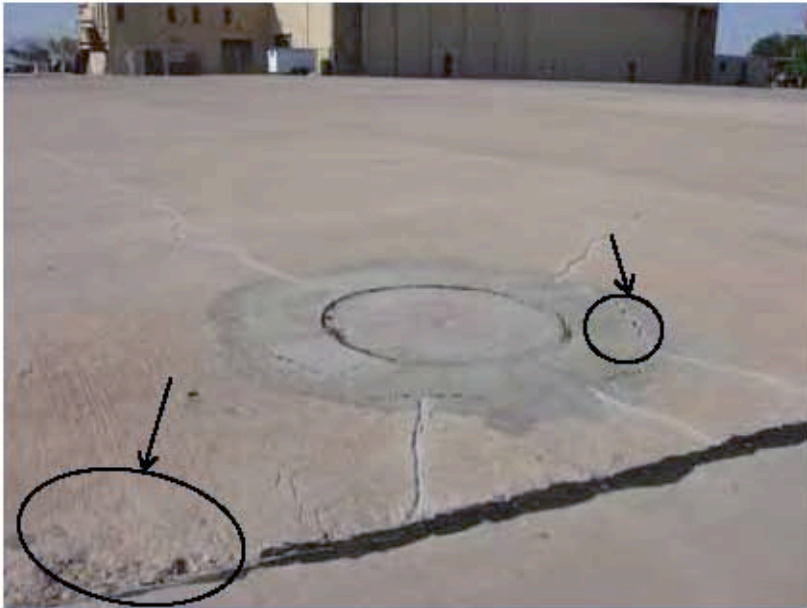
Photograph 11: A previous repair that may warrant additional repairs due to additional cracking and the presence of spalling. Most of the previous repairs within this area are still intact.

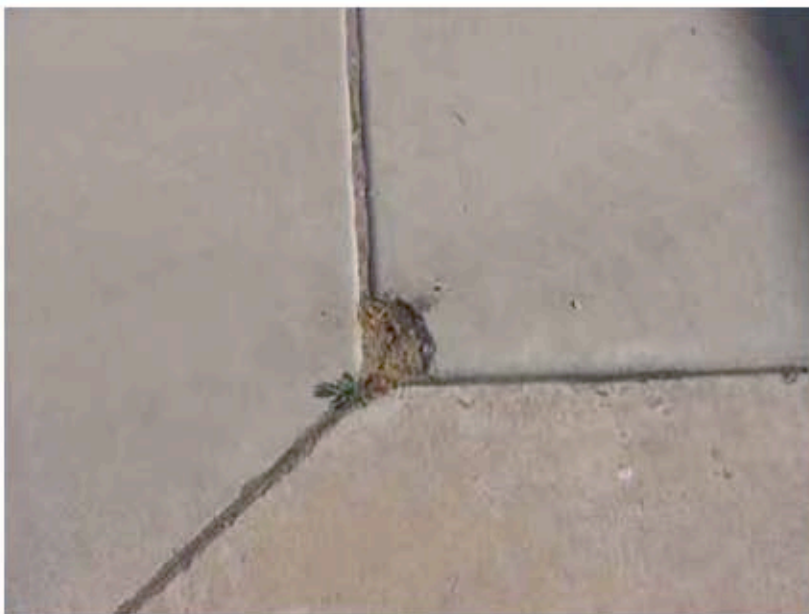
Photograph 12: A location in which a concrete popout has occurred at a corner joint. Repair may be warranted.

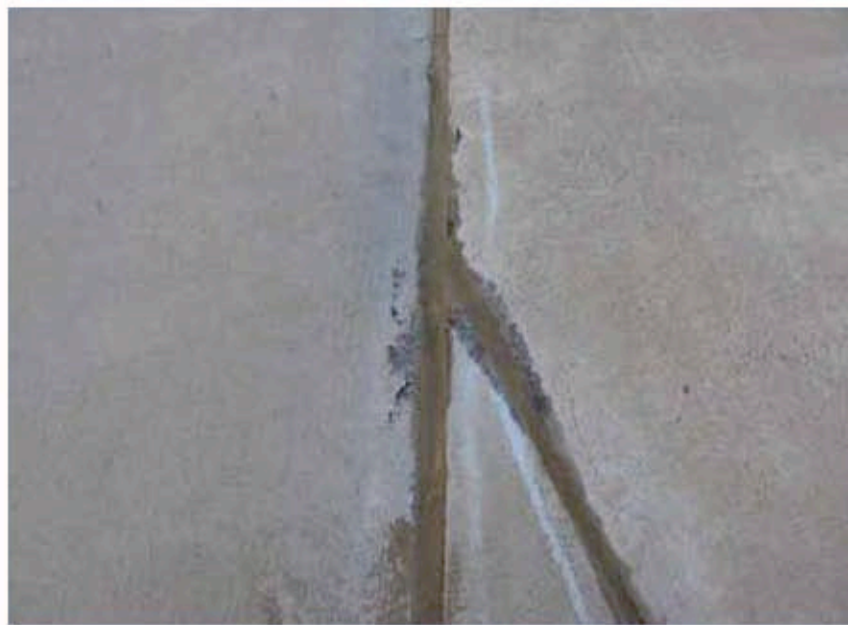
Photograph 13: For 2010 inspection, example of concrete crack that has been repaired and is in good condition.

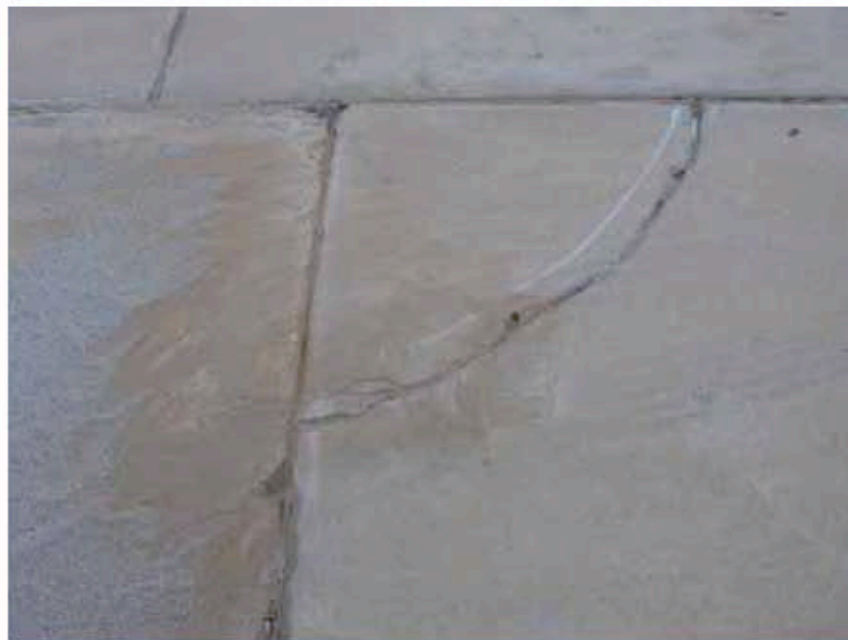
Photograph 14: Concrete crack that may warrant additional repair work; spalling observed adjacent to the crack and some gaping of repair sealant.

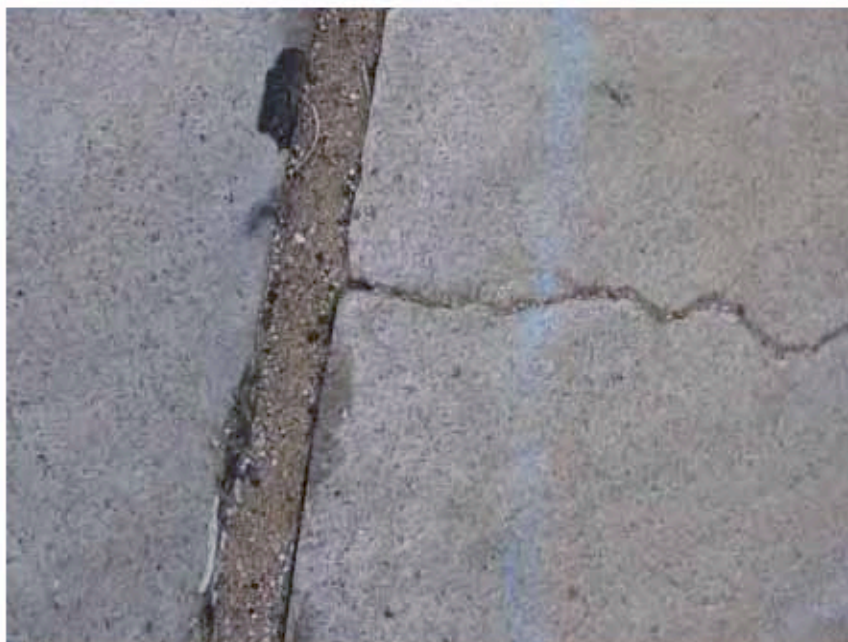
Photograph 15: Hairline concrete fracture intersecting with expansion joint.

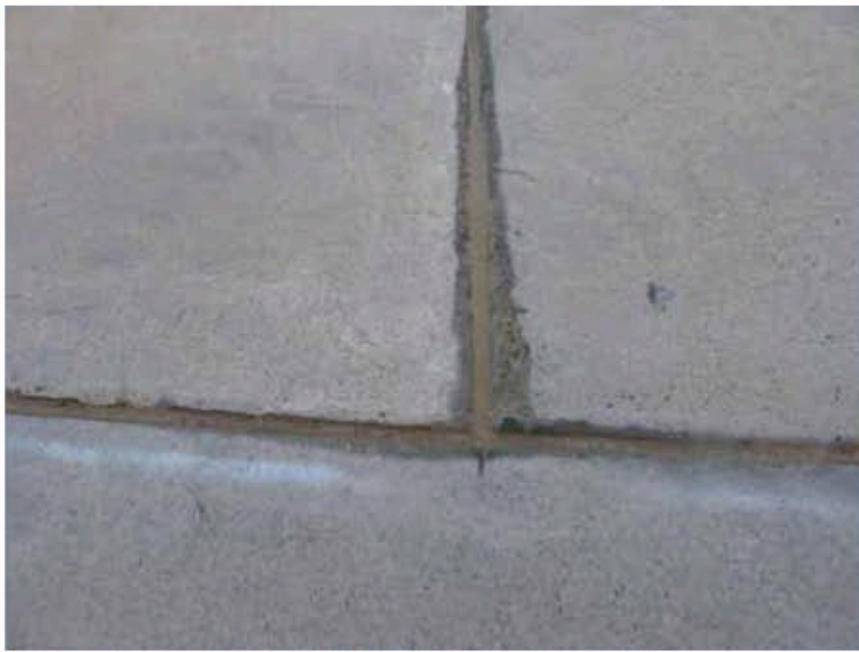
Photograph 16: Example of expansion joint in good condition.

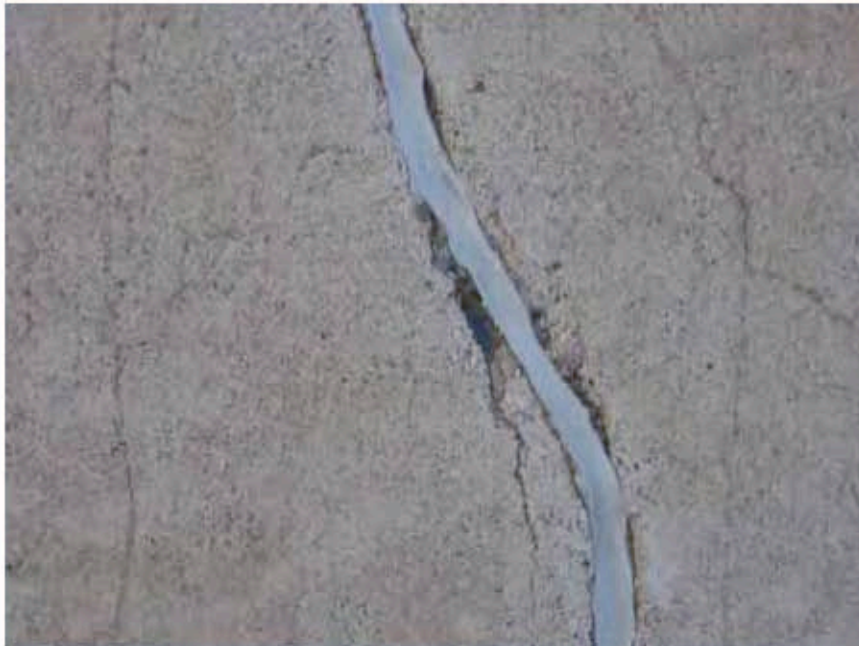
Photograph 17: Example of spalling adjacent to previous crack repair.

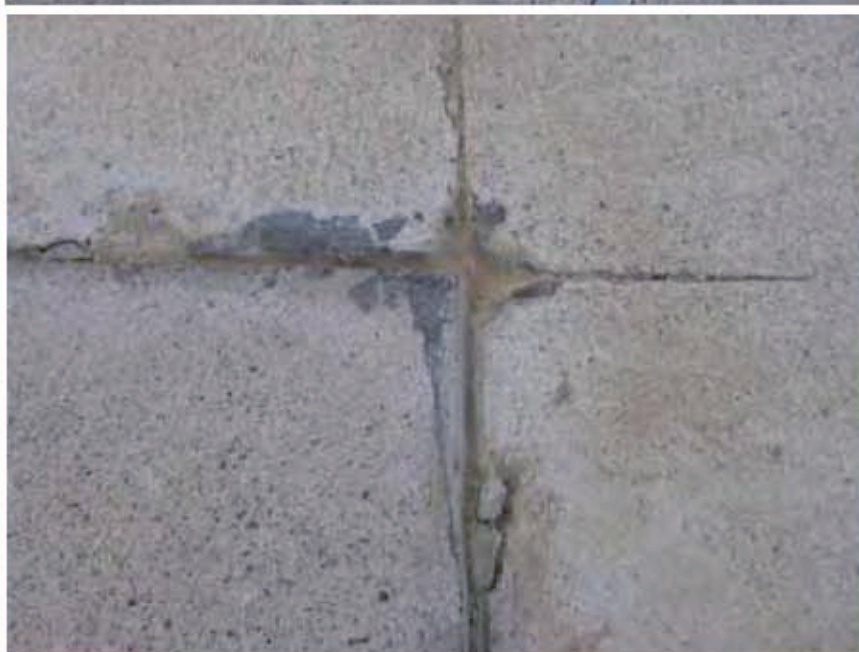
Photograph 18: Repairs on concrete cuts around monitoring well completion; spalling observed.

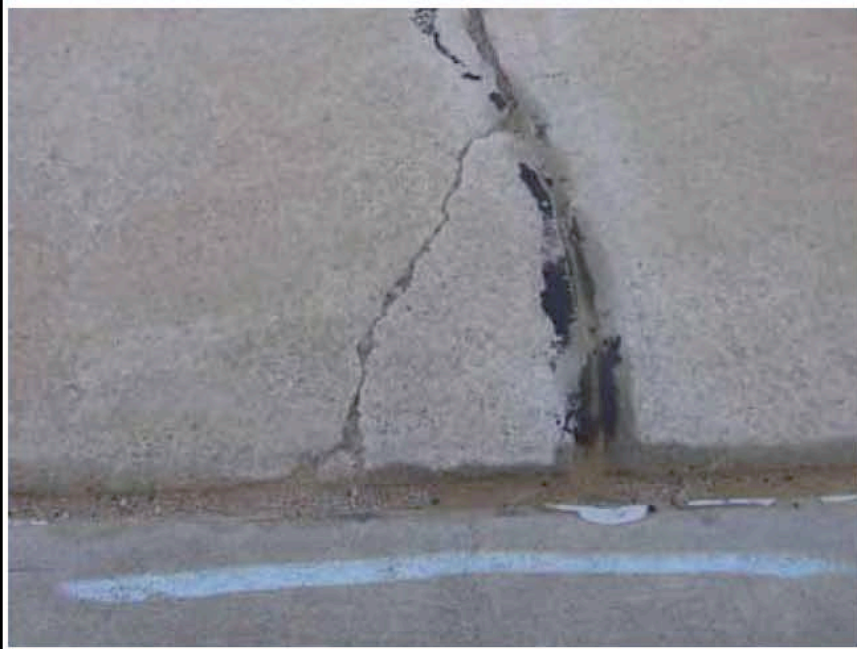
Photograph 19: Earlier repair that may warrant additional work due to presence of spalling and missing repair material.

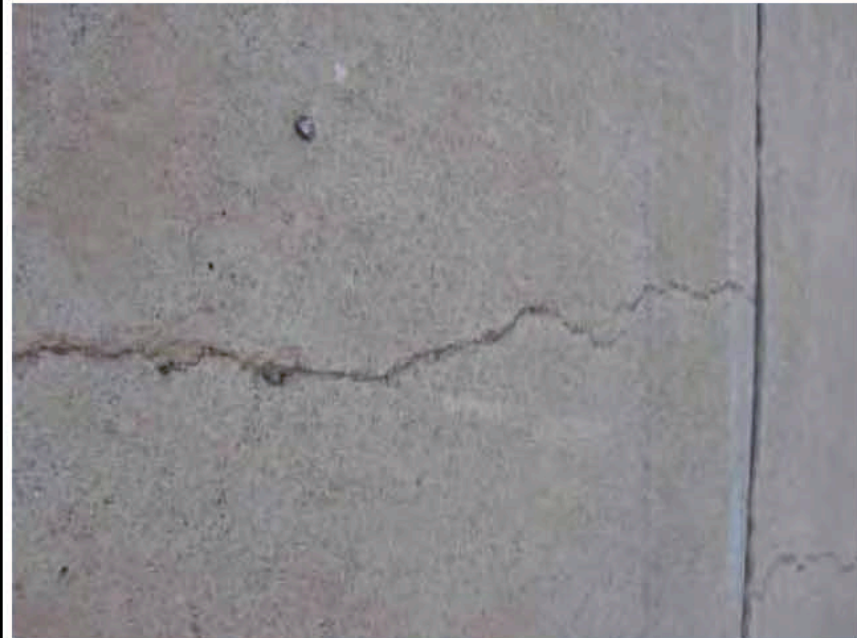
Photograph 20: Concrete crack, intersecting expansion joint, that is several feet long.

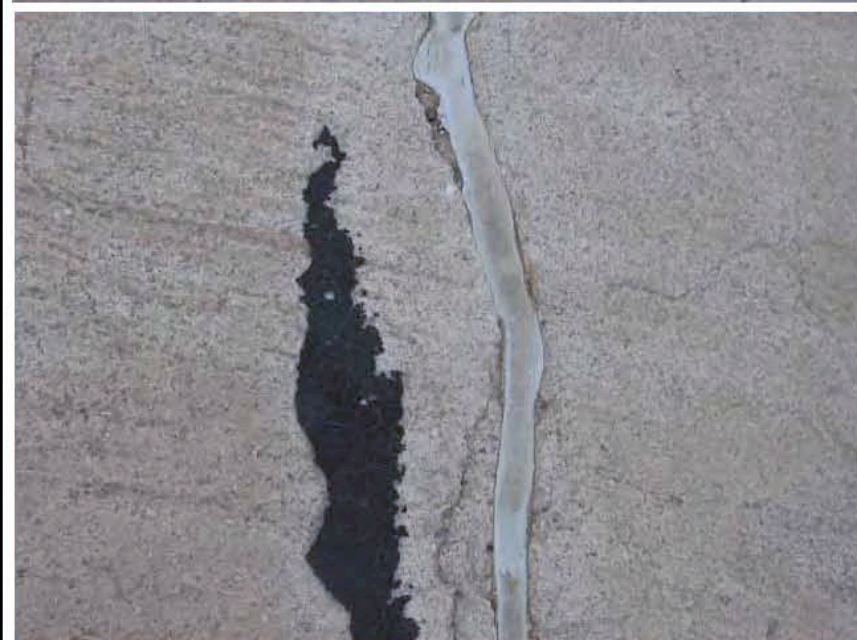
Photograph 21: Example of concrete crack that has been repaired multiple times.

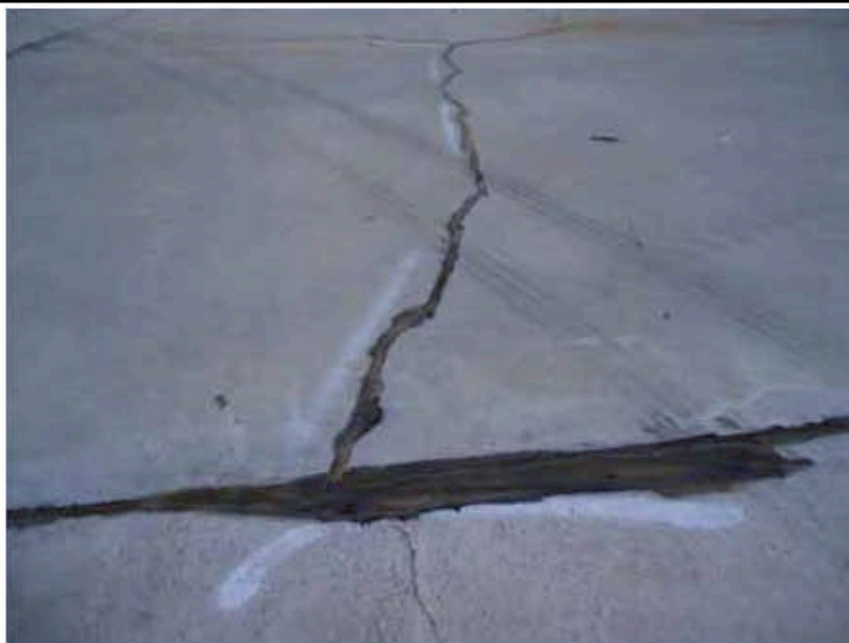
Photograph 22: From 2011 inspection, example of concrete crack that has been repaired (December 2010) and is in good condition.

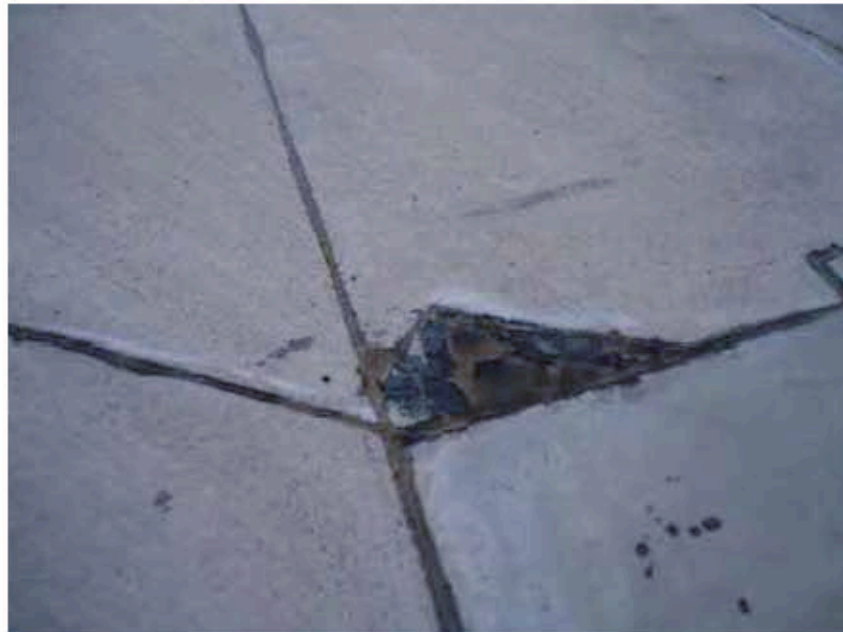
Photograph 23: Repair sealant in corner where spalling had been previously observed.

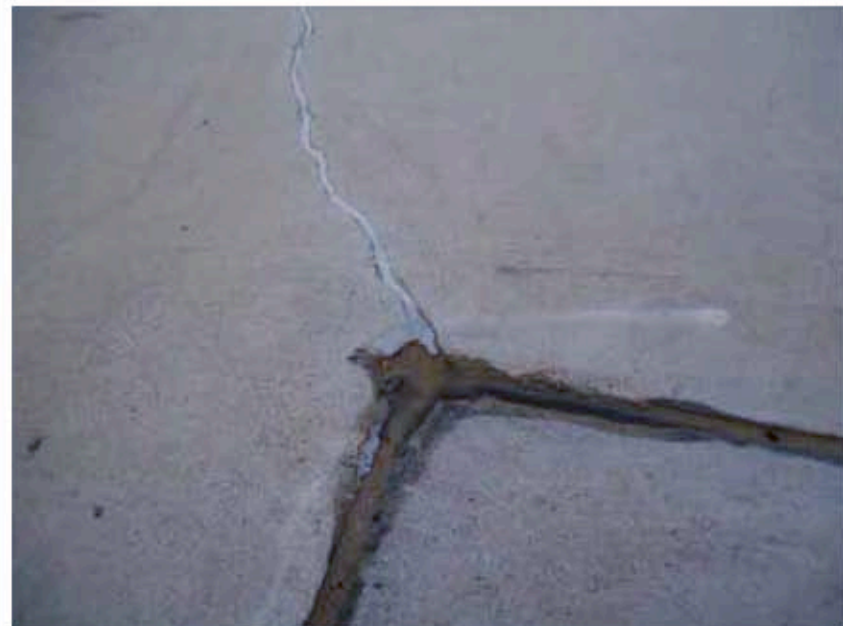
Photograph 24: Example of several generations of repairs.

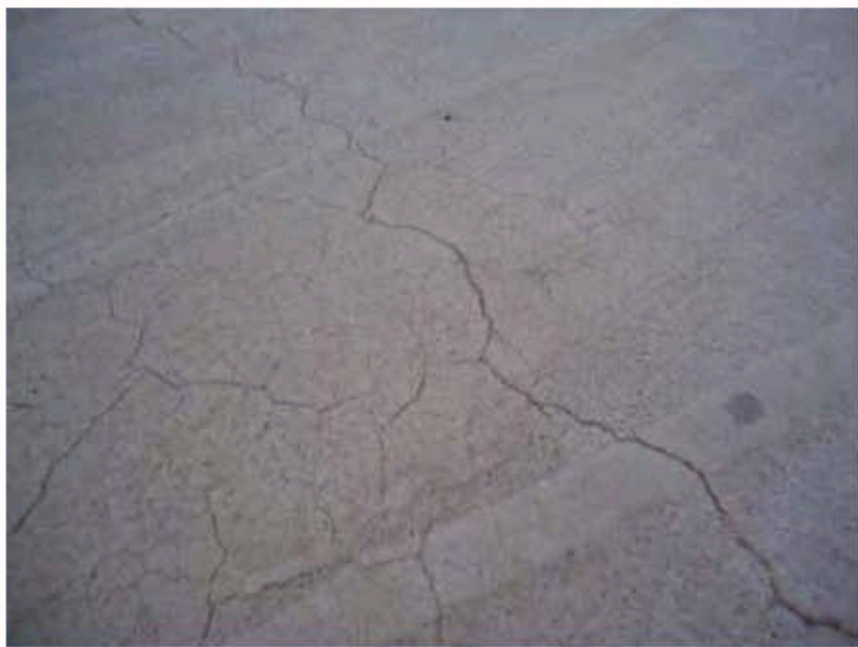
Photograph 25: Hairline cracks that will continue to be monitored.

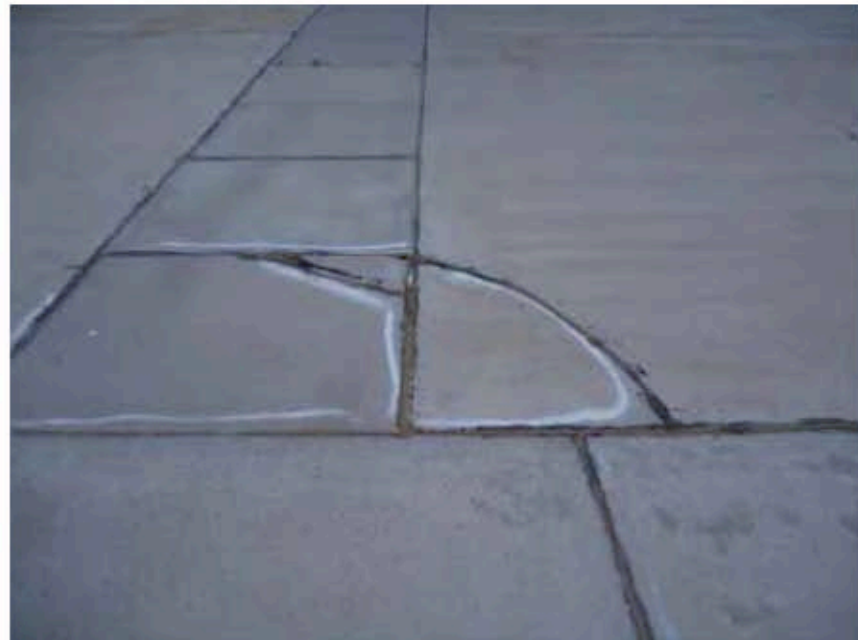
Photograph 26: Newly repaired areas marked by spray paint.

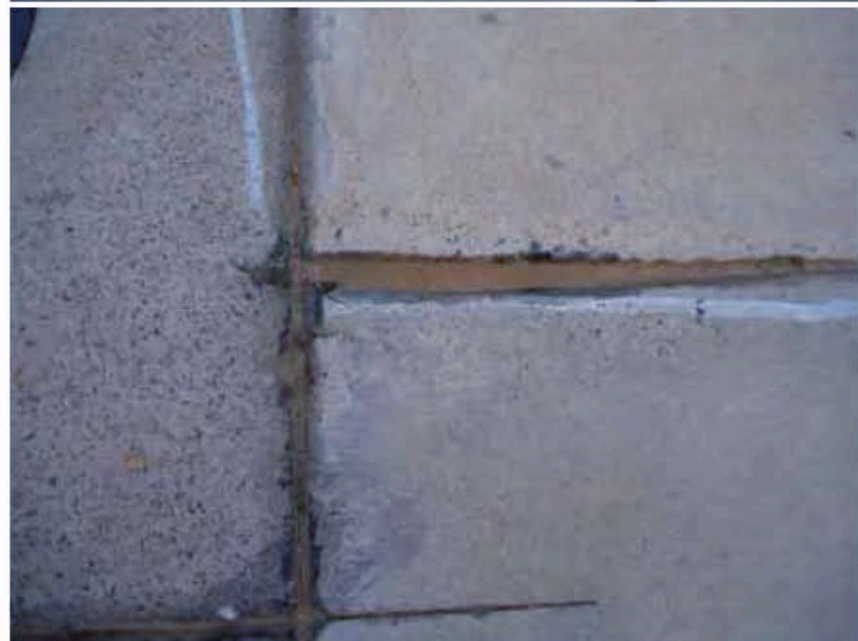
Photograph 27: Example of expansion joint that intersects monitoring well completion. Expansion joint repairs appear to be in good condition.

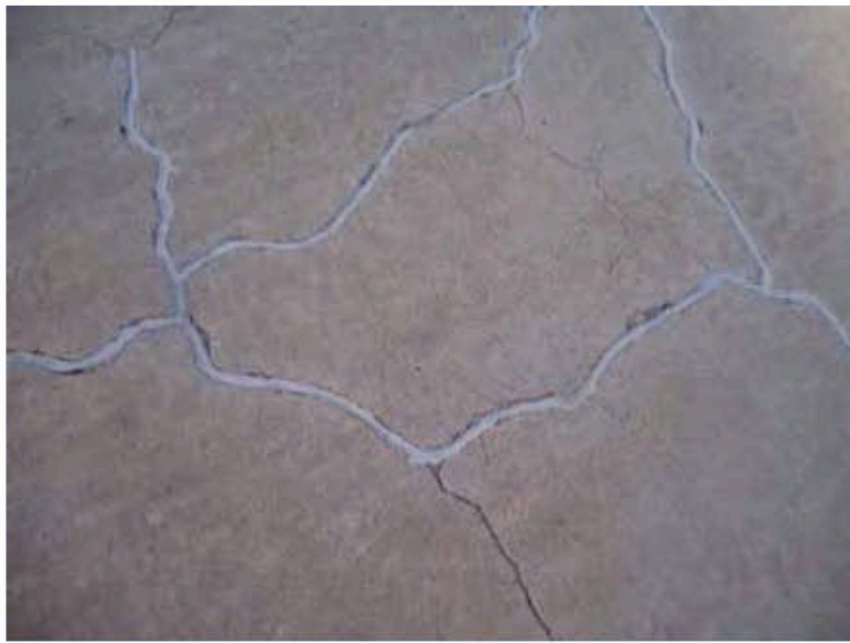
Photograph 28: Hairline crack coming off of previously repaired cracks; area will continue to be monitored.

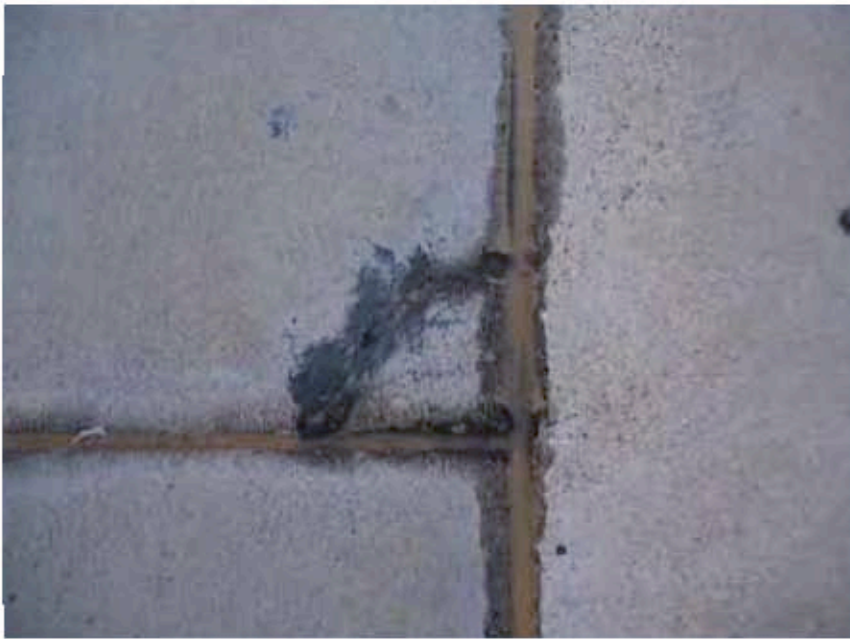
Photograph 29: Example of repaired pop-out on expansion joint corner.

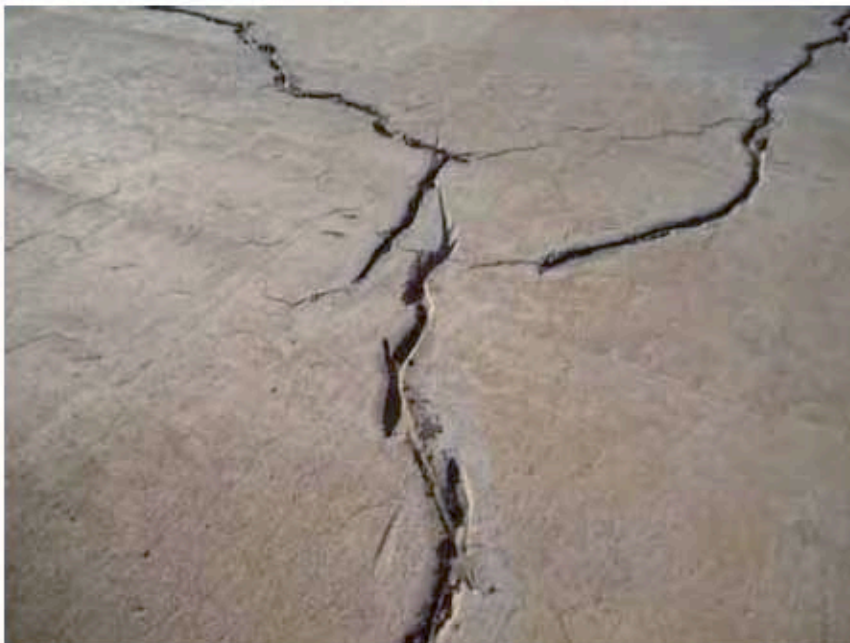
Photograph 30: Example of cracks that have been saw cut and repaired.

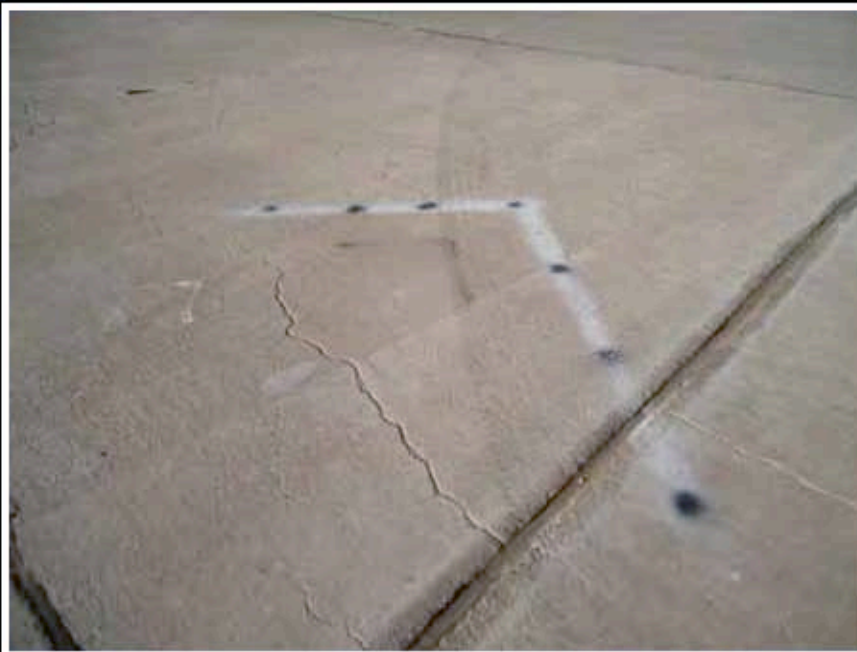
Photograph 31: Example of small crack at corner of concrete cap area.

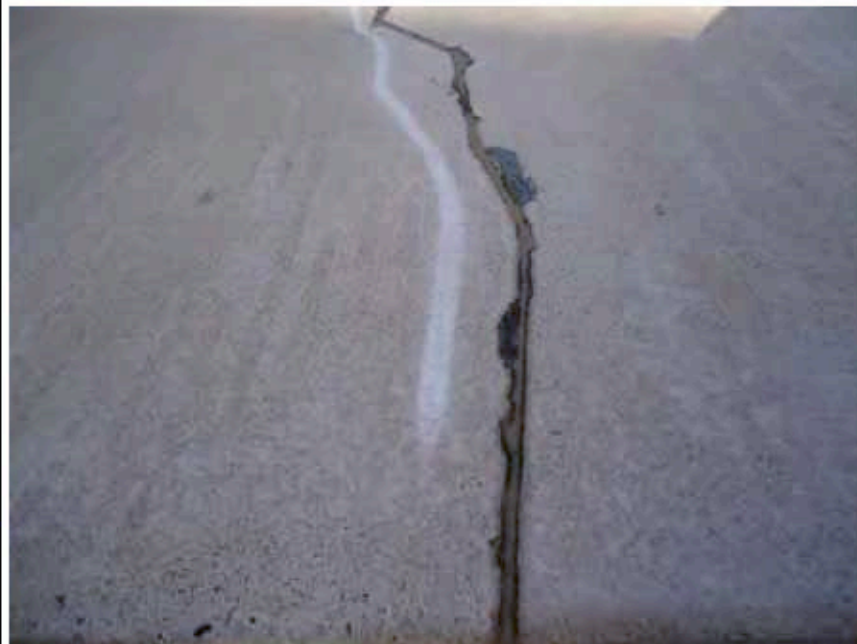
Photograph 32: Example of repaired crack that had limited spalling.

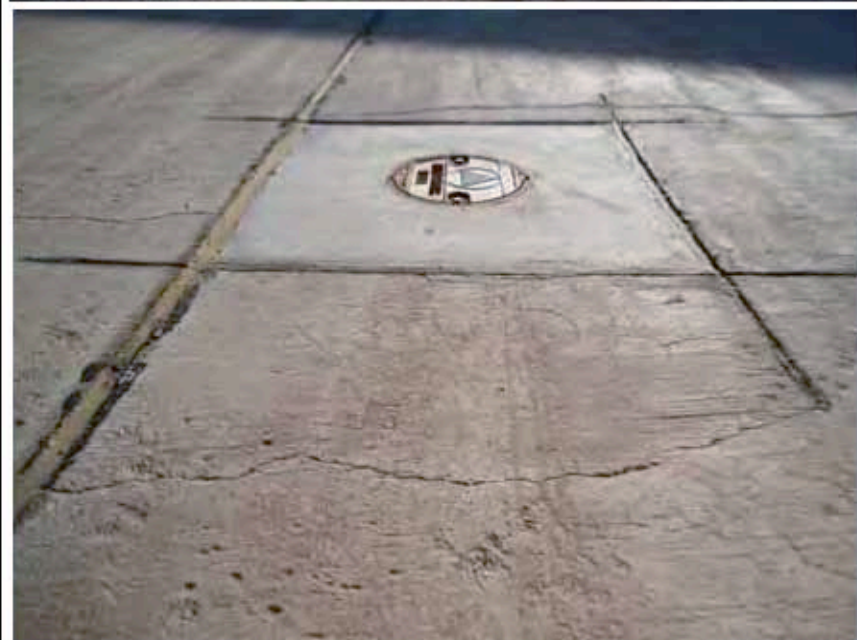
Photograph 33: Crack in concrete near monitoring well that will be monitored during the next cap inspection.
