From: Eeley, Scott (A.)
Sent: Wednesday, December 02, 2009 12:59 PM
To: Espinoza, Bob (R.J.); Bergeron, Leon (F.L.)
Cc: Davis, Craig (C.B.); Dixon, Mark (M.R.); Ricks, Kevin (K.J.); Horbal, Colin (C.P.); Polasek, John (J.A.); McDonagh, Scot (S.M.); Pekarscik, Brian (B.); Mohan, Robert (R.); Smith, Ryan (R.E.); Hale, Curt (B.C.); Armesto, Carlos (.); Dumler, Jeff (J.D.); Rudd, David (D.); McAllister, Derek (D.); Fulton, Brien (B.L.); Kromberg, Arnold (A.W.)
Subject: RE: 6.4 Pump & Injectors
Attachments: Stackchart.ppt

Subject: 6.4L: WIF detection operation and HP fuel system failure.
Importance: High

From: Castleberry, Larry (L.)
Sent: Wednesday, February 04, 2009 11:54 AM
To: Pumford, Ken (K.G.); Fulton, Brien (B.L.); Haven, Keith (K.)
Subject: Emailing: P473 HP Pump Corrosion.ppt

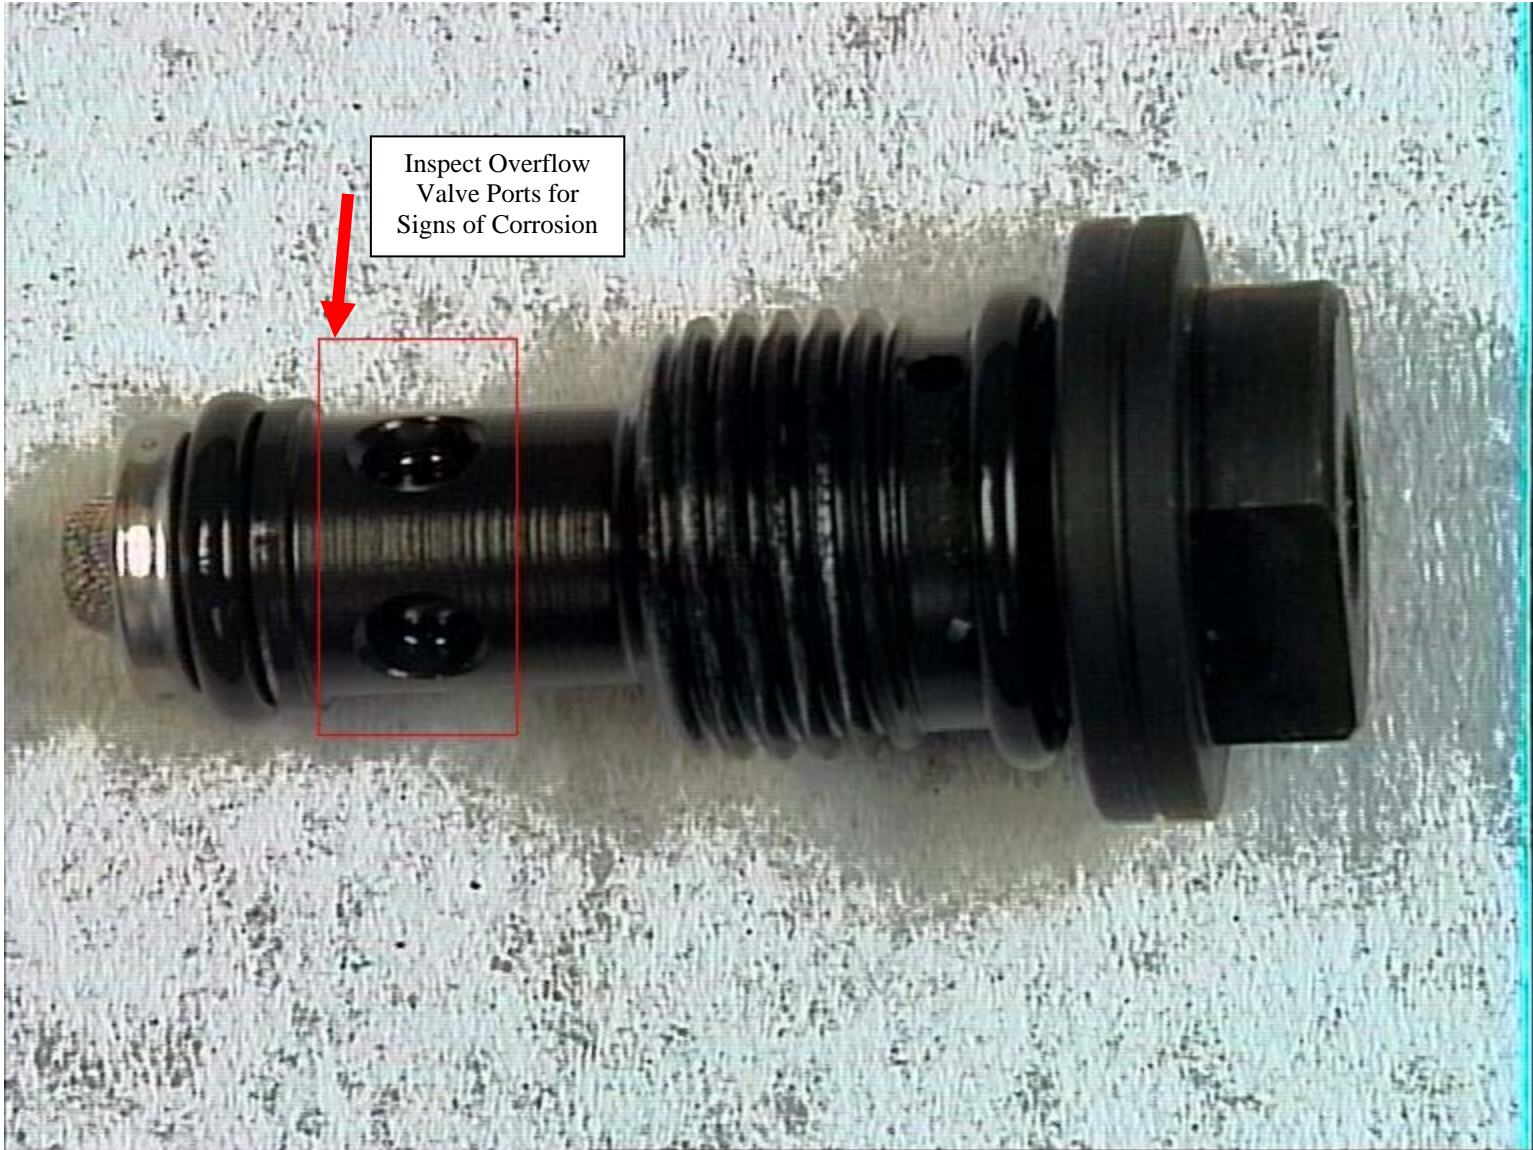
Overflow valve

Inspect Overflow
Valve Ports for
Signs of Corrosion

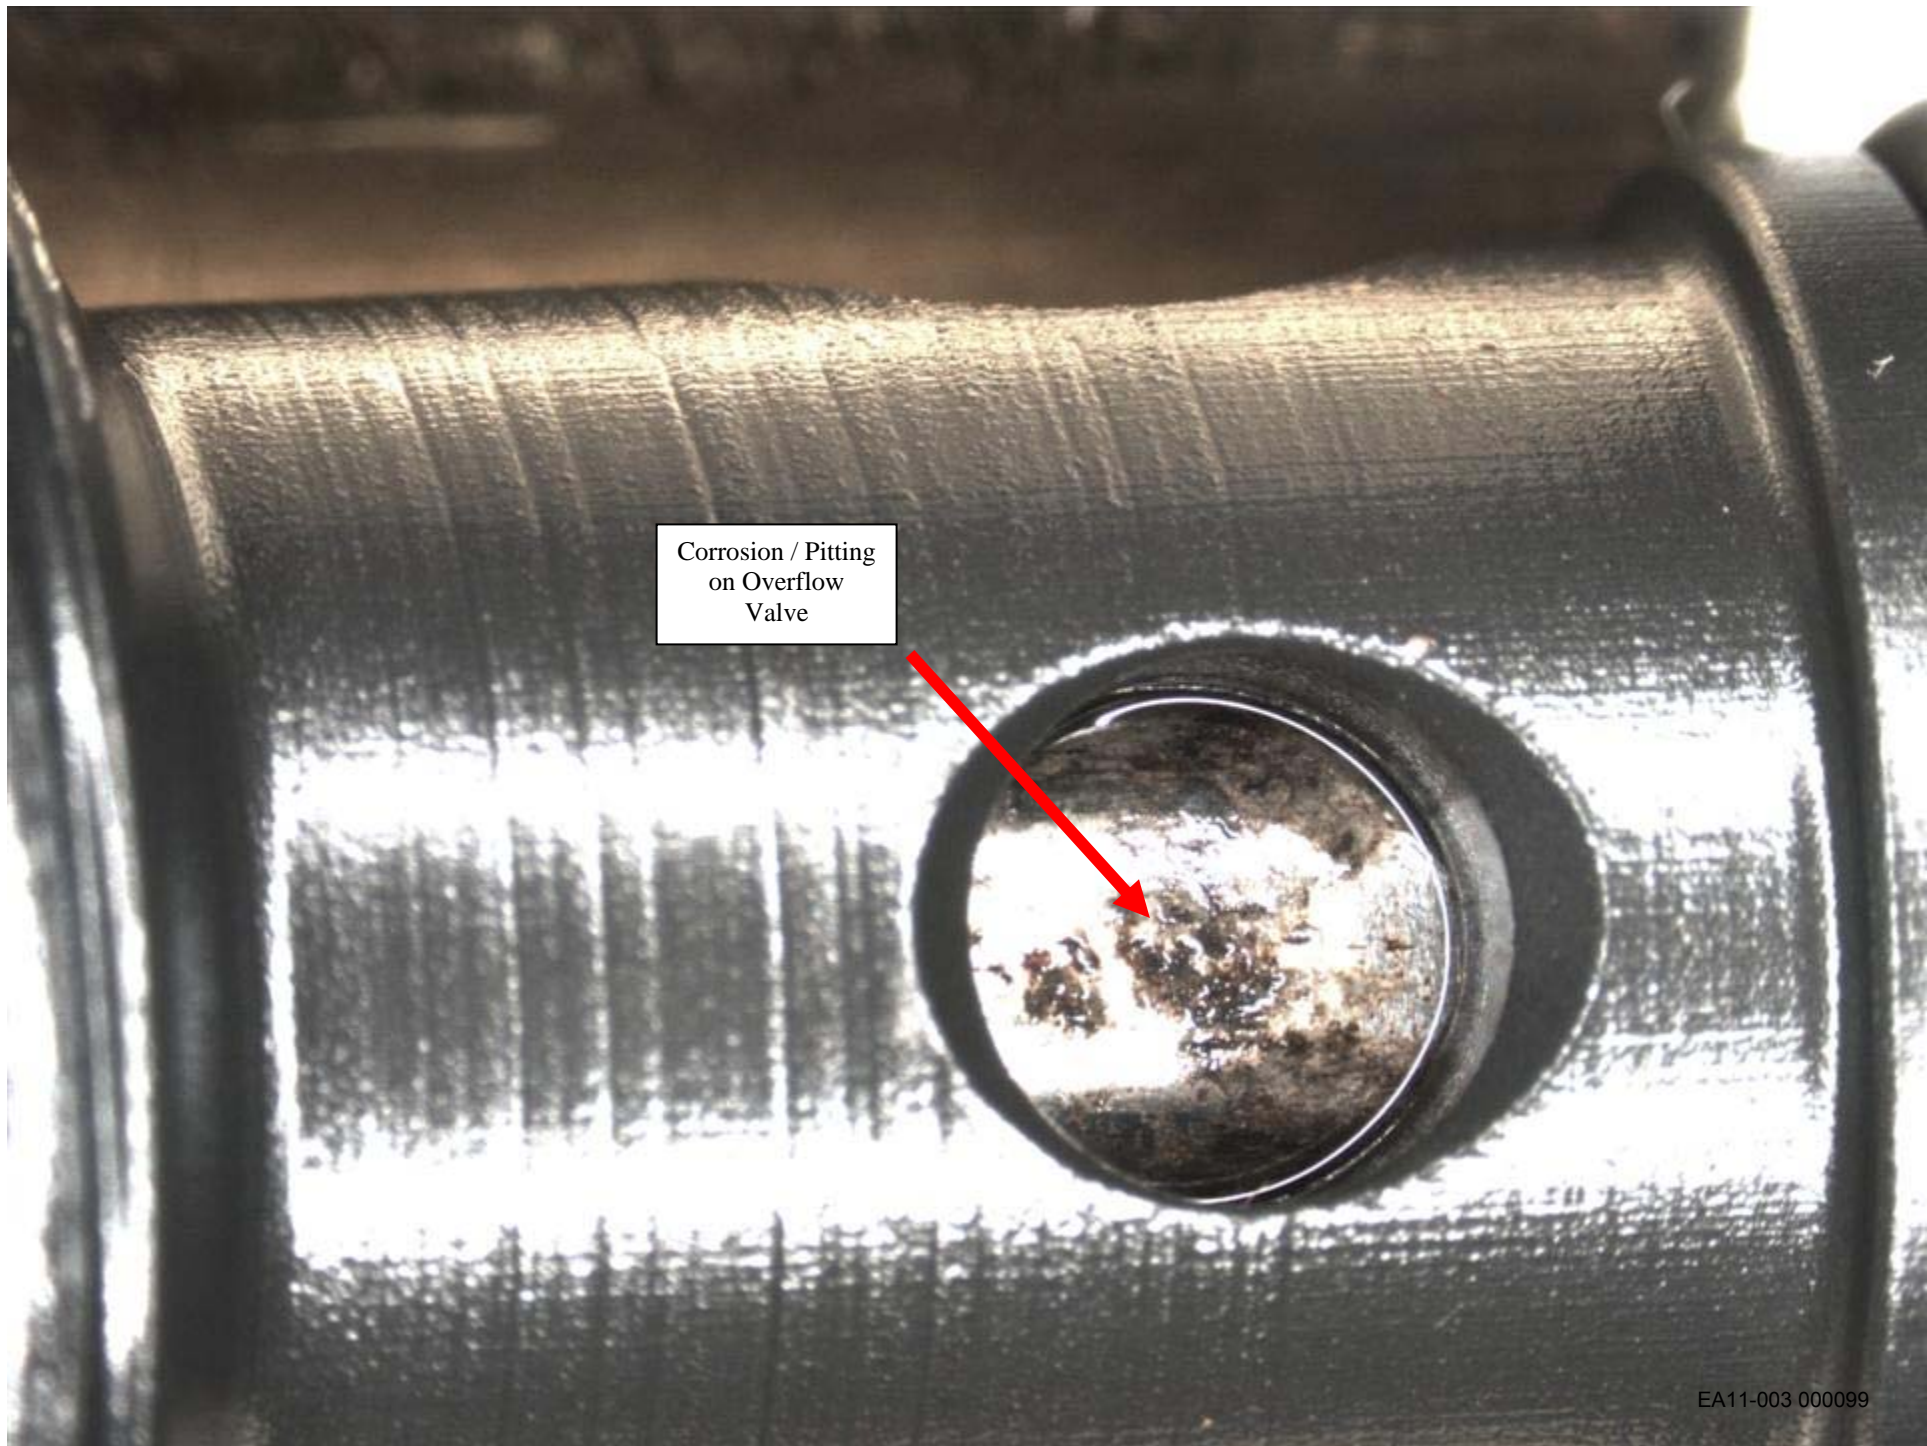
Corrosion / Pitting
on Overflow
Valve

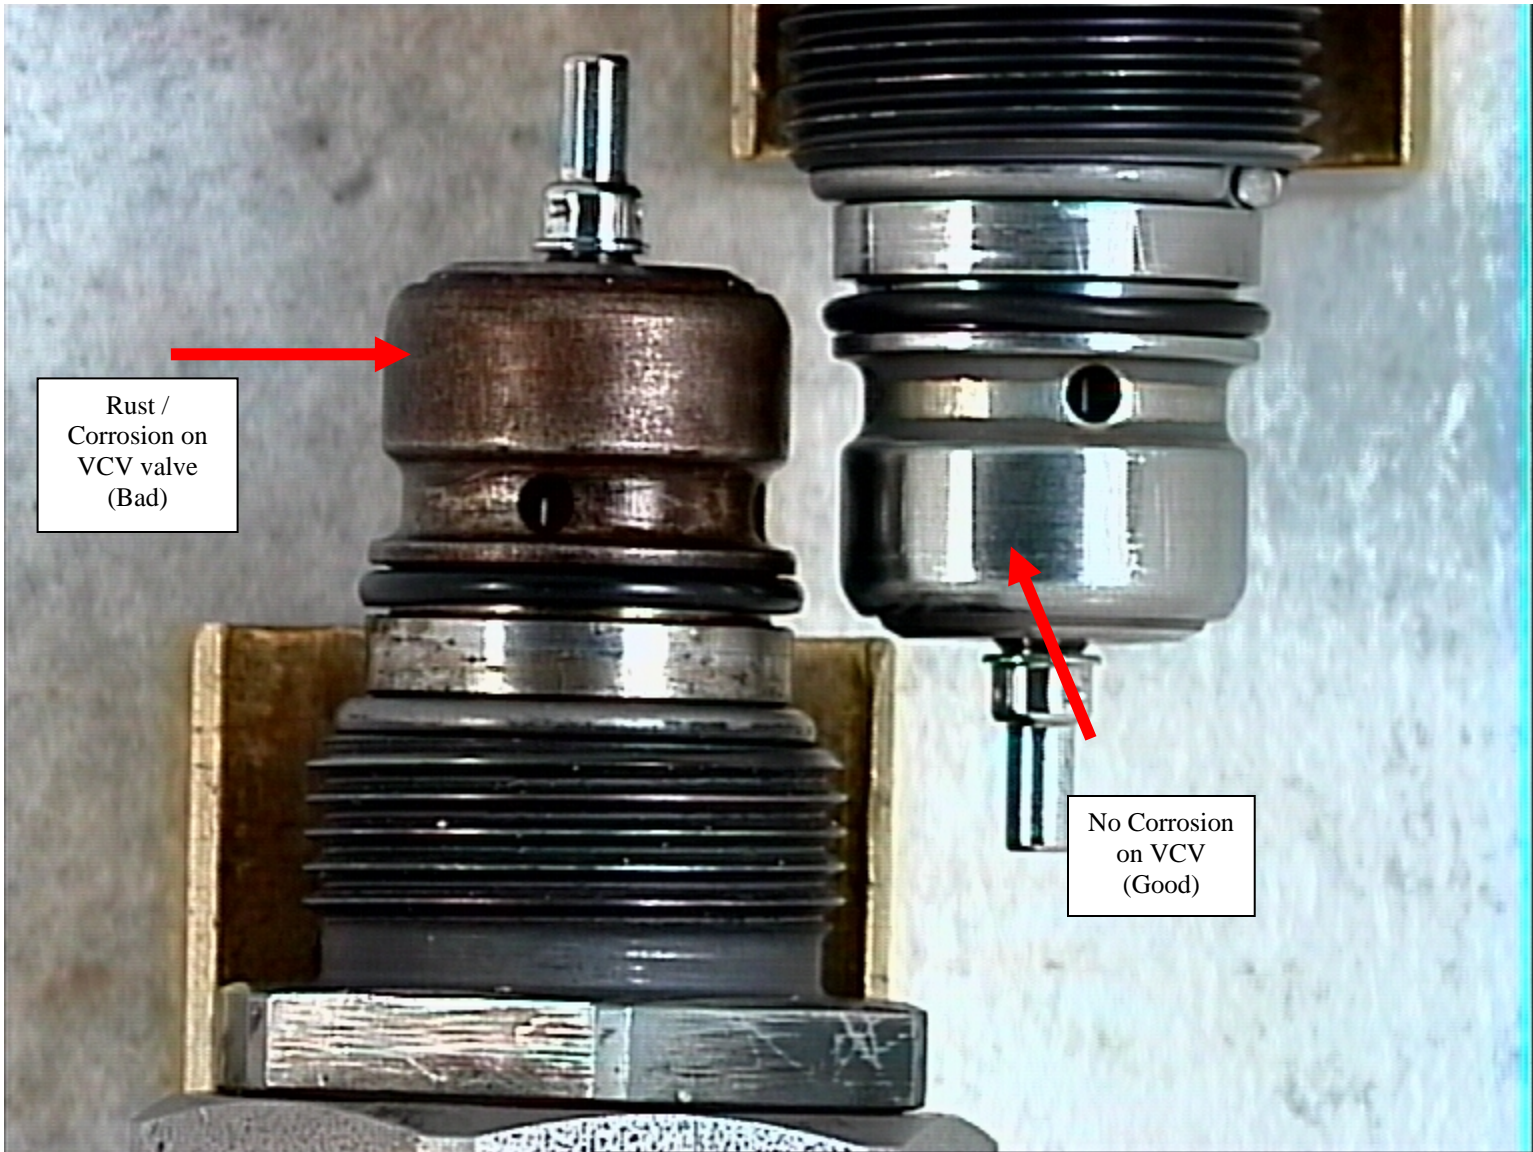
Rust /
Corrosion on
VCV valve
(Bad)

No Corrosion
on VCV
(Good)

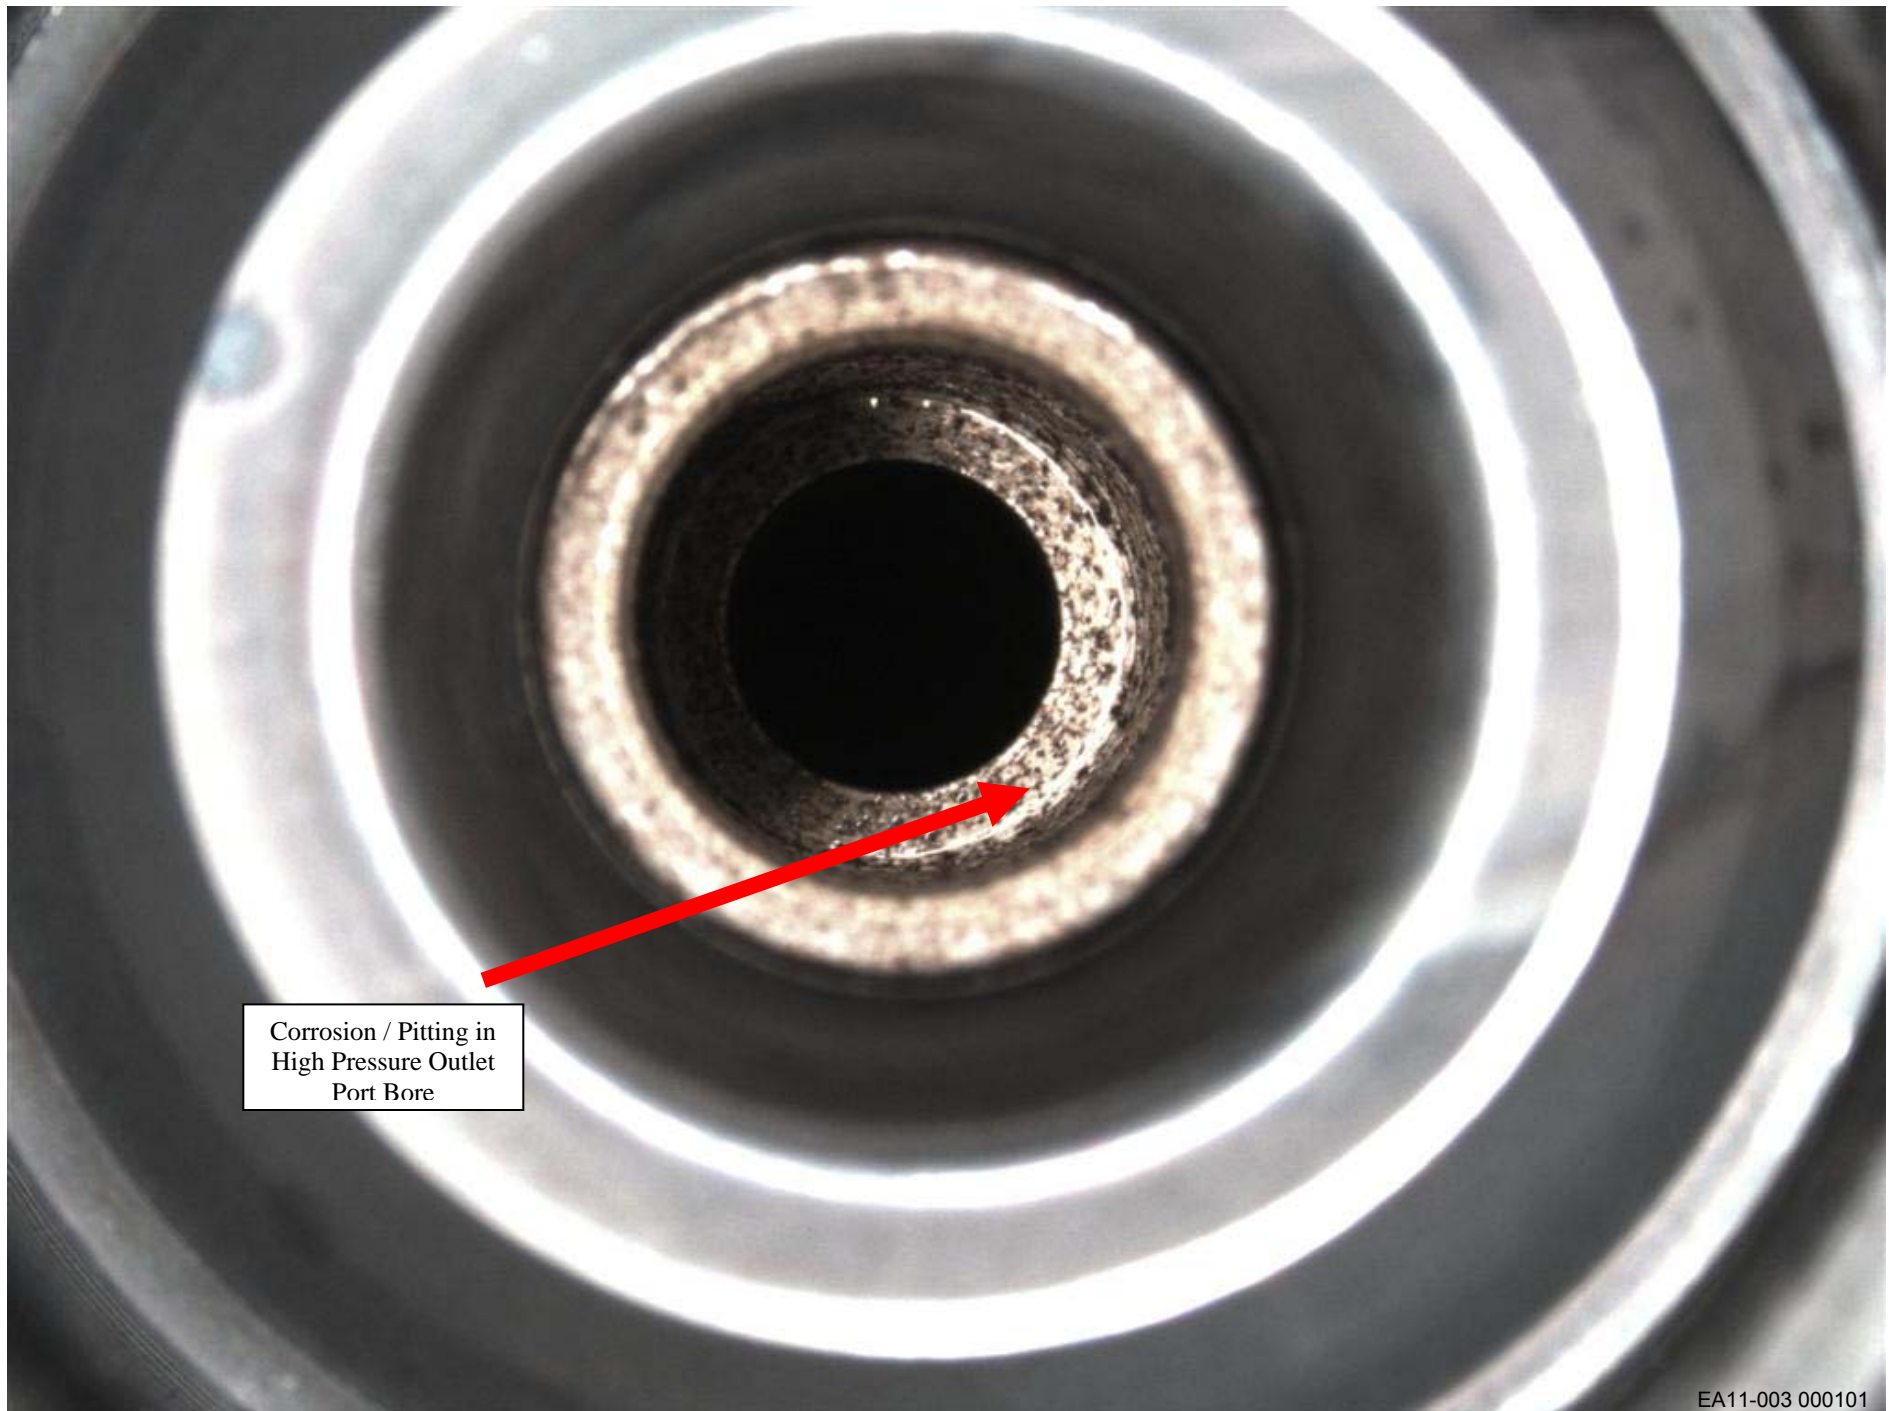
Corrosion / Pitting in
High Pressure Outlet
Port Bore

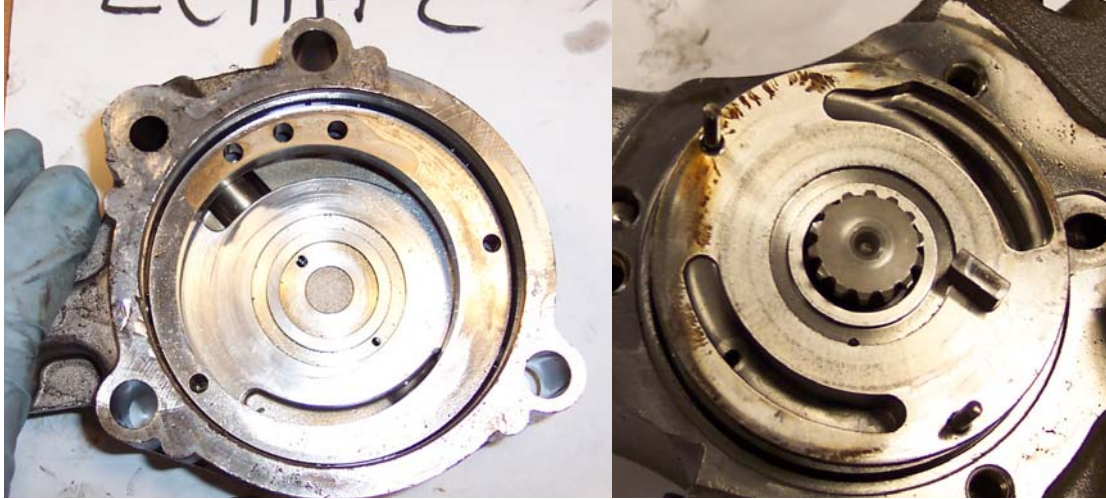
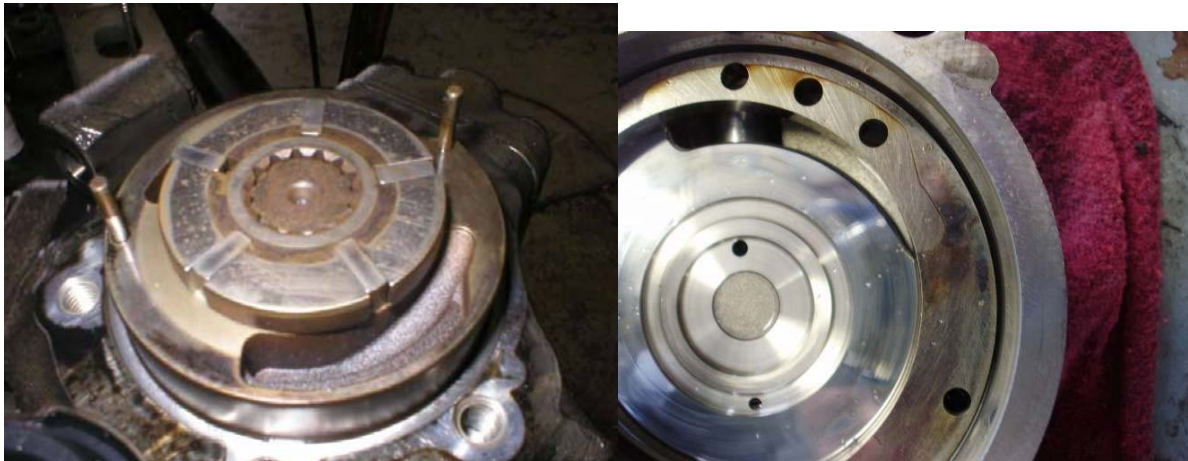
Examples of Corrosion under the Internal Transfer Pump Cover

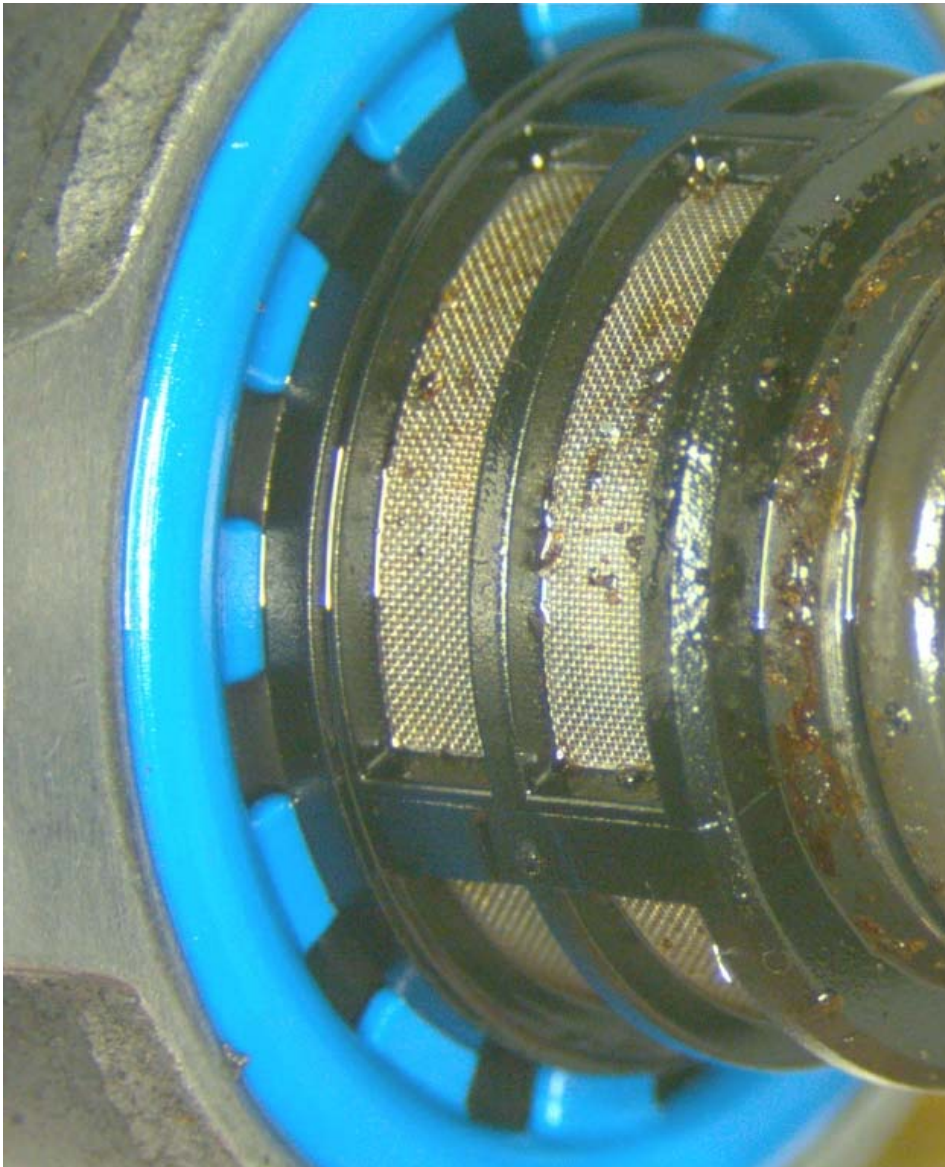
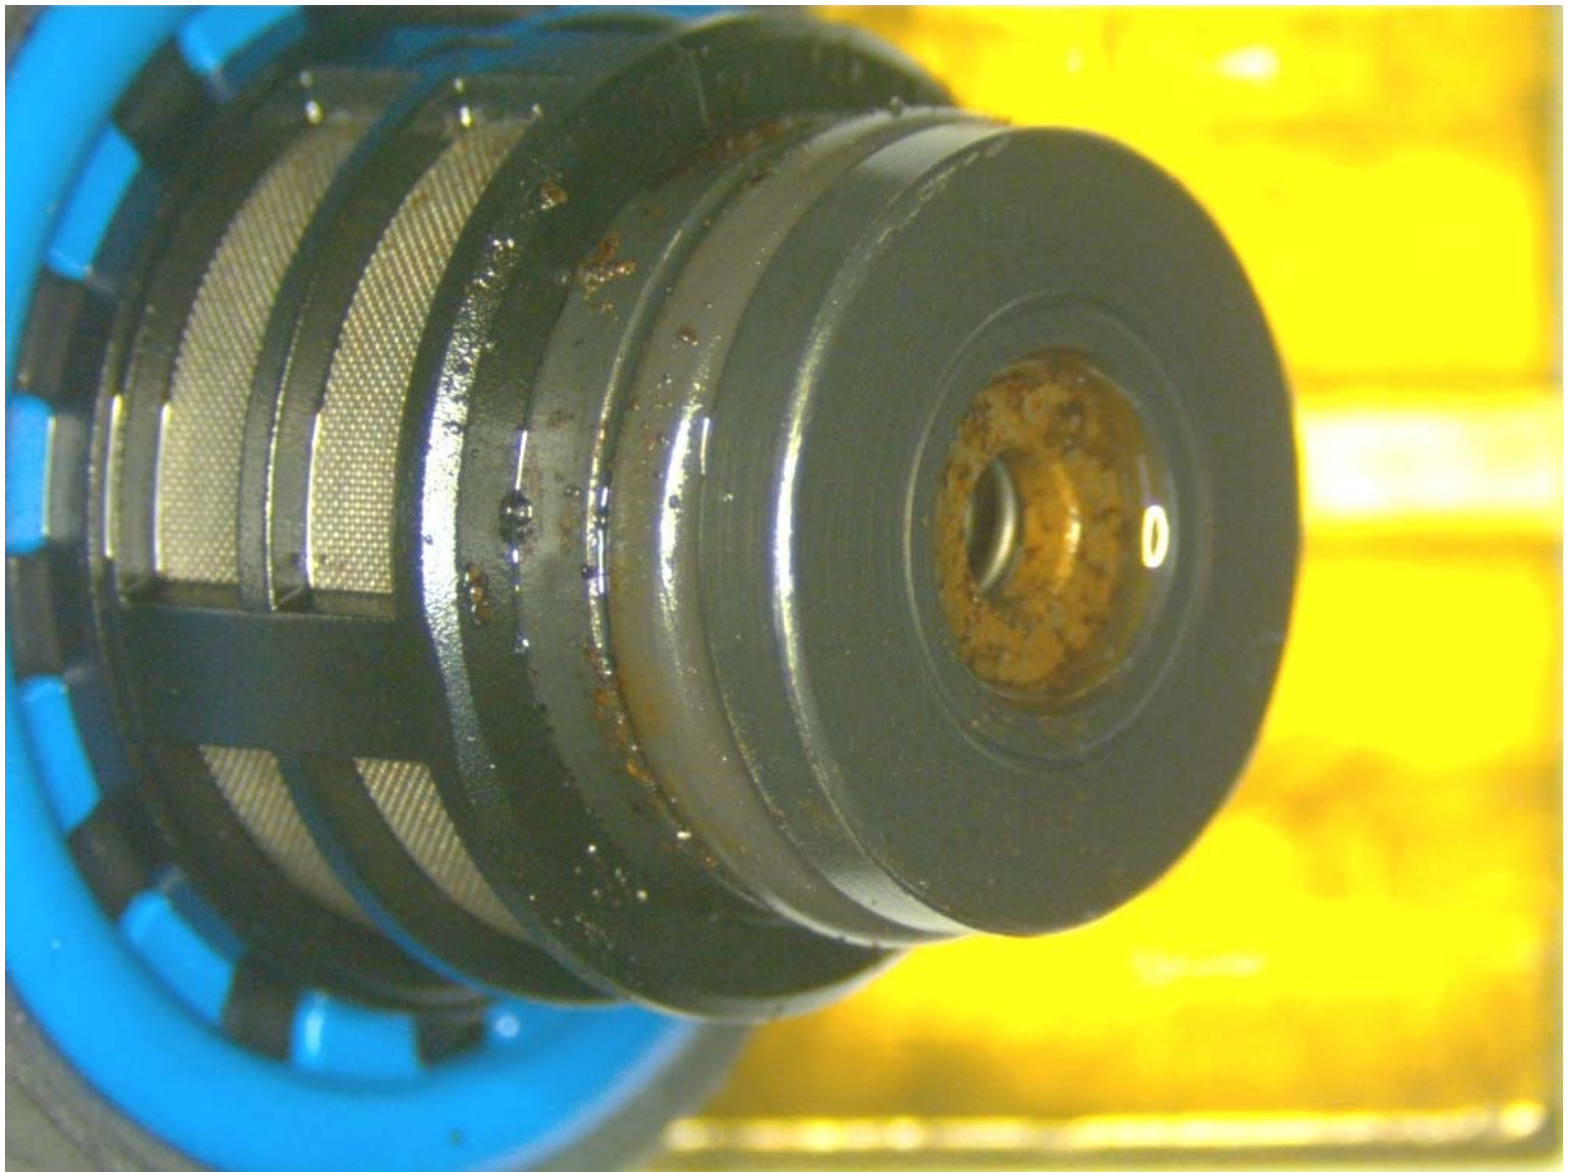
Hi Brien,
Here is a picture of a rusted VCV plate.

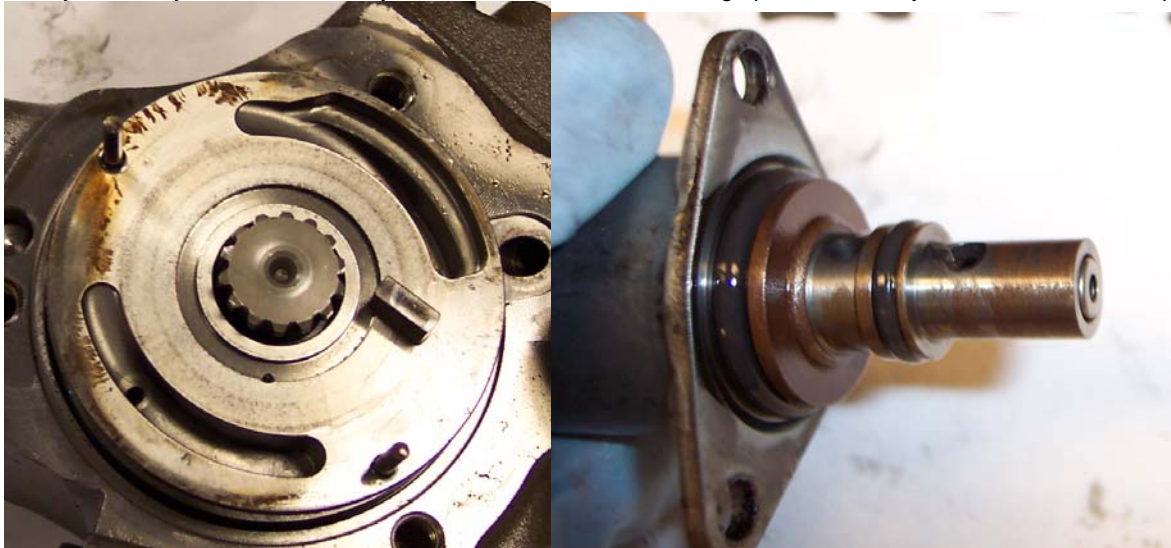
If the water is not drained or if the filters are not changed or if fuel additives with water dispersants or emulsifier are used your fuel system will eventually look like this. And the whole high pressure fuel system will have to be replaced.

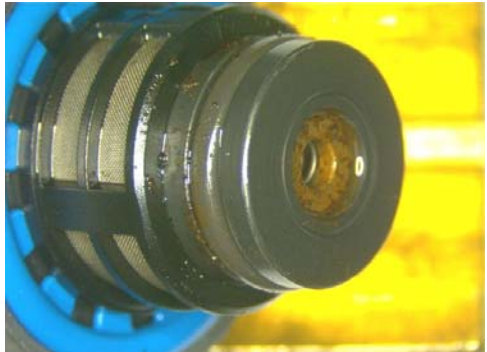
A visual analysis of a picture of a failed 6.4L diesel High-Pressure Fuel Pumps from Mexico shows galling in the ITP housing. This suggest a lubrication issue. We've requested that fuel samples be taken from vehicles that exhibit this type of wear. Our counterpart in Mexico has agreed to take samples and have them analyzed. He needs to know what to look for. Can you help by sending us the diesel Fuel Test Standards and Fuel Requirements; e.g., viscosity and lubricity vs. temperature? The attached JPG is a picture of the galling.

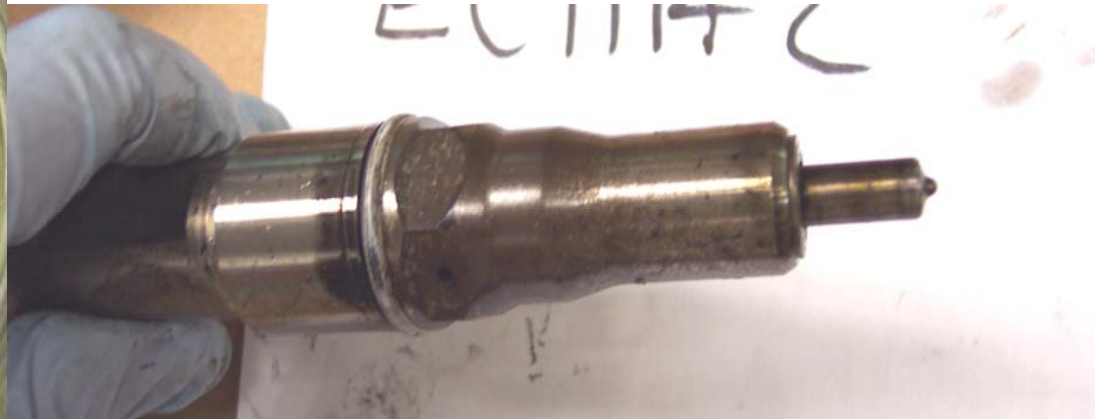
Rust on Housing, Inj, Pump, VCV
(EC11142 : 44773 miles)

NOT WARRANTABLE

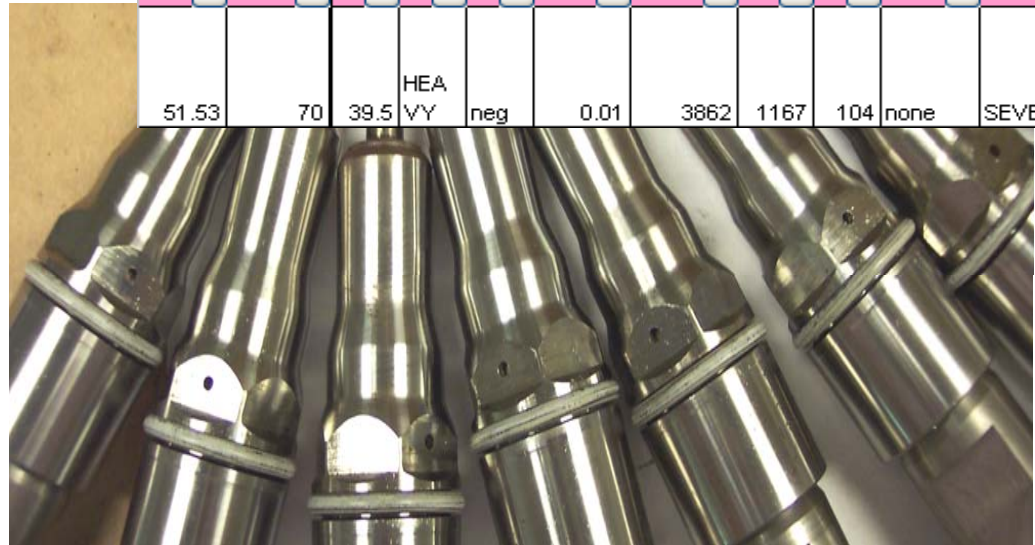
Rust on Housing: No Rust on Inj,
Rust on HP and VCV (EC52768, 75095 miles)

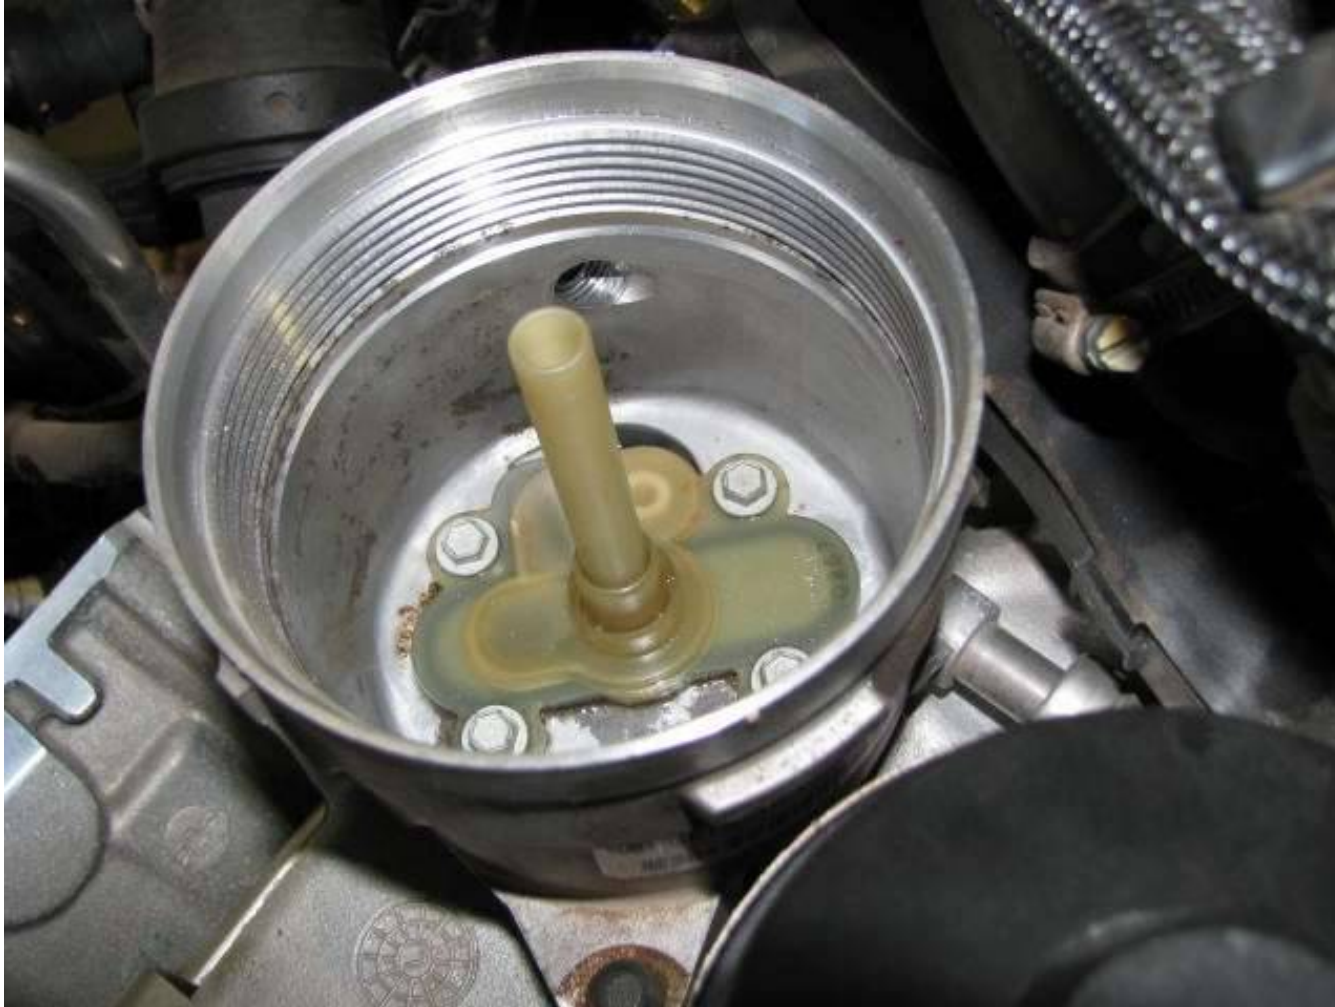
Originally reported no rust in housing pictures illustrate rust/corrosion in small quantity

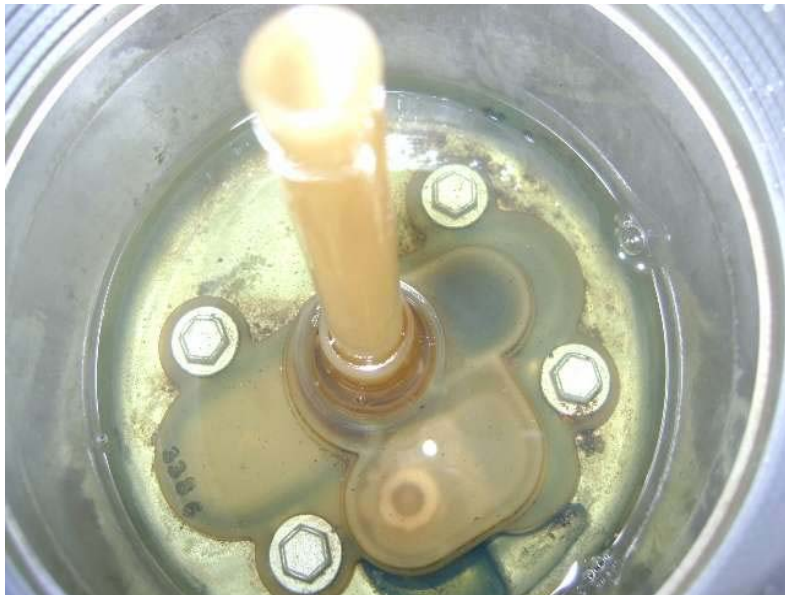
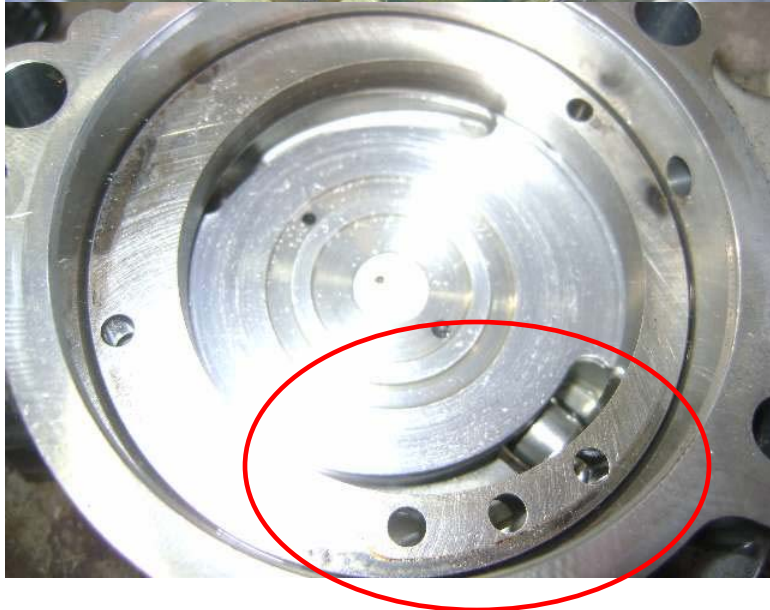
Rust in housing assessment at Dealer (EB16628:39191 miles)
