CALIFORNIA GEOLOGY

Coastal Landslides Caused By The October 17, 1989 Earthquake

Santa Cruz County, California

NATHANIEL PLANT and GARY B. GRIGGS

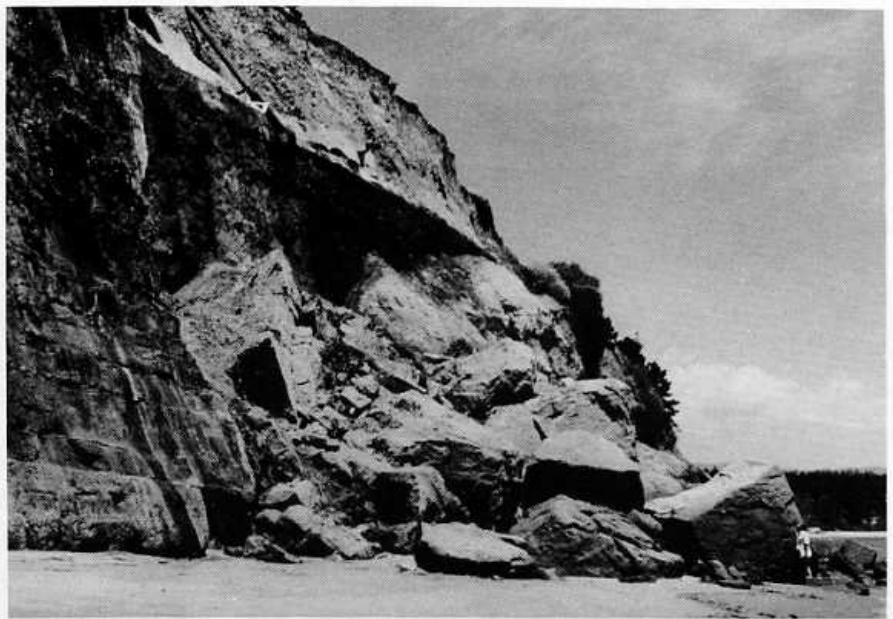
Photo 1. Joint controlled wedge failure in the Pliocene Purisima Formation. Marine erosion processes undercut these cliffs, which failed along intersecting joint planes.

it is extensively jointed and susceptible to wedge failure along joint surfaces (Photo 1). The unconsolidated terrace deposits typically consist of marine cobbles overlain by shallow marine to eolian sands, and a fluvial conglomerate that is capped by a thin soil horizon. The nearly vertical sea cliffs in this area are actively eroding where they are not protected by revetments, seawalls, or a wide sandy beach. In general, where unprotected, the coarse-grained and well-jointed Purisima Formation erodes at a relatively rapid rate (about 12 to 24 inches per year; 30-60 cm/yr) (Griggs and Johnson, 1979).

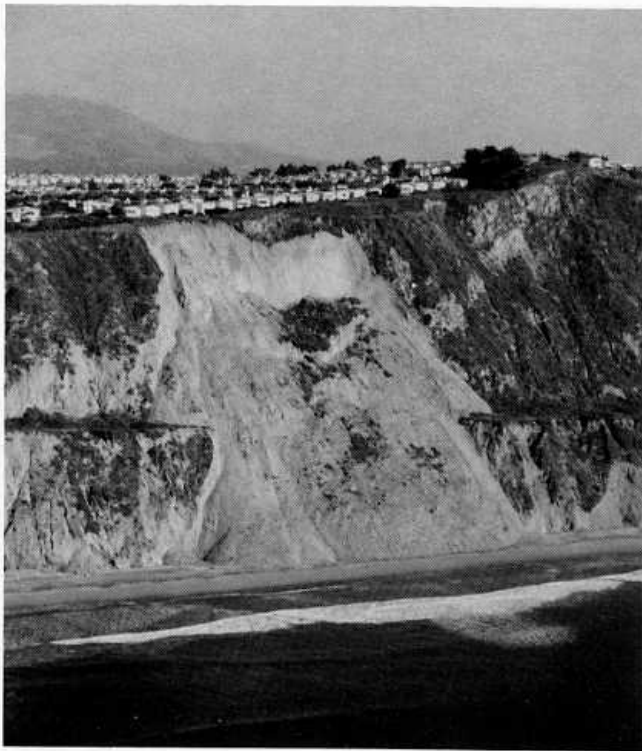
Photo 2. Large coastal landslide near Daly City. Note the proximity of cliff top houses to the head scarp.

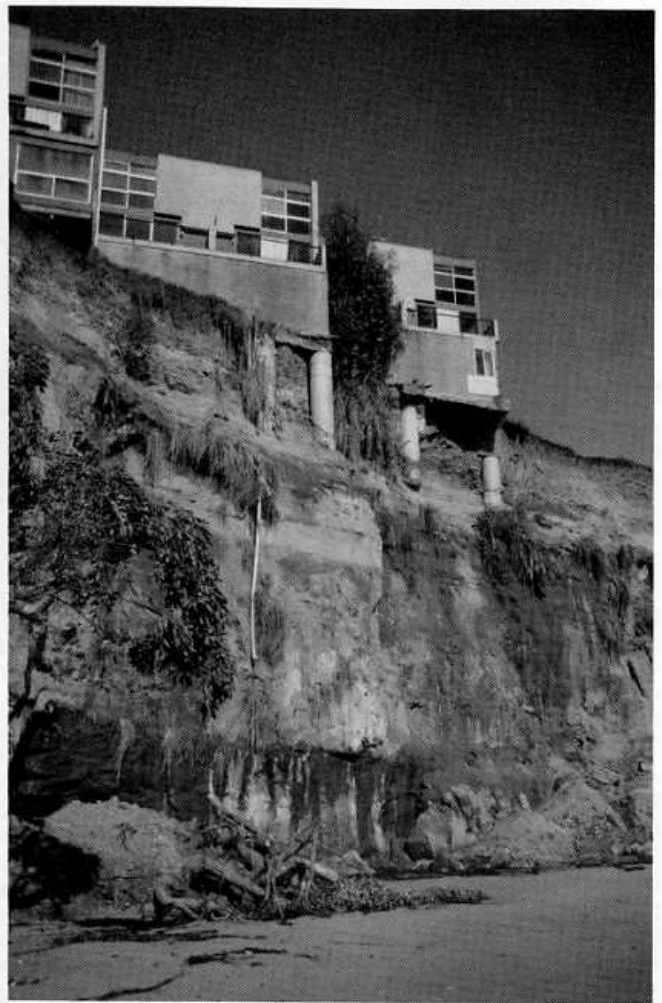
Damage to private property and public structures was minimal along the cliffs of this area with the exception of the cliffs immediately east of Capitola. In this area bedrock and terrace deposits toppled to the beach below and extensive bluff top fracturing also occurred. This caused further damage to walls and foundations of an apartment complex (already overhanging the sea cliff, Photo 3) and additional failure to an abandoned cliff top public road in the Capitola area.

Photo 3. Bluffs east of Capitola. Collapse of terrace deposits and underlying, extensively jointed siltstone further undermined the previously exposed foundation of this apartment building.

the top of bluffs, several structures were immediately damaged when cliff failure undermined the foundations (Photo 3). In nearly all cases of failure, tension cracks up to 30 feet (10 m) formed behind the head of scarps, and in some cases cut through house foundations (Photos 5 and 10). Cracking and slope failure were so extensive at three bluff top sites that the homes had to be demolished. Two of these homes were built on very narrow peninsulas (Photo 10); the third was at the crest of a very high, steep, narrow section of bluff top (Photo 8). These bluff top cracks probably represent incipient slides that may fail under winter conditions of increased pore pressure. The depth and width of such cracks can be used as a reasonable indicator of potential bluff top failure during seismic shaking.

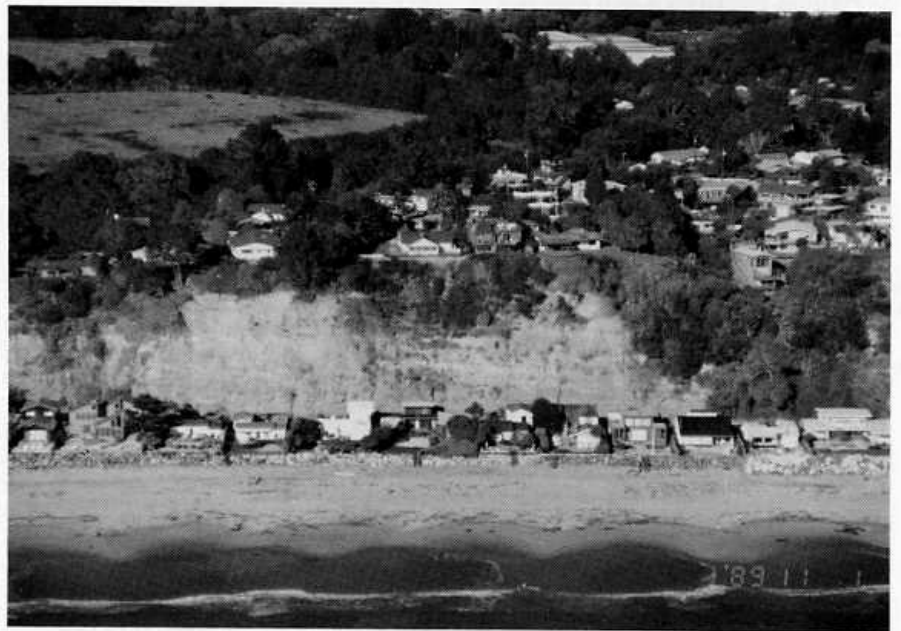
Seismic shaking initiated two types of failure here. Translation* (uniform movement) along a joint or weathering surface produced many large slides up to 180 feet wide (60 m wide) that originated in the upper 36 feet (12 m) of the sea cliff (Photo 4). The scarps of these slides tend to cut vertically through the Quaternary terrace deposits and then flatten as they approach the Purisima Formation (Figure 5). Deep tension cracks cut through the terrace deposits (Photo 5) and soils 3-18 feet (1-6 m) landward of many of the scarps; depth of cracks tends to increase with the size of the scarp (Figure 6). Some intact blocks and much loose soil cascaded down the face of the cliff, forming 60 foot (20 m) high coalescing talus cones that partially buried some automobiles and blocked access to homes (Photo 6).

Photo 4. Extensive sea cliff failure above Las Olas Drive. Failure occurred in the upper 36 feet (12 m) of the cliff and loose material cascaded down the steep slope. Note the many houses both above and below the landslide that are jeopardized by slope failure.

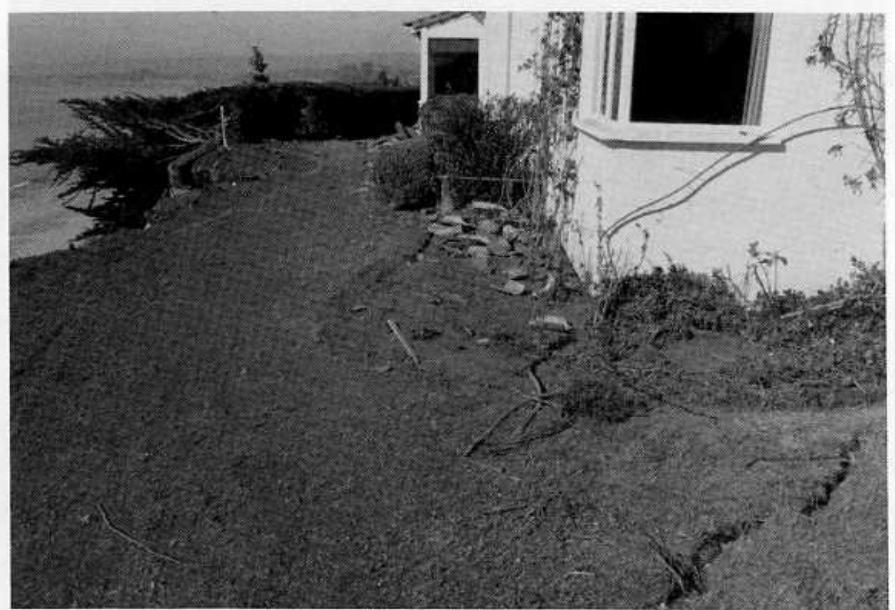
Photo 5. Deep tension crack in terrace deposits. These cracks often cut through house foundations and indicate the potential extent of future failure.

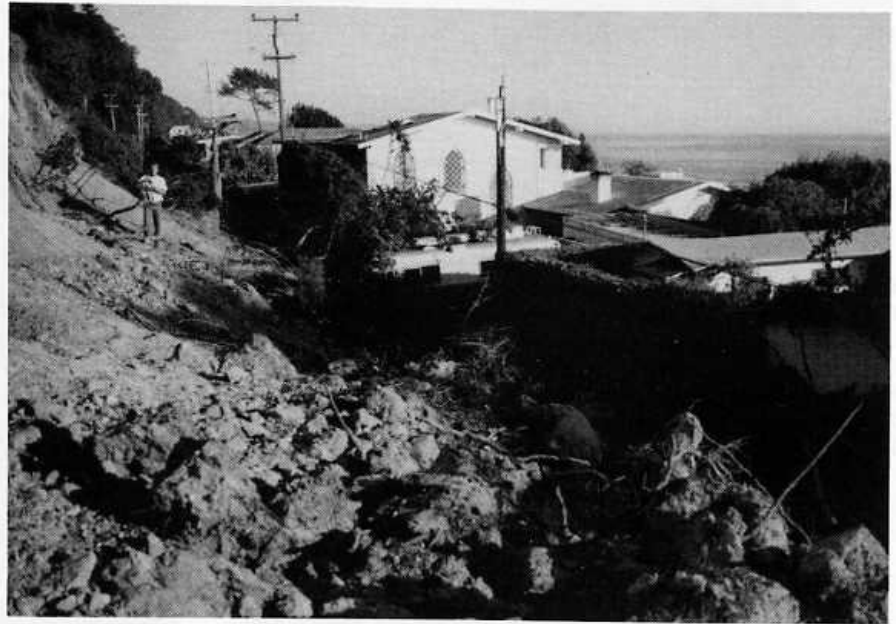
Photo 6. View facing east along Las Olas Drive. Material from a failure in the upper part of the bluff cascaded down the slope and blocked the road. Note the telephone pole broken by the landslide.

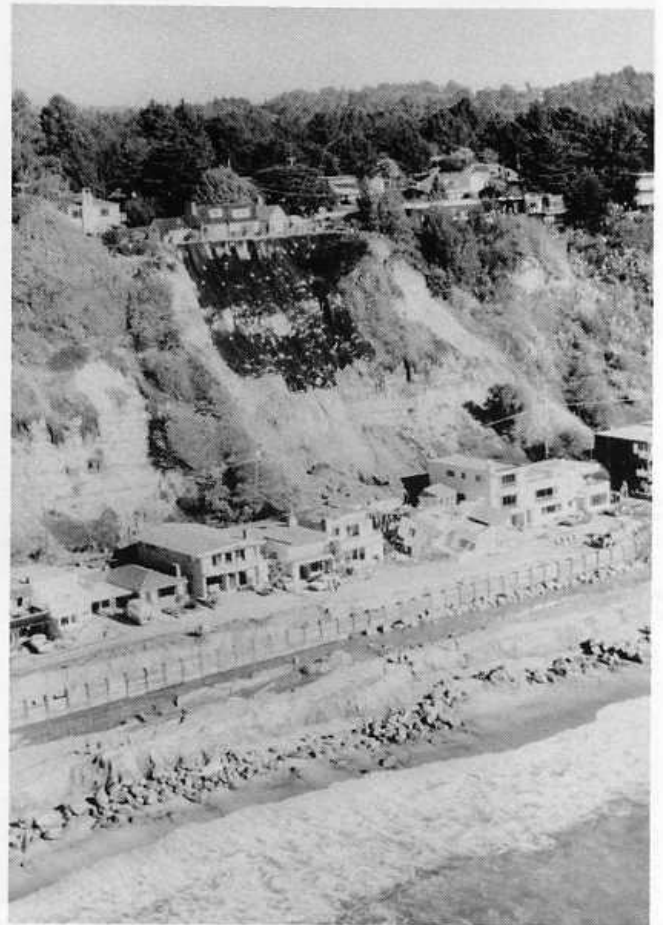
damage (Photo 7). The loose surficial sand liquified and flowed downslope over a weathered, less permeable surface and into homes at the base of the sea cliff (Griggs, 1982).

Photo 7. Slope failure in 1982 that destroyed a house on Beach Drive. This type of sea cliff failure is very similar to that caused by the October 17, 1989 earthquake.

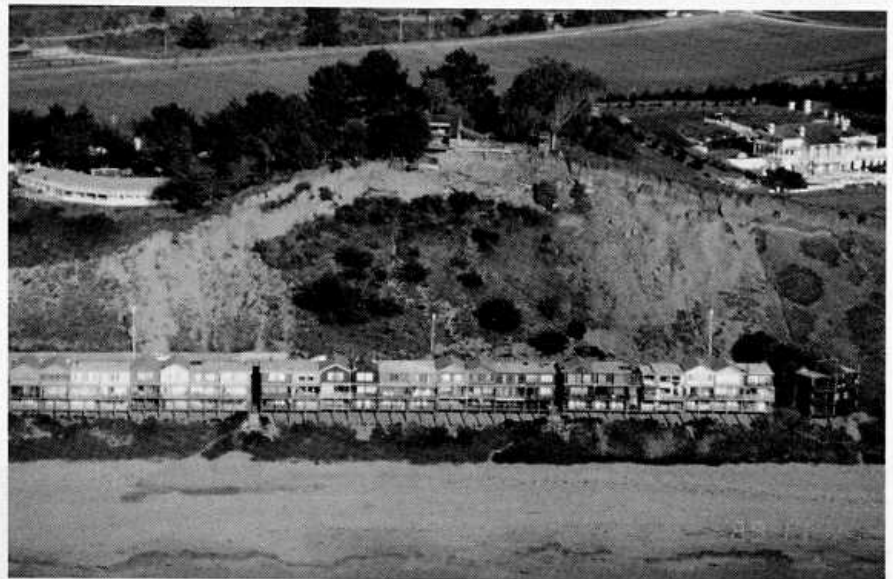
Three types of earthquake-induced failures prevailed along this stretch of coast. The first type was a shallow dry sand flow less than 3 feet (1 m) deep, 15-30 feet (5-10 m) wide, and 30-60 feet (10-20 m) long, which originated well below the bluff top (Figure 8, Photo 8). A vertical scarp cut through a thin, cohesive soil layer to a failure surface that paralleled the bluff face. Loose sand or small blocks of more cohesive material, often held together by roots, slid along this surface and then ramped over the less steep talus deposits at the base of the slope.

Photo 8. Very large dry sand flow above Place de Mer development. Houses at the top and base of this failure were at risk.

Most of the sea cliffs included in this study were too steep to support slope construction, and the hazard of building on such locations is verified by observations. In several locations, mid-slope sites received debris from upslope failures (Photo 8).

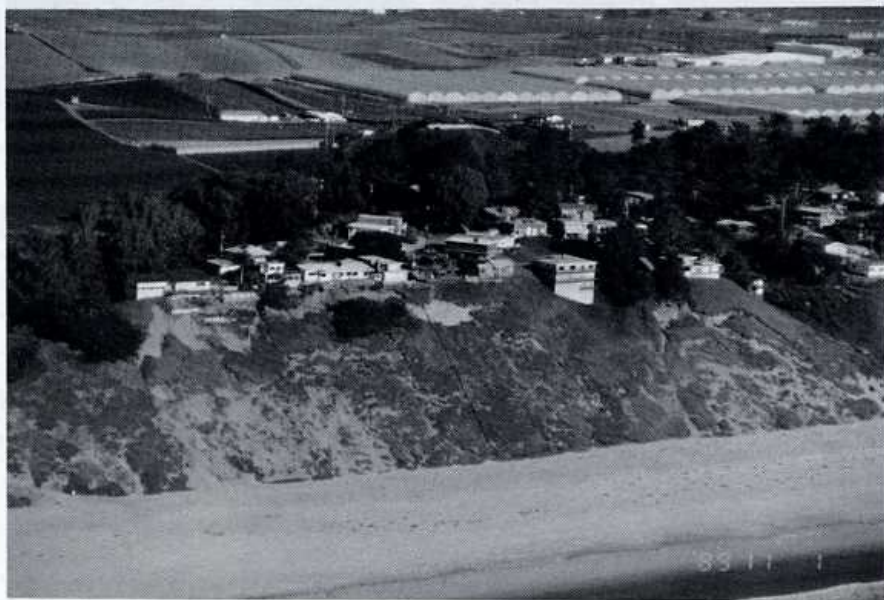
failure in this area occurred when shallow slabs up to 3 feet thick were detached and translated short distances downslope (Photo 9). This form of bluff retreat has threatened several homes and at least one will be relocated.

Photo 9. Large dry sand flows above Sunset State Beach. One of the bluff top houses will be moved farther back from the edge of the cliff.

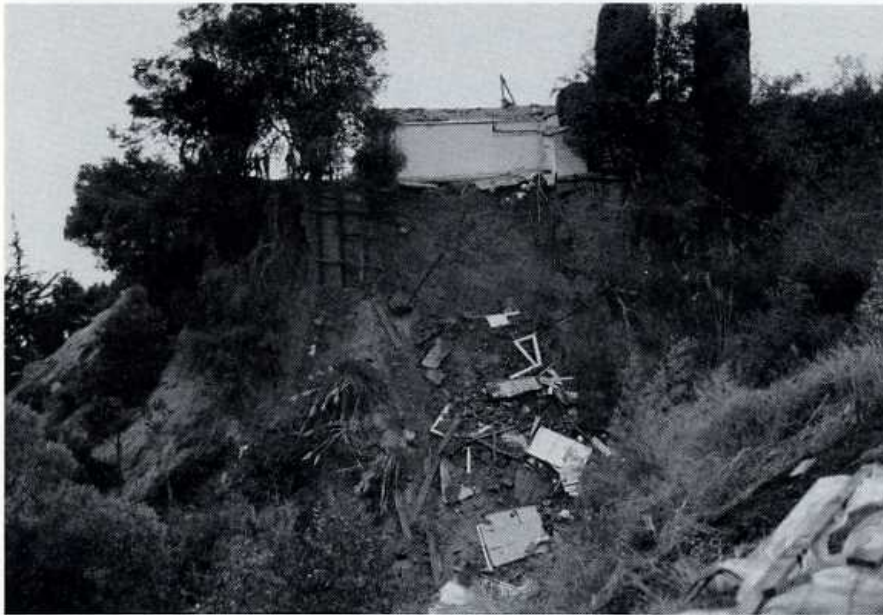
The lithology of the sea cliff materials controlled the mode of failure at most locations. Promontories, headlands, and narrow peninsulas or ridges along the coast were consistently the sites of the most extensive failure (Photo 10). On a larger scale, scientists also noted this effect in the Santa Cruz Mountains, as a result of this earthquake (Plafker and Galloway, 1989), and in other areas where large earthquakes have occurred in the past (Harp and others, 1981). In these non-coastal areas, the ground surface topography caused reflection of seismic

Photo 10. Extensive slope failure and cracking on a narrow ridge. This house will be torn down and the slope will be graded to a safer angle. Houses below this failure were evacuated.
