Former Colvert's Dairy Ardmore, Oklahoma

Final Remediation Report

Prepared by:
Department of Environmental Quality
707 North Robinson
Oklahoma City, Oklahoma 73101

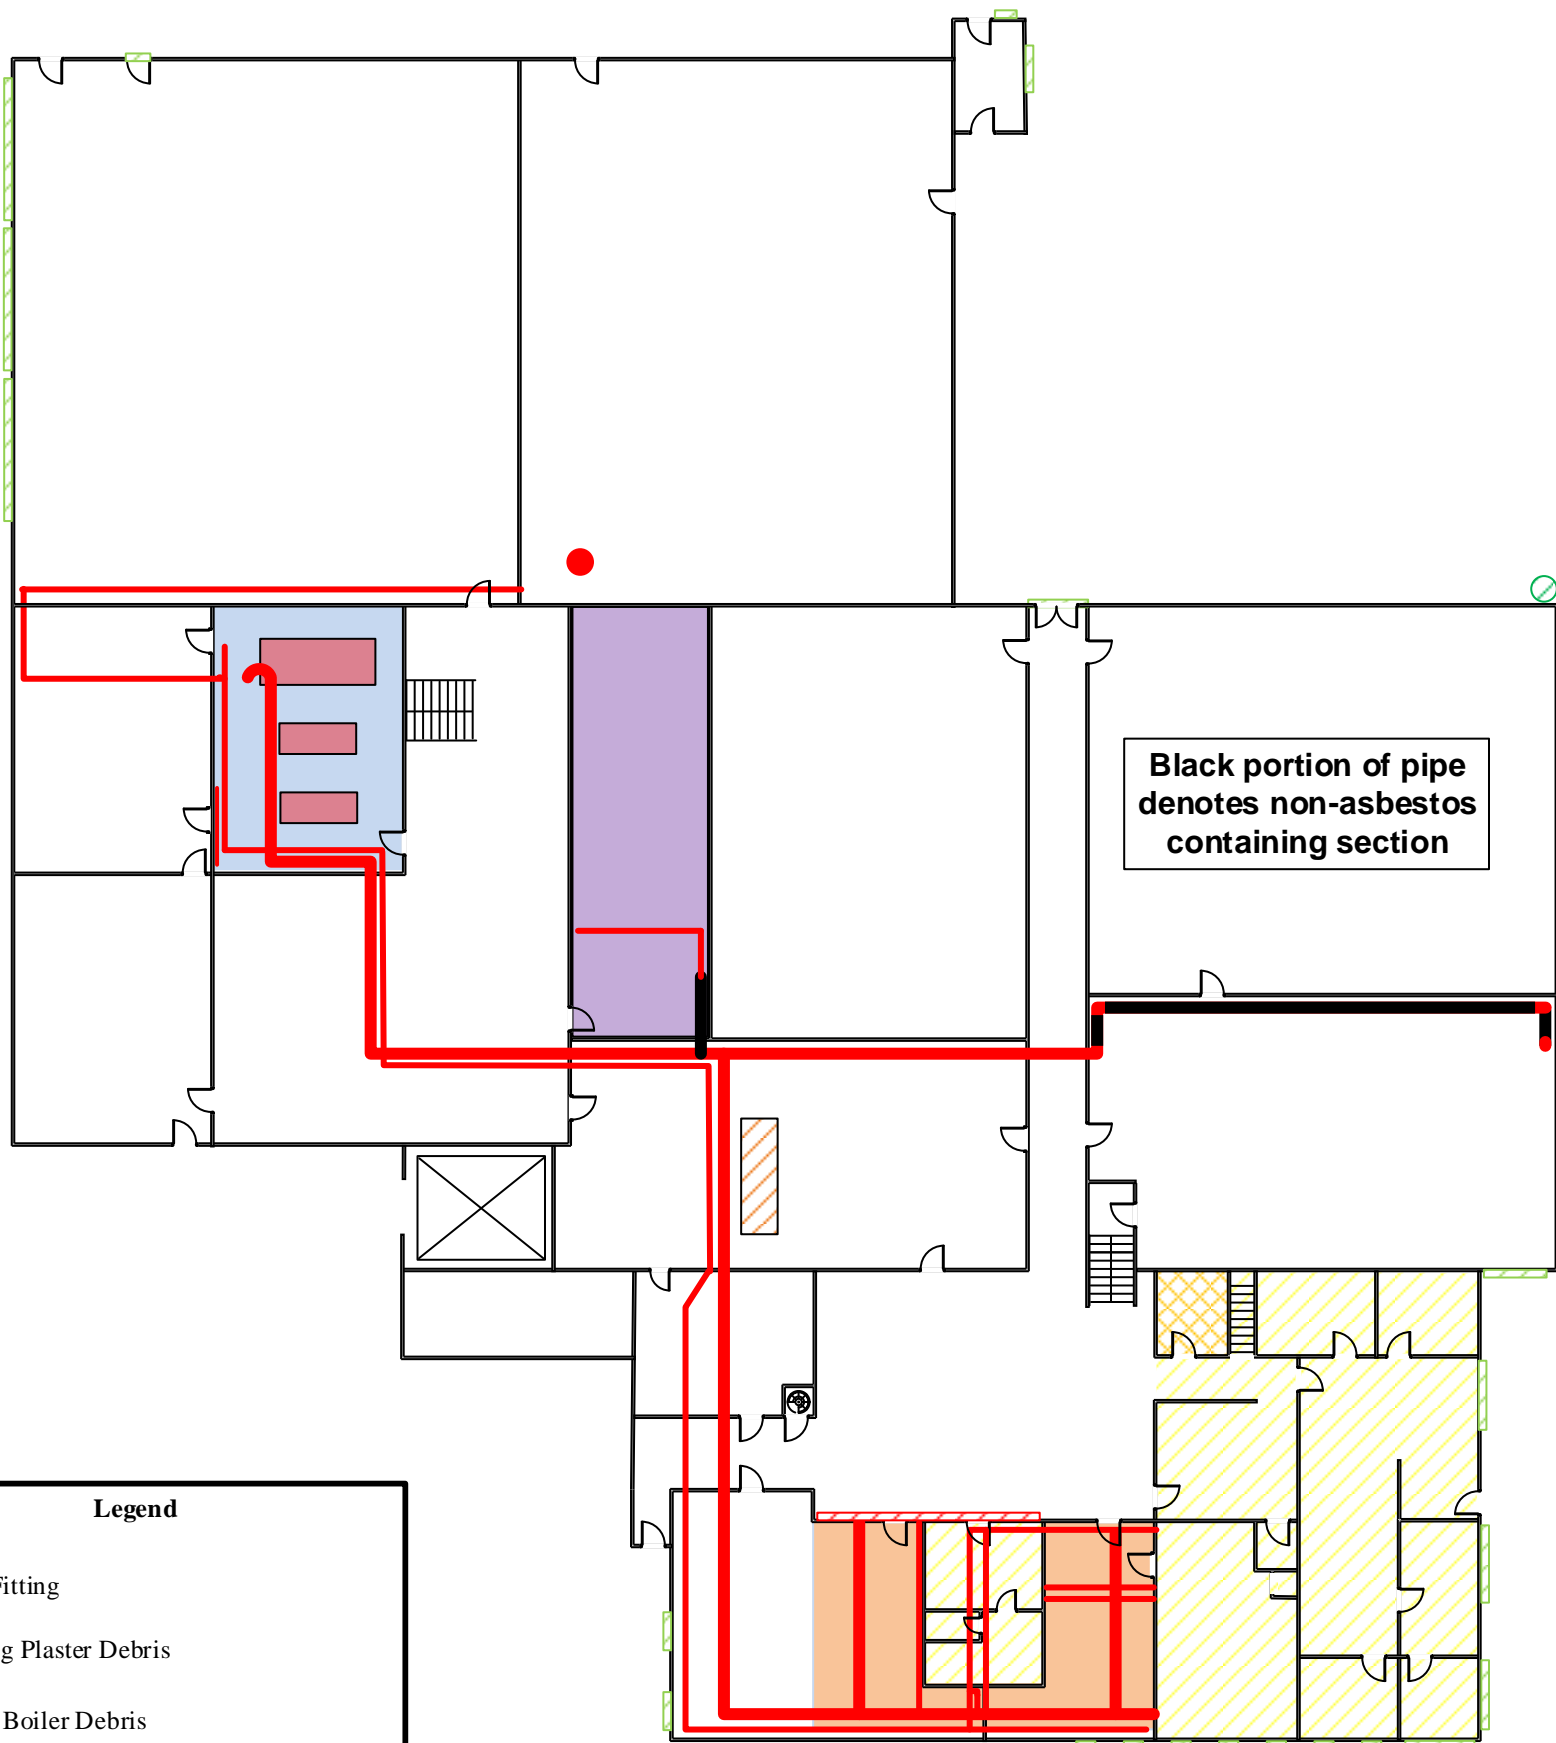
Figure 11
Exterior Sample Locations

Black portion of pipe denotes non-asbestos containing section

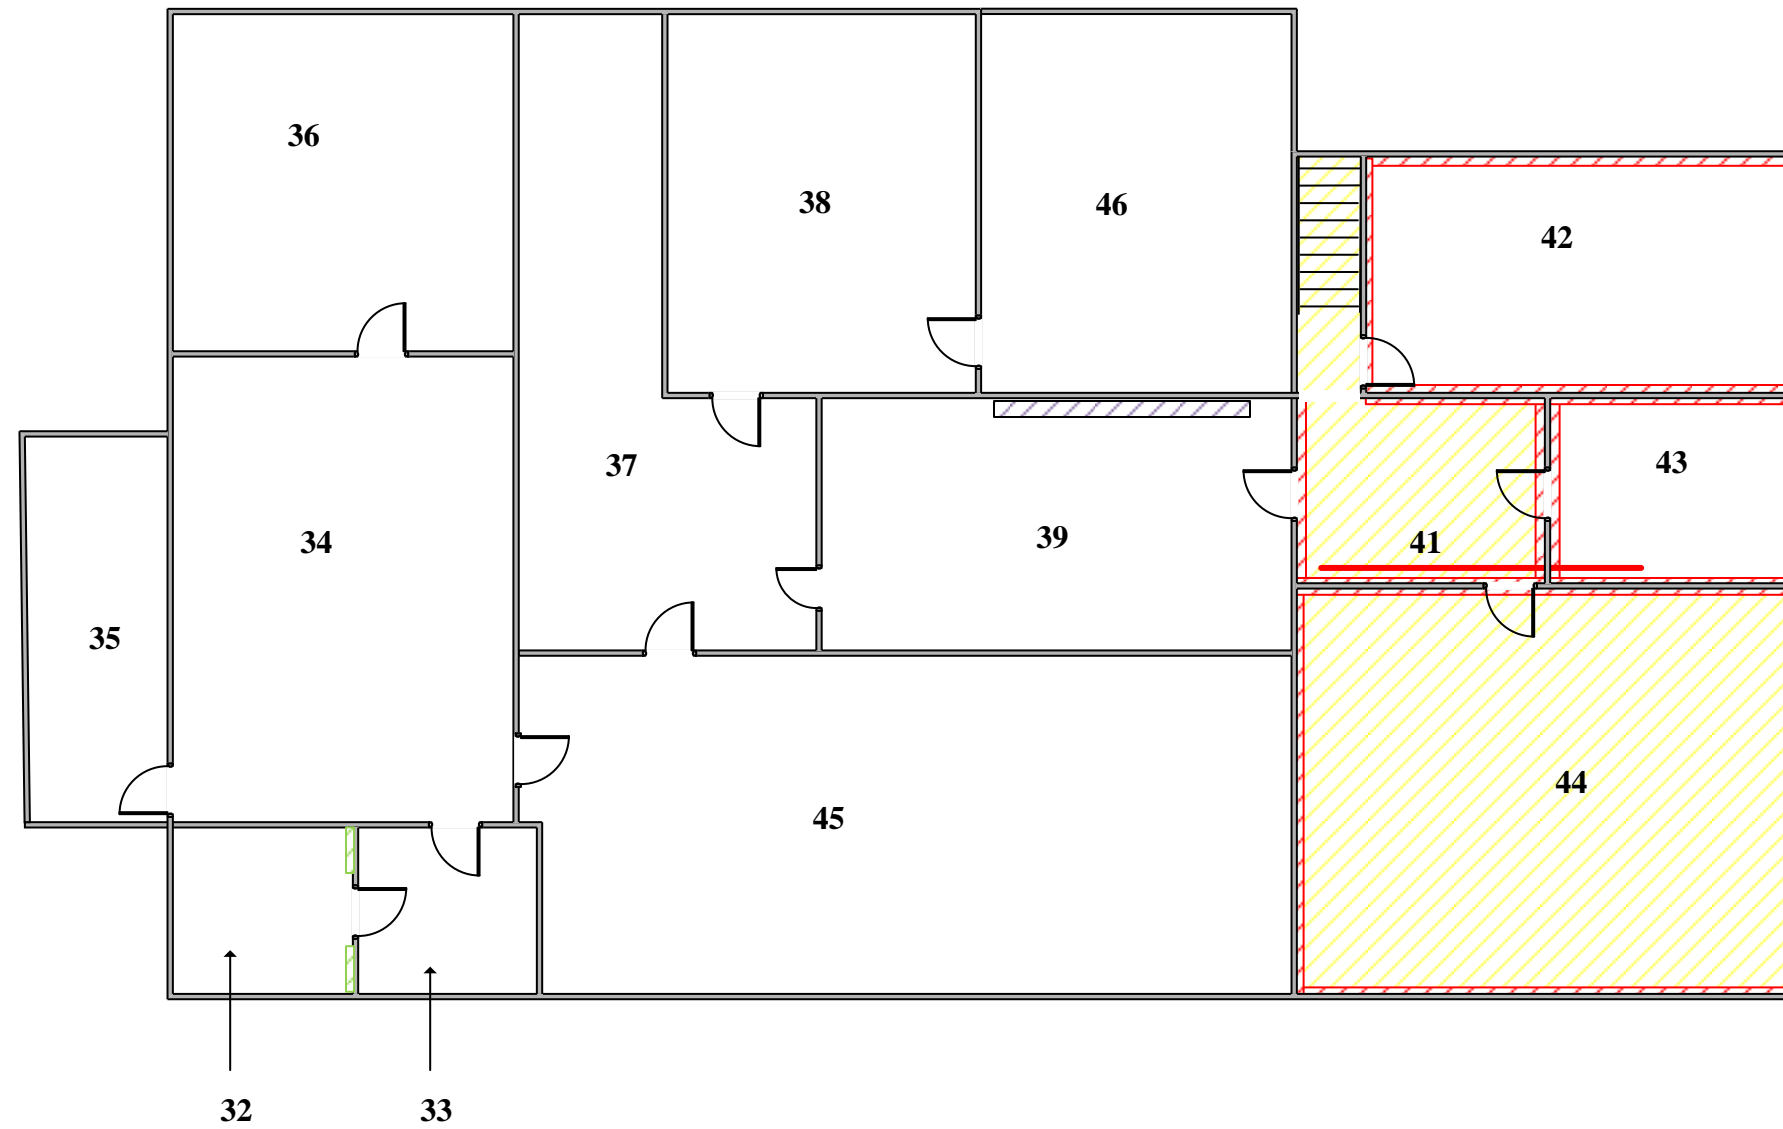
Asbestos Containing Material,
Mezzanine
