# The restoration of my 1966 Chevrolet Corvair Corsa 140 hp 4 speed.

Acquired January 2014.

The restoration, as shown in this document, is complete. I now have the confidence to drive this car anywhere, without the worry of a breakdown. At this time I think this car is reliable and safe to drive.

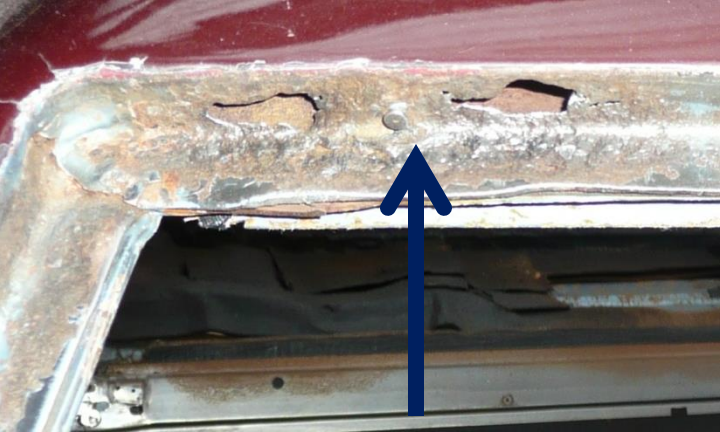
Front Windshield Rust Repair Top right

Trunk Bottom To be cut out and a new bottom (supplied) to be welded in.

Weld up Antenna hole Bottom right

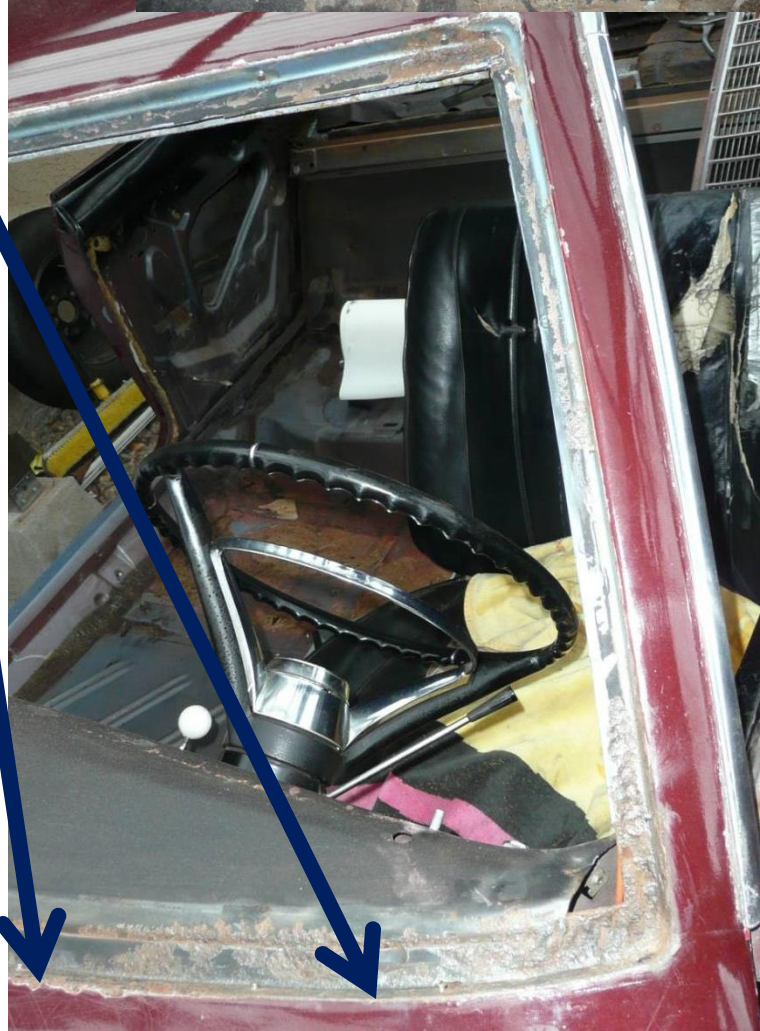
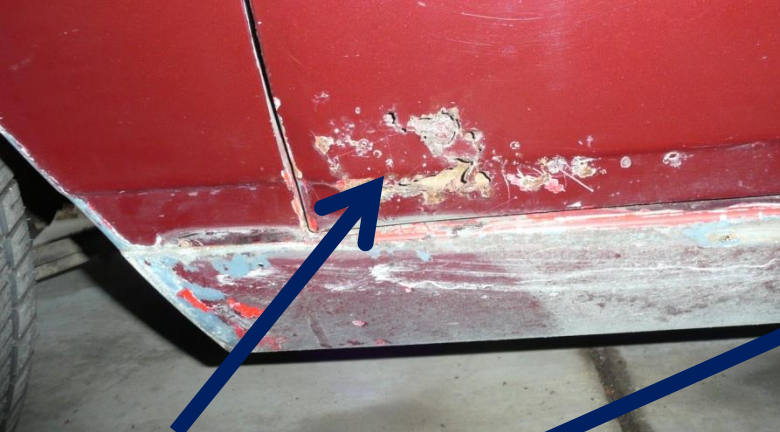
Left front Door Rust Repair

Left front Door Sill Rust Repair

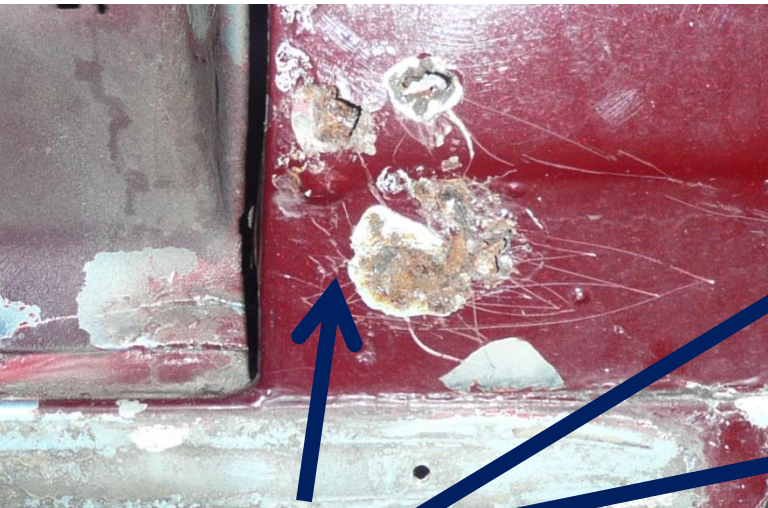
Right front Panel Rust Repair

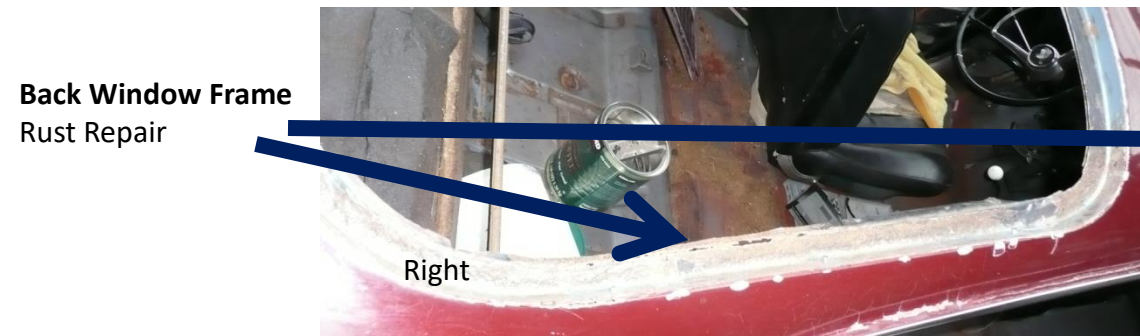
Back Window Frame Rust Repair

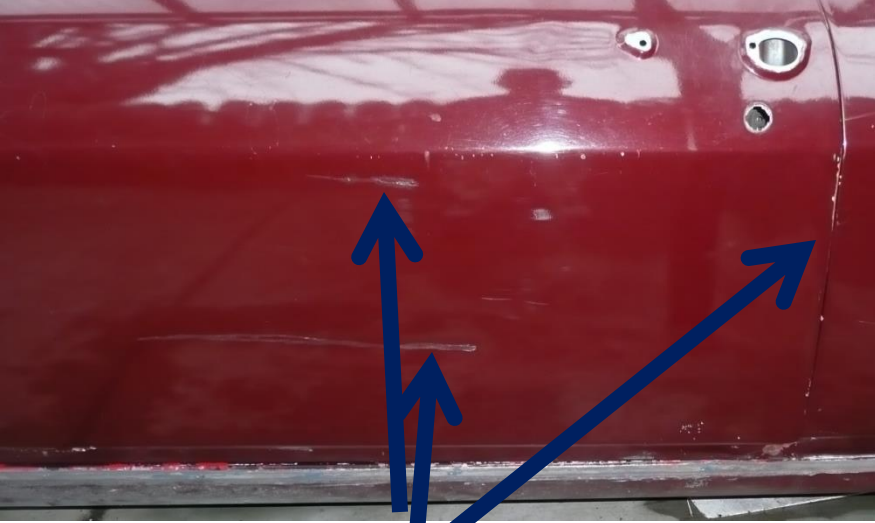
Left front Door Dent Repair  
Major and minor dents to be removed

Front nose Dent Repair

Top left rear fender Dent Repair

Left rear fender Dent Repair

Left and right rear skirt Dent Repair

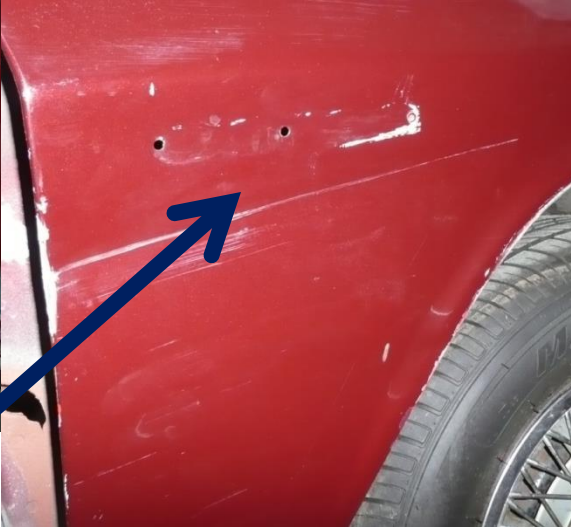
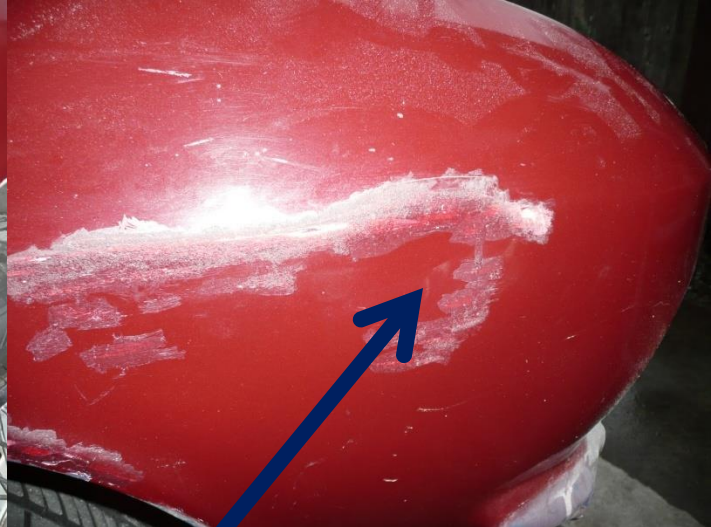
Right side in front and behind the door need dent Repair

Right front fender need dent Repair

A right side door is provided that must be installed prior to paint

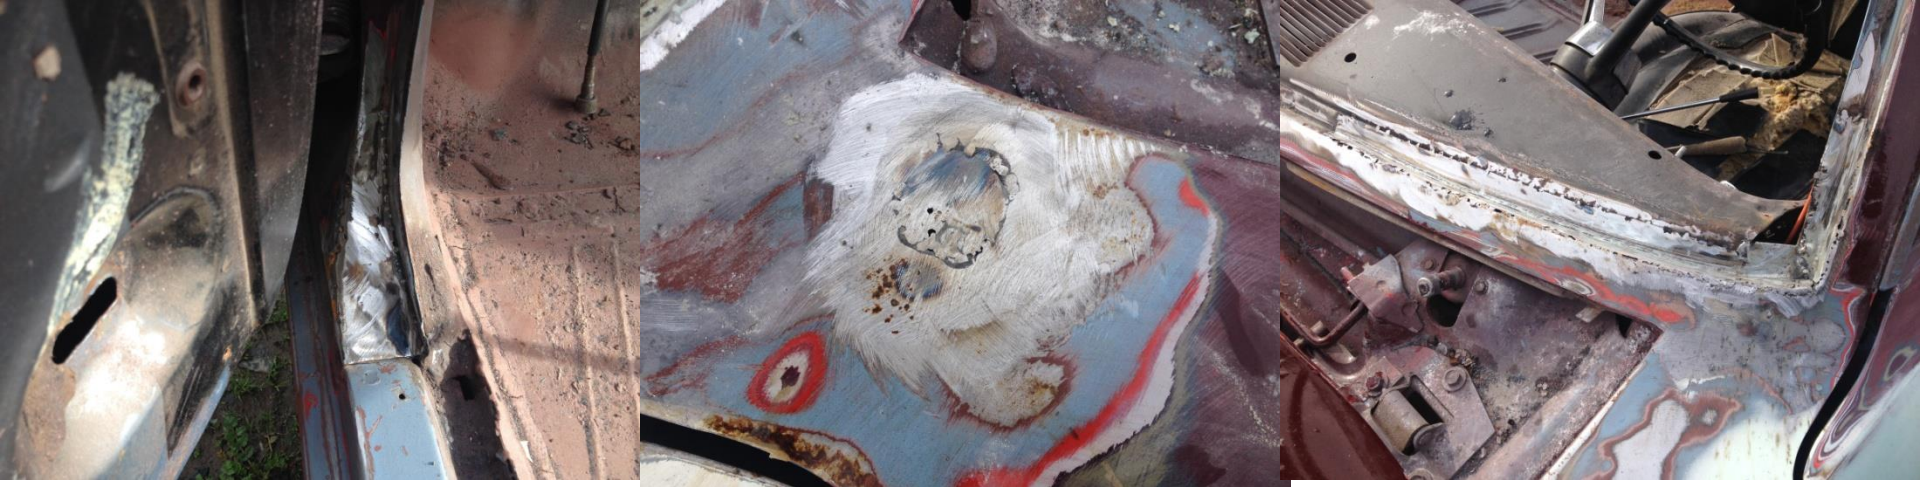
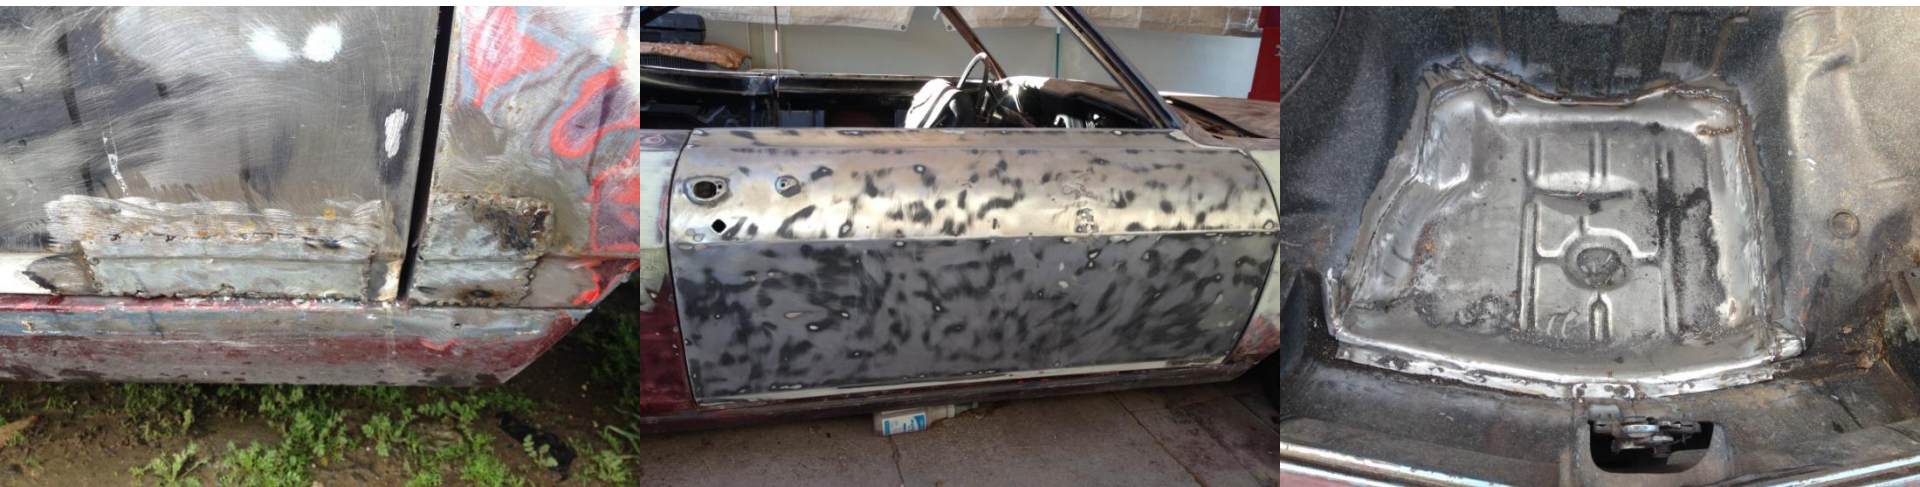
Corvair progress report. The metal work is coming to an end. The photos show some of the new metal pieces that were added to repair rust . In the 48 years the car has been around wet weather has produced some small pockets of rust. All these areas had to be removed and new metal welded in place. Once this is done the final body prep will begin. All in prep for new paint.

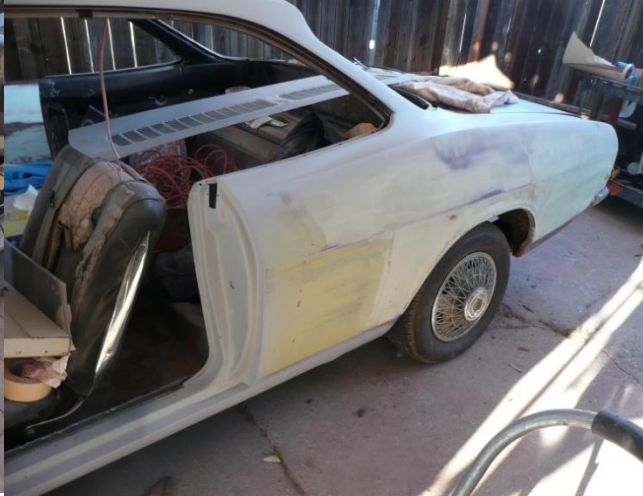
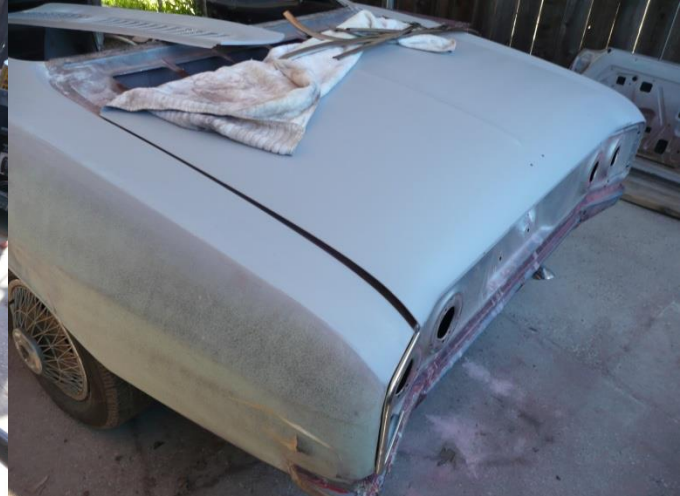
I went to see the progress on the car today. Good news, It looks like we will go to paint in around two weeks. This is what we have so far, the car needs a little tweaking around the front window.

I took the trim over to do a dry run and found a few places where we need to refine the radius on the window cutout.

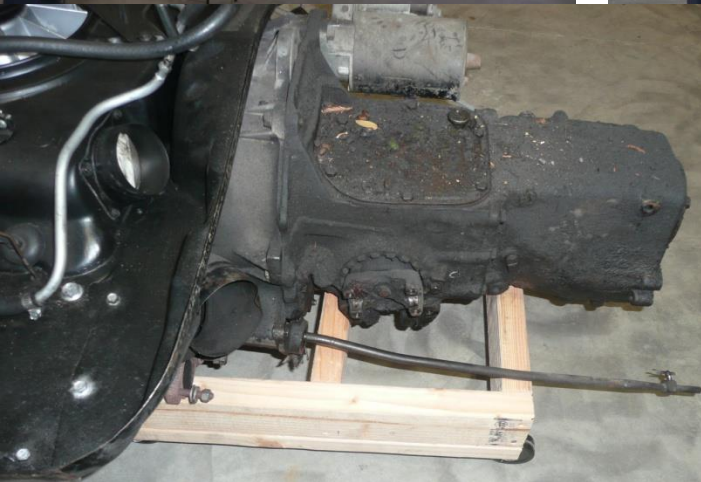
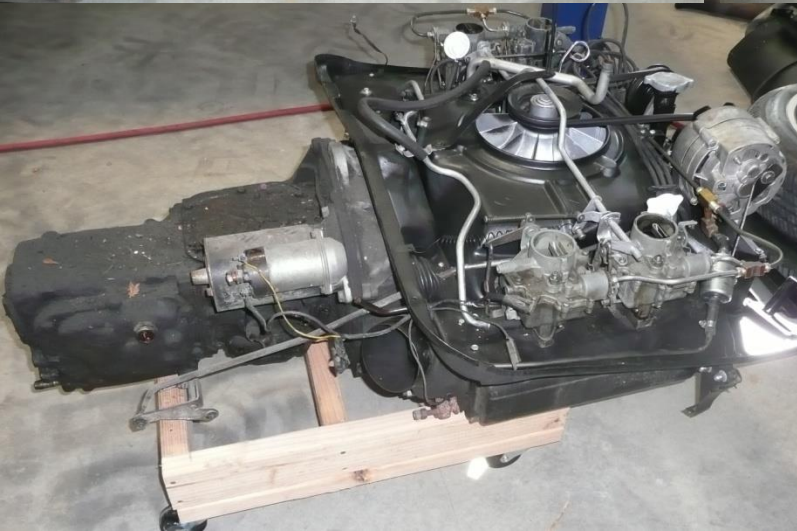
Engine removal to fix some poor workmanship and change the transaxle. A general cleanup with new transaxle mounts and shift tube bushings. New bell housing seal and trailing arm bushings. Stripped threads in pan need repair, Exhaust manifold hold down studs were also installed.

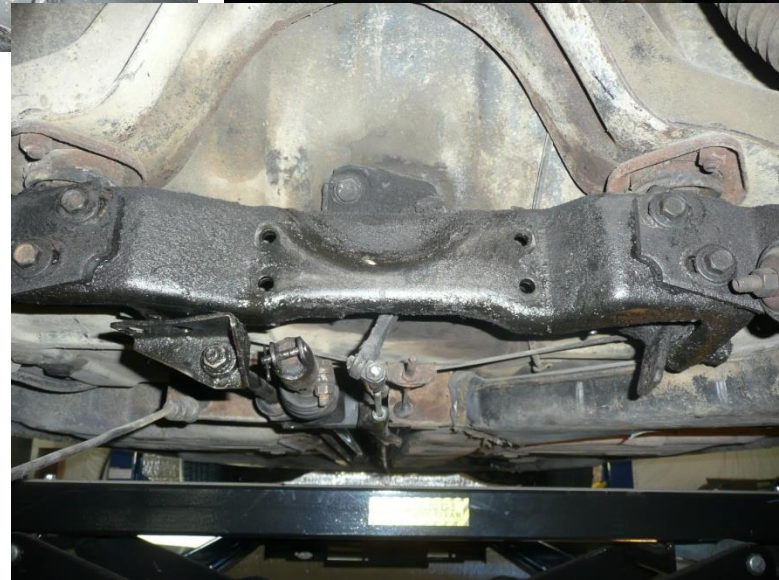
Engine removal and clutch and bell housing removal. Replaced bell housing seal. Cleaned and painted shrouds and tunnel covers.

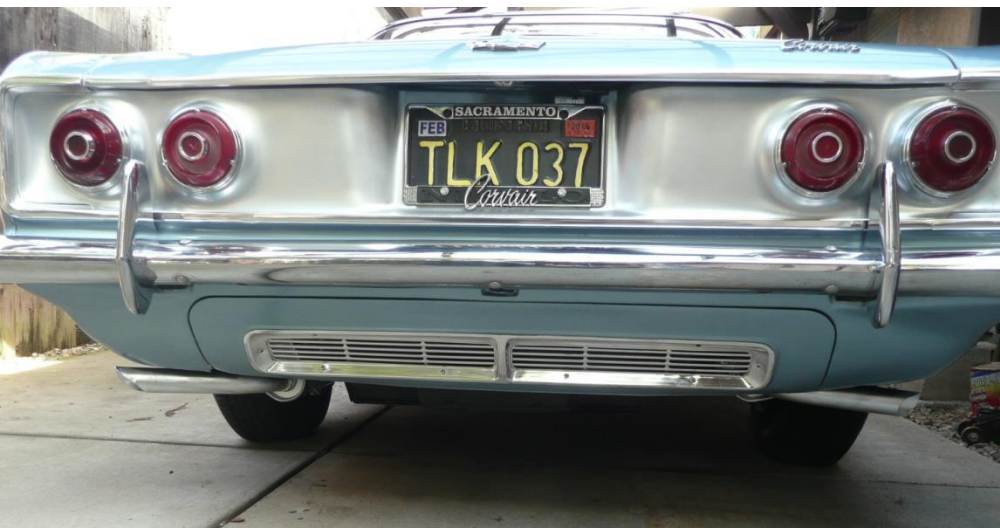
Both mufflers were replaced along with a new right side tail pipe. The mufflers are AP 6503 that are very close to the size and shape of the original mufflers. All seams were welded like the original factory equipment.

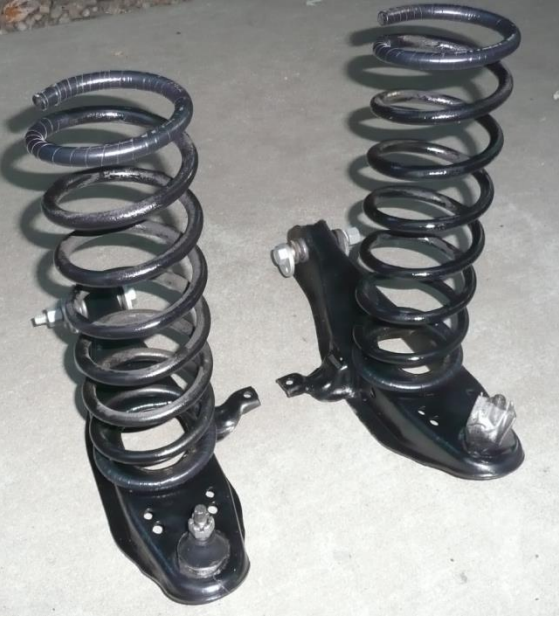
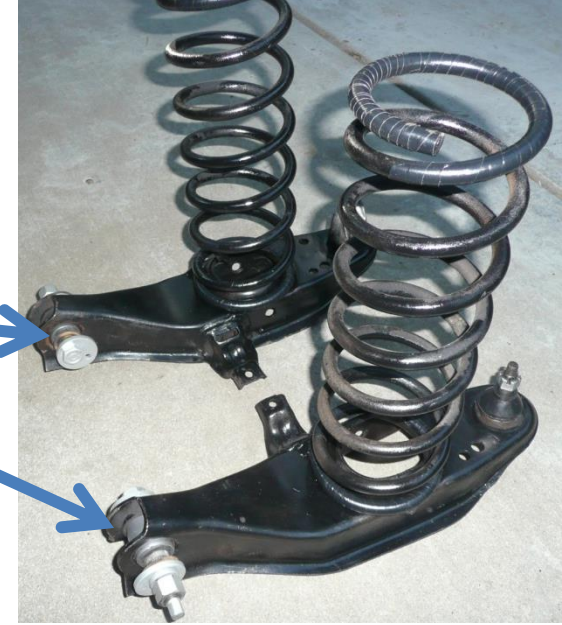
Removed and refurbished the lower front "A" arms.  
Replaced the inner bushings along with the ball joint  
on the right arm.
