BRITTLE MATERIALS DESIGN, HIGH TEMPERATURE GAS TURBINE

Arthur F. McLean, Ford Motor Company, Dearborn, Michigan 48121
Eugene A. Fisher, Ford Motor Company, Dearborn, Michigan 48121

Final Report, July 1, 1971 to August 31, 1979

Contract Number DAAG 46-71-C-0162

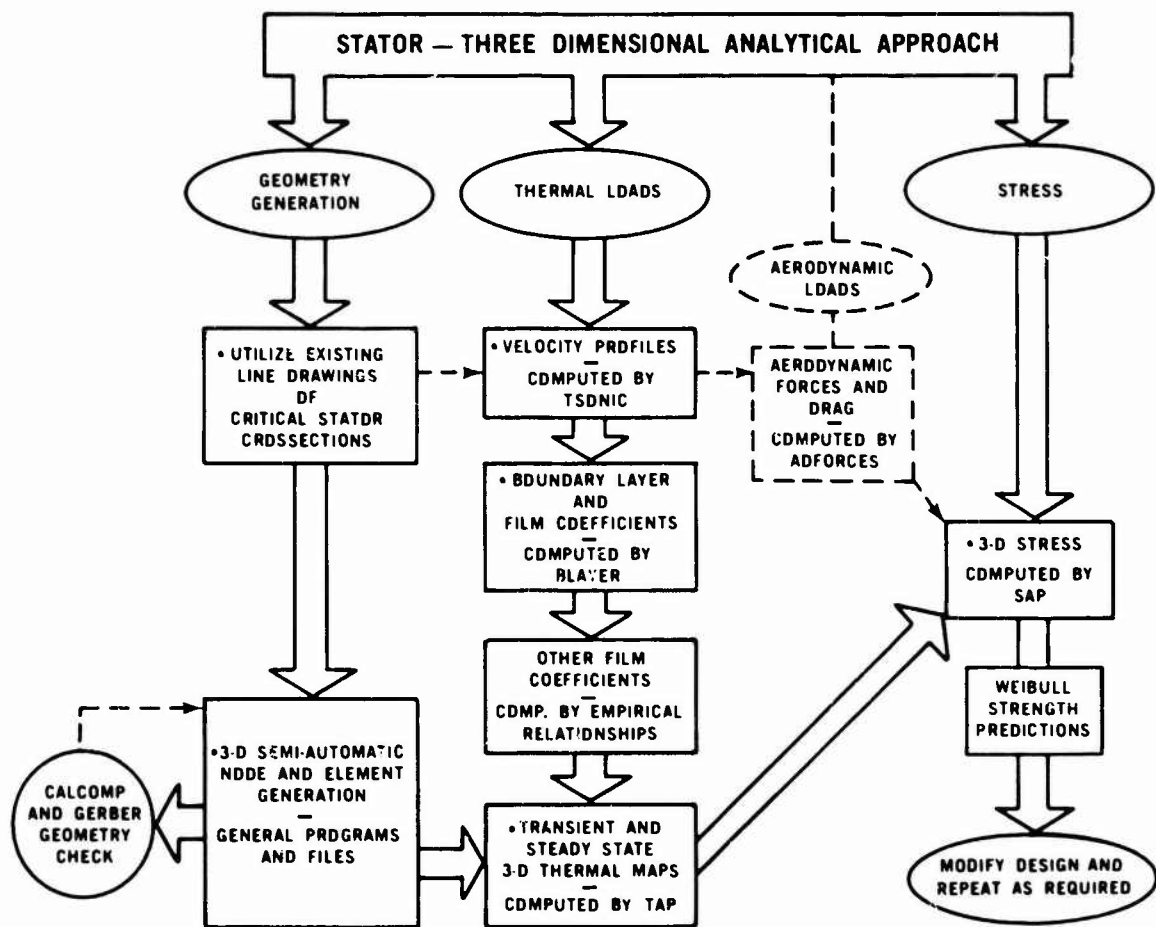
Figure 3.1.2-9 — Schematic Diagram of Three Dimensional Analytical Process as Applied to Ceramic Stator

All five programs (TAP, SAP III, TSONIC, BLAYER and ADFORCE) compose the basic units of an analytical process devised for the three-dimensional analysis of turbine flowpath components. A schematic diagram of the process developed for the stator study is displayed in Figure 3.1.2-9. The three-dimensional finite element models generated and used in the analysis of the first stage rotor and stator are displayed in Figures 3.1.2-5 and 3.1.2-10. The stator model, as shown, was generated by the Lawrence Livermore Laboratories under a separate ARPA contract.

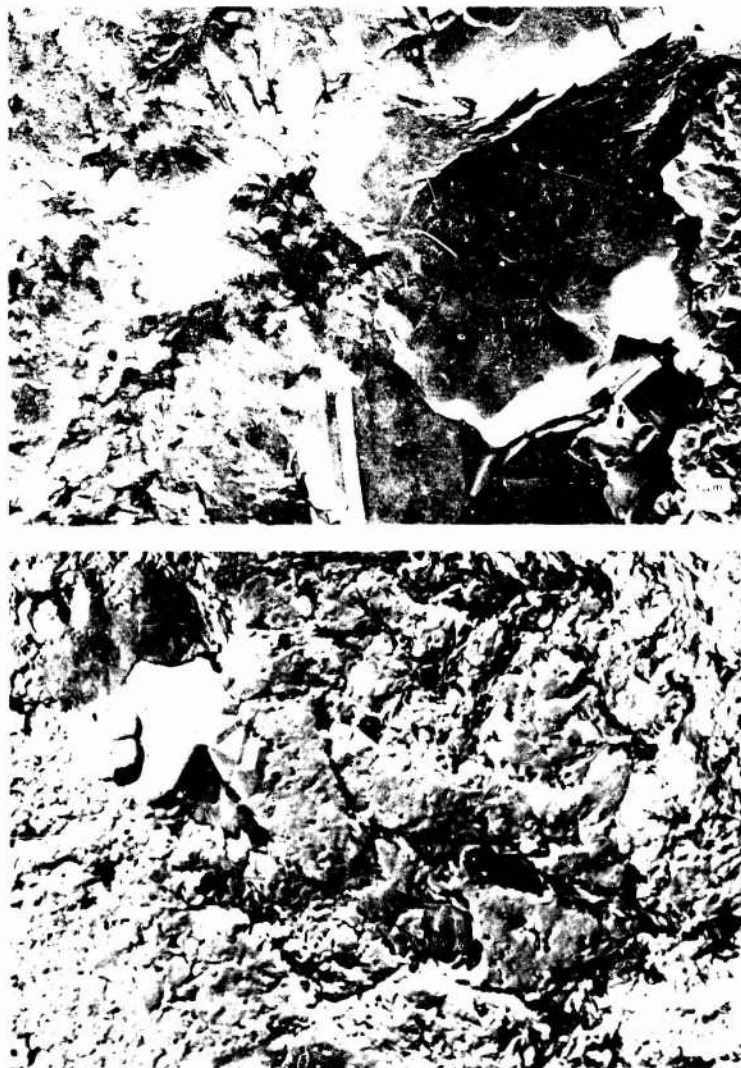
Figure 3.2.1-14 — Microstructure of RBSN Showing Effect of Changes in the Two Stage Nitriding Cycle

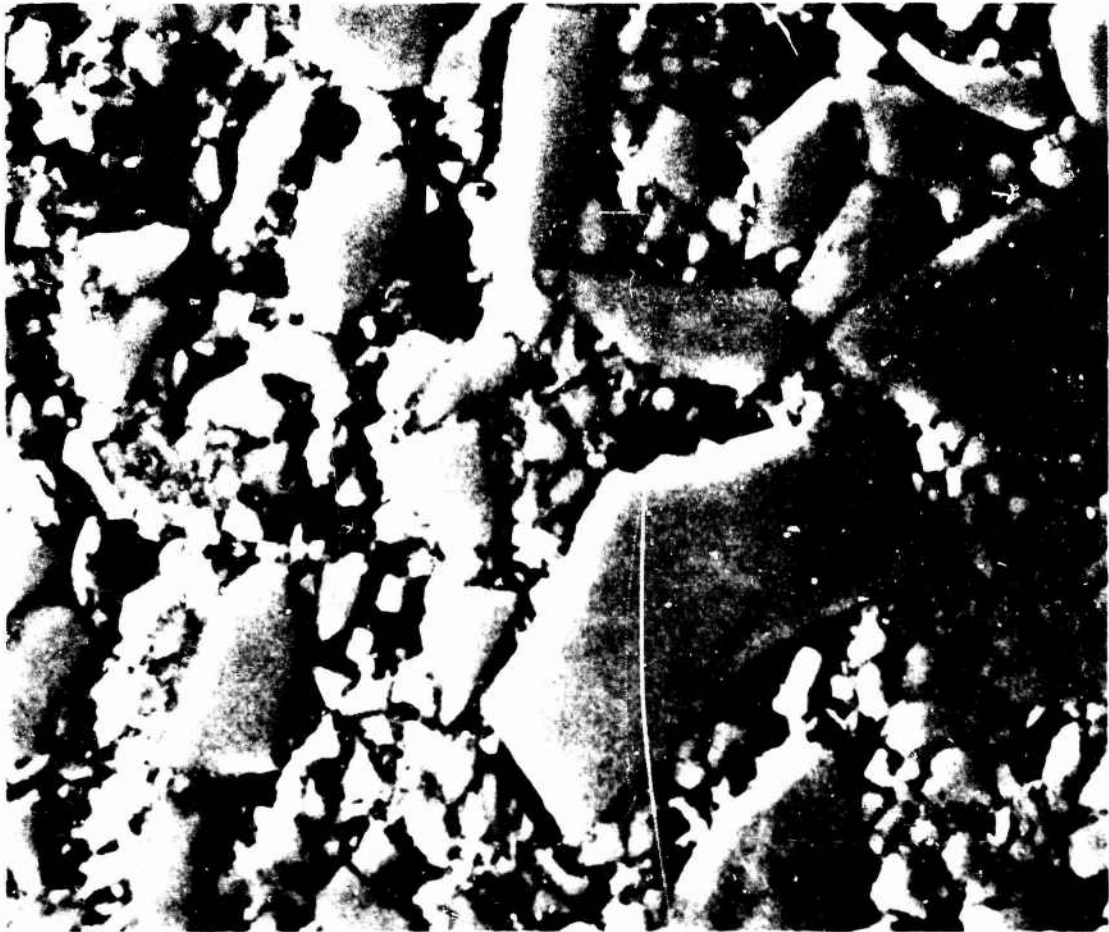
Figure 3.2.2-3 — Microstructure of Cast Silicon Structure (800x)

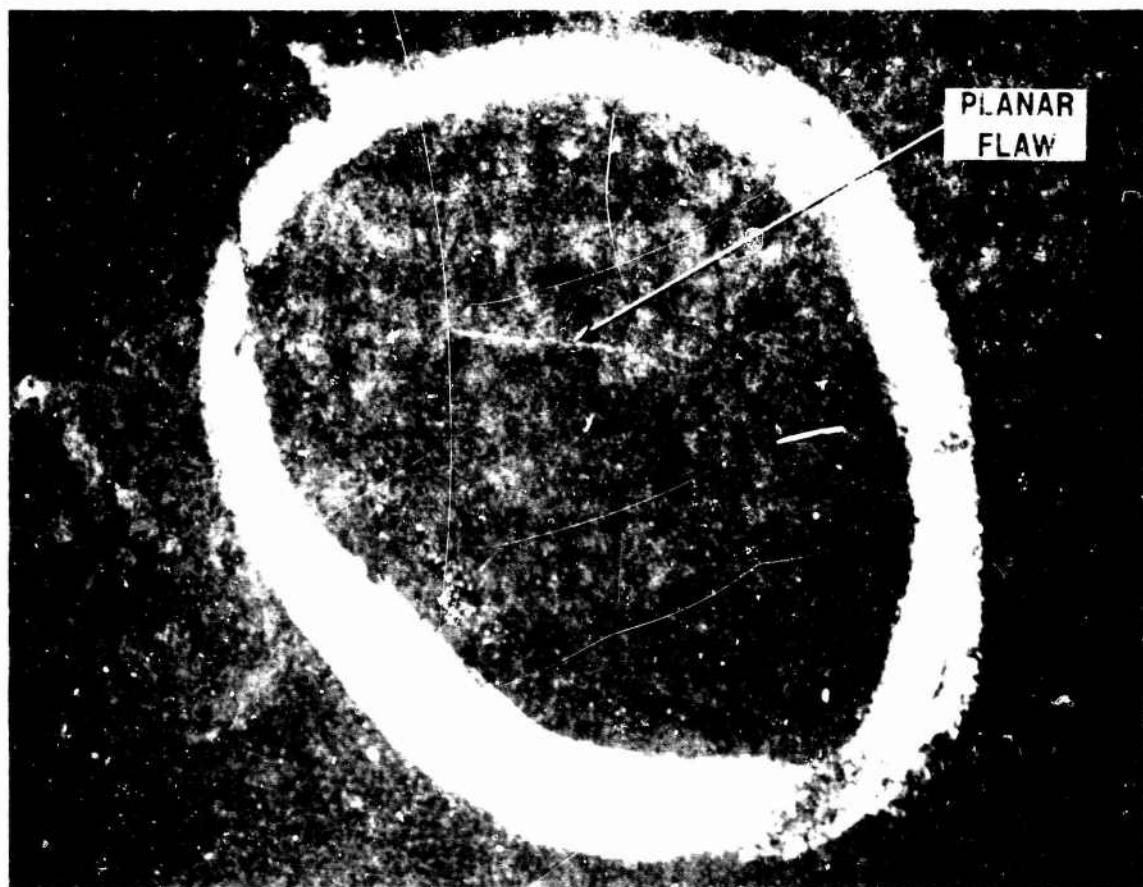
Figure 3.3.1-7 -- Planar Type Defect Detected by Visual Inspection (37X)

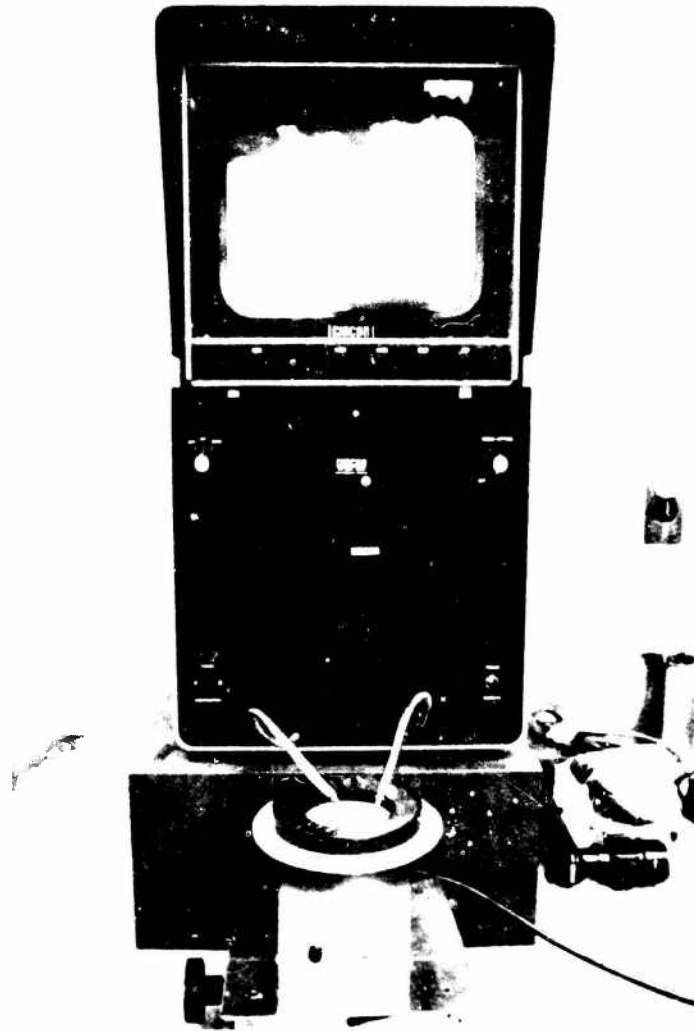
Figure 3.3.1-8 — Circon Video Visual Inspection Equipment

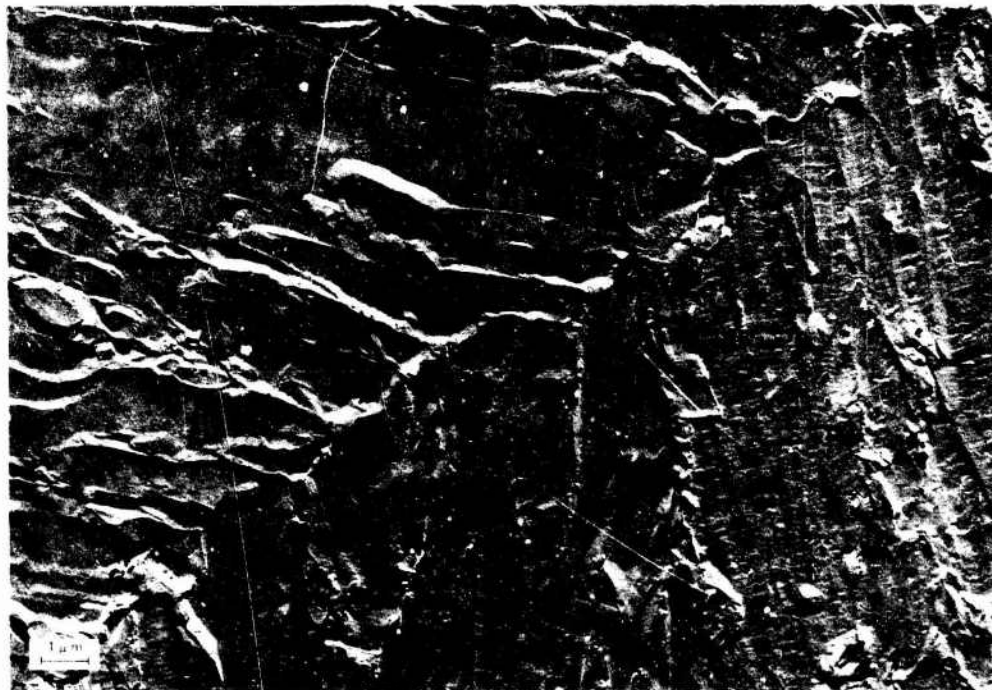
Figure 4.3.2-9 — Microstructure of CVD Silicon Carbide at Joint of Two Adjacent Areas (7100X)
