# ARCHAEOLOGY AT FORT CHAMBLY

Pierre Beaudet  
and Céline Cloutier

Studies in Archaeology, Architecture and History  
National Historic Parks and Sites  
Parks Service  
Environment Canada

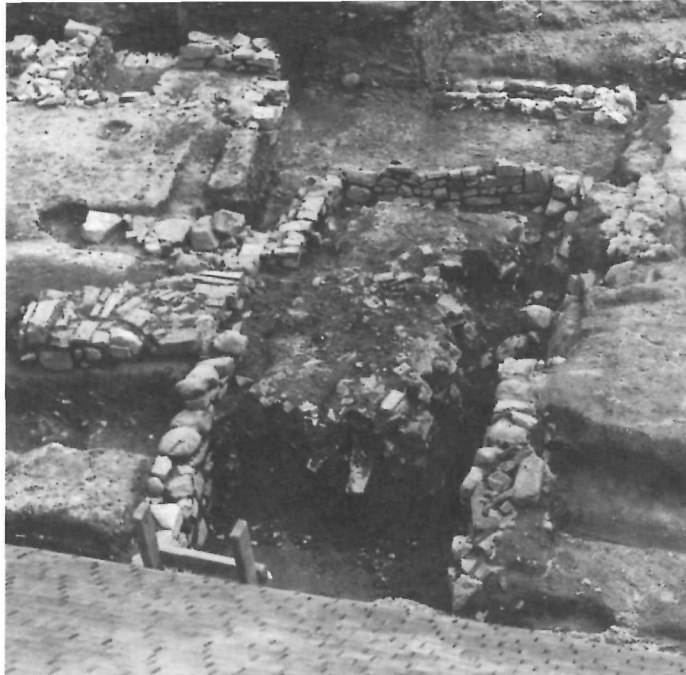
- 22 Foundations of a building associated with the first fort (Feature No. 5). In the background (upper lefthand corner), notice the remains of another small building associated with the larger one. Its eastern end was partially destroyed when a drain was constructed in about 1760.

A section of the excavated trenches was located under a building that is also associated with the first fort (Fig. 18: Feature No. 5). The foundations of this building were excavated in the central area of the enclosure (Fig. 22). The western part of this building had a cellar, while the eastern part did not. A smaller building is associated with it (Fig. 18: Feature No. 6). The fact that these two buildings were linked physically is indicated by the presence of wooden pickets that once constituted a fence. The first building was identified as a house or workshop because it had a fireplace base, while the other is thought to have been an outbuilding (Piédalue 1979: 29). The remains of what may have been other buildings with fireplaces were also found (Fig. 18: Features No. 9a, b, c), but their identity remains very uncertain.

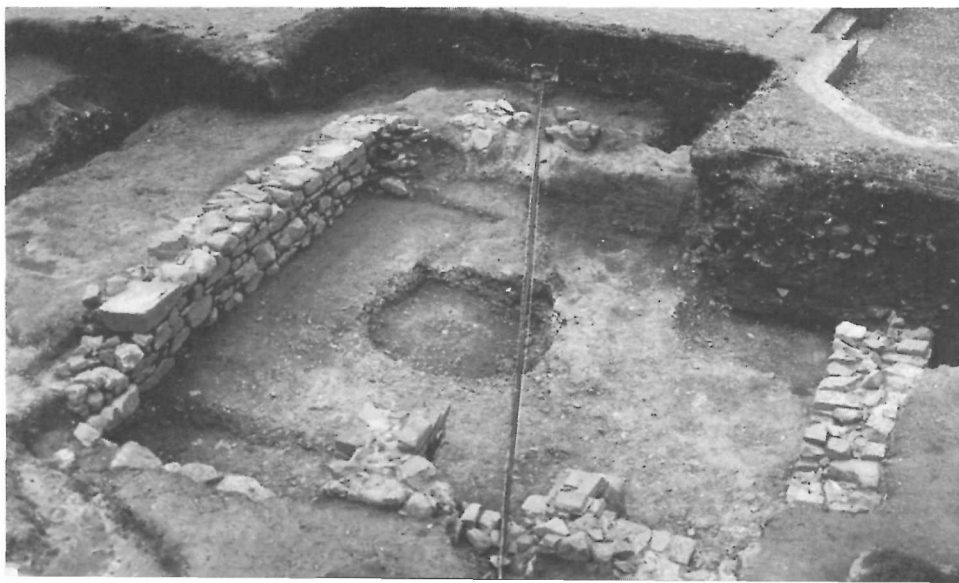
25 Stone and clay foundations of the King's Store associated with the second wooden fort.

The King's Store, which was the largest structure built inside the second wooden fort, was probably used as both a warehouse and a dwelling (Piédalue 1979: 36). The dry masonry foundations built of field stone are

thought to have supported a wooden superstructure (Fig. 25). The eastern part of the King's Store was built over a cellar; the remains of a wooden floor found at the bottom of this cellar represent a level of occupation dating from the time when the building was in use: "There seems to have been a cellar door with inner stairs on the east side, and another door with outer stairs on the north side" (Piédalue 1979: 36).

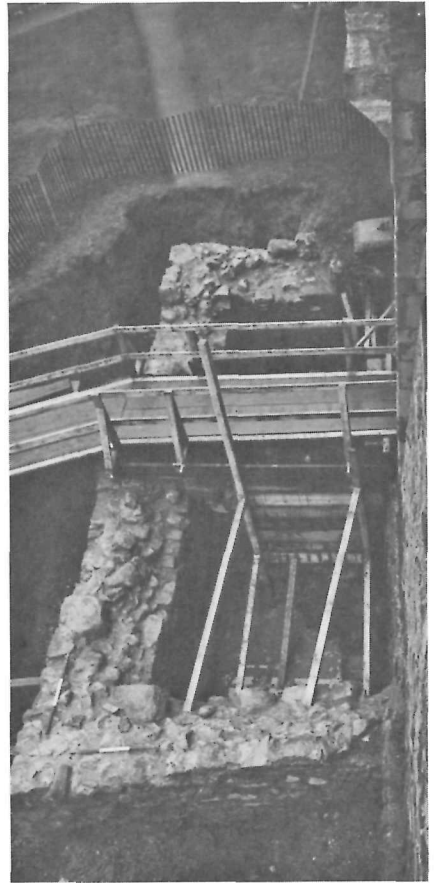
38 Masonry ditch of the drawbridge.
