**STUDY OF INLAND WIND EFFECTS OF HURRICANE OPAL  
AND ASSESSMENT OF INLAND WIND MODEL**

**DRAFT REPORT**

Greenhorne & O'Mara, Inc.  
9001 Edmonston Road  
Greenbelt, Maryland 20770

May 24, 1996

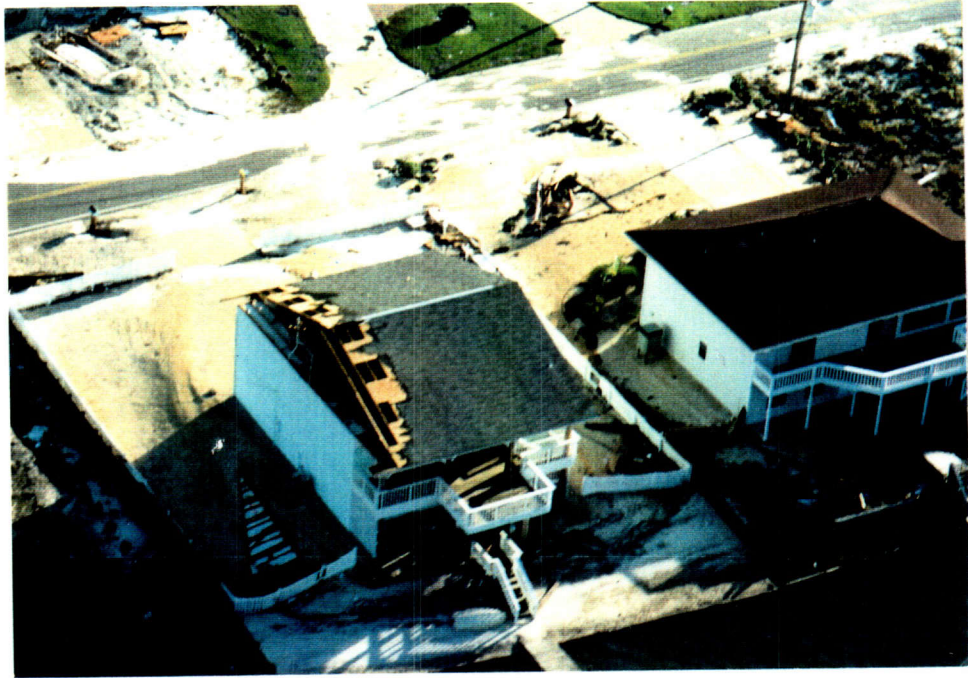
Most of the structural damage resulting from Hurricane Opal occurred along the coast. The majority of the wind damage was confined to the coastal region and occurred primarily to roof systems. Structural damage inland was caused mainly by falling trees. Some of this damage was extensive. See Figures 4-1 through 4-5 for pictures of common structural failures observed during the site visits.

Figure 4-1. Roof Failure -- Holiday Isle, Florida

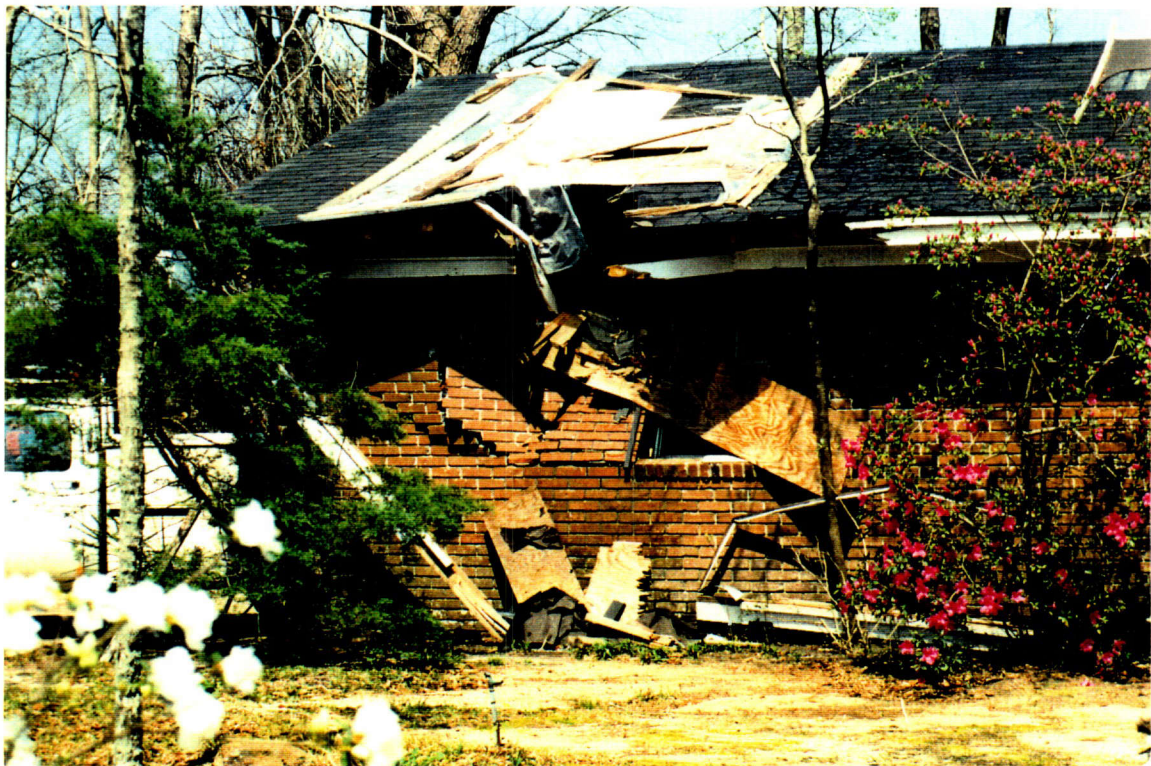
Figure 4-2. Residence Damaged by Tree -- Okaloosa County, Florida

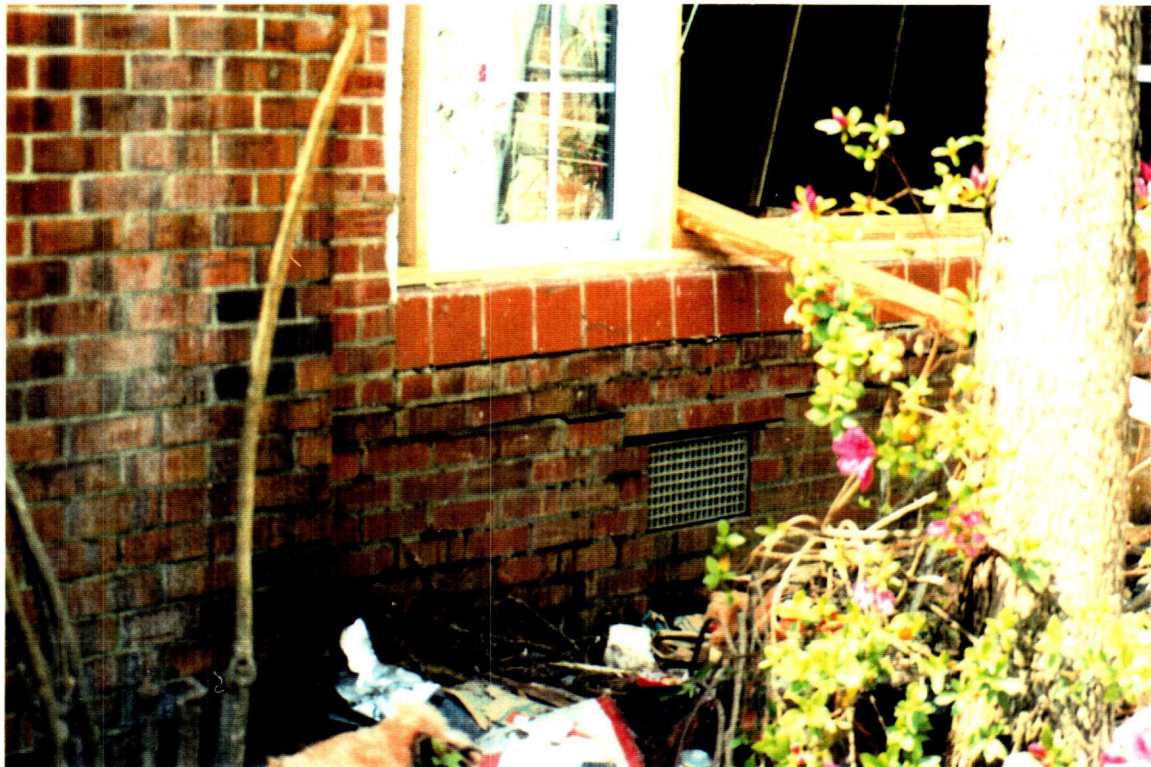
Figure 4-3. Residence Damaged by Tree -- Okaloosa County, Florida

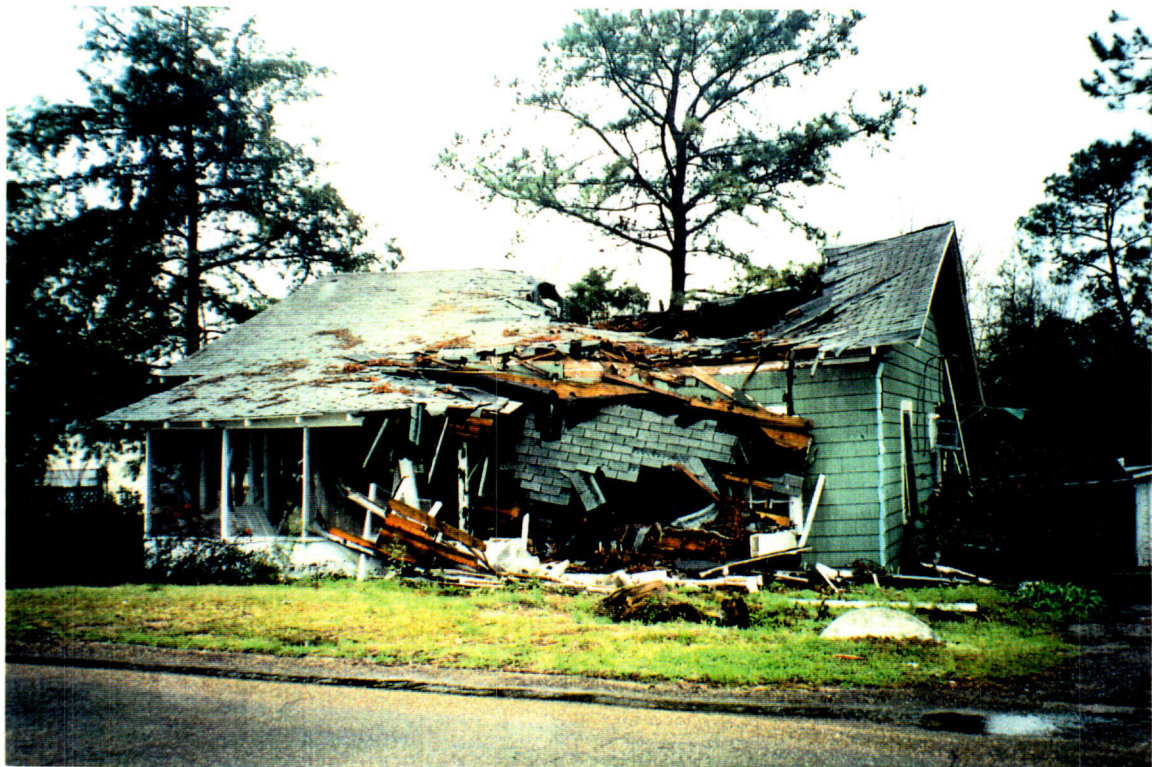
Figure 4-4. Residence Destroyed by Tree -- Opp, Alabama

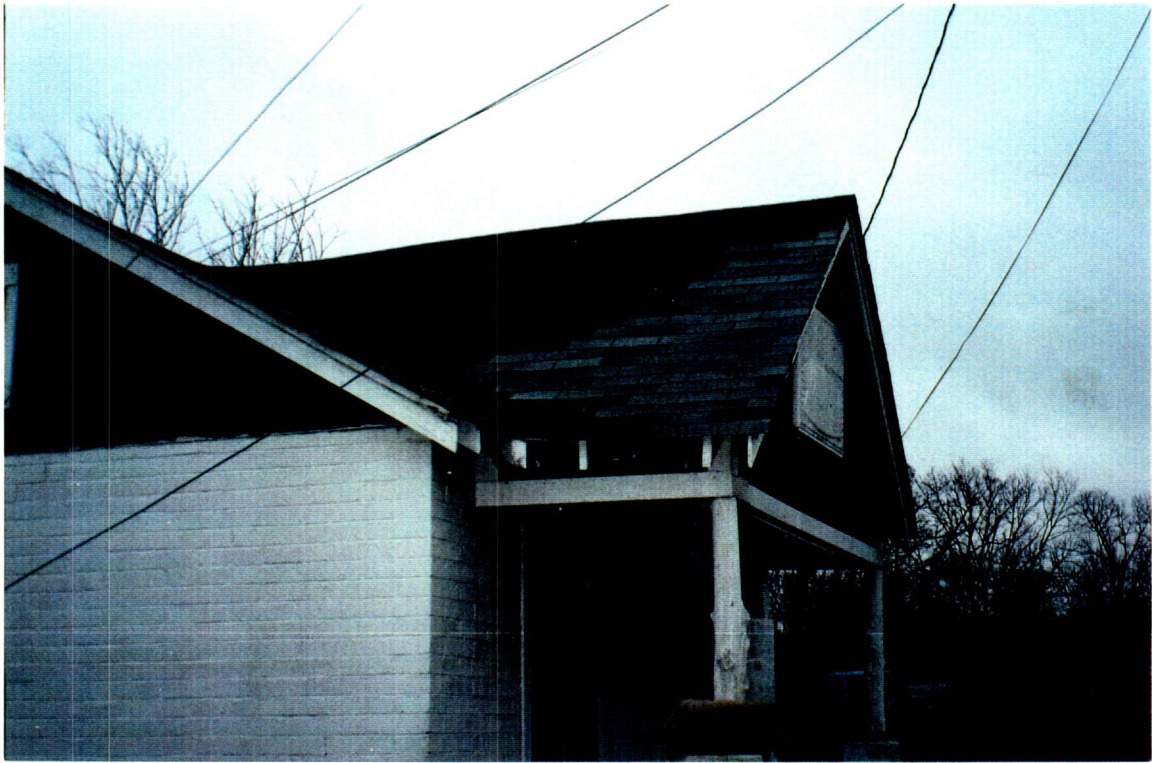
Figure 4-5. Roof Covering Damage -- Opp, Alabama

Roof covering failures begin to occur at sustained wind speeds of approximately 70 mph, although shingles and other coverings can come loose in 60-mph winds. These failures can be prevented if new roofs are designed and installed according to the appropriate building code documents and engineering standards, including ASCE 7-95. If roofs were designed and installed to these standards, the expected wind events would not do serious damage to them. Even winds moving at 60 mph significantly increase in speed at the edges of the roof surface. Additional care in the installation of roof materials in these critical areas would reduce damage.

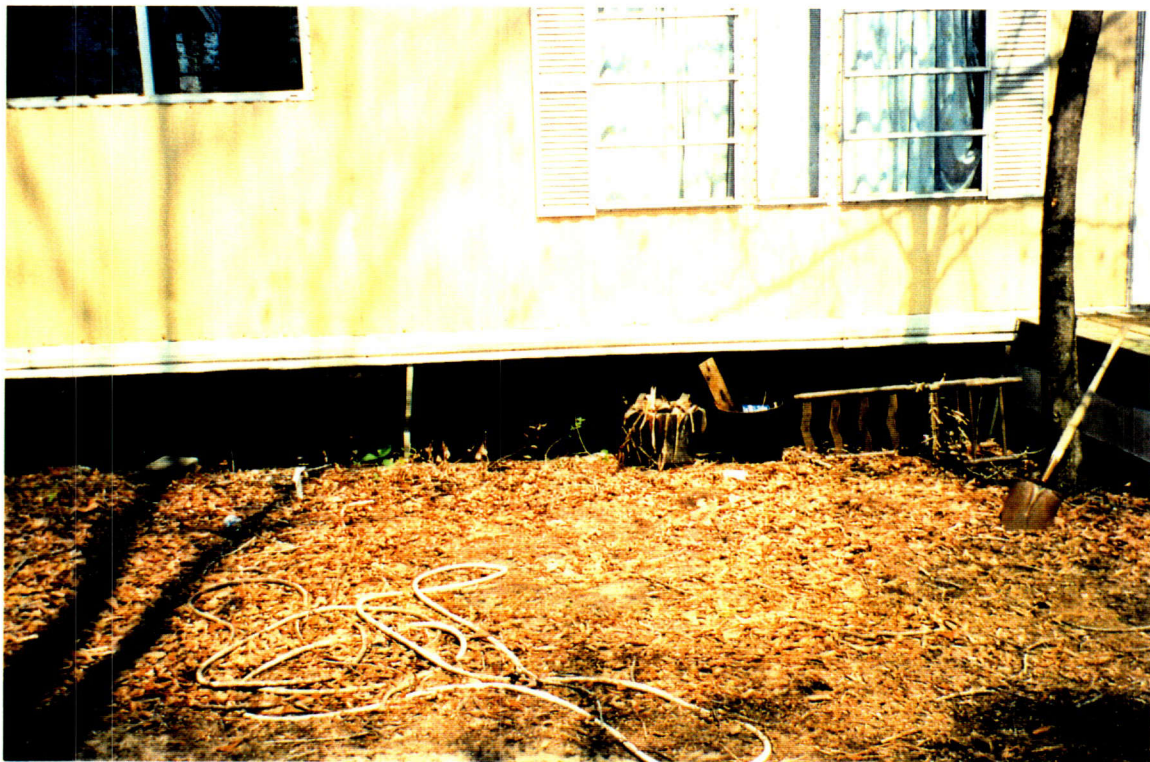
There are many manufactured housing units in the four-state affected area. Little of the reported damage to these units was caused by the wind alone. Most of the reported damage was caused by falling trees. One manufactured home observed in Florida had been shifted from its foundation by the wind (see Figure 4-6).

Figure 4-6. Manufactured Home Shifted by Wind

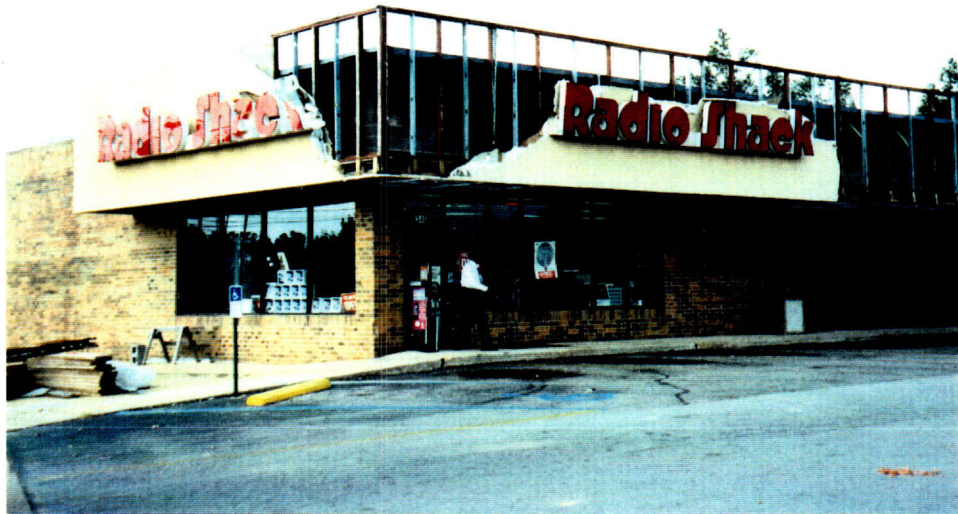
Figure 4-7. Building Facade Damaged -- Clearview, Florida

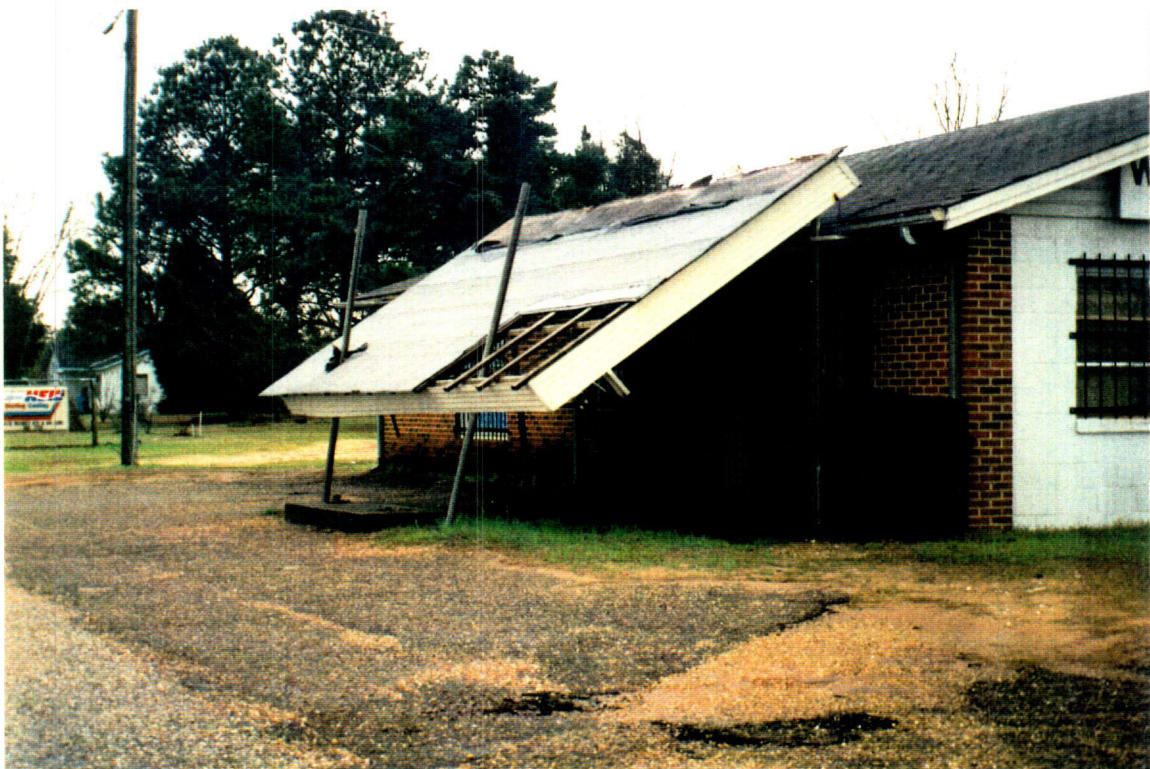
Figure 4-8. Roof Canopy Damaged -- Troy, Alabama

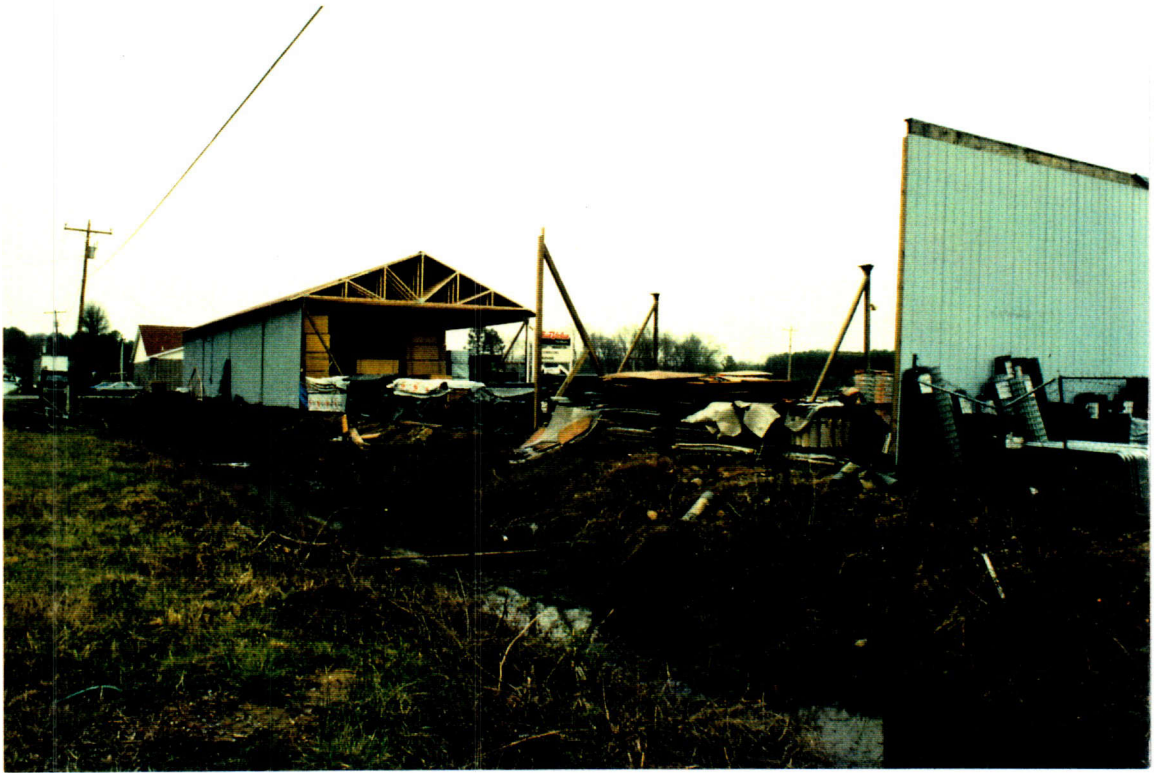
Figure 4-9. Wind Damage to Warehouse -- Walker County, Georgia

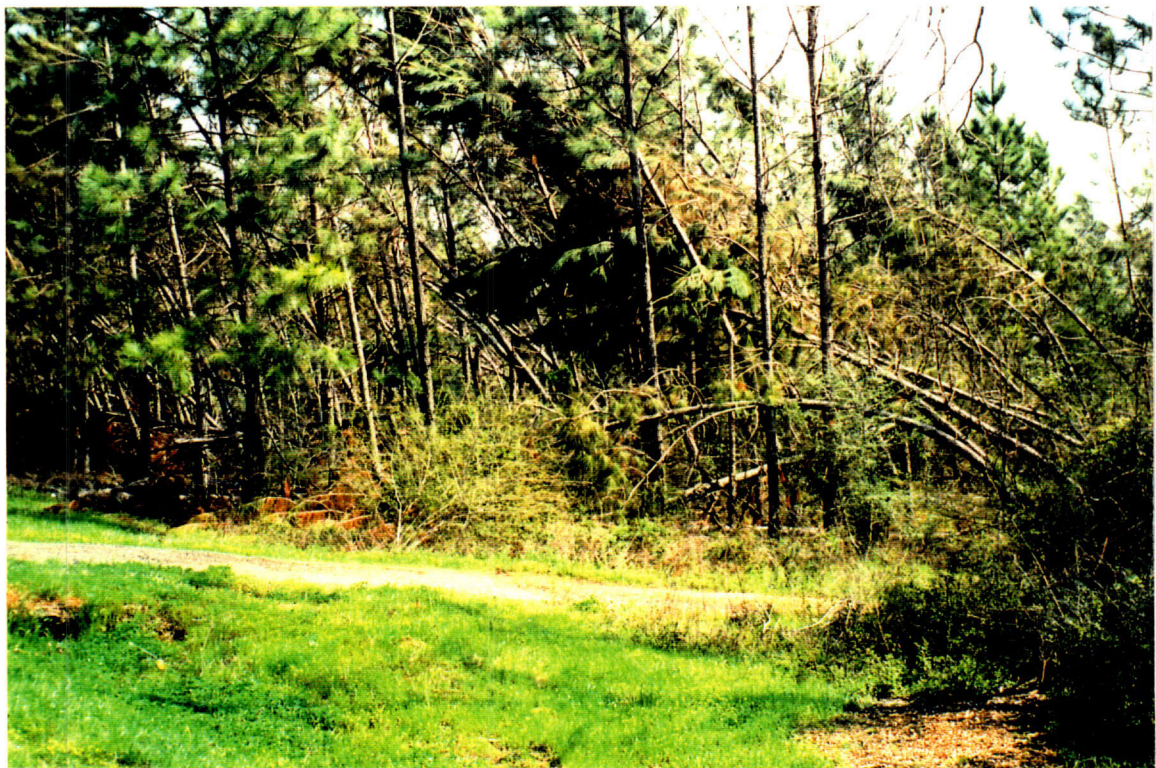
Extensive tree damage was reported in the State and National Forests of all four states, from the Blackwater State Forest in Florida to the Nantahala National Forest in western North Carolina. Sustained wind speeds greater than 55 mph have pushed over shallow-rooted trees in other high-wind events, and the tree damage from hurricane Opal verified this wind damage threshold. Several visits were made to State and National Forests in Alabama, Georgia, and North Carolina to document damage in those areas. Figures 4-10 through 4-12 illustrate the extent of damage to trees along the 500-mile path of the storm.

Much of the wind-induced tree damage can be attributed to the topography of the forest, as well as the wind speed. In some instances, a change in the topography created a wind acceleration effect. Although there was evidence of some diseased trees, these did not appear to contribute significantly to the damage levels that occurred. Both pines and hardwoods were affected by the gale-force and storm-force winds. The hardwoods with shallow roots were uprooted and blown over; the pines with tall, sturdy trunks were bent over or broken above the base. The leaves on the hardwoods contributed to the tree damage because they increased the surface area exposed to the wind. The heavy rains saturated the soil and loosened the soil in the tree rooting zone. These conditions would not be uncommon in any hurricane event.

Figure 4-10. Tree Damage -- Okaloosa County, Florida

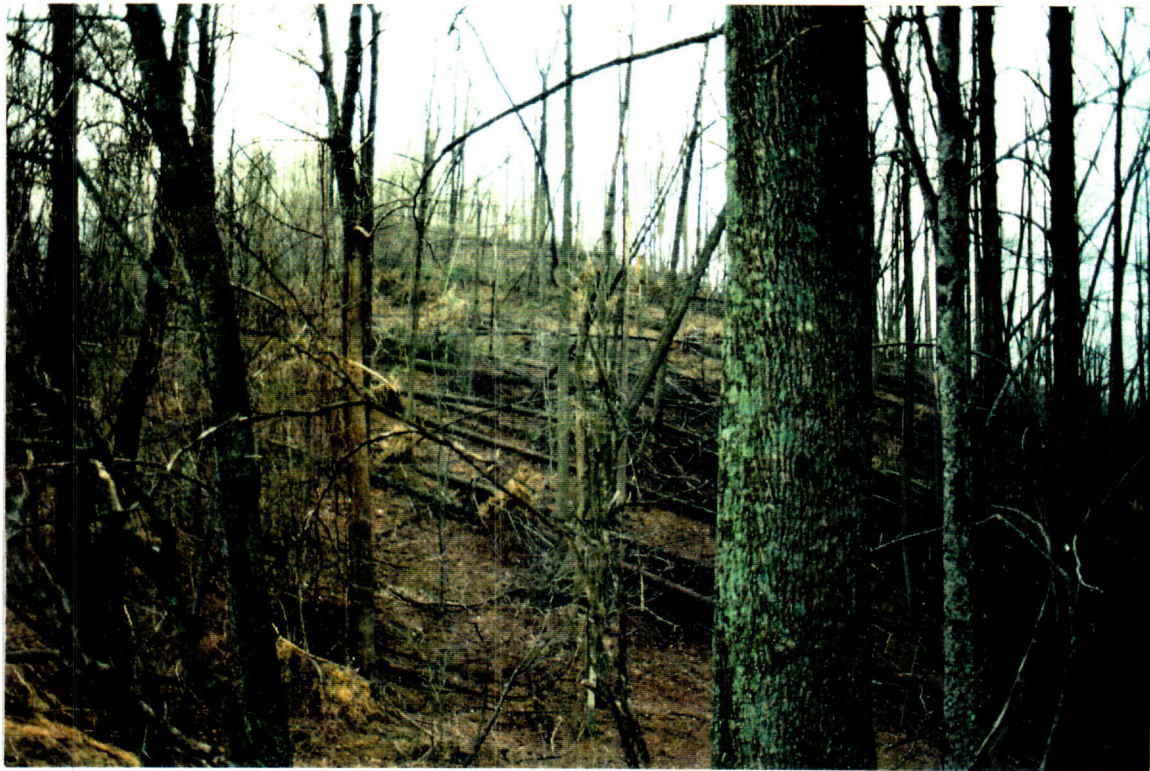
Figure 4-11. Tree Damage -- Blue Ridge, Georgia

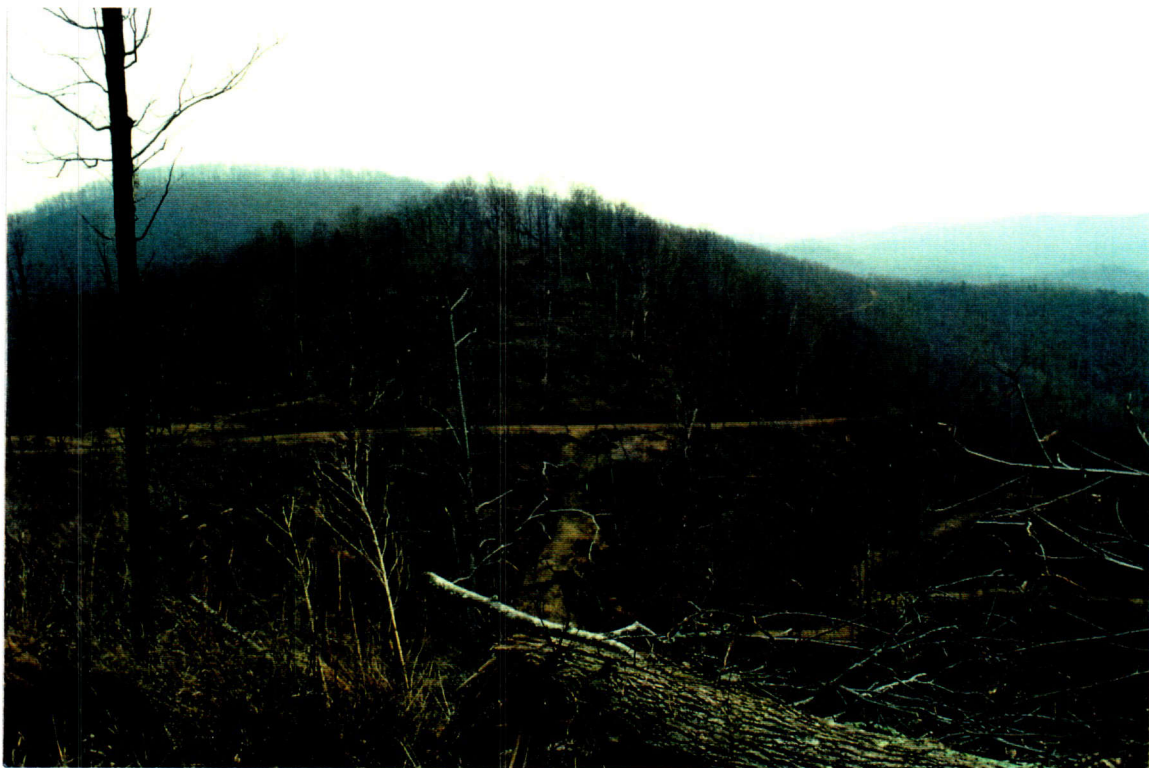
Figure 4-12. Tree Damage -- Blue Ridge, Georgia
