Reframing the Moderns

Substitute Windows and Glass

preservation technology
dossier 3
april 2000

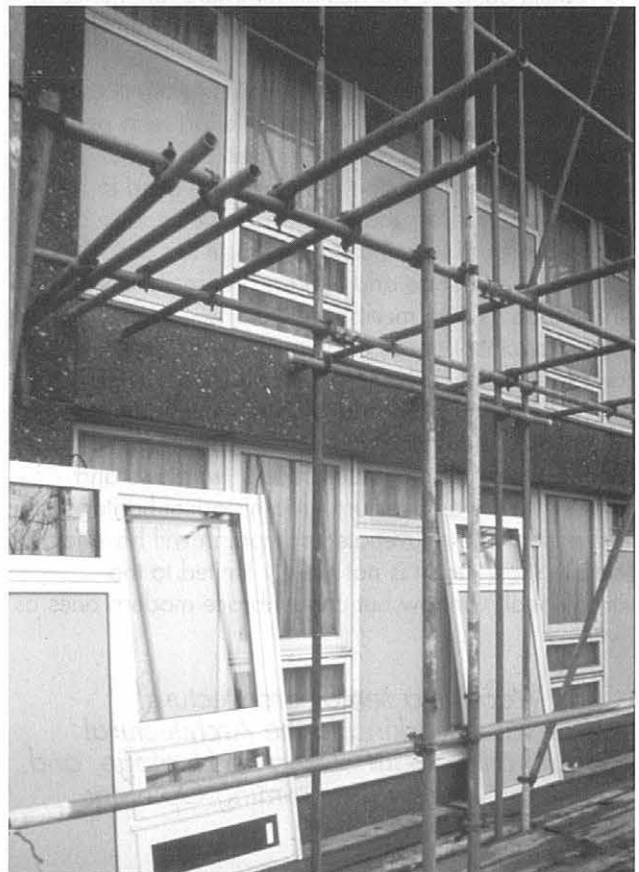
Original timber double glazed windows in situ shown against proposed PVC replacements which were rejected at Balfron Tower, East London.

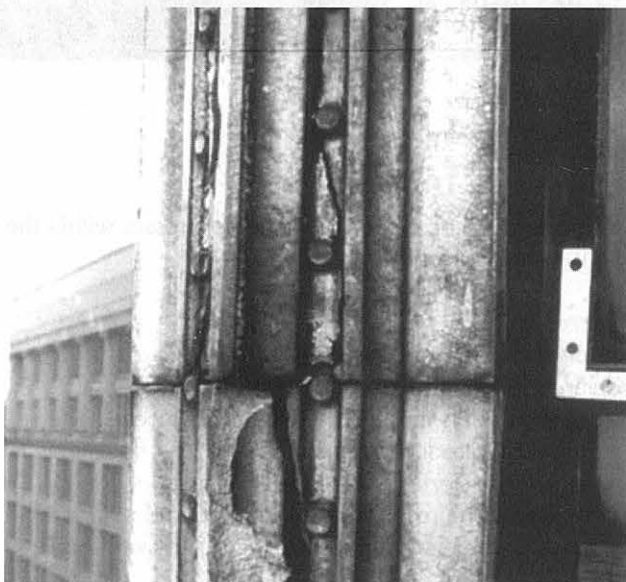
Deteriorated terra cotta mullion piece, 1994.
Photo: T. Gunny Harboe.

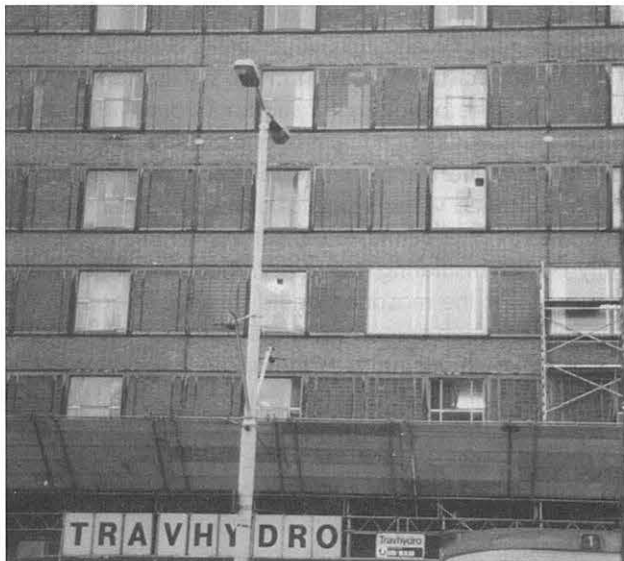
Full-size mock-up to test the aluminium replacement windows.
