Traffic Control Device Analysis, Testing, and Evaluation Program: FY2022 Activities

Technical Report 0-7096-R2

TEXAS A&M TRANSPORTATION INSTITUTE
COLLEGE STATION, TEXAS

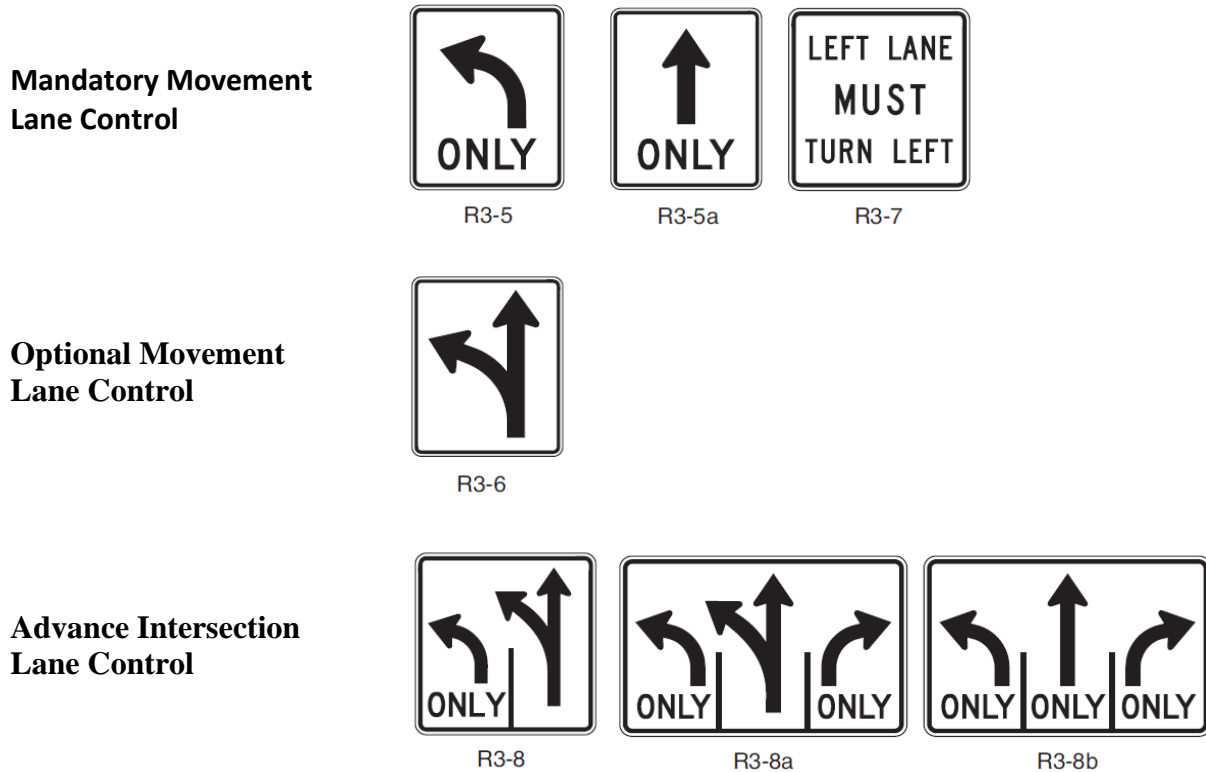
Figure 1. Example TMUTCD Intersection Lane Control Signs (Adapted from 1).

Examples of each type of TMUTCD Intersection Lane Control signing can be found in Figure 1. Guidance from Section 2B.19 states that when Intersection Lane Control signs are mounted overhead, each sign should be placed over the lane to which it applies. At signals where through lanes become turn lanes, multi-lane turns that include shared movements, or with other unexpected lane-use regulations, OLCS should be installed over the lanes at the intersection and in advance of the intersection over the appropriate lanes. Only where OLCS are impractical should roadside lane control signing be employed. However, the use of an overhead sign for one approach lane does not require the installation of overhead signs for the other lanes of that approach. For narrower approaches (i.e., two lanes or less), the Intersection Lane Control signs (R3-5, R3-6, or R3-8) may be overhead or (roadside) post-mounted.

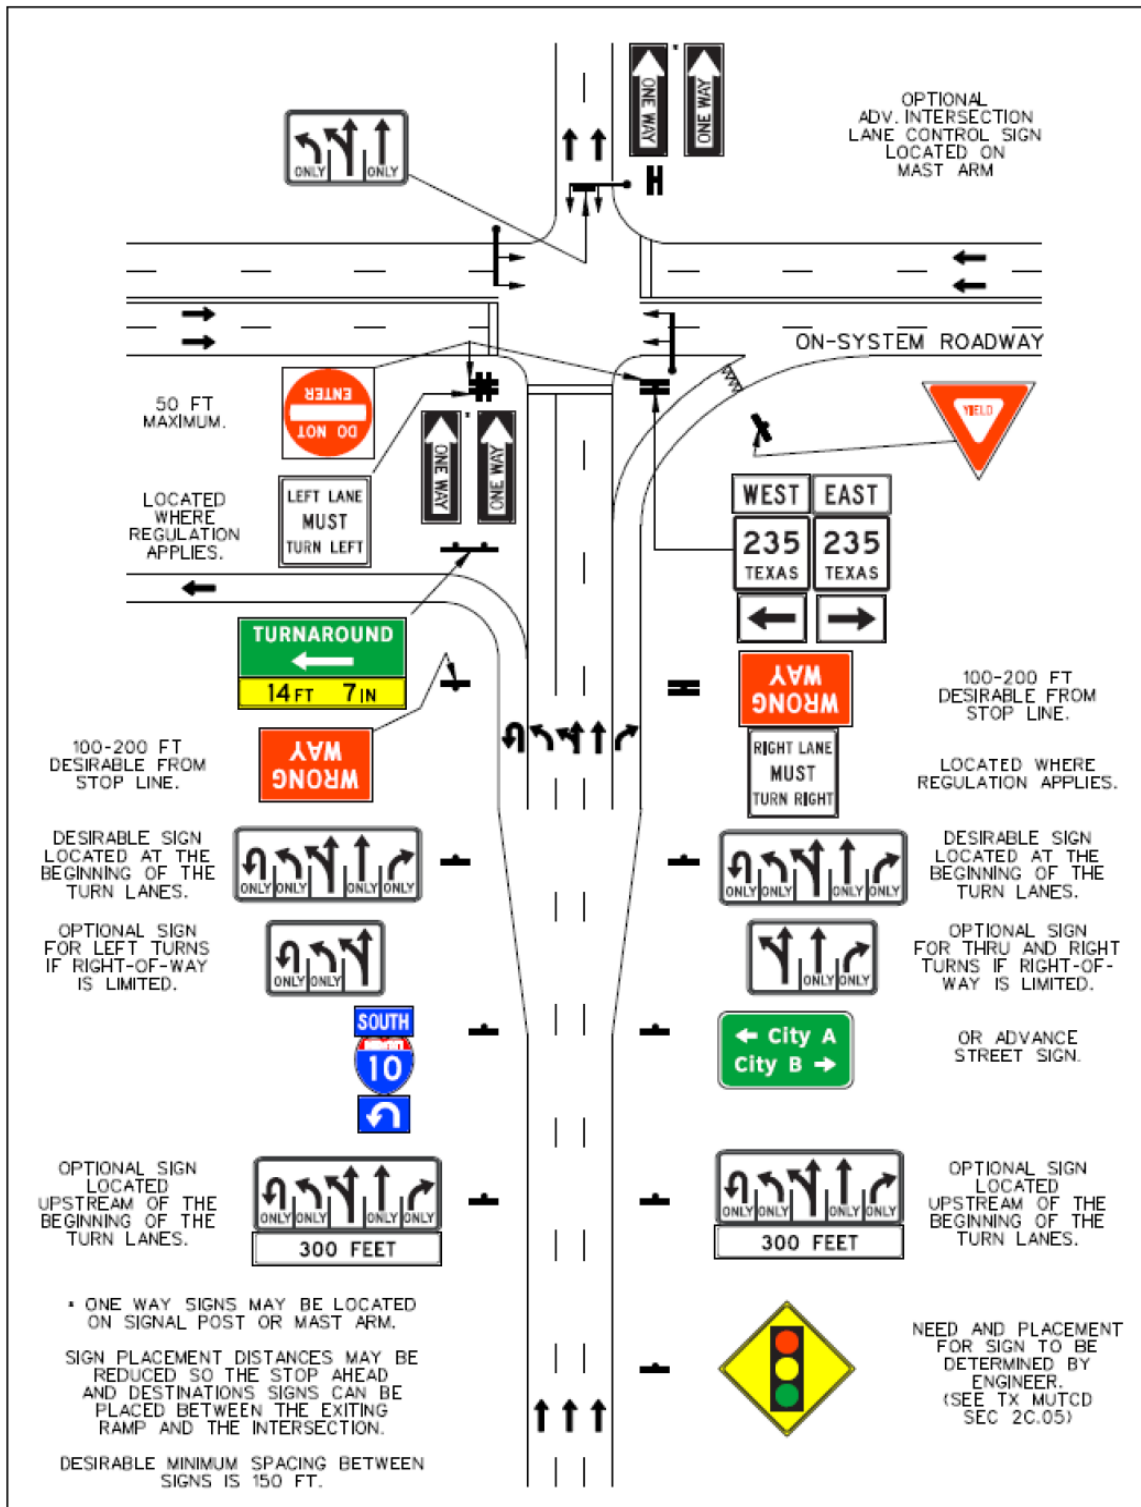
Figure 3. TxDOT Freeway Signing Handbook Frontage Road LCS Guidance (6).

virtually eliminating the time it takes drivers to associate the lane control with the (proper) corresponding lane on the roadway approach to the interchange.

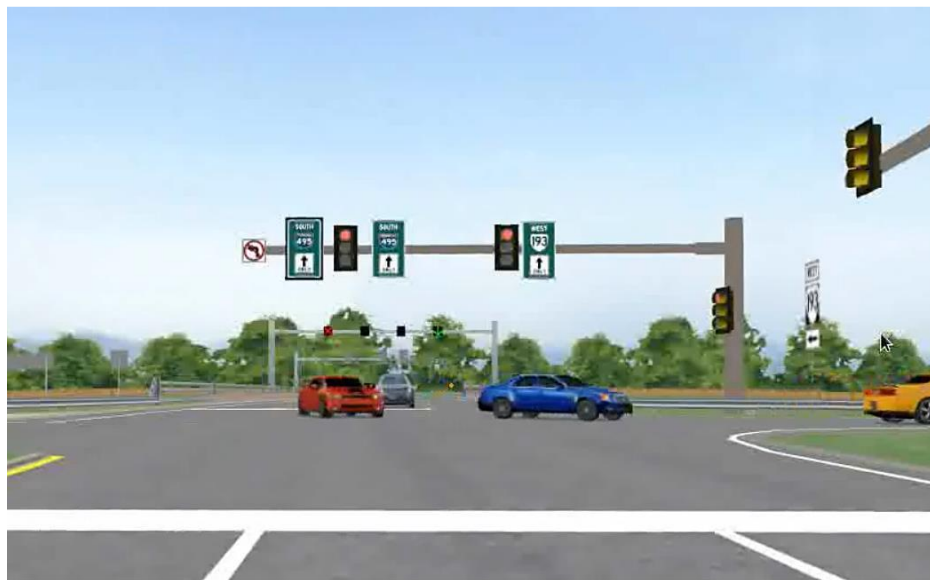
Figure 4. OLCS and Route Signing in Driving Simulator (Adapted from 12).

Recent research into innovative interchange design and management utilized a driving simulator to examine and analyze driver behavior in cases where arterial contraflow lanes were used within a dynamic reversible left-turn (DRLT) diamond interchange and on the approach to a contraflow left-turn (CLT) intersection (12). In both cases, versions of OLCS were used to inform drivers of downstream lane control (Figure 4). Despite the unusual interchange approach configuration—where drivers approaching a stop bar could be facing opposing traffic across the intersection—the driver comprehension rate for overhead signing was about 95 percent.

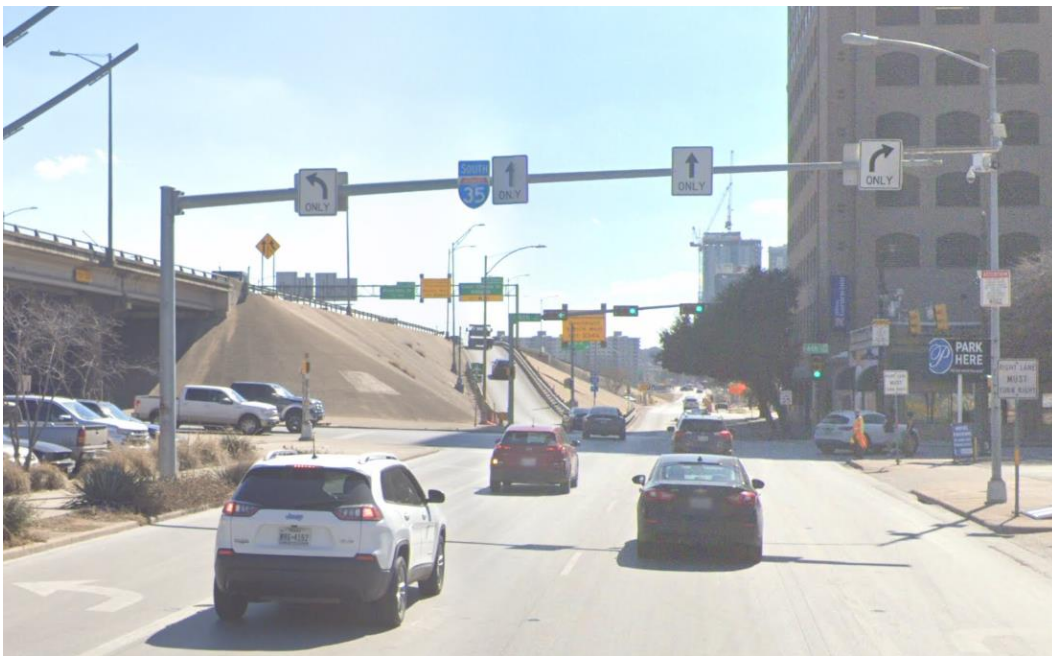
Figure 5. Frontage Road OLCS, IH 35 Southbound at E. 6th Street, Austin, Texas.

To provide a better understanding of how OLCS are used on frontage roads throughout Texas, TTI researchers identified real-world examples in metropolitan areas across the state. Structures for supporting signs vary from poles with mast arms to custom-designed monotube OSB structures. In some cases, route signing is combined with the individual lane control signs to clarify the relationship between lane selection and target route. Figure 2 provides a San Antonio example with a substantial pole and mast arm to provide individual OLCS across five frontage lanes. Figure 5 through Figure 7 contain other samples found in Austin and Dallas. A unique overhead dynamic message sign (DMS) form of lane control signing was found in Houston and is detailed in Figure 8 through Figure 10.

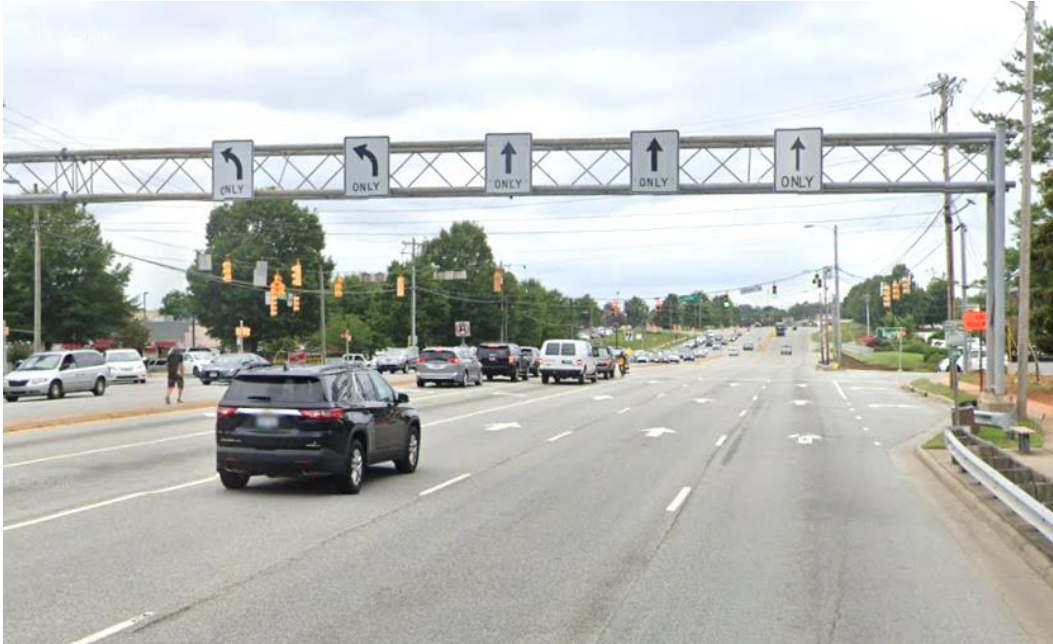
Figure 17. Arterial OLCS, Westbound W. Wendover Ave. at Stanley Road, Greensboro, North Carolina.

In North Carolina, OLCS examples were supported on truss OSBs (see Figure 17 through Figure 19). One of the North Carolina examples (see Figure 19) also includes route guide signing in combination with OLCS, expediting driver understanding of the route choice implications of lane choice approaching the interchange. An Ohio example (see Figure 20) of OLCS also combines route choice and lane use signing by lane to aid drivers in selecting the correct intersection approach lane to access or remain on their preferred route. The combination of lane control and route guide signing minimizes last-minute lane changing on the approach to a (very) nearby diamond interchange.

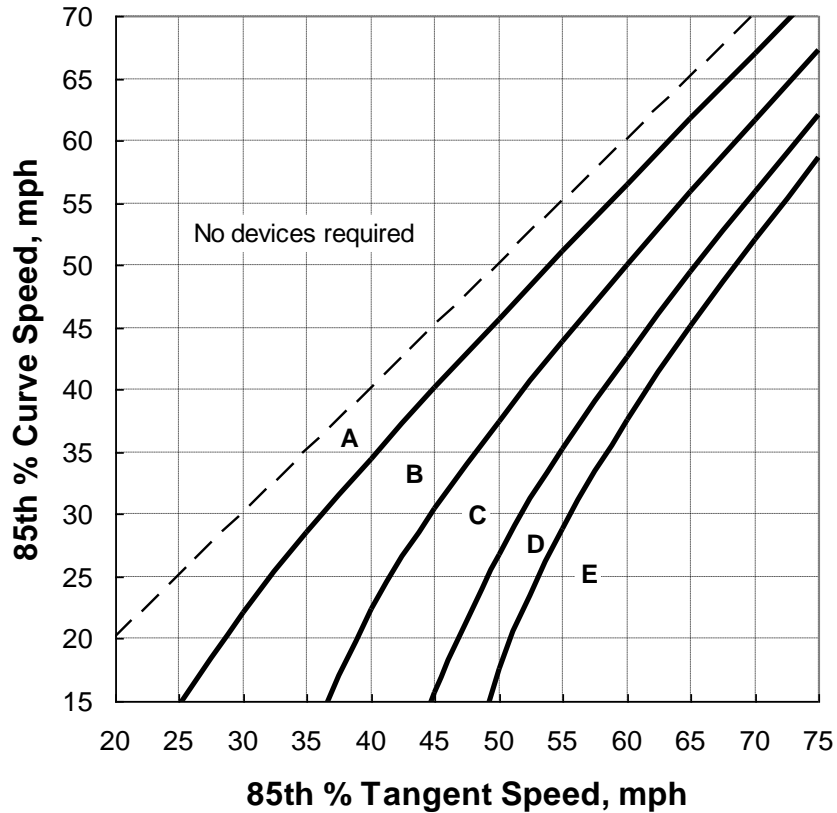
Figure 21. Alternative Guidelines for Choosing Curve Traffic Control Devices (16).

speed differentials between regulatory speed limit and curve advisory speed. This framework is illustrated in Table 3. This table has been incorporated into the TMUTCD (1) as Table 2C-5. TxDOT districts are now in the process of evaluating horizontal curves and updating curve traffic control devices based on the new TMUTCD guidance using the tools developed in Research Project 0-6960.

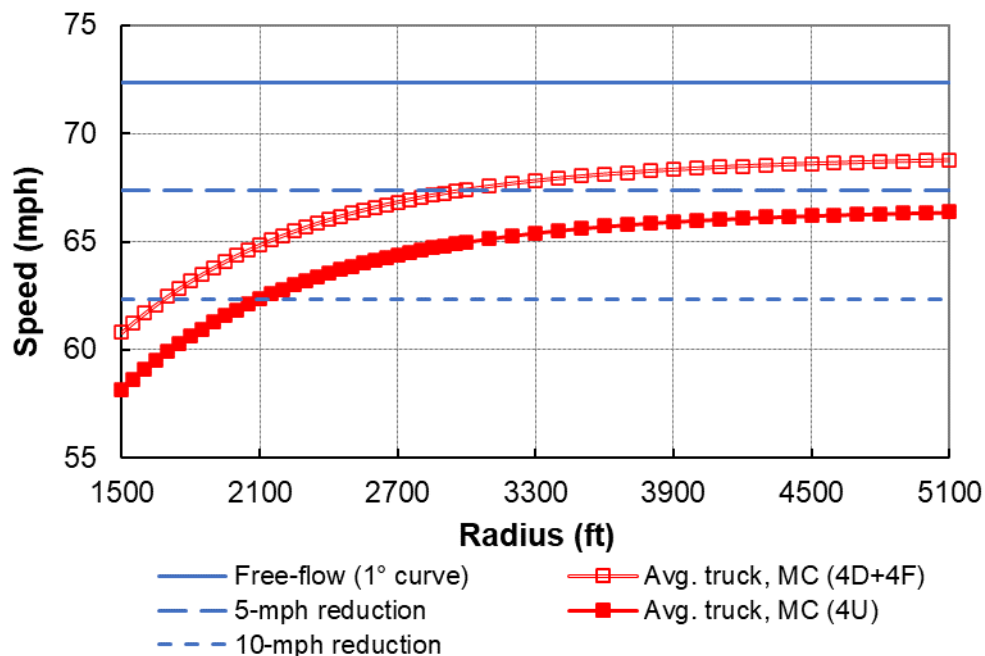
Figure 22. Speed Trends on Four-Lane Rural Highway Curves, 75 mph Speed Limit.

- On 4U roadways, the average truck speed is more than 10 mph below the free-flow speed on all curves with a radius less than about 2100 ft.

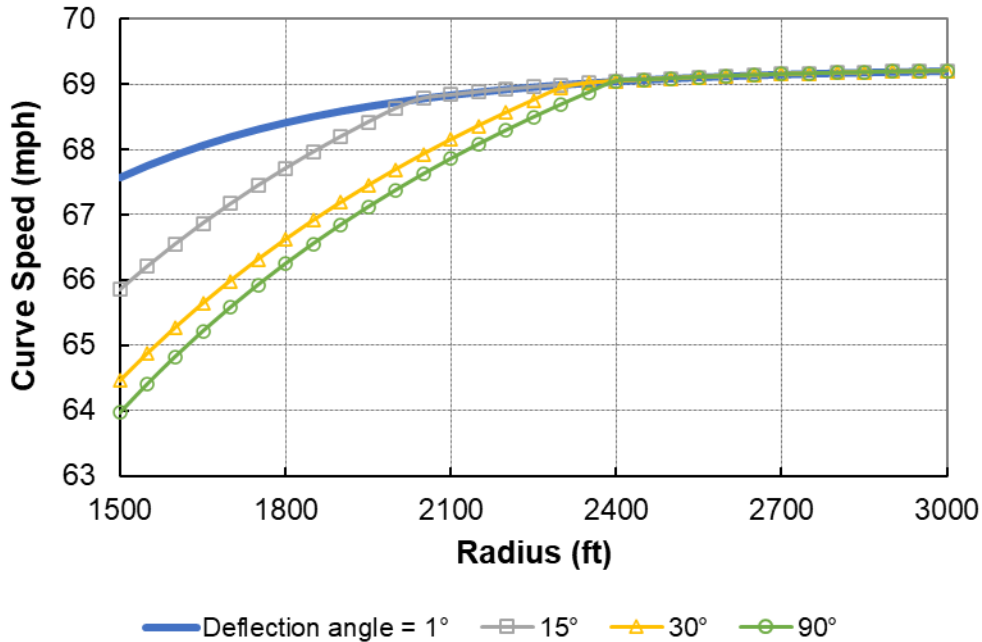
Figure 23. MC Speeds for Average Truck and 2-Percent Superelevation (2U Highway, 75-mph Regulatory Speed Limit).

for curves with a superelevation rate of 2 percent and a range of deflection angles. A superelevation rate of 2 percent is used to represent a curve that is built as a simple alignment change where the crown is reversed but no superelevation is otherwise provided.

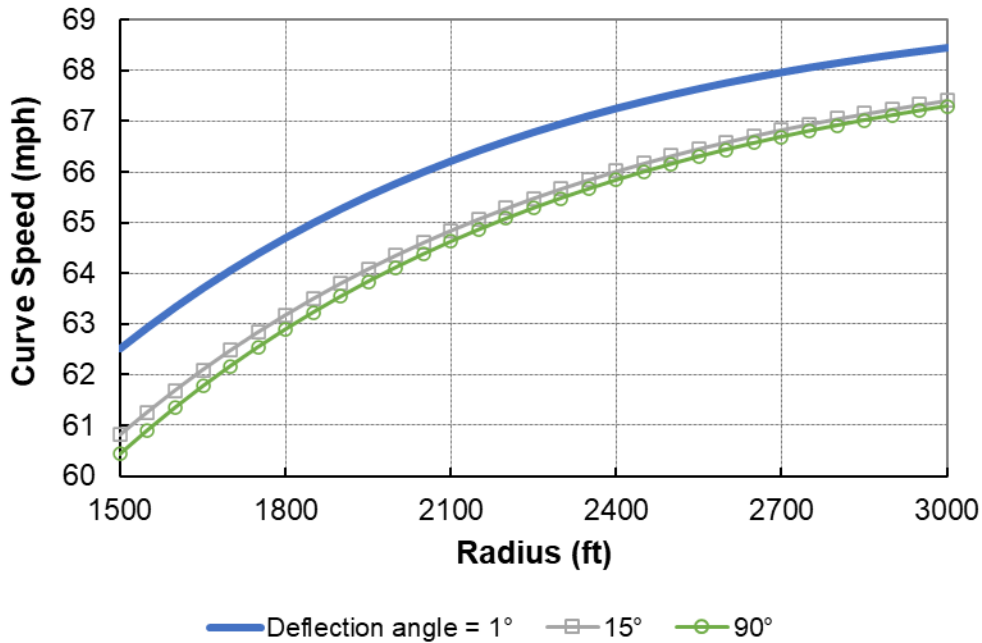
Figure 24. MC Speeds for Average Truck and 2-Percent Superelevation (4D or 4F Rural Highway, 75-mph Regulatory Speed Limit).

- Overall, drivers adopt lower speeds on 4D and 4F rural highways than on 2U rural highways, given the same regulatory speed limit (75 mph), radius, and superelevation rate (2 percent). This trend is apparent from the different y-axis ranges for the two graphs.
- On 4D and 4F rural highways, drivers appear to decelerate for curves even with more gradual radii (e.g., more than 2850 ft, roughly equating to curves with degree of curve values of 2 or less). However, the magnitude of speed reduction on these gradual curves is small. This trend is apparent by noting that Figure 23 has “knees” where curve speeds do not begin to decrease by more than a nominal amount until the radius decreases to a value in the range of 2000 to 2300 ft (depending on deflection angle), while Figure 24 has no such “knees.”

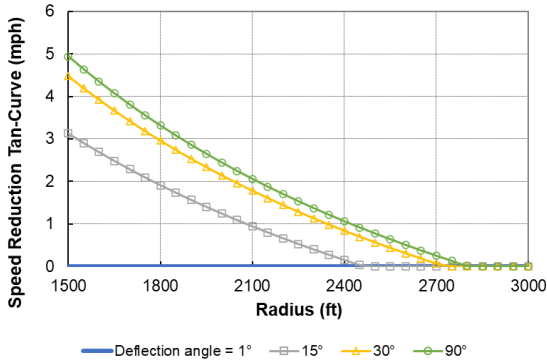
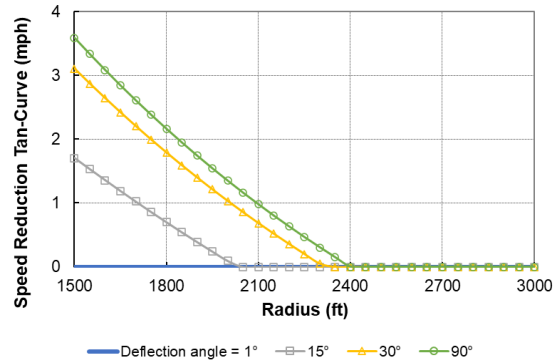
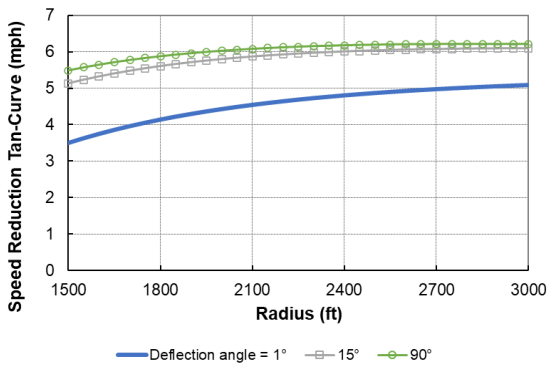
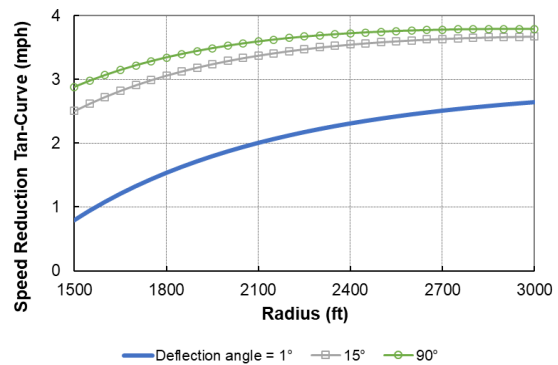
- Drivers decelerate more for the curve if the curve is on a highway with a lower regulatory speed limit (e.g., compare Figure 25a and Figure 25b). This trend has been noted elsewhere (16, 18).
- Drivers decelerate more for curves on 4U rural highways than curves on 4D or 4F rural highways (see Figure 25c and Figure 25d).
- Speed reduction (as measured between approach tangent and MC) increases with decreasing radius on two-lane highways but decreases with decreasing radius on four-lane highways.

estimated by computing the tangent speed for a curve with a radius of 5730 ft (or degree of curve = 1), and the tangent (Tan) speed is computed for the range of curve radii on the x-axis.

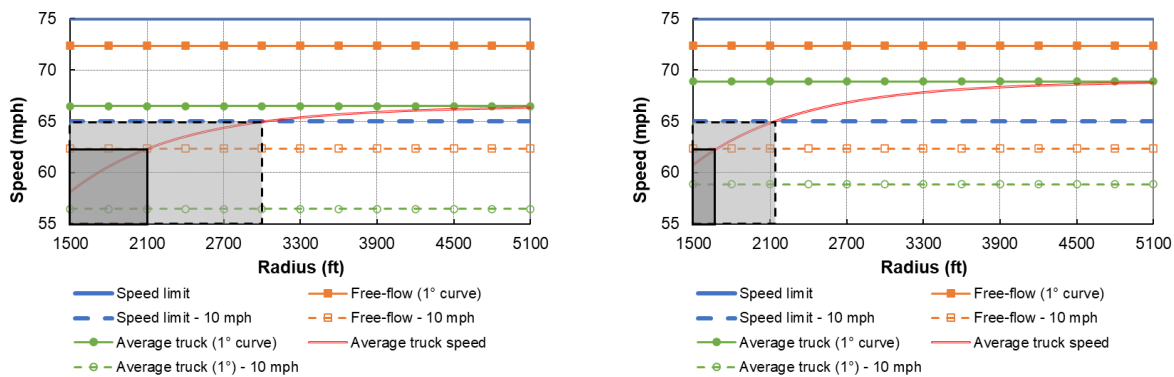
a. 4U, 75-mph Regulatory Speed Limit, 2-Percent Superelevation.

Figure 27 shows the effect of these revisions on the aforementioned example curves with a 2-percent superelevation rate and 15-degree deflection angle. The lighter shaded regions with the dashed lines represent curves where a horizontal alignment sign alone may be posted, and the darker shaded regions with the solid lines represent curves where a horizontal alignment sign and an Advisory Speed plaque shall be posted.

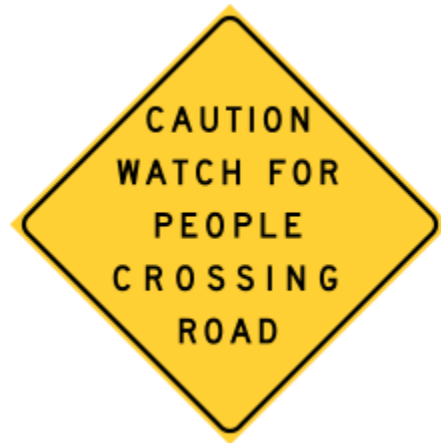
Figure 28. CAUTION WATCH FOR PEOPLE CROSSING ROAD Warning Sign.

Previous research regarding countermeasures is limited. California is the only state that tested a countermeasure specifically focused on reducing undocumented immigrant fatalities when crossing the highway near border regions in and around San Diego. In 1990, to address the increasing fatalities involving undocumented immigrant on highways, the California Department of Transportation (Caltrans) installed a “Caution Watch For People Crossing Road” warning sign (see Figure 28) and later replaced it with a more distinguishable symbol to warn drivers about the potential safety risk. The newer yellow rectangle signs show two adults and a child running (see Figure 29). The image was the source of controversy as some saw it as an offensive caricature of Mexican immigrants (30). Around the same time that the signs were erected (1994), California started the Operation Gatekeeper program, which constructed fences and militarized the border areas between San Diego and Mexico. These efforts successfully reduced the number of pedestrian crossing attempts into the San Diego/Chula Vista/San Ysidro region, forcing undocumented immigrant traffic to move eastward to Arizona (26). Thus, the effectiveness of the signs could not be examined.

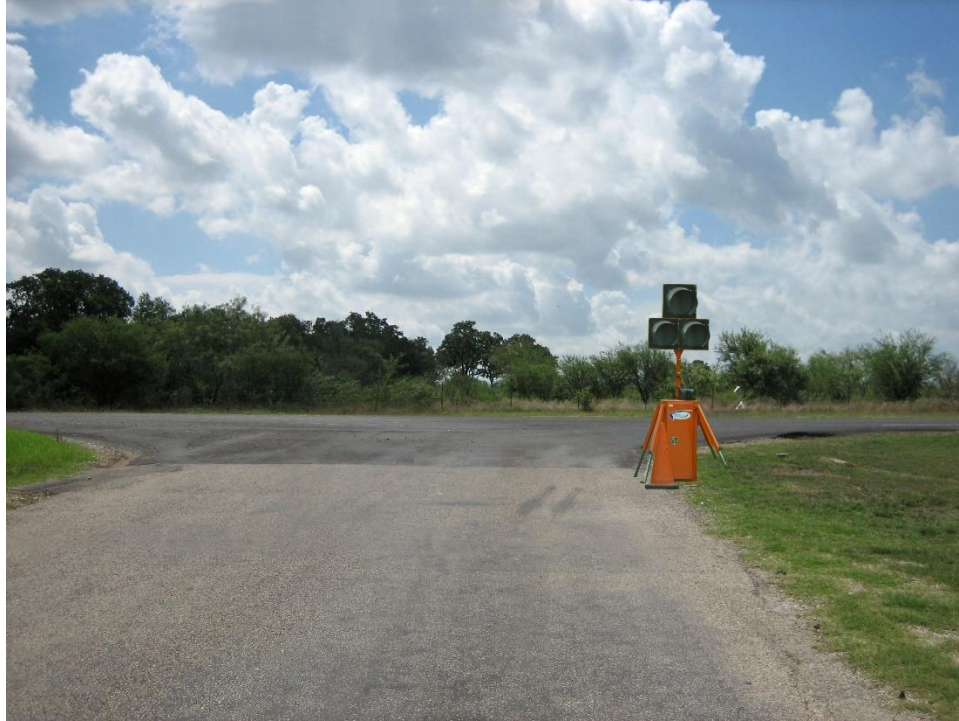
Figure 37. Mock Prototype DAD.

- Ninety-one percent of respondents stated that the top indication would be illuminated to show when a driver must stop and remain stopped. All participants thought the top indication would be red, 91 percent thought the top indication would be a circular indication, and 84 percent thought the top indication would be steady.
- Ninety-seven percent of the respondents replied that the bottom indications would be illuminated to show which direction drivers on the minor approach could turn. Sixty-six percent thought the bottom indications would be yellow (the remainder thought it would be green), 88 percent thought the bottom indications would be a symbol (all but one wanted an arrow), and 53 percent thought the bottom indications would be flashing (the remainder thought it would be steady).

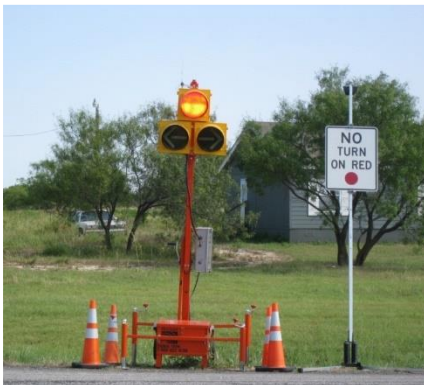
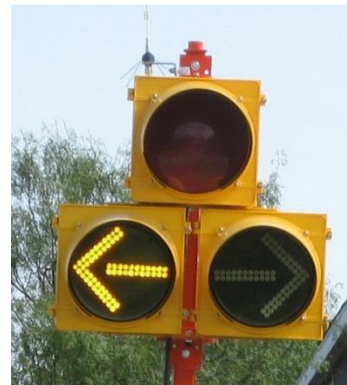
Based on these findings, researchers designed the three-section doghouse DAD in Figure 38. This device uses a 12-inch steady circular red indication and 12-inch flashing yellow arrows to control traffic. The steady circular red indication is shown when the minor approach traffic must stop and remain stopped. Since drivers facing a steady circular red indication may turn right after stopping when no other traffic control device is in place prohibiting a turn on red, a NO TURN ON RED sign (R10-11) was also displayed. The flashing yellow arrows indicate that the minor approach traffic is permitted to cautiously enter the roadway only in the direction of the arrow.

a. Steady Stop Indication.

b. Flashing Proceed Indication.

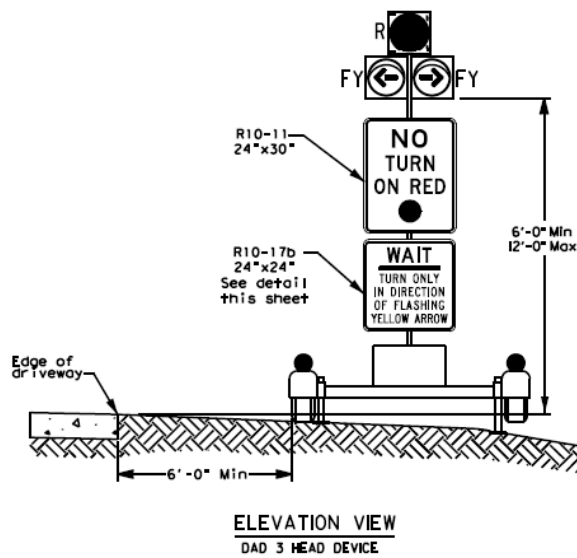
Figure 40. TxDOT Three-Section Doghouse DAD Design.

Currently, TxDOT allows the two DAD designs in Figure 40 and Figure 41 to be used and evaluated in Texas with prior approval from the TxDOT Traffic Safety Division.

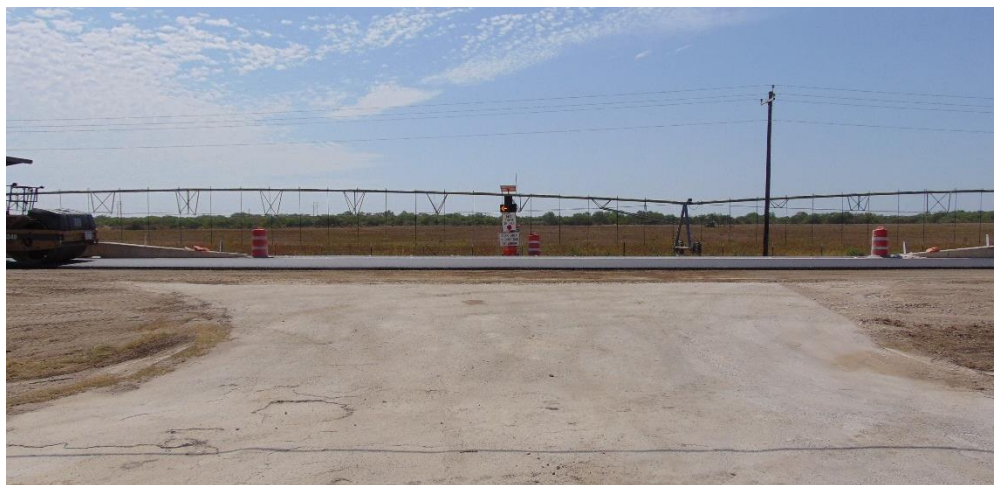
Figure 47. Project 1 DAD at Business Driveway SB-33.

On July 14–15, 2020, TTI researchers observed traffic exiting a convenience store driveway (SB-33) in Section 5 (see Figure 46). The DAD was located directly across the main road from the driveway since construction was occurring in the SB lanes (see Figure 47). Data collection began around 11:00 a.m. on Tuesday, July 14, and ended around 8:00 a.m. on Wednesday, July 15. The average phase duration for the DAD (i.e., red and flashing yellow arrow indications for one direction of travel) was approximately four minutes with a two-minute red clearance interval. The total DAD cycle length was about eight minutes. Due to the pandemic, traffic volume at the store was much lower than initially expected.

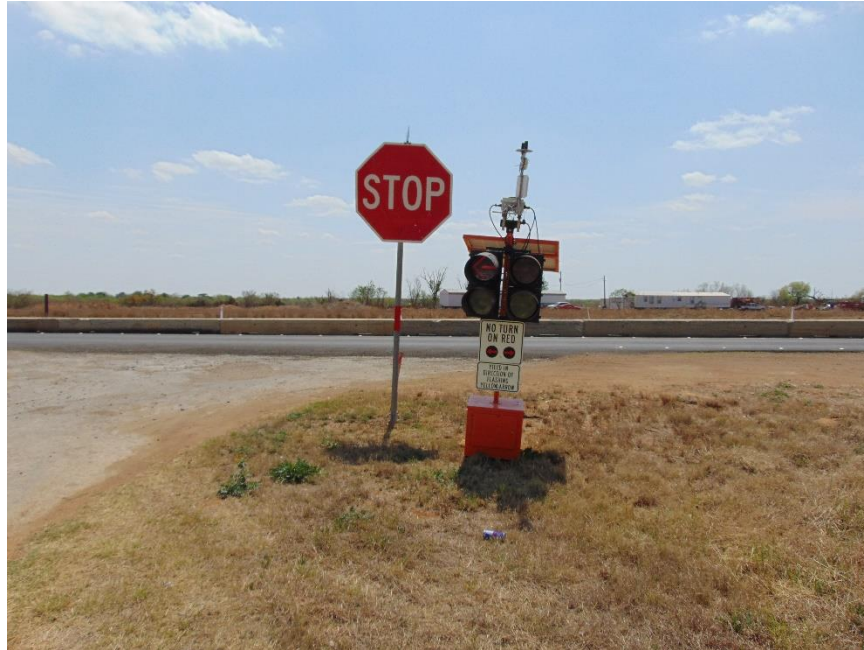
Figure 54. Project 2 DAD at Intersection of SH 85 and CR 3800.

contractor installed the DAD on February 20, 2022. During both data collection periods, the DAD was located on the nearside of the intersection next to a STOP sign (see Figure 54). Figure 55 and Figure 56 show views from CR 3800 looking east and west, respectively. The one lane section was approximately 2.7 miles long.
