De Soto National Memorial Cultural Landscape Report

January 2017

David Sacks Landscape Architecture, LLC

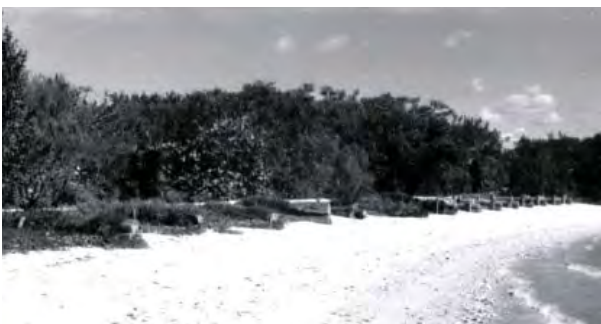
FIGURE 2-69. Cypress log groins along cove trail, installed after earlier palm logs failed, 1959. (DESO Archives)

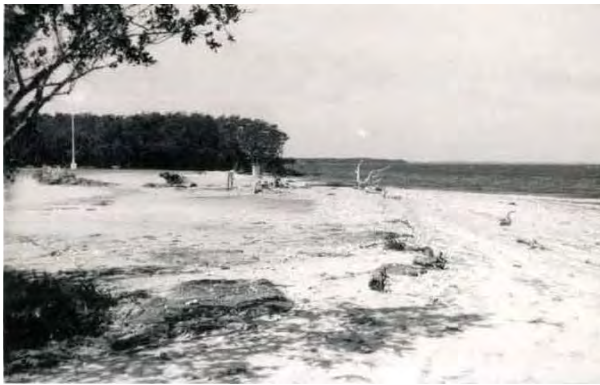
FIGURE 2-71. Hurricane Donna damage, 1960; the Superintendent's Monthly Report described this photograph as showing the area "pushed back 20' to 30', waves are now eating into grass at right of flagpole." (DESO Archives)

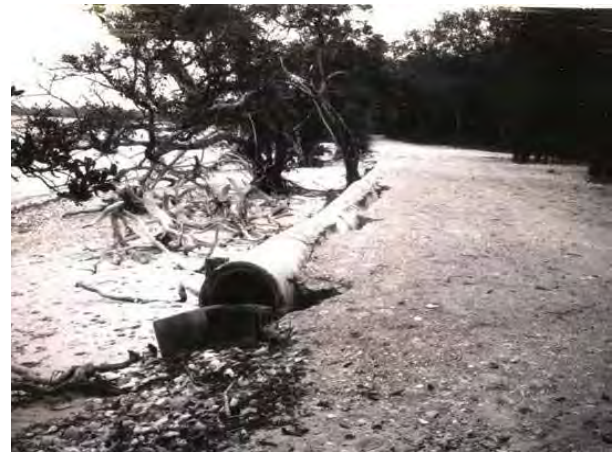
FIGURE 2-77. Culvert bulkheading, photographed after storm damage, November 1968. (DESO Archives)

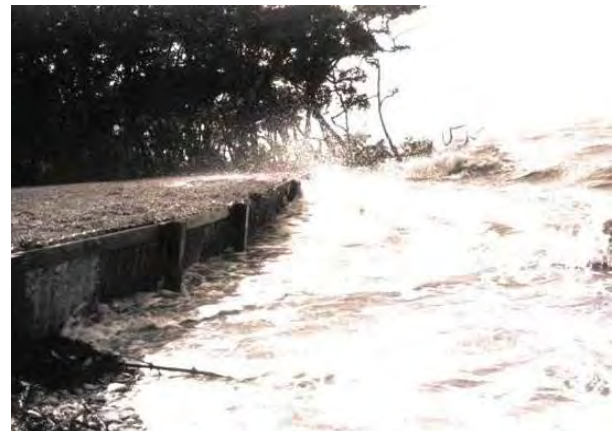
FIGURE 2-78. Panel bulkheading at plaza, near flagpole, 1972. (DESO Archives)

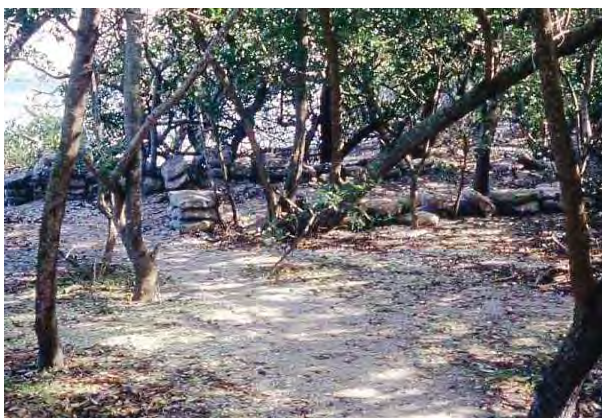
FIGURE 2-80. Staff formed these edging stones by filling sandbags with cement; here shown staged for use in reinforcing trail edges and a drainage channel, c. 2000-2005. (DESO Archives)

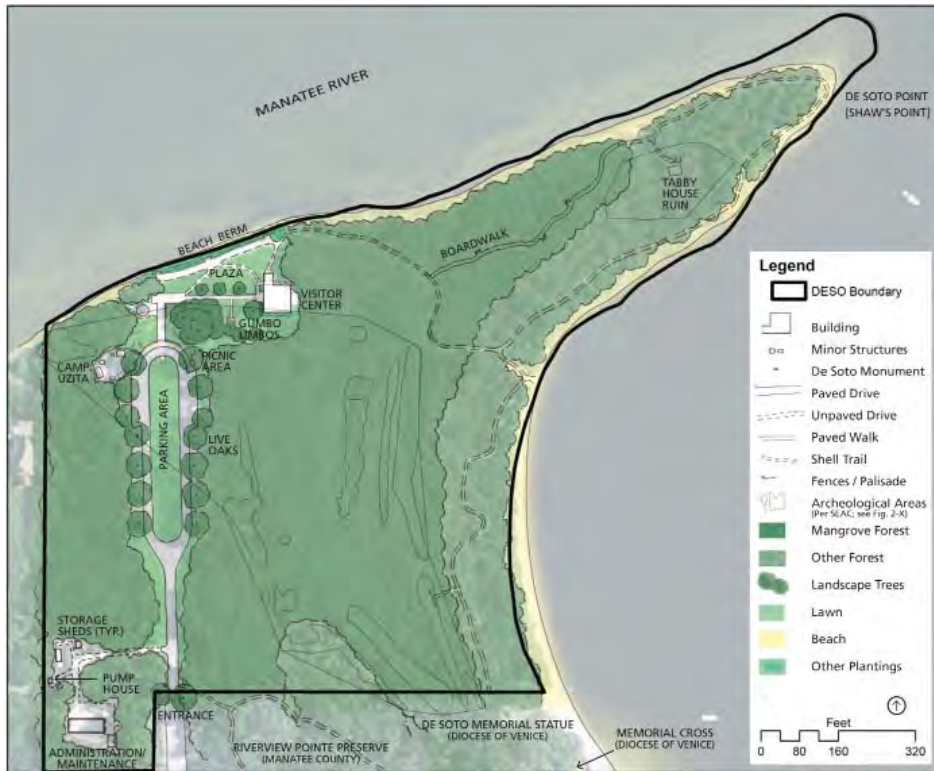
FIGURE 3-1. Existing Conditions Plan. (See also Appendix C)

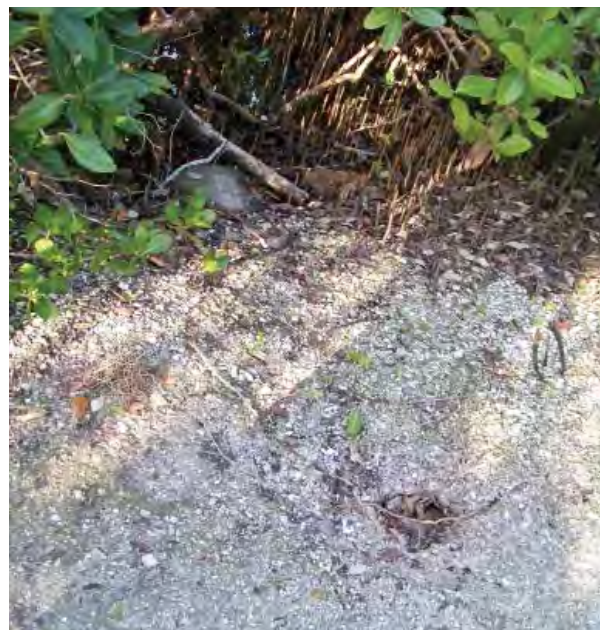
FIGURE 3-74. Path subsidence, south loop trail at culvert.

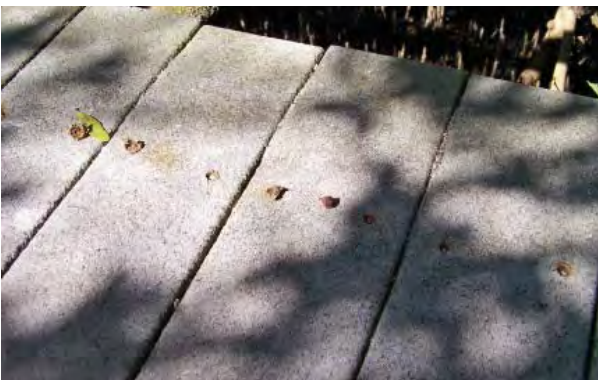
FIGURE 3-80. Failed deck screws.

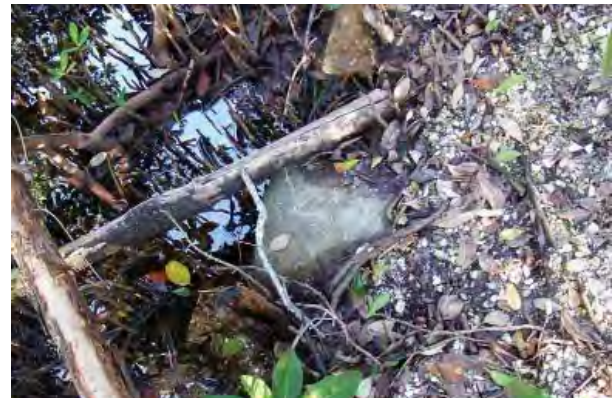
FIGURE 3-176. Detail of pipe culvert under shell path, channel crossing under south loop trail.

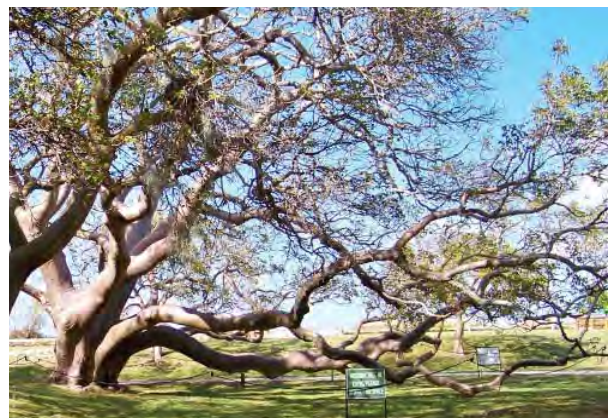
FIGURE 3-188. Largest gumbo limbo, infected with *Ganoderma*; view north.

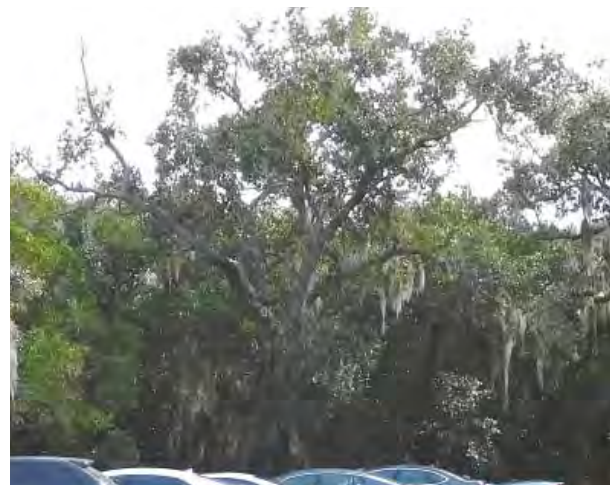
FIGURE 3-193. Live oak with apparent crown dieback and distinct lean, at east side paved parking spaces.
