(E83-10258) THEMATIC MAPPER FLIGHT MODEL
PRESHIPMENT REVIEW DATA PACKAGE, VOLUME 2,
PART A: SUBSYSTEM DATA Final Report
(Hughes Aircraft Co.) 276 p HC A13/MF A01

Prepared for
GODDARD SPACE FLIGHT CENTER
Greenbelt, Maryland 20771
CONTRACT NAS 5-24200

FLIGHT MODEL
PRESHIPMENT REVIEW
DATA PACKAGE
VOLUME II - SUBSYSTEM DATA
PART A

THEMATIC MAPPER
FLIGHT MODEL
PRESHIPMENT REVIEW
VOLUME II
SUBSYSTEMS
TABLE OF CONTENTS

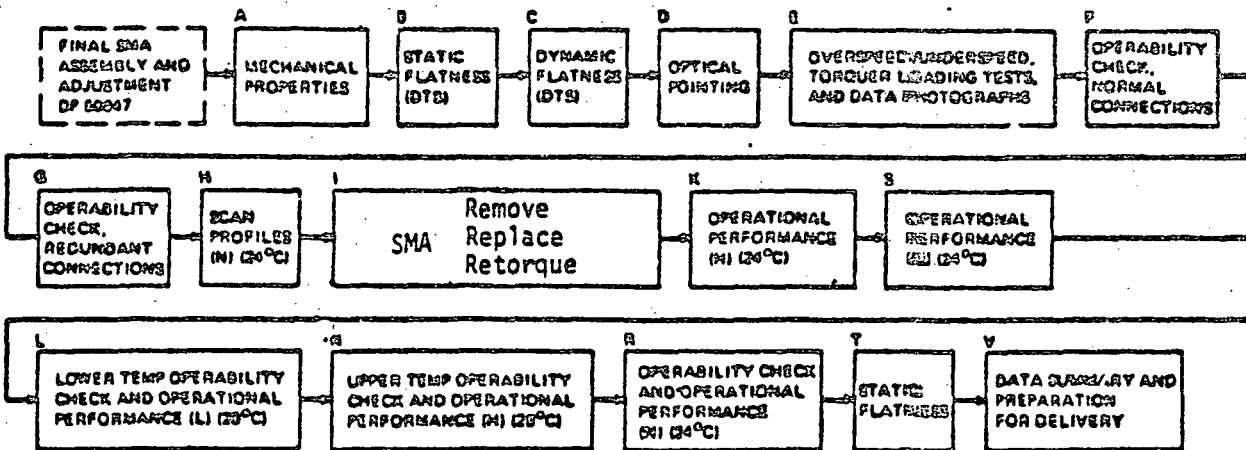
F-1 SMA Test Flow Event Sequence.

The reduced data, and the aforementioned investigation was conclusive of the fact that both SAM Offset and Pointing angle discrepancy were not related to the SMA's thermal and/or vibrational test.

For this reason the recommendation is made that the F-1 SMA re-enters the Acceptance Test starting with Test Flow Event "H" as shown below.

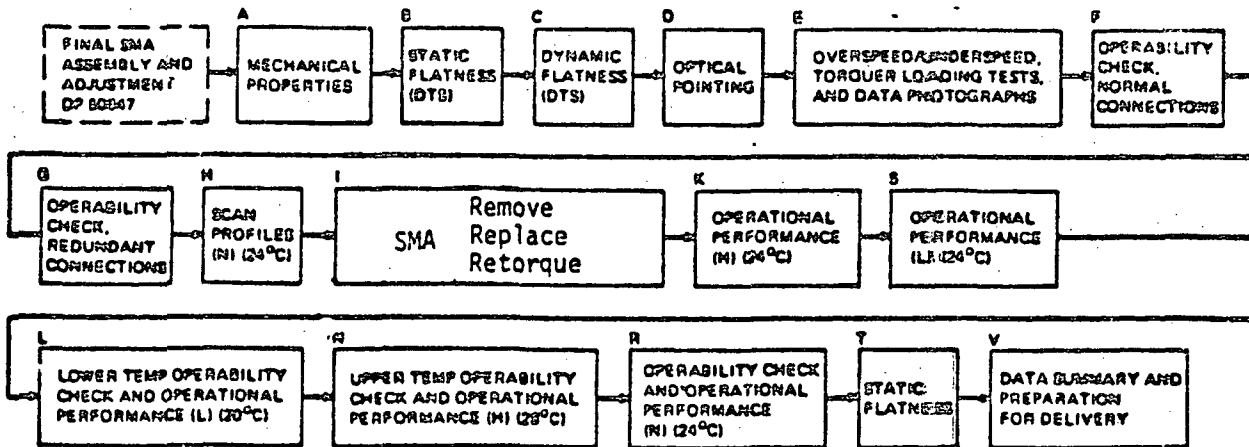
F-1 SMA Test Flow Event Sequence.

The reduced data, and the aforementioned investigation was conclusive of the fact that both SAM Offset and Pointing angle discrepancy were not related to the SMA's thermal and/or vibrational test.

For this reason the recommendation is made that the F-1 SMA re-enters the Acceptance Test starting with Test Flow Event "H" as shown below.

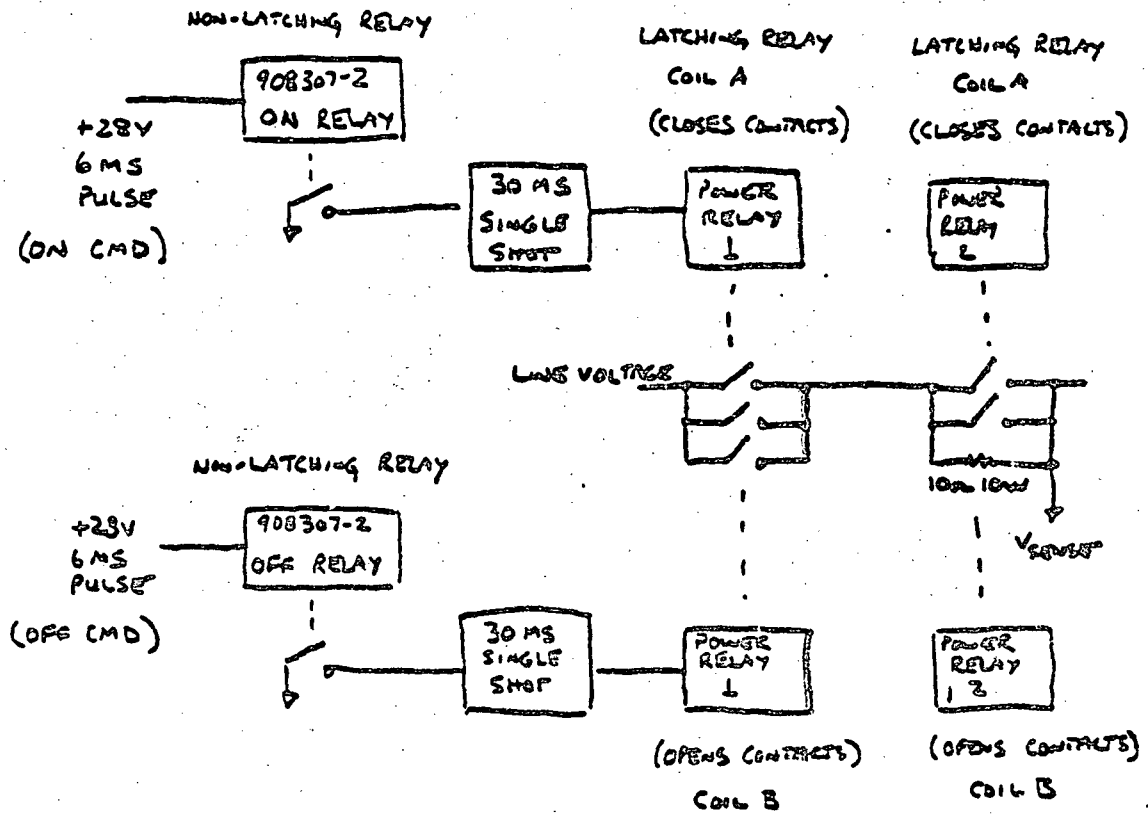
FIGURE 1. PRIMARY (OR REDUNDANT) POWER SUPPLY
ON/OFF RELAY COMMAND STRUCTURE (CONCEPTUAL)

A failure mode can be defined in which one power supply (primary) cannot be commanded off, and its multiplexer relay cannot be commanded to the multiplexer position (two relay failures exist). This requires that the redundant power supply be commanded ON, and that its multiplexer relay be commanded ON. The configuration is then as shown in Figure 3.

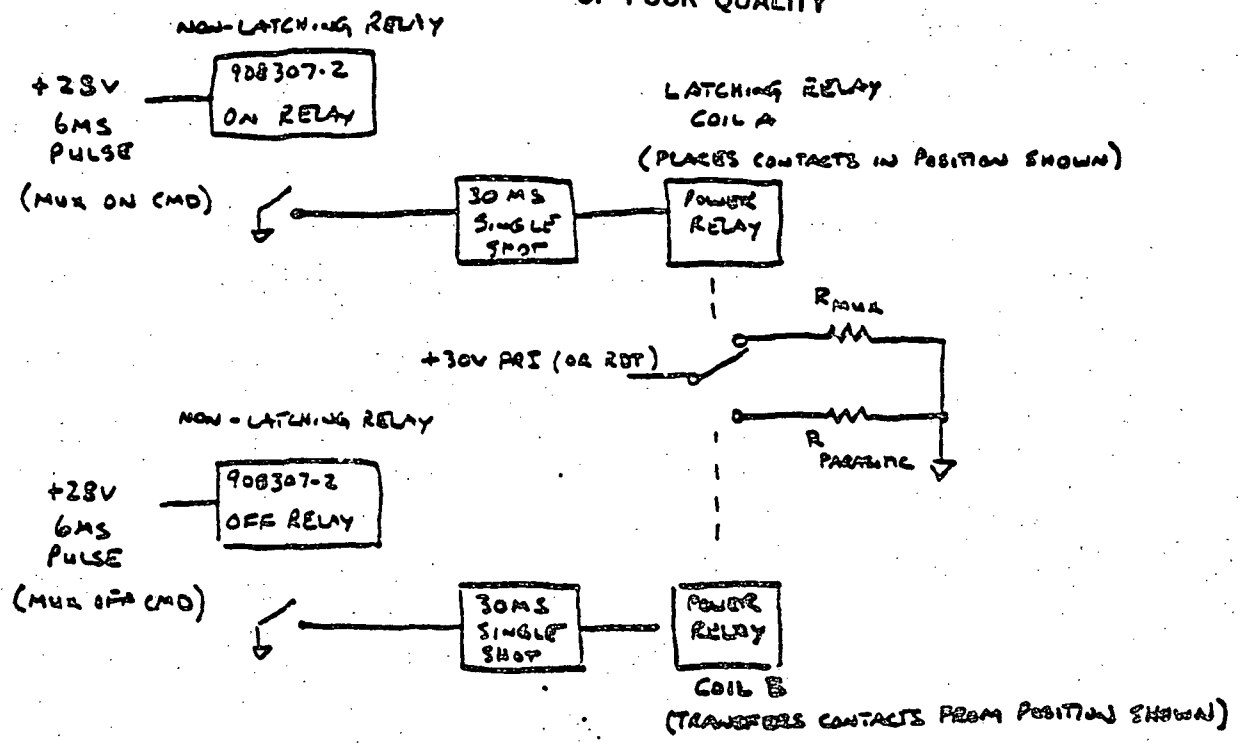
FIGURE 2. MULTIPLEXER COMMAND RELAY STRUCTURE
(ONE POWER SUPPLY)

Figure 2 illustrates the circuitry associated with the two relays that control the application and removal of 30V to the multiplexer and the parasitic mux load. Each command relay (908307-2) momentarily (6MS) applies signal ground to the input of a 30MS single shot. The single shot, in turn, applies voltage to the coil of a latching power relay.

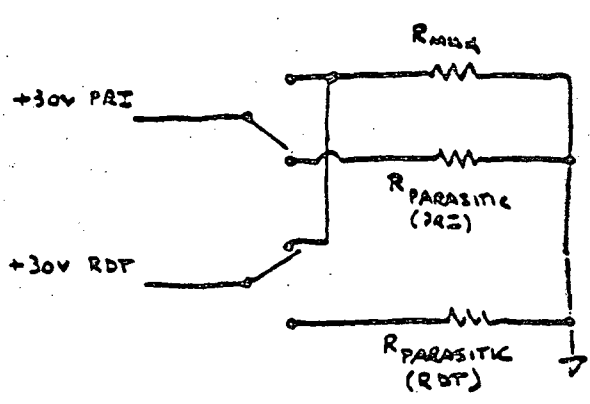
FIGURE 3. PRIMARY/REDUNDANT MULTIPLEXER RELAY CONTACT
CONFIGURATION

Figure 3 illustrates the interconnection of the contacts of the multiplexer relays of the primary and redundant power supplies. For the configuration shown, the redundant power supply is connected to the multiplexer and the primary power supply is connected to the parasitic load.
