# Historic Structures Report

## Olympia Brewery

Prepared by Chrisanne Beckner  
In Association with Artifacts Consulting, Inc.  
On Behalf of Old Brewhouse, LLC  
April 2011

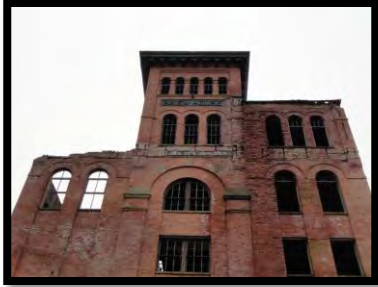
### Masonry: Common Red Brick

Materials: Chehalis Brick

American Bond: 6 stretcher courses per header

Condition: Fair to Good

Recommendations:

- Use original brick for repairs, when possible
- Replacement brick should be of a similar size, color and texture
- Repoint with hand tools to maintain joint profile
- All brick ornament, including corbelling at the cornice, pilasters, projections and recessions should be retained

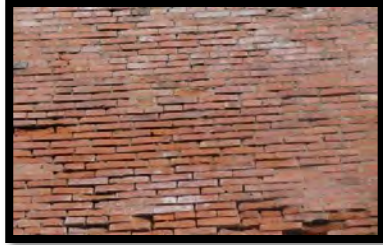
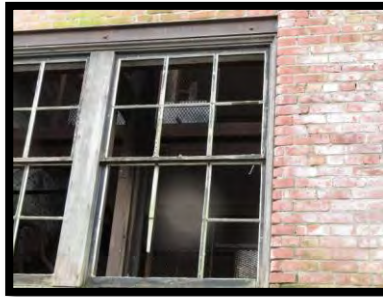
## Mortar

Mortar: Unknown composition

Condition: Poor to Good

Mortar's deterioration has left historic brick unprotected and more susceptible to water infiltration on the upper floors. Intact joints are flush, approximately half inch, but are somewhat inconsistent. New mortar should match the requirements identified by the National Park Service in Preservation Brief 2 , included in appendix:

Further Recommendations:

- Historic mortar should be tested to determine quantities of lime, sand and Portland cement for adequate matching
- Repoint with mortar similar in composition, color, texture, joint size, method of application and joint profile
- Choose a mason who's familiar with historic brick buildings and is willing to hand tool the joints before repointing

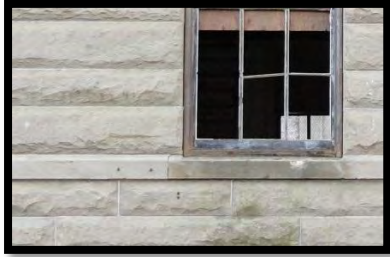
### Masonry: Sandstone

Material: Coursed Rock-Faced Tenino Sandstone

Condition: Good

Tenino sandstone was used as an ornamental accent on the primary façade of the Brewhouse. It is found on pilasters, around doors and windows and in horizontal bands between floors. Original plans identify stone sills, keystones, and capitals.

Recommendations:

- Retain all historic sandstone details
- If repair is needed, test mortar and match its composition, color, texture, joint size, method of application and joint profile
- Paint does not appear in historic photos from the period of significance. It can be removed by the gentlest means possible (See appendix).
- Replacement sandstone may be available from quarries recently reopened in Tenino

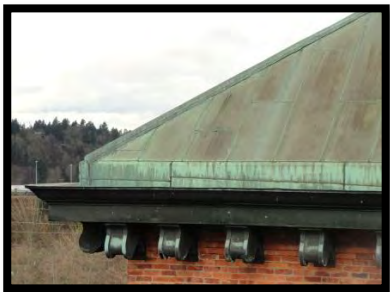
### Tower Roof

Material: Copper

Condition: Good

Copper roofing was used on the hipped-roof central tower, providing the Brewhouse with an ornamental cap that was further emphasized by a cornice and gutter system featuring large, console brackets. The copper roof appears to be intact and investigations of the supporting wood structure show no obvious signs of leakage or deterioration. Original plans drawn by Viltner call out “copper roof with raised seams” and “copper cornice and brackets”. However, separate elevation drawings refer to the cornice and console brackets as “galvanized iron.”

Recommendations:

- Retain in place

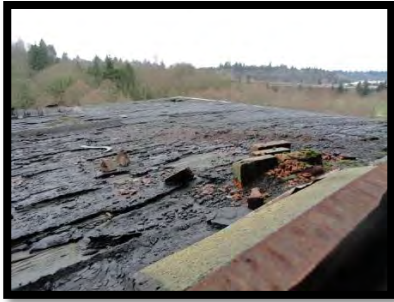
## Secondary Roof

Material: Composition  
Condition: Poor to Nonexistent  
Significance: Minimal

Though historians claim that all roofs on the Brewhouse were copper, the lower tiers were apparently composition roofs forming shallow hips. They have ultimately performed poorly, with the first collapse occurring in the early 1990s.

### Recommendations:

- Repair or replace. Maintain historic roof slope to help with drainage.

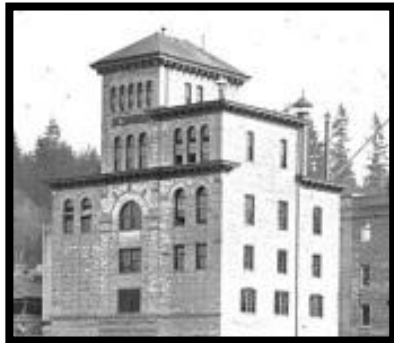
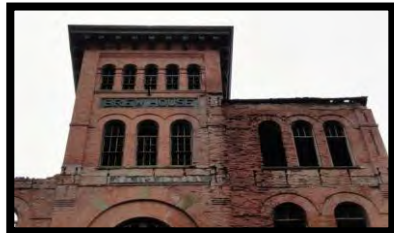
## Console Brackets and Cornice

Materials: Galvanized Iron  
Condition: Fair on tower; missing on other tiers  
Significance: Primary

The brackets remaining under the tower's copper roof have been minimally protected by a cornice and gutter system, but the cornices on lower level roofs have been lost, along with the console brackets that emphasized the building's tiers. The tower is shown above left, brackets and cornices are in place in the historic photo, left, and the contemporary photo, below, shows where the brackets were once affixed to the brick.

### Recommendations:

- All new construction should be recognizably new and not create a false sense of history. However, the roof emphasis and delineated tiers were a central design element and should be addressed in restoration plans.
- The remaining brackets, cornices and copper roof are highly visible character-defining features and should be repaired and retained in place. The highest priority is to protect significant historic fabric.

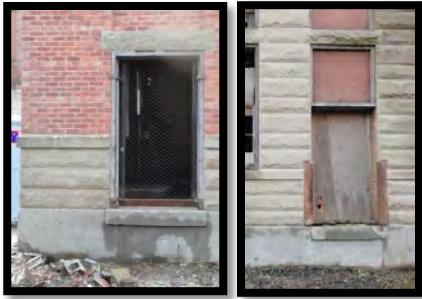
### First Floor Doors

Materials: Metal Mesh/Wood  
Condition: Good/Missing  
Significance: Minimal

This metal door, shown below left, is not original to the building, though its sandstone sill and lintel are. Original plans identify a paneled door. Original drawings also call for a metal door in the central bay, below right, but the door is missing and is boarded up by a wood panel. This opening enters into the historic platform lift.

Recommendation:

- Doors may be replaced though the historic opening should be maintained, along with stone sills and lintels
- New construction should be visible new, but constructed of historically appropriate materials

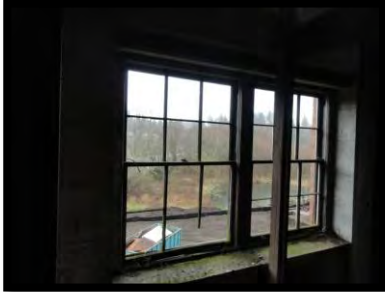
## Second Floor Windows

Materials: Wooden frames, missing lights

Condition: Fair

On the second floor, the only windows are a pair of double hung wood windows in the central bay. They are six-over-six sash windows with stone sills and metal lintels. The frames remain, though their condition has deteriorated.

### Recommendations

- Retain and repair frames; reglaze
- Replacement windows, if needed, should retain the original fenestration and should, when possible, match the original materials, design and function. Replacement windows should be operable when the originals were operable; windows originally built with divided lights should be replaced by windows with divided lights.
- Retain sills and lintels

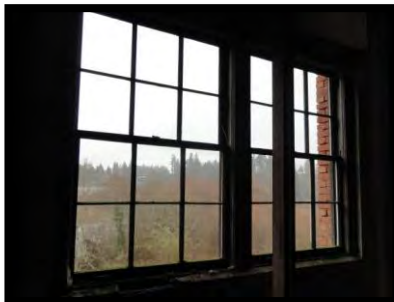
## Third Floor Windows

Materials: Wooden frames, missing lights

Condition: Fair

### Recommendations

- Retain and repair frames; reglaze
- Replacement windows, if needed, should retain the original fenestration and should, when possible, match the original materials, design and function. Replacement windows should be operable when the originals were double hung; windows originally built with divided lights should be replaced by windows with divided lights.
- Retain sills and lintels

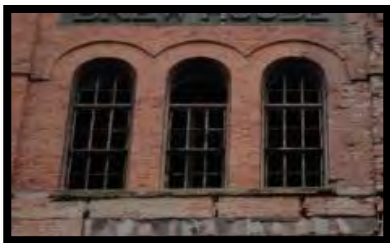
### Fifth Floor Windows

Materials: Wooden frames, missing lights

Condition: Fair

#### Recommendations:

- Retain and repair frames; reglaze
- Replacement windows, where needed, should retain the original fenestration and should, when possible, match the original materials, design and function. Replacement windows should be operable when the originals were; windows originally built with divided lights should be replaced by windows with divided lights.
- Retain sills
- Retain fixed lights

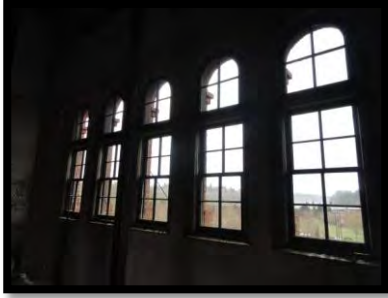
### Sixth Floor Windows

Materials: Wooden frames, missing lights

Condition: Good

Recommendations:

- Retain and repair frames; reglaze
- It's unlikely that replacement windows will be needed. However, any replacement windows, should retain the original fenestration and should, when possible, match the original materials, design and function. Replacement windows should be operable when the originals were double hung; windows originally built with divided lights should be replaced by windows with divided lights.
- Retain sills
- Retain fixed lights

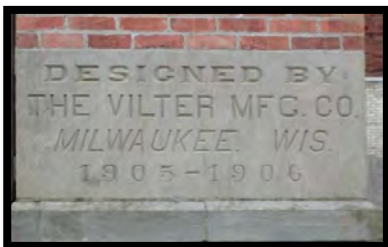
### Ornamental Features: Corner Stone

Material: Sandstone

Condition: Good

Recommendation:

- Retain in place

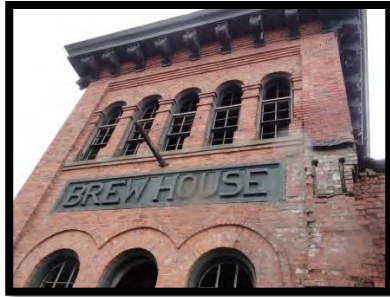
## Ornamental Features: Brick Detail

Materials: Chehalis Brick  
Condition: Fair to Good  
Significance: Primary

Brick ornamentation, including corbelling, pilasters, arcades and mullions in the shape of columns are all central to the significance of the primary façade.

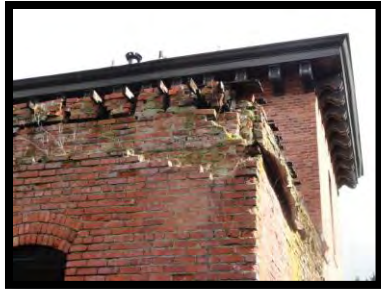
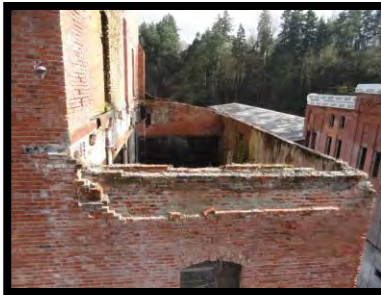
## Masonry: Common Red Brick

Materials: Chehalis Brick  
American Bond: 6 stretcher courses per header  
Approximate size: 8 ¼" x 2 ½" x 4"  
Condition: Fair to Good  
Significance: Primary

Roof collapse has left the brick at critical wall and roof junctures exposed, leading to the loss of historic material. However, most historic brick is intact, though in need of repointing in places. Brick size varies.

The condition of the brick is most deteriorated at the tops of fourth and fifth floors where the removal of cornices and the lack of roofs have left brick susceptible to moisture. Popping, spalling and general deterioration have eroded historically significant material. Other damage has occurred around a punch through on the second floor. Otherwise, the brick is generally intact.

### Recommendations:

- Original brick should be used for repair whenever possible
- Replacement brick should be of a similar size, color and texture
- Repoint with hand tools to maintain joint profile
- All brick ornament, including segmental arches, shall be retained.

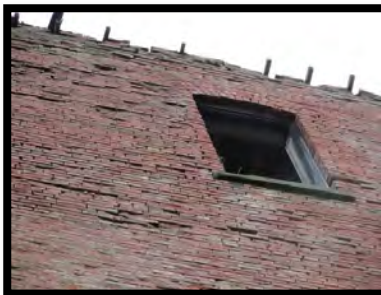
## Mortar

Mortar: Unknown composition  
Condition: Poor to Good  
Joints: Half inch, flush  
Significance: Primary

Mortar's deterioration has left historic brick unprotected and more susceptible to water infiltration on the upper floors. New mortar should match the requirements identified by the National Park Service in Preservation Brief 2, included in appendix:

- The new mortar must match the historic mortar in color, texture and tooling
- Texture of sand must match that of historic mortar
- The new mortar must have greater vapor permeability and be softer than historic brick
- The new mortar must be as vapor permeable and as

<p>soft or softer than the historic mortar</p> <p>Further Recommendations:</p> <ul style="list-style-type: none"> <li>• Historic mortar should be tested to determine quantities of lime, sand and Portland cement for adequate matching</li> <li>• Repoint with mortar similar in composition, color, texture, joint size, method of application and joint profile</li> <li>• Choose a mason who's familiar with historic brick buildings and is willing to hand tool the joints before repointing</li> </ul>
<p><b>Roofing</b></p>

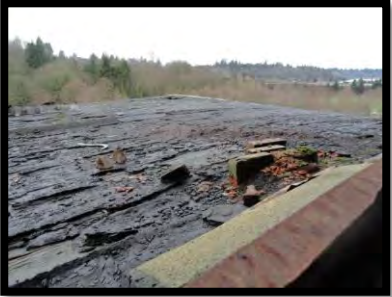
<p>Material: Composition Condition: Poor Significance: Minimal</p> <p>The composition roof on the fifth floor on the western elevation has deteriorated greatly, though the roof system below is intact. It's also possible to see the deterioration along the southern elevation. Though historians claim that all roofs on the Brewhouse were copper, the lower tiers were apparently composition roofs forming shallow hips.</p> <p>Recommendations:</p> <ul style="list-style-type: none"> <li>• Repair or replace. Maintain historic roof slope to help with drainage.</li> </ul>

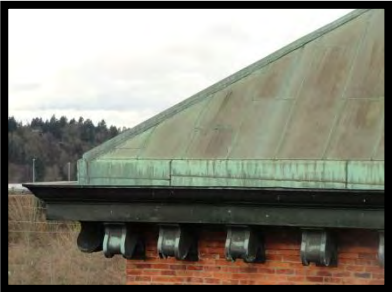
<p><b>Tower Roof</b></p>

<p>Material: Copper Condition: Good Significance: Primary</p> <p>Copper was used to roof the central tower, providing the Brewhouse with an ornamental cap that was further emphasized by a cornice and gutter system featuring large, console brackets. The copper roof appears to be in good condition on all elevations. Original plans call out "copper roof with raised seams" and "copper cornice and brackets". However, separate elevation drawings refer to the cornice and console brackets as "galvanized iron."</p> <p>Recommendations:</p> <ul style="list-style-type: none"> <li>• Maintain and protect roof and brackets in place</li> </ul>

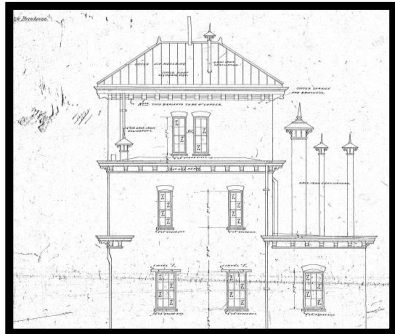
### Cornices and console brackets

Materials: Galvanized Iron  
Condition: Fair on tower; missing elsewhere  
Significance: Primary

The brackets remaining under the tower’s copper roof have been minimally protected by a cornice and gutter system, but the cornices on lower level roofs have been lost, along with the console brackets that emphasized the building’s tiers. The brackets and cornices are visible in historic plans, left. Removal of these cornices has increased brick deterioration.

#### Recommendations:

- All new construction should be recognizably new and not create a false sense of history. However, the roof emphasis and delineated tiers were a central design element and should be addressed in restoration plans.
- The remaining brackets, cornices and copper roof are highly visible character-defining features and should be repaired and retained in place. The highest priority is to protect significant historic fabric.

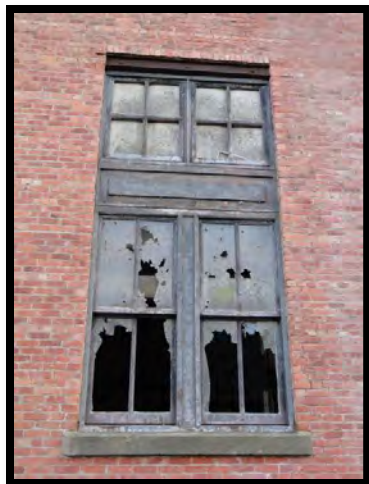
### First Floor Window, Northern Bay

Materials: Galvanized iron  
Condition: Fair  
Significance: Primary

This metal “fireproof” window includes fixed four-light windows above a pair of two-over-two double hung sash windows. It lights a room used specifically for a baudelot cooler. The window is the only one identified as fireproof in original first floor plans, though “fire shutters” also existed on the eastern elevation.

#### Recommendations:

- Retain frames and glazing; reglaze where necessary
- Retain stone sills and iron lintels

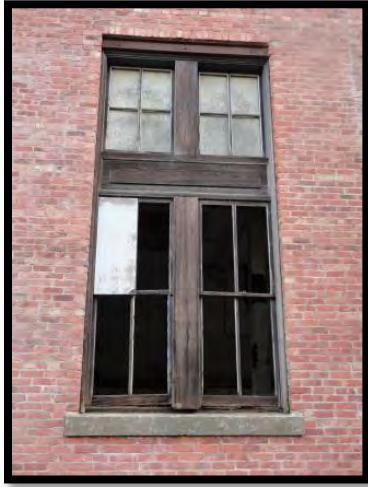
**First Floor Window, Central Bay**

Materials: Wood  
Condition: Fair  
Significance: Primary

Fixed four-light windows are separated by a wooden panel from two-over-two double-hung sash windows. Stone sill; iron lintel. Plans identify this opening as a door.

Recommendations:

- Retain and repair frame; reglaze
- If an entrance is needed on the western elevation, this would be the appropriate location

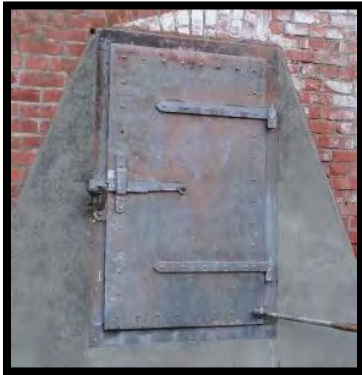
**First Floor Door, Southern Bay**

Materials: Iron  
Condition: Good  
Significance: Primary

This door was used for hops disposal. The hop jack was located just inside.

- Retain in place as an artifact of the building's former life as a working brewery

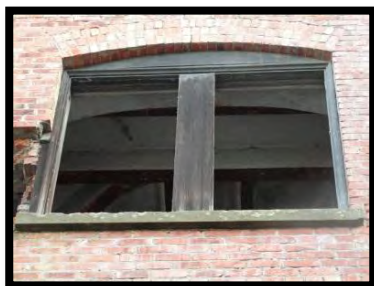
**Second Floor Window, North and South Bays**

Material: Wood  
Condition: Fair  
Significance: Primary

The second floor includes windows of two types. In the exterior bays, windows include brick segmental arches, sandstone sills, wood mullions and wood panels in the arch. They were originally two-over-two, double-hung sash windows. Evidence of weights and pulleys remains.

<p>Recommendations:</p> <ul style="list-style-type: none"> <li>• Retain and repair window casings and replace windows with operable double-hung sash windows</li> <li>• Retain arches, lintels, mullions, panels and sills</li> </ul>
<p><b>Second Floor Window, Central Bay</b></p>

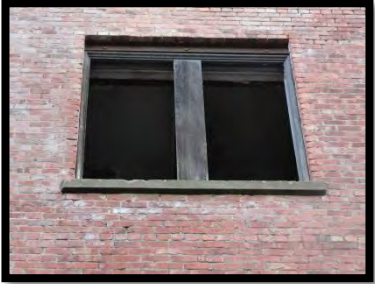
<p>Materials: Wood Frame Condition: Fair Significance: Primary</p> <p>The central opening contained a pair of two-over-two, double-hung sash windows separated by a wood mullion. The mullion remains, as does evidence of a weight and pulley system.</p> <p>Recommendation:</p> <ul style="list-style-type: none"> <li>• Repair casing and replace windows with double-hung sash windows</li> <li>• Retain lintel, mullion and sill</li> </ul>
<p><b>Third Floor Windows</b></p>

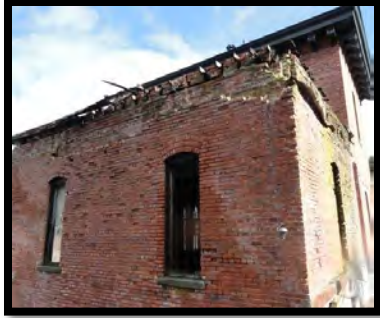
### Fifth Floor Windows

Materials: Wood frames  
Condition: Poor  
Significance: Secondary

The fifth floor included two windows of one type. These arched windows were original four-over-four, double-hung sash windows. They also have sandstone sills and wood paneled lintels.

- Repair surrounds and replace windows with operable double-hung sash windows
- Retain sills and lintels

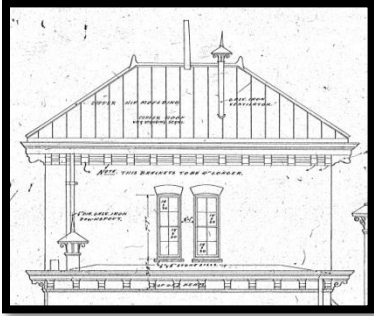
## Sixth Floor Windows

Materials: Wood frames

Condition: Poor

- Repair surrounds and replace windows with operable, double-hung, sash windows
- Retain sills and lintels

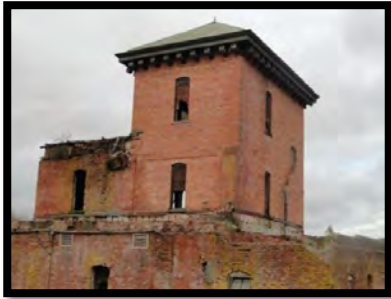
## Masonry

Materials: Chehalis Brick

Condition: Fair to Good

The condition of the brick is most deteriorated at the top of the fourth floor where roof collapse has left brick completely open to the weather. Popping, spalling and general deterioration have significantly eroded historic material. All repairs will meet the following historic preservation guidelines:

- Original brick should be used for repair whenever possible
- Replacement brick should be of a similar size, color and texture
- Repoint with hand tools to maintain joint profile
- Brick ornament, including shallow pilasters, shall be retained.

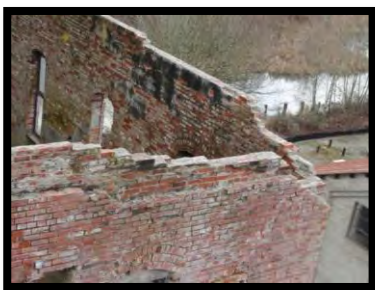
## Mortar

Mortar: Unknown composition

Condition: Poor to Good

Mortar's deterioration has left historic brick unprotected and more susceptible to water infiltration on the upper floors, especially at corners, seen left. New mortar should match the requirements identified by the National Park Service in Preservation Brief 2:

- The new mortar must match the historic mortar in color, texture and tooling
- Texture of sand must match that of historic mortar
- The new mortar must have greater vapor permeability and be softer than historic brick
- The new mortar must be as vapor permeable and as soft or softer than the historic mortar

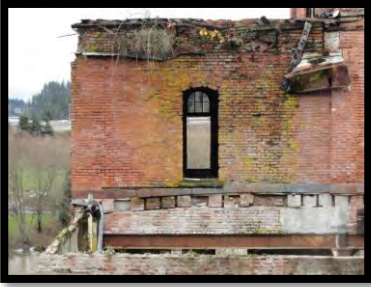
<p>Material: Composition  Condition: Missing  Significance: Minimal</p> <p>The composition roof on the fourth floor of the southern elevation has collapsed. On the fifth floor, the composition roof is deteriorated but in place.</p> <p>Recommendations:</p> <ul style="list-style-type: none"> <li>• The secondary roofs are not visible from the ground. New composition roofs would be appropriate.</li> </ul>
<p><b>Tower Roof</b></p>

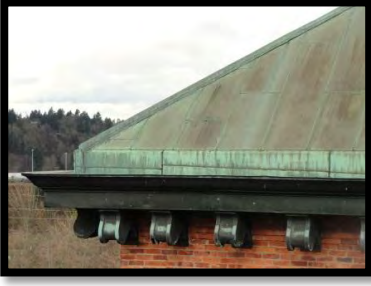
<p>Material: Copper  Condition: Good  Significance: High</p> <p>Copper was used on the hipped-roof central tower. The copper roof appears to be intact on all elevations and investigations of the supporting wood structure show no obvious signs of leakage or deterioration. Original plans drawn by Viltner call out "copper roof with raised seams" and "copper cornice and brackets". However, separate elevation drawings refer to the cornice and console brackets as "galvanized iron."</p> <p>Recommendations:</p> <ul style="list-style-type: none"> <li>• Maintain and protect roof and brackets in place</li> </ul>

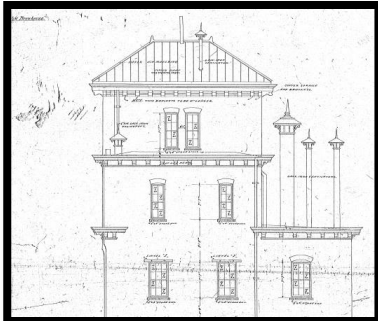
## Cornices and Console Brackets

Materials: Galvanized Iron  
Condition: Fair along tower; missing elsewhere  
Significance: High

Though the cornice and brackets on the tower are intact, the southern elevation has lost all other cornices. A cornice once wrapped the building at the fifth floor and at the fourth floor, emphasizing the building's tiers. The roof and any evidence of the original cornices and brackets are missing.

- It would be inappropriate to replicate the cornices exactly, as all new construction must be recognizably new. However, the roof emphasis and delineated tiers are a central design element and should be included in restoration plans.
- The cornice and brackets that remain along the top of the sixth floor should be repaired and retained. The highest priority is to protect and retain significant historic fabric. The brackets, cornices and copper roof are a highly visible character-defining feature.

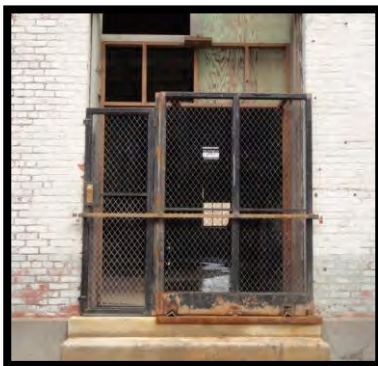
## First Floor Door

Materials: Metal  
Condition: Good  
Significance: Minimal

The metal gate installed over this opening is not original, but the opening appears with a transom window in mid-century historic photos. The original plans call for paired double-hung sash windows in this location. No documentation exists for installing an opening at this location.

- Retain opening in place and restore transom or return to original fenestration

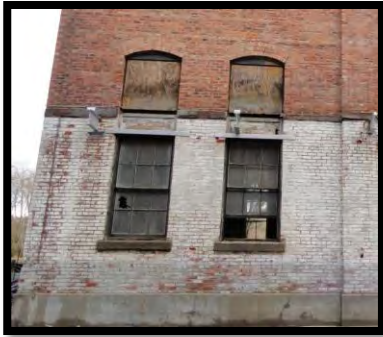
### First Floor Windows

Materials: Wood frames

Condition: Fair

- Retain and repair windows and retain original glazing where possible
- Uncover and reglaze fixed lights
- Replacement windows, if needed, must be of the same materials, size and shape. Historically operable windows should be replaced with operable windows with true divided lights.

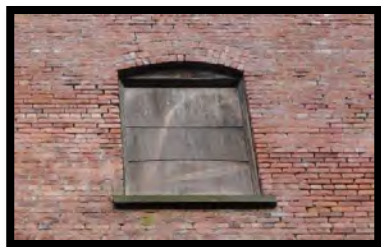
### Third Floor Windows

Materials: Wood Frames

Condition: Fair

Only two windows exist on the western and central bays of the third floor. Though the windows are missing, one of the wooden casings remains. The other retains only its opening, its stone sill and its segmental arch.

- Retain openings and existing casings and sills
- Replacement windows should be operable double-hung sash windows

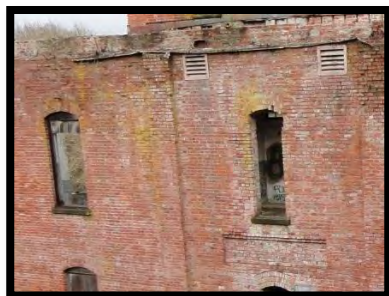
### Fourth Floor Windows: Western bays

Material: Wood Frames

Condition: Fair to Missing

The fourth floor includes one opening per bay. The central bay is missing its window and casing and is framed by deteriorating masonry, as on the third floor. Sill and segmental arch remain. The western window (left) retains its casing and sill but the window is missing.

- Repair masonry and retain the opening in the central bay. Replacement window should be operable, double-hung sash
- The window frame in the western bay should be repaired and the replacement windows should be an operable, double-hung sash.

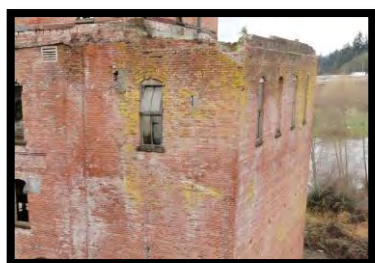
### Fourth Floor Window: Eastern Bay

Materials: Metal and safety glass

Condition: Good

- Retain in place
- Reglaze with safety glass where needed

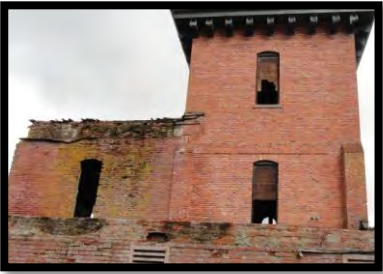
<p>Materials: Wood  Condition: Fair  Significance: Primary</p> <p>On the fifth floor, the southern and eastern volumes of the building have terminated and only the tower and the western volume continue. The windows on these floors are similar to others with deteriorated casings, missing windows, damaged brick and remaining sandstone sills and paneled arches.</p> <p>Recommendations:</p> <ul style="list-style-type: none"> <li>• Retain and repair casings</li> <li>• Replace windows with operable double-hung sash windows</li> </ul>
<p><b>Remaining Features: Corbelled panel</b></p>

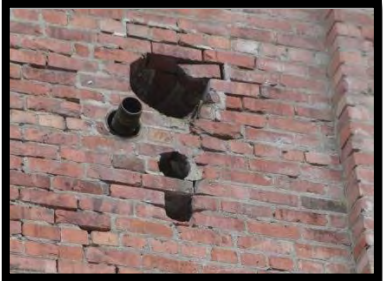
<p><b>Remaining Features: Piping</b></p>

<p>Materials: Metal  Condition: Good  Significance: Secondary</p> <p>These pipe ends and openings were used to transfer materials from the Brewhouse to the Cellar building to the south.</p> <p>Recommendations:</p> <ul style="list-style-type: none"> <li>• If possible, they should be left in place as an artifact of the building's use as a working brewery.</li> </ul>

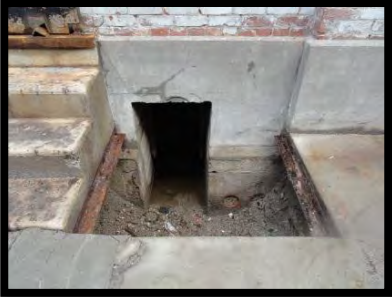
<p><b>Remaining Features: Underground Access</b></p>

<p>Materials: Concrete and Iron Condition: Good Significance: Unknown</p> <p>This recessed opening leads under the building and is filled with water. The opening in the floor panel is surrounded with iron and likely held a cover. It is yet unknown how the underground space was used by the brewery, but plans for the Cellar building, south, included mention of wells and water tanks underground.</p> <p>Recommendations:</p> <ul style="list-style-type: none"> <li>• If possible, the recession should remain visible.</li> </ul>
<p><b>Remaining features: Stairs</b></p>

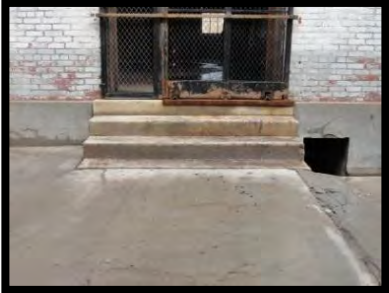
<p>Materials: Sandstone Condition: Good Significance: Secondary</p> <p>These sandstone stairs appear to predate the pad poured around them, though they do not appear on original plans.</p> <p>Recommendations:</p> <ul style="list-style-type: none"> <li>• If possible, they should remain in place</li> </ul>

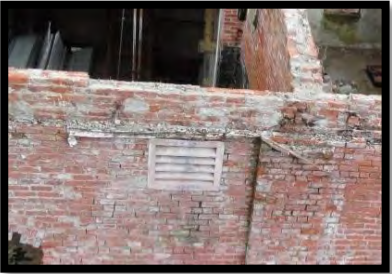
<p><b>Remaining Features: Vents</b></p>

<p>Materials: Metal Condition: Good Significance: Secondary</p> <p>The vent on the southern elevation is a good example of the fire resistant details added to the Brewery's dry grain storage.</p> <p>Recommendations:</p> <ul style="list-style-type: none"> <li>• If possible, this example or others should remain in place as artifacts of the building's history as a working brewery</li> </ul>

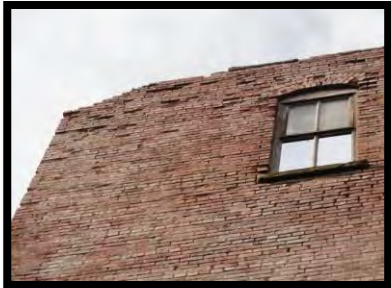
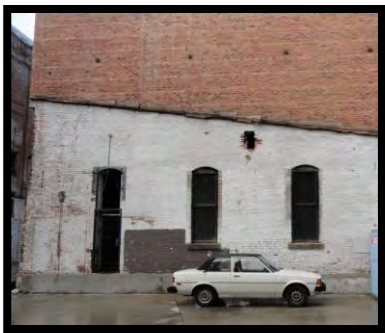
## Masonry

Materials: Chehalis Brick

Condition: Fair to Good

The condition of the brick is most deteriorated at the top of the fourth floor where the lost roof has left brick susceptible to moisture. Popping, spalling and general deterioration have eroded historically significant material. All repairs should meet the following historic preservation guidelines:

- Original brick should be used for repair whenever possible
- Replacement brick should be of a similar size, color and texture
- Repoint with hand tools to maintain joint profile
- All brick ornament, including segmental arches, shall be retained.

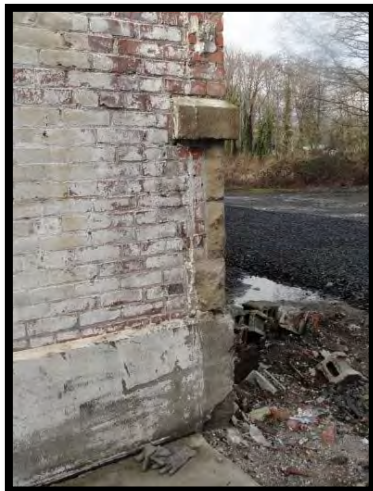
## Mortar

Mortar: Unknown composition

Condition: Poor to Good

Mortar's deterioration has left historic brick unprotected and more susceptible to water infiltration. New mortar should match the requirements identified by the National Park Service in Preservation Brief 2:

- The new mortar must match the historic mortar in color, texture and tooling
- The sand's texture should match that of the historic mortar
- The new mortar must have greater vapor permeability and be softer than the brick.
- The new mortar must be as vapor permeable and as soft or softer than the historic mortar

<p>Further Recommendations:</p> <ul style="list-style-type: none"> <li>• Historic mortar should be tested to determine quantities of lime, sand and Portland cement</li> <li>• Repoint with mortar similar in composition, color, texture, joint size, method of application and joint profile</li> <li>• Choose a mason who's familiar with historic brick buildings and is willing to hand tool the joints before repointing</li> </ul>
<p><b>Tower Roof</b></p>

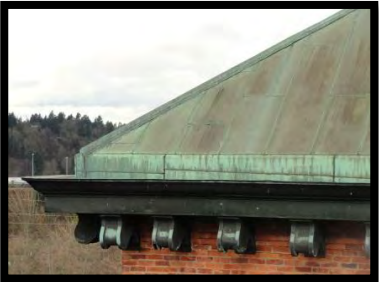
<p>Material: Copper  Condition: Good  Significance: Primary</p> <p>Copper was used to sheath the central tower, providing the Brewhouse with an ornamental cap that was further emphasized by a cornice and gutter system featuring large, console brackets. The copper roof appears to be intact on all elevations and investigations of the supporting wood structure show no obvious signs of leakage or deterioration. Original plans drawn by Viltner call out "copper roof with raised seams" and "copper cornice and brackets". However, separate elevation drawings refer to the cornice and console brackets as "galvanized iron."</p> <p>Recommendations:</p> <ul style="list-style-type: none"> <li>• Maintain and protect the roof and cornices in place</li> </ul>

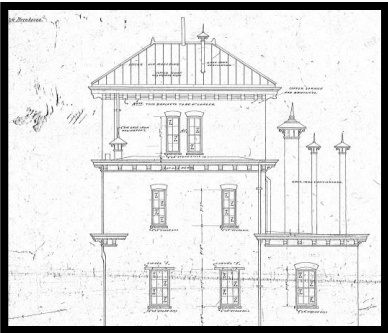
<p><b>Cornices and console brackets</b></p>

<p>Materials: Galvanized Iron  Condition: Missing  Significance: Primary</p> <p>Though the cornice and brackets on the tower are intact, the eastern elevation has lost all other cornices. A cornice once wrapped the building at the top of the fourth floor. The roof and any evidence of the original cornices and brackets are missing.</p> <p>Recommendations:</p> <ul style="list-style-type: none"> <li>• It would be inappropriate to replicate the cornices exactly, as all new construction must be recognizably new. However, the roof emphasis and delineated tiers are a central design element and should be included in restoration plans.</li> <li>• The cornice and brackets that remain along the top of</li> </ul>

<p>the tower should be repaired and retained. The highest priority is to protect and retain significant historic fabric.</p>
<p><b>Secondary Roofing</b></p>

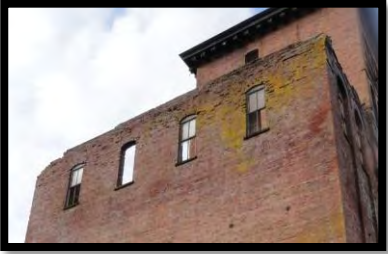
<p>Material: Composition  Condition: Missing  Significance: Minimal</p> <p>The composition roof on the fourth floor of the grain storage room, visible from the eastern elevation, has collapsed.</p> <p>Recommendations:</p> <ul style="list-style-type: none"> <li>• May be replaced with new composition roofs</li> </ul>
<p><b>First Floor Doors</b></p>

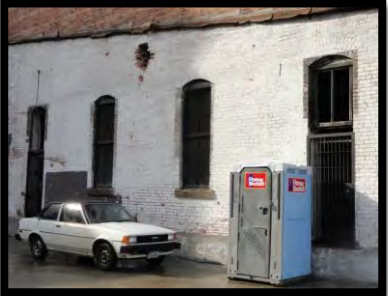
<p>Material: Metal  Condition: Good  Significance: Minimal</p> <p>The two metal doors are not original to the building, and the openings may have been windows originally. An infill structure was connected to the eastern elevation and has since been removed. Openings may have been expanded to allow access between the two buildings. Original window frames remain above doors.</p> <p>Recommendations:</p> <ul style="list-style-type: none"> <li>• Retain openings or return to original fenestration</li> <li>• Retain and repair window frames as needed</li> <li>• Reglaze with safety glass when necessary</li> </ul>

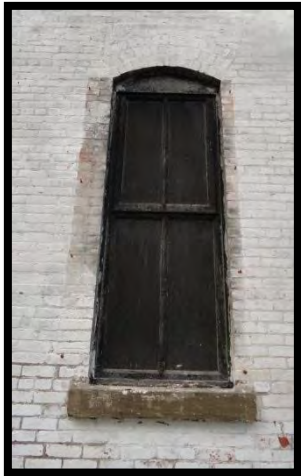
### First Floor Windows

Materials: Metal and Safety Glass  
Condition: Good  
Significance: Primary

The grain storage room was fire-proofed to a greater degree than other parts of the Brewhouse. This is reflected in the metal windows that line the first floor of the eastern elevation. These two-over-two double-hung windows are called out as "fire shutters" on the original plans. They include stone sills and paneled, arched lintels.

- Retain and repair, if necessary
- Reglaze with safety glass where needed

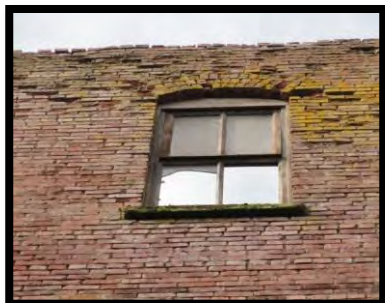
### Fourth Floor Windows

Materials: Metal and Safety Glass  
Condition: Good  
Significance: Primary

Four windows on the fifth floor were made in metal for fire protection. These two-over-two windows include a pivotal upper sash and stone sills, along with paneled arched lintels.

#### Recommendations:

- Retain in place
- Reglaze with safety glass where needed

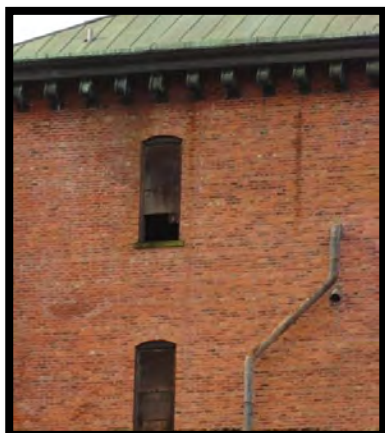
### Fifth and Sixth Floor Windows

Materials: Wood  
Condition: Fair  
Significance: Primary

On the tower, which rises above the terminated grain storage room, the windows are similar to other tower openings, with missing windows, wood casings, stone sills and paneled, arched lintels. Each floor has a single boarded-up window.

#### Recommendations:

- Retain and repair surrounds
- Replace windows with operable double-hung sash windows

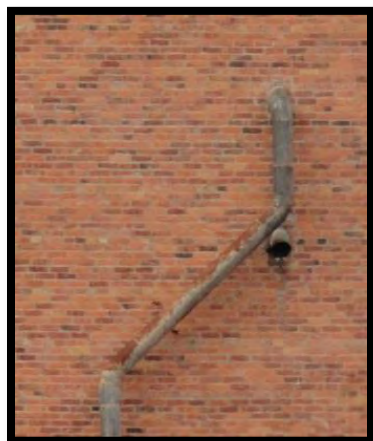
### Remaining Features: Drain Pipe

Materials: Metal  
Condition: Good  
Significance: Primary

These systems were central to the successful functioning of the brewery, and should be retained as artifacts of the building's history as a working brewery. This pipe appears in early historic photos of the Brewhouse.

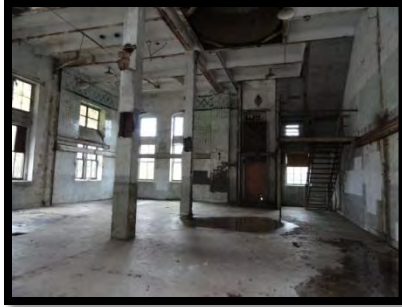
### Structure: Interior Volume

Significance: Primary

The first floor of the Brewhouse is now an open space broken only by structural beams, a stair and lift, and a dividing wall between the Brewhouse and the grain storage room. The hopjack and baudelot cooler are missing, as are the walls that once defined the cooler room. Damage to the columns, and steel supports along the walls appear to mark a catwalk or platform that once divided this volume.

Recommendation:

- Missing material does not need to be replaced, but remaining supports should be left in place, if possible
- Volumes should remain as open as possible, though a room on the footprint of the original cooler room would also be appropriate.

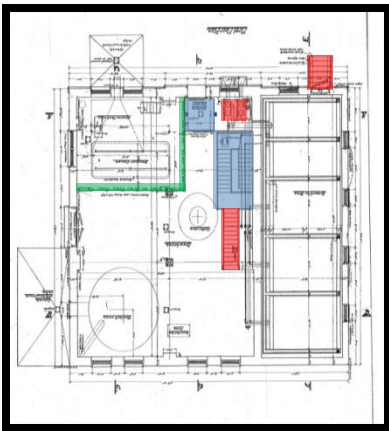
### Structure: Traffic and Conveyance

Bucket elevator, lift, and stairs were all located at the northeastern edge of the building's main volume. Stair cleats embedded in the floor and wall show that former stairs have been removed. Access to the grain storage room was in the southeast corner of the building's main volume.

While a redevelopment plan may incorporate greater access to all portions of the building, original traffic patterns should be maintained, with openings and access to the upper floors located in the northeast corner of the building's primary volume. Access to the grain storage room should remain in the southeastern corner, where it exists today.

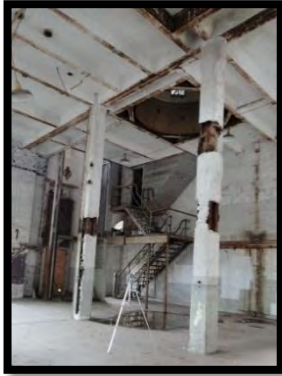
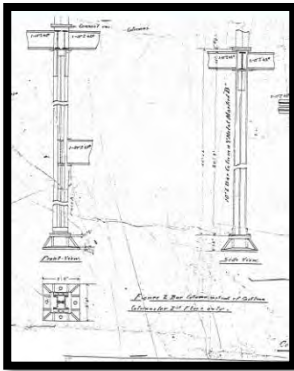
## Structure: Columns and Beams

Material: Cast iron  
Condition: Should be tested  
Significance: Primary

The first floor of the Brewhouse includes columns of cast iron that have been covered with plaster and painted. In places, the plaster, which increased the columns' fire protection, has been damaged, exposing the iron to water and corrosion. Cracks have formed in some structural beams.

Recommendations:

- Columns throughout the building should be investigated by structural engineers
- Columns should be retained in place if possible
- Treatment should include plaster repair and paint

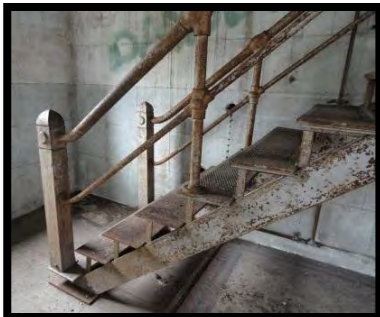
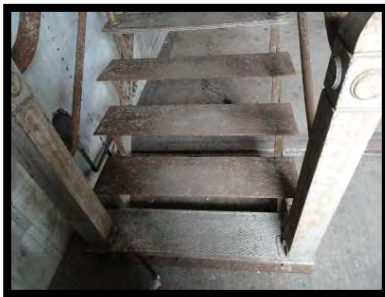
## Stair Rail and Tread

Material: Cast Iron and Steel  
Condition: Fair to Good  
Significance: Primary

Two-inch gas pipes make up the railing for this stair. The treads and newel posts are cast iron and the supporting structure is made of steel. Though treads have been replaced in some cases, the overall integrity of the stair is excellent.

Recommendations:

- Retain in place, along with replacement treads

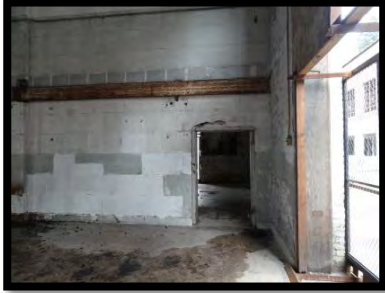
### Doorway to Grain Storage

Materials: Wood Frame  
Condition: Missing Door  
Significance: Primary

This doorway was the main access point between the grain storage room and the main body of the Brewhouse. Nothing remains of the door but some historic hardware affixed to the door frame.

Recommendations:

- The opening should be retained in place

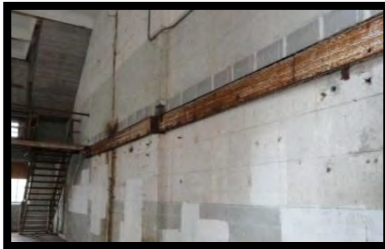
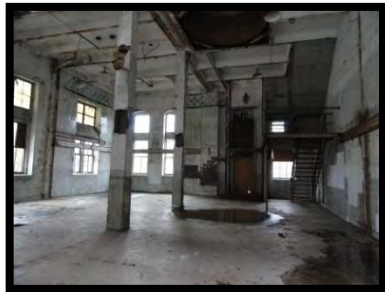
### Structural Supports: Former Platform

Materials: Metal  
Condition: Fair  
Significance: Primary

The steel supports embedded in the walls correspond to damage in the support columns, emphasizing that a platform or catwalk was original in place.

Recommendation:

- Though the platform and/or walkways are missing, their supports should remain if possible. They provide evidence of the former use of the building and contribute to its industrial character.

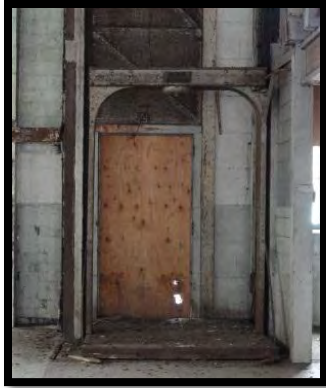
### Platform Elevator

Materials: Multiple  
Condition: Fair  
Significance: Primary

The lift was accessible through iron doors on the exterior of the building and from the interior. Both doors are missing, as is the wire mesh cage called out in plans. The platform, however, is still in place.

Recommendation:

- Retain structural materials in place
- Rehabilitate as a working lift, if appropriate

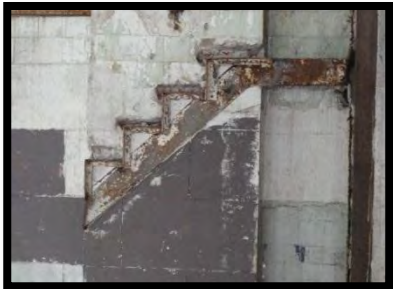
### Former Elements

Material: Steel and Cast Iron  
Condition: Missing  
Significance: Primary

The remnants of missing stairs and machinery remain in place throughout the building and are valuable artifacts of the building's former use.

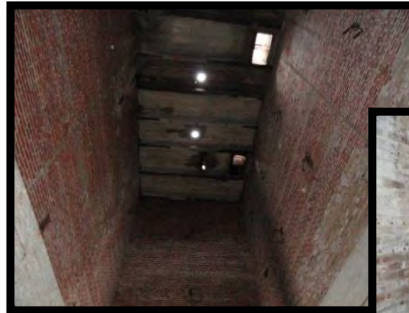
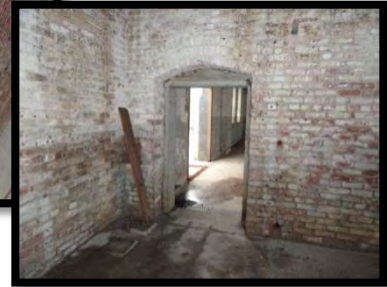
Bolts mark the location of previous tie bars that are now missing.

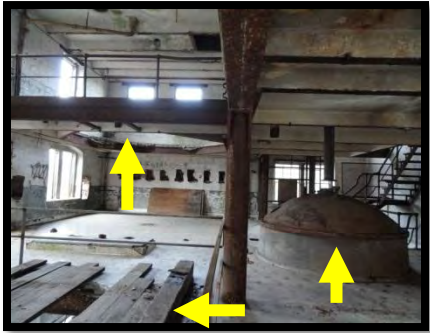
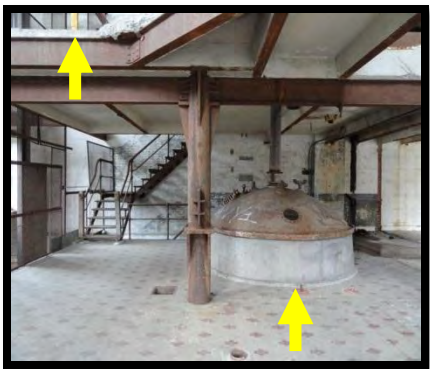
## Structure: Interior Volume

The large rice cooker lid, the only remnant of the brewery's extensive system of tanks and hoppers, is visible in both pictures left. These pictures also highlight two notable holes, a large hole in the ceiling (visible in the center of picture left and in the picture below) and a large hole in the floor, visible in the lower left corner of the picture left. These openings, along with the lid, are some of the most readable artifacts of the Brewhouse's history as a gravity brewing system.

As you can see from the rice cooker lid, it was designed to be chest high, while the volume of the cooker protruded through the floor. This was the case for the missing mash tub and kettle as well.

### Recommendations:

- Though this space is challenging, the remaining lid and evidence of a gravity system are some of the building's more readable features. If it's necessary to fill holes, the visible beams that supported these openings should remain visible. New construction, distinguishable from historic material, will help provide evidence of the unique design of the building.

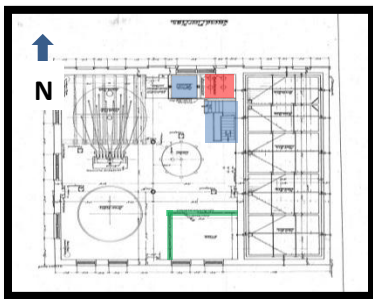
## Structure: Traffic and Conveyance

A stair, marked in blue, and the lift, also in blue, remain in place, as per the original plans. The bucket elevator, marked in red, has been removed. Former walls of an office that have since been removed are marked in green.

### Recommendations:

- Retain all stairs and elevator in place

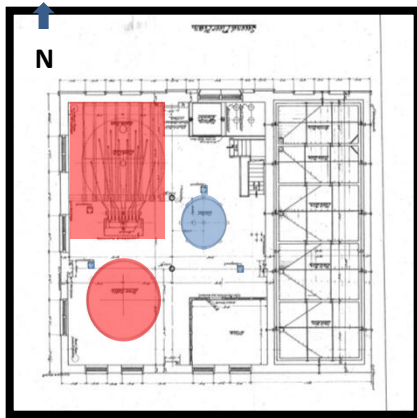
## Structure: Machinery

Very little remains of the gravity brewing system that once filled the Brewhouse with tanks and kettles, but the openings in floors and ceilings remain.

The floor plan to left shows remaining machinery features in blue, which include the lid of the rice tub and three cesspool drains. Missing features are shown in red. These include the kettle and the mash tub, along with the mash tub platform.

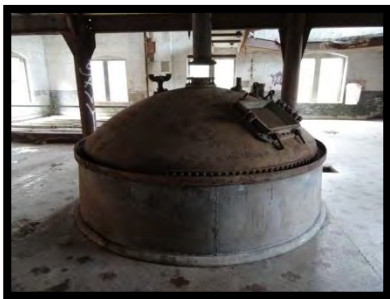
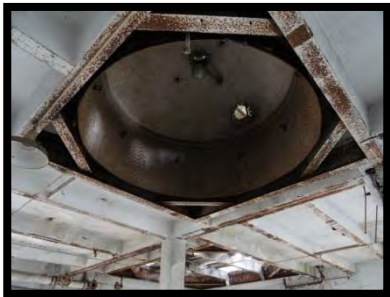
## Rice Cooker Lid

Materials: Sheet Steel and Iron  
Condition: Good  
Significance: Primary

The rice cooker lid retains evidence of its controls, visible at the top of the dome, left. Above the dome protrudes a pipe that runs through the ceiling and emerges on the third floor.

In the lower photo, one can see the underside of the lid as it appears to someone standing on the first floor.

The rice cooker was used specifically to toast rice, which had to be cooked separately from malt before being added to the mash. No documentation has been found that details when or why machinery was removed from the Brewhouse.

Recommendations:

- Retain in place

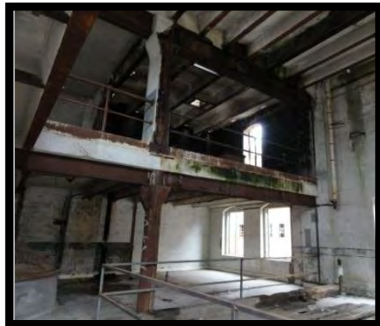
### Structure: Columns and Beams

Material: Cast Iron  
Condition: Should be tested  
Significance: Secondary

Structural supports have been left visible on the second and third floors. Columns, beams, floor plates and all structural materials were painted white, but the paint has eroded over time.

#### Recommendations:

- Have all columns and beams assessed by engineering team
- Retain in place

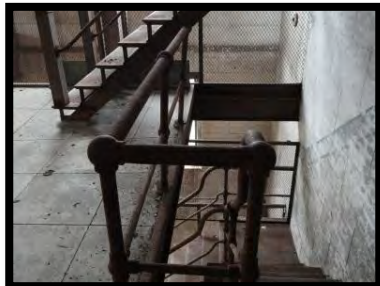
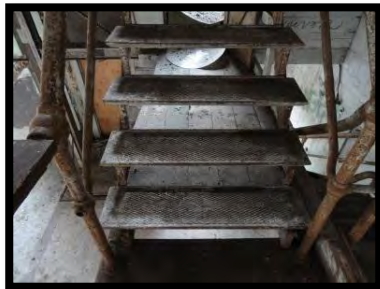
### Stair Rails and Treads

Material: Cast Iron and Steel  
Condition: Good  
Significance: Primary

Two-inch gas pipes make up the railing for this stair. The treads are cast iron and the supporting structure is made of steel.

#### Recommendations:

- Retain in place
- Metal replacement treads may remain in place
- Broken treads should be repaired or replaced

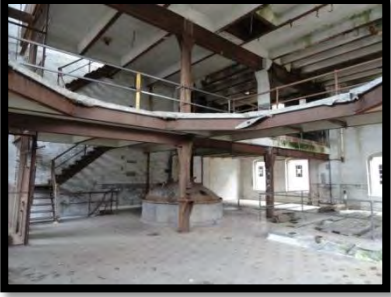
<p><b>Absences: Mash tub</b></p>

<p>The hole that once surrounded the mash tub is still distinguished by its support structure.</p> <p>Recommendations:</p> <ul style="list-style-type: none"> <li>• If it's necessary to fill holes in floors and ceilings, the visible structure that supported these openings should remain visible. New construction should be distinguished from historic material.</li> </ul>
<p><b>Finishes: Floor</b></p>

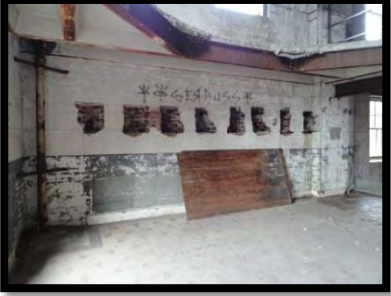
<p><b>Finishes : Wall</b></p>

<p>Material: Plaster and Paint Condition: Fair Significance: Secondary</p> <p>Interior spaces were generally plastered and painted.</p> <p>Recommendation:</p> <ul style="list-style-type: none"> <li>• Repair plaster where necessary</li> <li>• Test paint for lead</li> <li>• Consider restoring the original design</li> </ul>

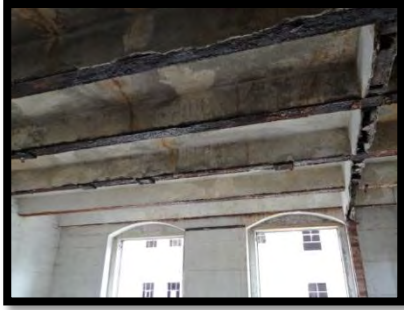
## Finishes: Ceiling

Material: Steel  
Condition: Fair to Poor  
Significance: Secondary

All structural materials were left visible in the design of the Brewhouse, but they were coated and painted white.

- Historically painted materials should be repaired and repainted

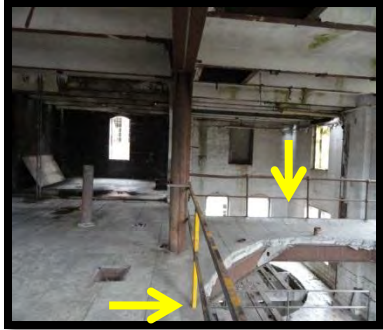
### Structure: Interior Volumes

The two primary holes in the floor are pictures to the left. The mezzanine, indicated by the downward facing arrow, surrounded the kettle. The opening indicated by the right facing arrow supported the mash tub.

The mezzanine provided views to the floor and the kettle below, while the hole for the mash tub was filled by the tank's mass.

- The mezzanine should be retained if possible, as it was intended to provide a view of the works below, but the mash tub surround may be filled, as long as the new material is distinguishable as new construction.

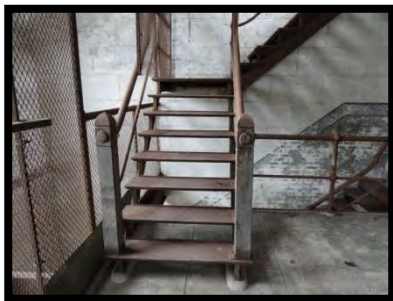
### Structure: Traffic and Conveyance

As on other floors, the stair and platform elevator are in place, while all evidence of the bucket elevator has been removed.

As on the second floor, there is no access from this floor to the grain storage room on the other side of the eastern wall.

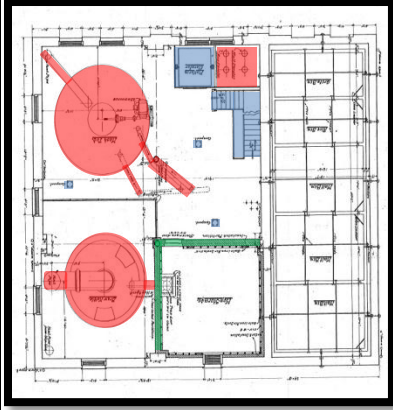
## Remaining and Missing Elements

Traditional methods of conveyance that are still in place are highlighted in blue. These include the platform elevator and stair. Missing elements, including the bucket elevator, are marked in red. Other missing elements highlighted in red include the mash tub and the brewing kettle. The green lines indicate walls that once defined a storage room for hops that are now missing.

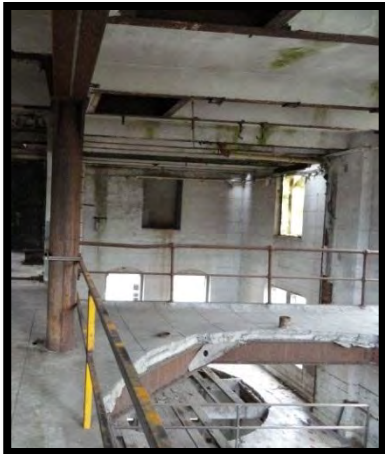
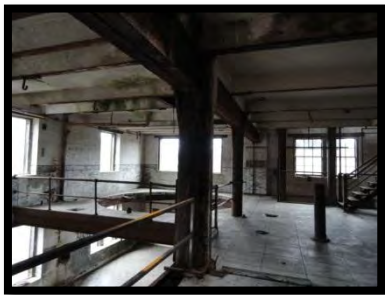
## Structure: Columns and Beams

Materials: Iron and Steel  
Condition: Should be tested  
Significance: Secondary

The third floor includes visible structural columns and beams as well as railings that now block off the mezzanine and the location of the mash tub. The columns are currently unpainted.

- Columns throughout the building should be investigated by structural engineers
- Columns should be retained in place
- Those surfaces that were historically unpainted should remain unpainted

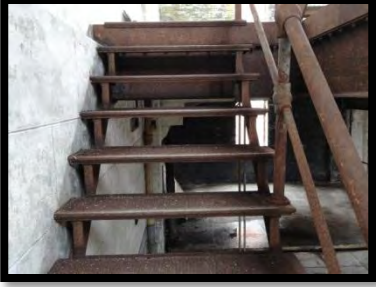
<p><b>Stair</b></p>

<p>Material: Iron and Steel  Condition: Good  Significance: Primary</p> <p>The stair that rises consistently from the first through sixth floors includes nearly all of its original materials: two inch gas pipe railings, steal supports and iron treads.</p> <p>Recommendations:</p> <ul style="list-style-type: none"> <li>• Repair and retain in place</li> </ul>
<p><b>Mezzanine</b></p>

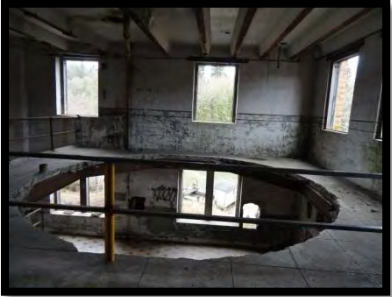
<p><b>Absences: Mash tub</b></p>

<p>Material: Steel surround  Significance: Minimal</p> <p>The steel frame supporting this opening helped hold the mash tub in place. With the mash tub missing, the hole itself is not of primary importance.</p> <p>Recommendation:</p> <ul style="list-style-type: none"> <li>• If filling this absence is necessary, consider marking the original absence to distinguish new materials from historic materials</li> <li>• Retain sections of the railing and preserve removed sections for use elsewhere</li> </ul>

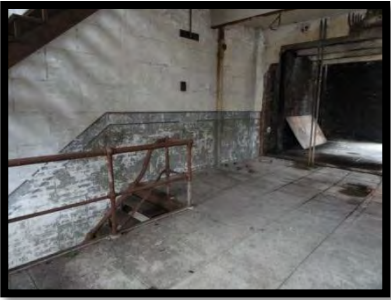
<p>Materials: Plaster and Paint  Condition: Fair  Significance: Secondary</p> <p>The white wall includes remnants of the green and blue paint that marked the historic traffic patterns and ran along the perimeters of rooms.</p> <p>Recommendations:</p> <ul style="list-style-type: none"> <li>• Test paint for lead</li> <li>• Retain in place, if possible</li> <li>• Repaint surfaces that were historically painted</li> </ul>
<p><b>Finishes: Ceiling</b></p>

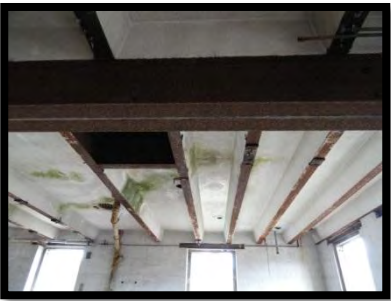
<p>Materials: Steel  Condition: Fair to Good  Significance: Secondary</p> <p>The steel beams supporting the ceiling, and the weight above it, were left visible, though they were painted white.</p> <p>Recommendations:</p> <ul style="list-style-type: none"> <li>• Supports should be investigated by a structural engineer</li> <li>• If possible, beams should be left visible and historic treatment, which includes white paint, should be restored</li> </ul>

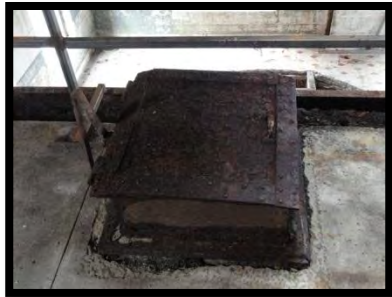
### Additional Elements: Trap Door

Materials: Iron  
Condition: Poor  
Significance: Primary

This trap door was used to deliver hops from the insulated room in which it was placed to the kettle below, which would have been visible through the mezzanine at the top of the photo, left.

- Repair and retain in place as an artifact of the building's former use
