# Historic Structures Report

## Olympia Brewery

Prepared by Chrisanne Beckner  
In Association with Artifacts Consulting, Inc.  
On Behalf of Old Brewhouse, LLC  
April 2011

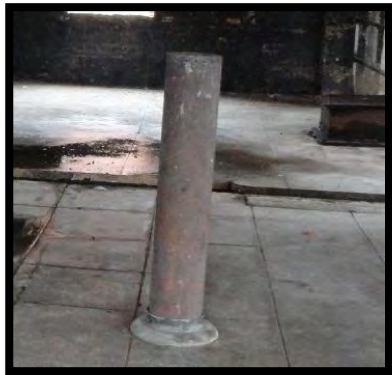
### Additional Elements: Pipe

Material: Metal  
Condition: Good  
Significance: Secondary

This was a vent pipe for the rice cooker below, though only a portion of it remains.

- Retain in place, if possible

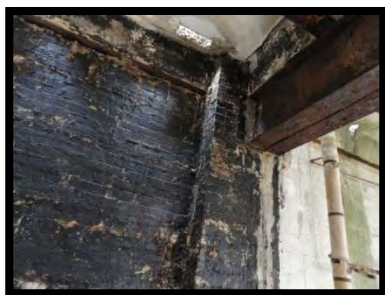
### Additional Elements: Wall Insulation

Materials: Cork and glue  
Condition: Poor  
Significance: Secondary

Cork was used to insulate the hop storage room in the southeastern corner of the main volume. Though the finish has been removed, some remnants of cork remain, as does the residue from the glue that held the insulation in place.

- Though the cork insulation was the historic treatment, it does not need to be reinstalled and the glue does not have the same significance and can be removed or covered in place.

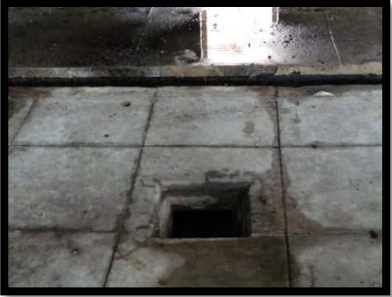
<p><b>Additional Elements: Cesspools</b></p>

<p>Material: Metal Condition: Good Significance: Secondary</p> <p>The brewery employed a series of drains, defined as “cesspools” on plans, to handle waste. The recessed openings remain.</p> <p>Recommendations:</p> <ul style="list-style-type: none"> <li>• Retain in place as artifacts of the building’s history as a working brewery</li> <li>• There are two to three cesspools per floor and it may be practical to retain good examples rather than all examples</li> </ul>
<p><b>Additional Elements: Remaining Machinery</b></p>

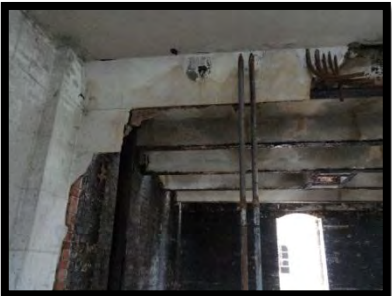
<p>Materials: Metal Condition: Fair Significance: Secondary</p> <p>Pipes ran from one floor to the next throughout the Brewhouse, delivering power, water and raw materials. The remnants are artifacts of the building’s history as a working brewery.</p> <p>Recommendations:</p> <ul style="list-style-type: none"> <li>• If possible, retain in place as artifacts</li> </ul>

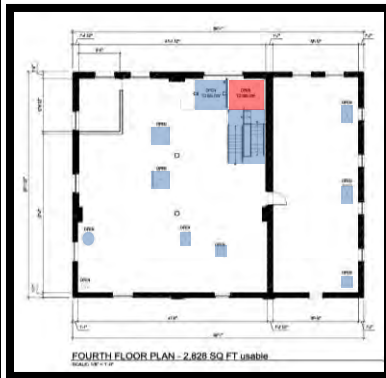
### Remaining and Missing Elements

A fourth floor as-built plan developed by Urbanadd Architects and Ryan Rhodes Design shows a contemporary view of the fourth floor. In the plan at left, missing elements are marked in red, including the bucket elevator. The two hoppers, which were located in the center of the main volume, are also missing, but the openings for a series of chutes, along with cesspools and pipe openings, remain.

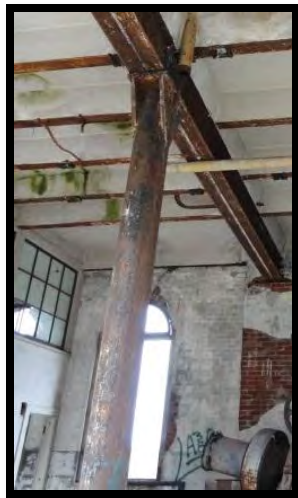
### Structural: Columns and Beams

Materials: Metal  
Condition: Should be tested  
Significance: Primary

The fourth floor includes visible structural columns and a visible structural system of steel beams.

- Columns throughout the building should be investigated by structural engineers
- Columns should be retained in place

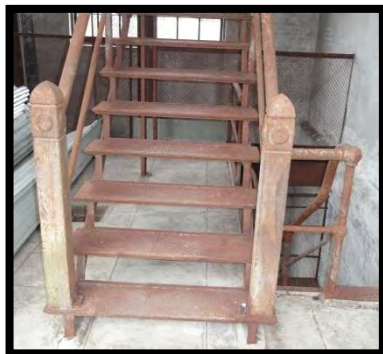
### Stair

Material: Cast Iron and Steel  
Condition: Good  
Significance: Primary

The stair that rises throughout the building is of great significance and is in fair to good condition throughout. Two-inch gas pipes make up the railing for this stair. The treads and newel posts are cast iron and the supporting structure is made of steel. The fourth floor retains good examples of the stair's elegant newel posts.

- Retain in place

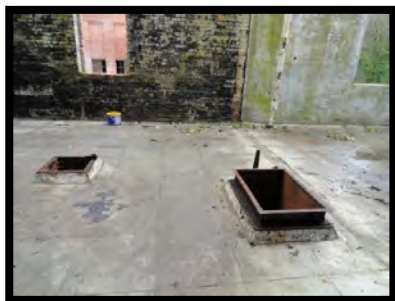
### Absences: Hoppers

Materials: Metal  
Condition: Good  
Significance: Secondary

A pair of chutes was once used to deliver raw materials from hoppers on the fourth floor into the mash tub on the third floor. The hoppers themselves are missing, but their location is marked by the remaining openings.

- Retain in place, if possible

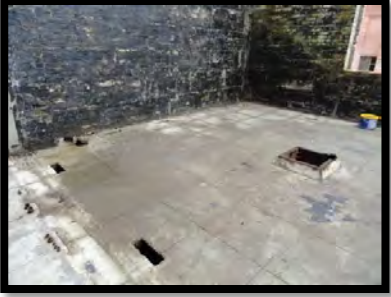
<p><b>Finishes: Floor</b></p>

<p>Materials: Concrete  Condition: Good  Significance: Primary</p> <p>The upper floors are laid with scored concrete. The edges of cesspool drains are molded.</p> <p>Recommendations:</p> <ul style="list-style-type: none"> <li>• Consider retaining the concrete surface as is as it contributes to the industrial character of the space</li> </ul>
<p><b>Finishes: Wall</b></p>

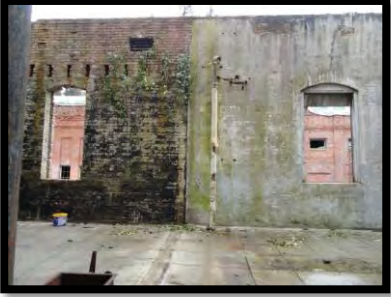
<p>Material: Plaster and Paint  Condition: Poor  Significance: Secondary</p> <p>Though the walls on this floor were originally plastered and painted, the wall finishes have been damaged by lack of protection from the weather. There was also a hot water tank on this floor and the black glue that would have held cork insulation to the wall behind it remains visible, as in photo left. The floor above the grain storage room was also plastered and painted though the finish has been almost entirely stripped away in places by weather.</p> <p>Recommendations:</p> <ul style="list-style-type: none"> <li>• Test paint for lead</li> <li>• Replaster and paint surfaces that were historically plastered and painted, as these surfaces were</li> </ul>

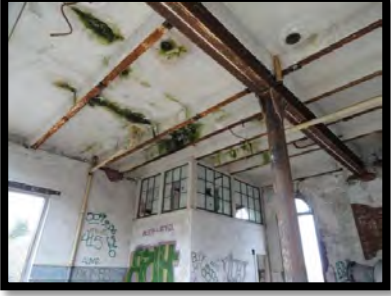
<p><b>Finishes: Ceiling</b></p>

<p>Material: Paint  Condition: Poor  Significance: Secondary</p> <p>The supports, though visible, have been painted white in the past.</p> <p>Recommendations:</p> <ul style="list-style-type: none"> <li>• Test paint for lead</li> <li>• Repaint surfaces that were originally painted</li> </ul>

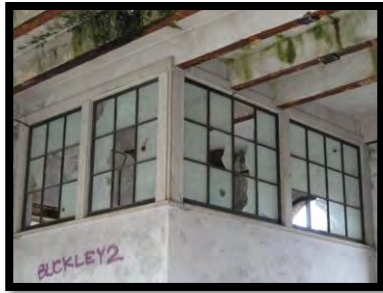
**Additional Elements: Pump Room**

Materials: Various  
Condition: Fair  
Significance: Primary

The room with clerestory windows is unique to this floor. Its windows, while in need of repair, contain fixed wood frames with true divided lights. This room held the pump station on stanchions, which remain in place, and are pictured left.

- Retain windows and reglaze where necessary with frosted glass
- Retain walls in place
- Retain or relocate stanchions

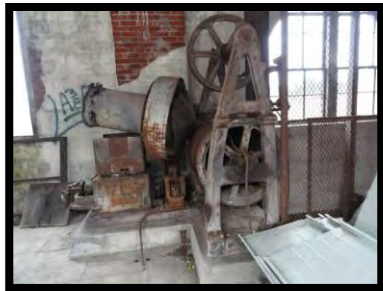
**Additional Elements: Elevator Motor**

Materials: Metals  
Condition: Unknown  
Significance: Primary

The machinery bolted to a pad on the fourth floor drove the elevator system. A vent and other machinery have been piled on top of it.

- If the lift is to remain operable, retain machinery in place
- Vent may be removed and used elsewhere
- If lift will not be operable, machinery should be left in place or relocated

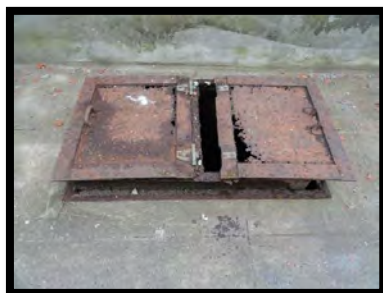
**Additional Elements: Trapdoor**

Material: Iron  
Condition: Poor  
Significance: Primary

Three trapdoors embedded in the floor above the grain storage room were probably used for distributing materials, including bales of hops or other raw grain for brewing.

- Retain in place or relocate for use elsewhere

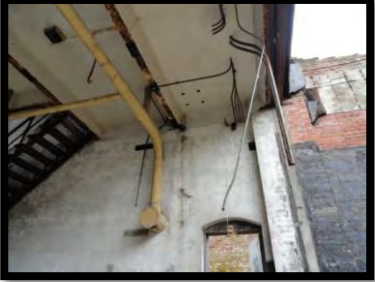
<p><b>Additional Elements: Systems</b></p>

<p>Materials: Metals Condition: Varied Significance: Secondary</p> <p>Electrical connectors, pipes and other mechanical remnants still hang from ceilings and are bolted to walls.</p> <p>Recommendations:</p> <ul style="list-style-type: none"> <li>Retain in place as artifacts of the building's former use</li> </ul>
<p><b>Additional Elements: Metal Door</b></p>

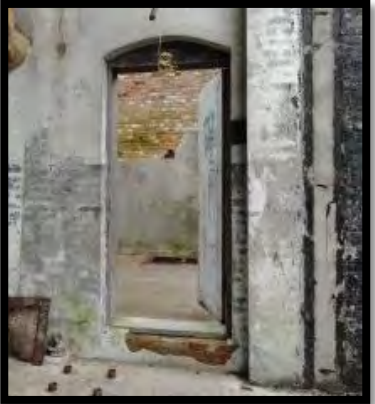
<p>Material: Metal Condition: Fair Significance: Primary</p> <p>This metal door was part of the fire-proofing enhancements made to the grain storage room. It closed the eastern block of the building off from the main body of the brewery. Like the windows, this door is made of fire resistant material. It has a metal paneled lintel in the arch.</p> <p>Recommendations:</p> <ul style="list-style-type: none"> <li>Repair and retain in place</li> </ul>
<p><b>Additional Elements: Systems</b></p>

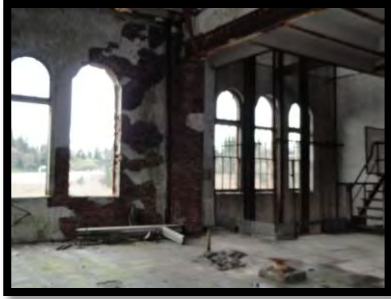
Significance: Secondary

Unlike lower floors, the fifth floor includes no openings in the floor or ceiling, leaving the room complete and whole, dominated by windows on one façade, by a central space once devoted to machinery, and by the terminating floor of the western volume. From the fifth floor, only the tower achieves yet another floor.

- Retain openness of original floor plan

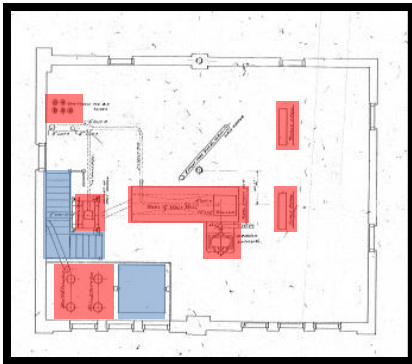
The fifth floor relied on the stair, bucket elevator and lift in the northeast corner of the main volume. Those features that remain, including the stair and lift, are marked in blue. Missing elements, including the bucket elevators, the mill and scales are marked in red.

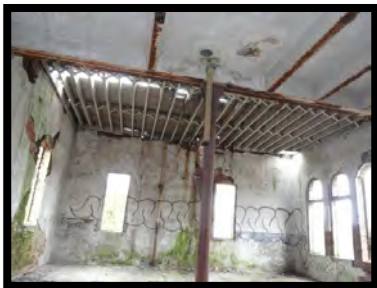
Material: Steel

Condition: Should be tested

- Columns throughout the building should be investigated by structural engineers
- Columns should be retained in place

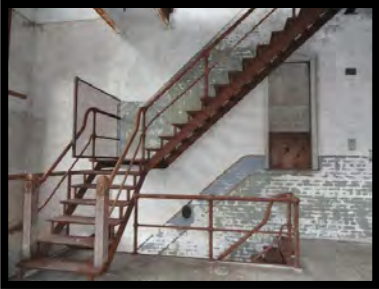
<p>Material: Cast Iron and Steel  Condition: Good  Significance: Primary</p> <p>The Brewhouse stair continues on the fifth floor, retaining the two-inch gas pipes, treads and newel posts that characterize this feature on other floors.</p> <p>Recommendations:</p> <ul style="list-style-type: none"> <li>• Retain in place</li> </ul>
<p><b>Finishes: Floor</b></p>

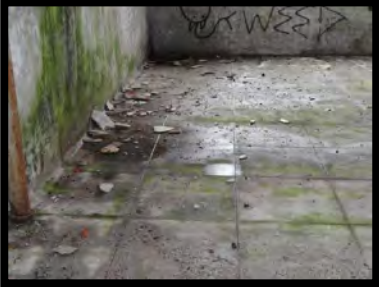
<p>Materials: Concrete  Condition: Good  Significance: Secondary</p> <p>The upper floors are laid with scored concrete.</p> <p>Recommendations:</p> <ul style="list-style-type: none"> <li>• Consider retaining the concrete as is</li> </ul>
<p><b>Finishes: Wall</b></p>

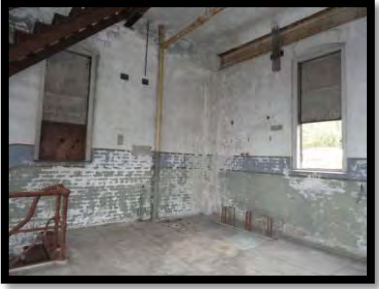
<p>Materials: Plaster and paint  Condition: Fair  Significance: Secondary</p> <p>The walls of the fifth floor are better protected than those that have lost roof coverage. The remnants of blue and green paint are more visible here and could provide a model for restoration.</p> <p>Recommendations:</p> <ul style="list-style-type: none"> <li>• Test paint for lead</li> <li>• Retain in place</li> <li>• Surfaces that were historically plastered and painted should be repaired and repainted.</li> </ul>

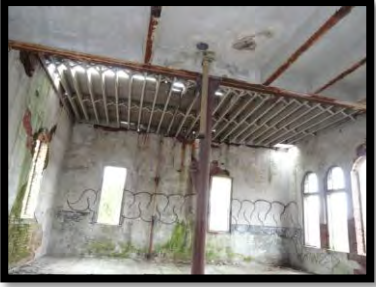
<p>Material: Paint  Condition: Fair  Significance: Secondary</p> <p>The supports, though left visible, were painted white.</p> <p>Recommendations:</p> <ul style="list-style-type: none"> <li>• Test paint for lead</li> <li>• Restore finish</li> </ul>
<p><b>Secondary Ceiling</b></p>

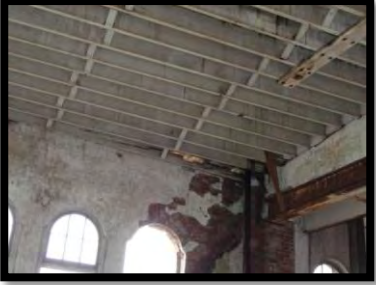
<p>Material: Wood  Condition: Good  Significance: Primary</p> <p>This is the only remaining portion of a secondary roof in the Brewhouse, and it provides a model for how the roofs were constructed. Rafters and cross-bracing can be replicated under other secondary roofs.</p> <p>Recommendation:</p> <ul style="list-style-type: none"> <li>• Retain in place</li> <li>• Potentially use as a model for rehabilitating lost roofs</li> </ul>
<p><b>Additional Elements: Pads</b></p>

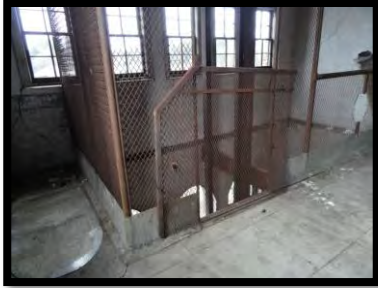
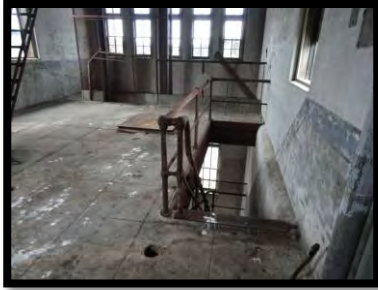
Significance: Secondary

The sixth floor includes one main volume, with stairs and lift in the northeast corner, a bank of arcaded windows, and a narrow stair to a platform that looks over machinery housed just under the copper roof, as shown below.

- This floor is small enough that its open volume should be maintained

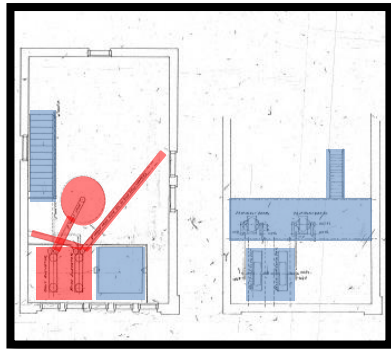
The plan at left shows both the main volume and the platform, approached by a second stair. The elements that are still in place, including the platform, the machinery, the stair and lift, are highlighted in blue. Missing elements, including the bucket elevator and pipes that routed materials to various hoppers and mills, are marked in red.

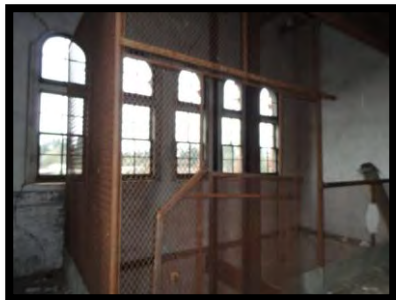
Materials: Metal Mesh

Condition: Good

The platform elevator cage on the sixth floor is in place and in good condition. There is some corrosion and rust, but the cage is intact.

- If possible, retain lift in place and restore historic fabric
- If the elevator is to be removed, retain opening for any added conveyance, and relocate material for use in another location within the building

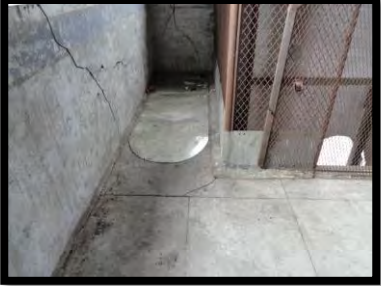
<p>Material: Concrete and metal patch  Condition: Fair  Significance: Secondary</p> <p>This floor is finished in gridded concrete, similarly to other top floors. However, a portion of the floor next to the platform elevator is covered in a thin sheet of metal, possibly as a patch for former damage or an unsafe opening.</p> <p>Recommendations:</p> <ul style="list-style-type: none"> <li>• Repair concrete and retain in place</li> <li>• Investigate the patch and repair any hidden damage</li> </ul>
<p><b>Finishes: Wall</b></p>

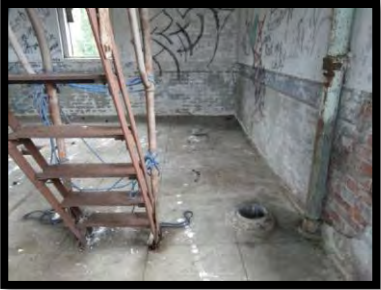
<p>Materials: Plaster and Paint  Condition: Fair  Significance: Secondary</p> <p>The colors and patterns are most visible on the sixth floor, but there are also portions of exposed brick. There are also significant cracks that should be investigated before the wall is refinished.</p> <p>Recommendations:</p> <ul style="list-style-type: none"> <li>• Test paint for lead</li> <li>• Patch and repaint or leave in place, but do not expose remaining brick</li> </ul>

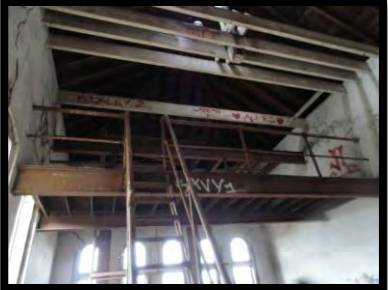
<p>Materials: Wood Rafters  Condition: Good  Significance: Primary</p> <p>The copper tower sits on wooden rafters. Wood is unpainted.</p> <p>Recommendations:</p> <ul style="list-style-type: none"> <li>• Retain in place</li> <li>• Retain flagpole</li> </ul>

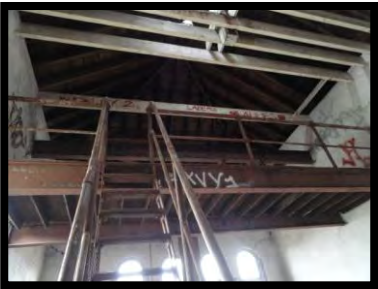
<p>Materials: Metal Condition: Good Significance: Primary</p> <p>As a unique feature of the Brewhouse, this platform allows a view down through all six floors via the platform elevator and the location of the missing bucket elevator.</p> <p>Recommendations:</p> <ul style="list-style-type: none"> <li>• Retain in place</li> </ul>
<p><b>Additional Elements: Trapdoor</b></p>

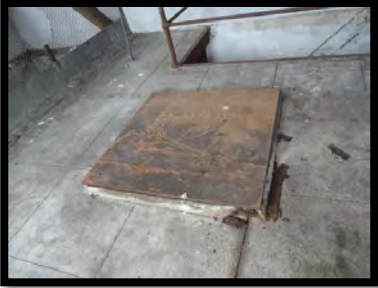
<p>Materials: Molded Concrete Surround Condition: Fair Significance: Secondary</p> <p>These openings in floors and ceilings were a means of conveyance. In this case, it's believed that the opening allowed for the raising of machinery that was placed in the upper reaches of the tower.</p> <p>Recommendation:</p> <ul style="list-style-type: none"> <li>• If possible, retain in place</li> </ul>
<p><b>Additional Elements: Piping</b></p>

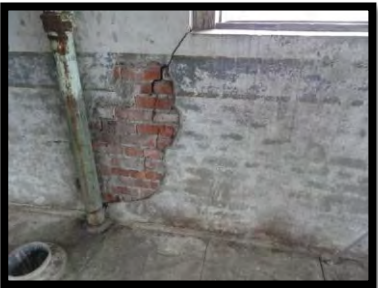
<p>Materials: Metal Condition: Good Significance: Secondary</p> <p>As on other floors, pipes and pipe holes remain in place, artifacts of the brewery's gravity system, which used these pipes as conveyances for grain and other raw materials.</p> <p>Recommendations:</p> <ul style="list-style-type: none"> <li>• Retain in place as artifacts of the building's historic use</li> </ul>

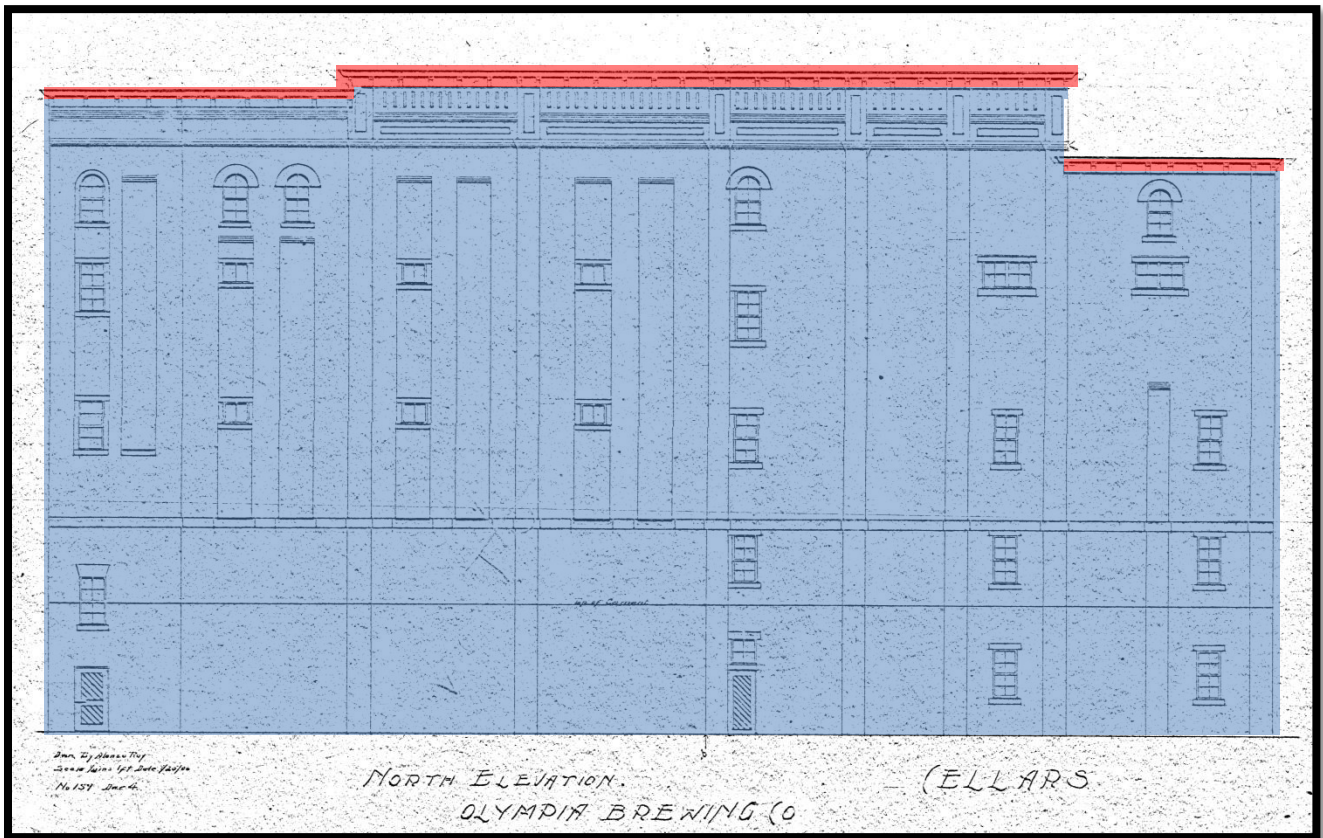
## Cellars Building: North Elevation

The fenestration on the north façade of the Cellars differs slightly from this historic drawing. Windows are larger and more numerous than appear here. It's not known whether the original plan was altered or if windows were filled and opened in later alterations. The most likely period of alteration would have occurred when drawings for the western façade were drawn up in 1945. Any changes that occurred during that period are now over 50 years old and have earned a degree of historic significance over time. The only exceptions are the cornices. The cornices have been removed very recently due to deterioration.

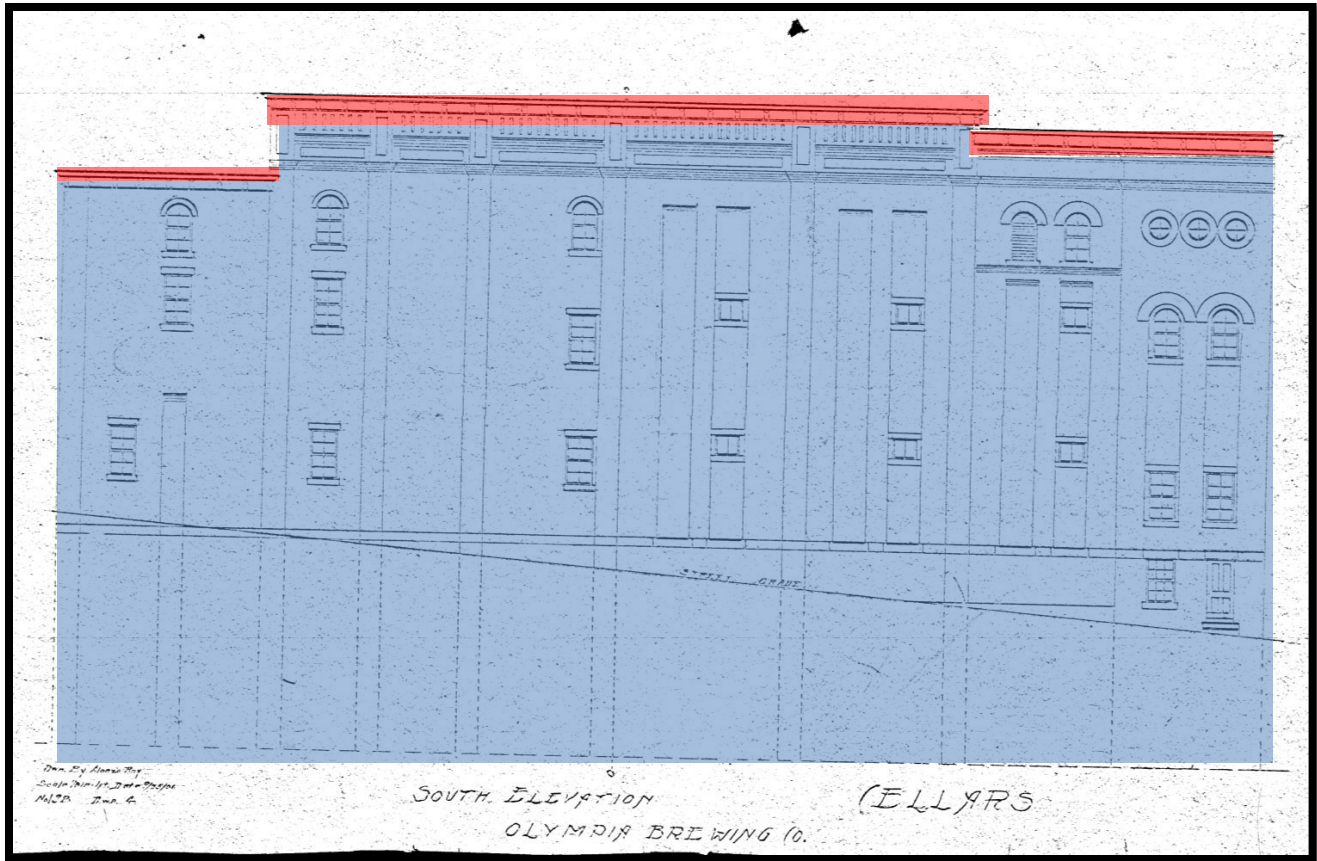
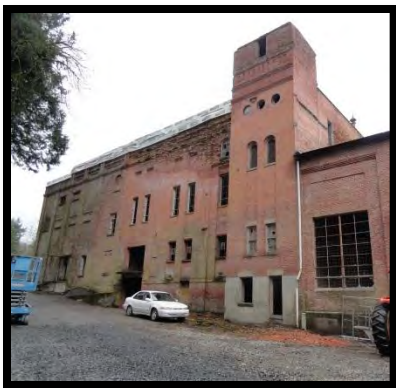
## Cellars Building: South Elevation

The south elevation is also slightly different from this original drawing. As on the north façade, windows are more numerous in the 1905 cellar than called for on drawings. There are fewer windows on the 1907 addition. Also, the elevator shaft, which here

appears to end at the fifth floor, continues above the roofline, as seen in the photo left. It's also clear from the photo that doors have been added to the south façade. It's unknown whether the building was constructed with these changes or whether they date from later alterations. The west elevation and the building's interior was altered in 1945.

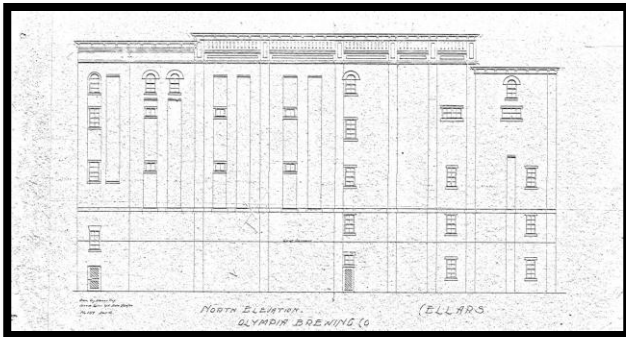
The historic elevation drawing differs slightly from the building's current design, especially on the western addition. Also, the building no longer includes the belt course that divides the lower, flat façade from the more ornamented façade above. This belt course may have been altered by an infill structure that has since been removed.

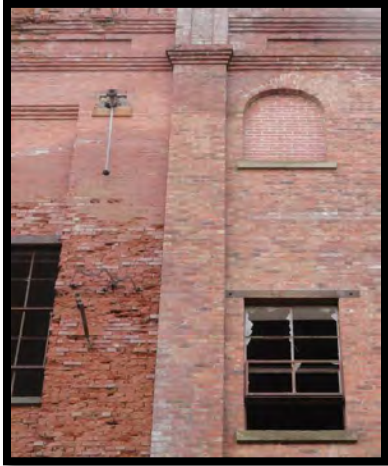
Materials: Chehalis Brick  
American Bond: 6 stretcher courses per header  
Approximate size: 8 ¼" x 2 ½" x 4"  
Condition: Variable  
Significance: Primary

The brick used on the Cellars building is in excellent shape in some places and has deteriorated in others. It matches the brick on the Brewhouse in color and size. Brick size varies.

- Original brick should be used for repair when possible
- Replacement brick should be of similar size, color and texture
- Repoint with hand tools to maintain joint profile
- All brick ornament, including pilaster, corbelling at the cornice, projections and recessions should be retained
- If material is to be removed to create openings, concentrate on bricked in panels

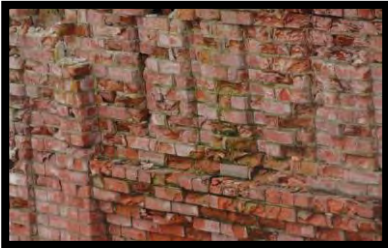
Materials: Unknown composition  
Condition: Variable  
Joint: Flush, half inch  
Significance: Primary

The mortar is most deteriorated where historic cornices have been removed. New mortar should match the requirements identified by the National Park Service in Preservation Brief 2:

- Historic mortar should be tested to determine quantities of lime, sand and Portland cement
- Repoint with mortar similar in composition, color, texture, joint size, method of application and joint profile
- Choose a mason familiar with historic brick buildings who is willing to hand tool joints before repointing

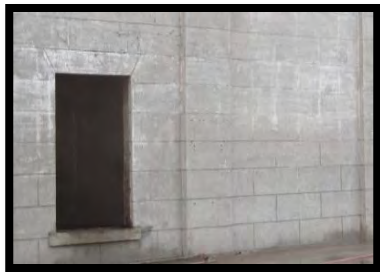
Materials: Cement, aggregate, cinders

Condition: Good

Cinder block is called out on plans and is used on the north and west facades. It appears to be in good condition.

- Leave in place
- Clean by the gentlest means possible
- If repair is needed, test mortar and match its composition, color, texture, joint size, method of application and joint profile

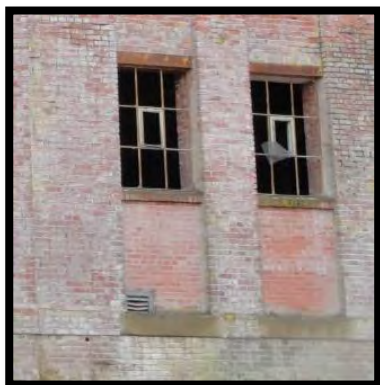
Materials: Tenino Sandstone

Condition: Good

- Retain all historic sandstone details
- If repair is needed, test mortar and match its composition, color, texture, joint size, method of application and joint profile
- Replacement sandstone may be available from quarries recently reopened in Tenino

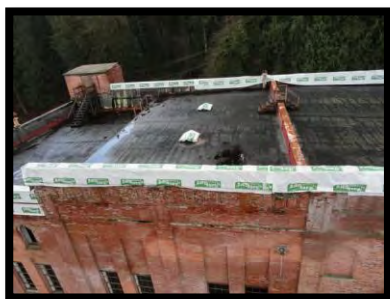
Materials: Composition Roof with Flashing

Conditions: Fair to Poor

The Cellar roof includes a number of historic features, including wood stairs, seen left, and access to the elevator tower. Flashing is called out on plans as galvanized iron. Though the roof looks sound, water infiltration is a problem on upper floors and roof repair is a priority.

- Repair and retain or replace in kind
- Retain all additional features, including stairs and flashing, if possible

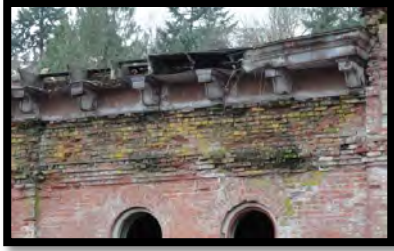
## Cornice and Brackets

Materials: Galvanized iron

Condition: Missing

The cornices were recently removed based on their deteriorated condition. However, they were one of the design features that tied together buildings of the Brewhouse era.

- If possible, the removed cornices should be repaired and reused
- All new construction must be recognizably new. However, the roof emphasis was central to the original design and cornices should be incorporated into restoration plans

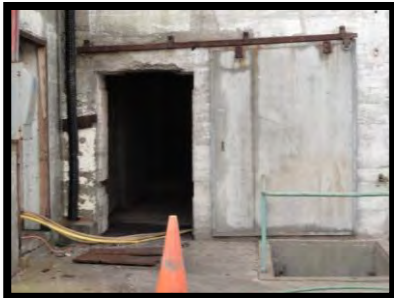
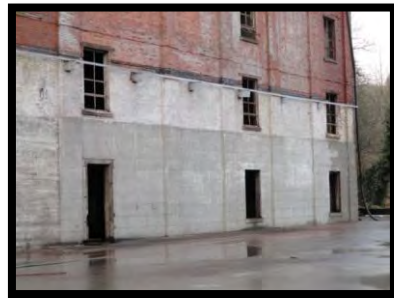
## First Floor Doors

Materials: Metal/Missing

Condition: Good/Missing

The second opening on the first floor, pictured below left, is missing entirely, along with its casing, but the opening remains.

- Retain doors in place or replace with historically appropriate materials
- Where replacements doors are needed, original historic plans can provide models

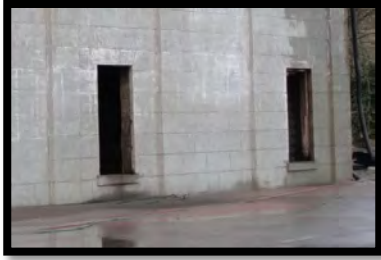
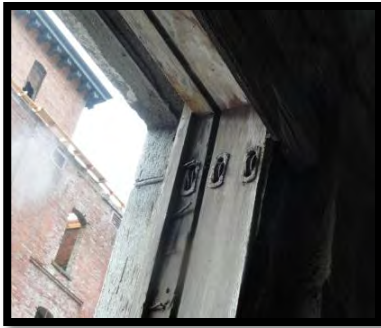
## First Floor Windows

Materials: Wood Casings

Condition: Missing

- Replacement windows should match the existing fenestration, materials, design and function. Replacement windows should be operable when the originals were operable and should include true divided lights
- Original windows should match the original pivoting sashes
- Retain sills and lintels, when in place

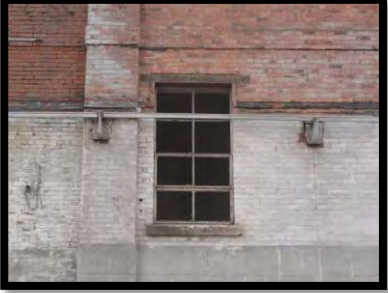
<p><b>Additional Elements: Paint</b></p>

<p>Materials: Paint  Condition: Good  Significance: Secondary</p> <p>Remnants of white paint on the brick correspond to the portions of the façade that were once covered by an infill structure that's since been removed.</p> <p>Recommendations:</p> <ul style="list-style-type: none"> <li>• Retain or remove by the gentlest means possible</li> </ul>
<p><b>Additional Elements: Flashing and Supports</b></p>

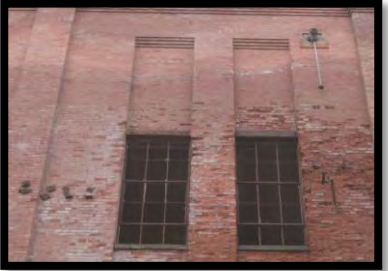
<p>Materials: Various  Condition: Good  Significance: Primary</p> <p>The pipe fittings, ties and other connectors that continue to project from the building are artifacts of the buildings' original uses and help communicate the industrial character of the buildings.</p> <p>Recommendations:</p> <ul style="list-style-type: none"> <li>• Retain in place</li> </ul>

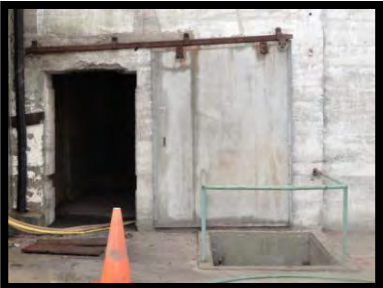
<p><b>Additional Elements: Sliding Door</b></p>

<p>Materials: Iron and Wood  Condition: good  Significance: Secondary</p> <p>The sliding door appears to be historic but its date of installation is unknown. It does not resemble original plans, and the opening has received some alteration that suggests a different door was once installed.</p> <p>Recommendations:</p> <ul style="list-style-type: none"> <li>• Retain in place or replace</li> <li>• Retain and repair opening</li> </ul>
<p><b>Additional Elements: Roof Finials</b></p>

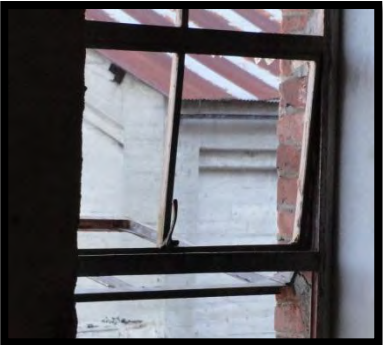
<p>Materials: Metal  Condition: Various  Significance: Primary</p> <p>Window hardware is integral to the historic character of the window system.</p> <p>Recommendations:</p> <ul style="list-style-type: none"> <li>• Retain historic hardware where possible</li> </ul>

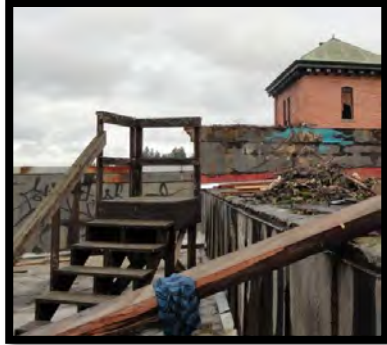
### Additional Elements: Roof Stairs

Materials: Wood  
Condition: Good  
Significance: Secondary

The roof of the Cellar building is accessible and includes four sets of wooden stairs that provide access to each section of the roof.

- Retain in place where useful

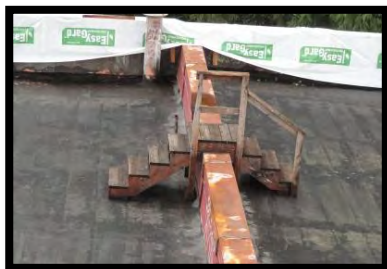
### Additional Elements: Roof Flashing

Materials: Iron  
Condition: Unknown  
Significance: Primary

Called out in plans: "entire wall to be flashed down to roof with gal. iron."

- Retain in place if in good condition

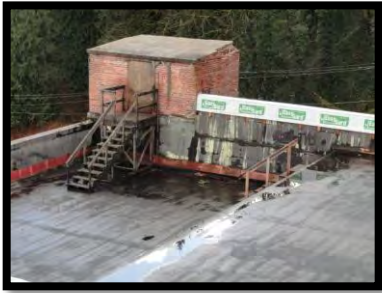
## Additional Elements: Tower

Materials: Various  
Condition: Good  
Significance: Primary

Access to the elevator tower is gained through a roof stair

- Retain in place

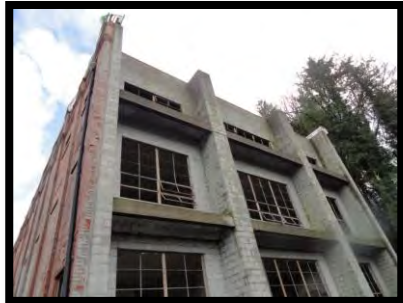
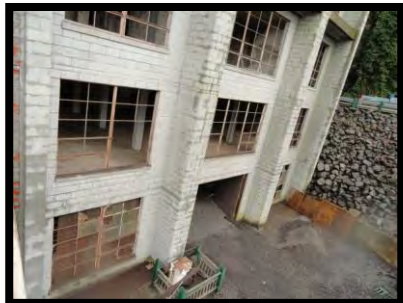
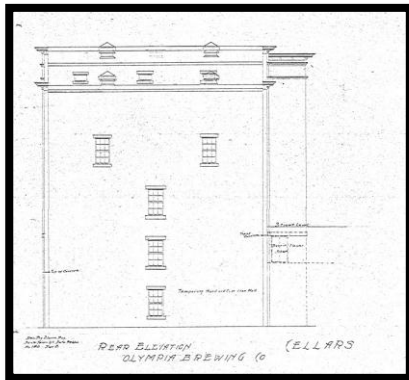
# West Elevation

The west elevation, called the “rear” elevation in the historic drawing shown below, is the building’s least visible and most altered facade. As seen in the photo left, cinder block columns dividing three banks of large windows have replaced a brick wall with relatively small windows and a well-defined cornice.

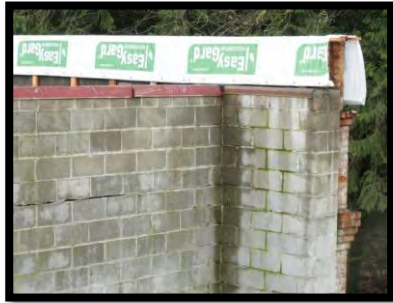
## Concrete Block

Materials: Cement  
Condition: Good  
Approximate size: 32 x 15"  
Significance: Secondary

This façade is not original to the building but has gained historic significance of its own.

- Retain in place

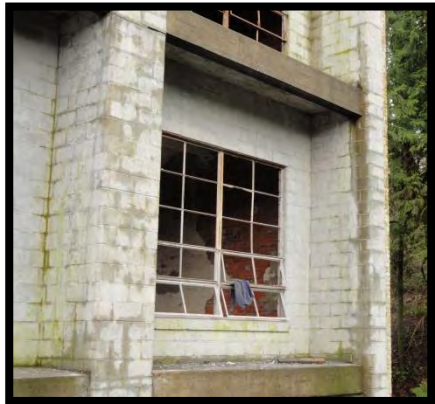
## Mortar

Materials: Unknown composition  
Condition: Good  
Joint: Flush  
Significance: Secondary

- Historic mortar should be tested to determine quantities of lime, sand and Portland cement
- Repoint with mortar similar in composition, color, texture, joint size, method of application and joint profile
- Choose a mason who's familiar with historic brick buildings and is willing to hand tool the joints before repointing

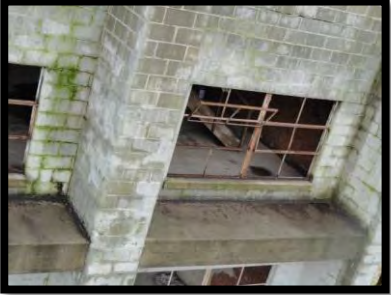
<p><b>Ornamental Concrete Work</b></p>

<p>Materials: Cement  Condition: Good  Significance: Secondary</p> <p>Massive, board-formed aprons appear between the third and fourth floors, and between the fourth and fifth floors. They are a primary feature of the design.</p> <p>Recommendations:</p> <ul style="list-style-type: none"> <li>• Retain in place</li> </ul>
<p><b>Doors</b></p>

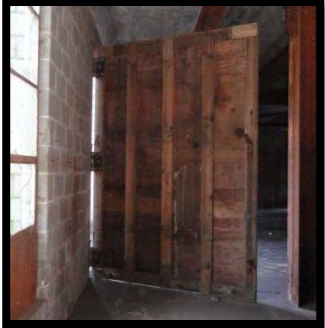
<p>Materials: Wood  Condition: Good  Significance: Secondary</p> <p>Paired wood doors with historic hardware take up the central bay of the western elevation. Their age is unknown.</p> <p>Recommendation:</p> <ul style="list-style-type: none"> <li>• Retain in place</li> </ul>
<p><b>First Floor Window</b></p>

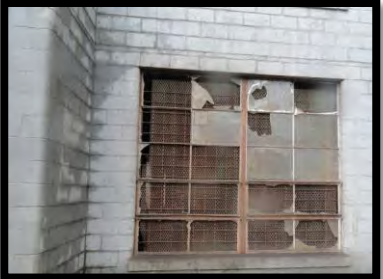
<p>Materials: Steel  Condition: Fair to Good  Significance: Primary</p> <p>Though these windows were part of the redesign of the western façade, they are similar to industrial windows on the north elevation. These paired windows of ten lights a piece are called out as “standard steel commercial projected windows No. A3416: w/ wire glass.”</p> <p>Recommendations:</p> <ul style="list-style-type: none"> <li>• Retain and repair frames when possible; reglaze, maintaining historic industrial fireproofing</li> <li>• Replacement windows, when needed due to sever corrosion, should match the original fenestration, original materials, design and function</li> <li>• Retain sills</li> </ul>

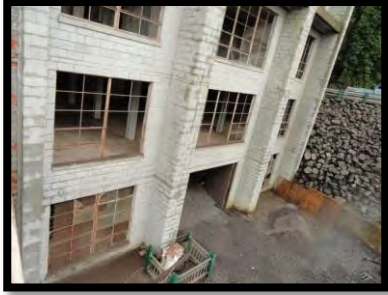
### Second Floor Window

Materials: Steel  
Condition: Fair to Good  
Significance: Primary

Though these windows were part of the redesign of the western façade, they are similar to industrial windows on the north elevation. These windows are called out as “standard steel architectural projected windows #235 w/D.S.GL.” Outer bays include paired windows; central bay includes three windows.

- Retain and repair frames when possible; reglaze
- Replacement windows, when needed due to sever corrosion, should match the original fenestration, original materials, design and function.
- Retain sills

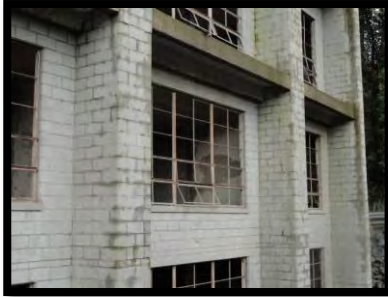
### Third Floor Window

Materials: Steel  
Condition: Fair to Good  
Significance: Primary

Though these windows were part of the redesign of the western façade, they are similar to industrial windows on the north elevation. These windows are called out as “standard steel architectural projected windows #235 w/D.S.GL.” Outer bays include paired windows; central bay includes three windows.

- Retain and repair frames when possible; reglaze
- Replacement windows, when needed due to sever corrosion, should match the original fenestration, original materials, design and function.
- Retain sills

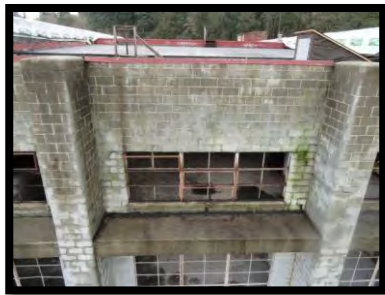
### Fifth Floor Window

Materials: Steel  
Condition: Fair to Good  
Significance: Primary

Though these windows were part of the redesign of the western façade, they are similar to industrial windows on the north elevation. These windows are called out as “No. A32 com. Proj. st. sash w/D.S. glass.” Outer bays include paired windows; central bay includes three windows.

- Retain and repair frames when possible; reglaze
- Replacement windows, when needed due to sever corrosion, should match the original fenestration, original materials, design and function.
- Retain sills

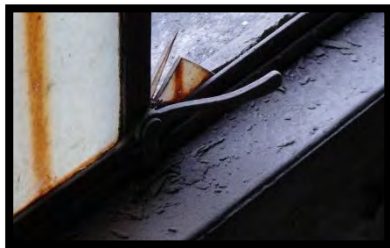
### Additional Elements: Window Hardware

Materials: Metal  
Condition: Various  
Significance: Primary

Window hardware is integral to the historic character of the window system.

- Retain historic hardware where possible

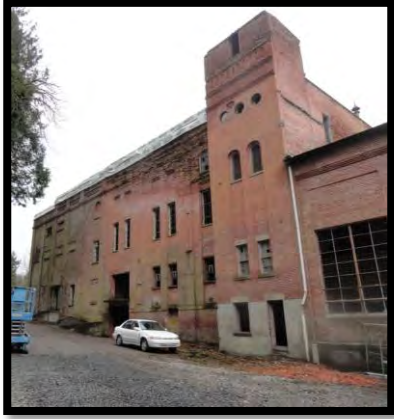
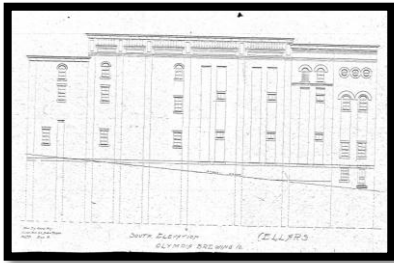
## South Elevation

As on the northern facade, the fenestration on the south differs from the original elevation drawing, shown below. Windows are larger and more numerous on the oldest section of the building, the 1905 original, and are smaller and less common on the 1907 addition. The elevator tower also extends past the top of the building to provide an upper section that's accessible from the roof.

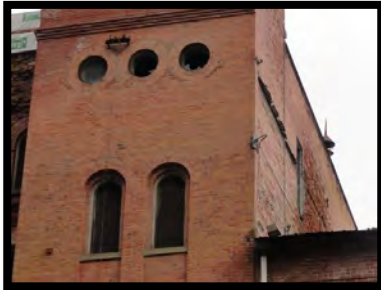
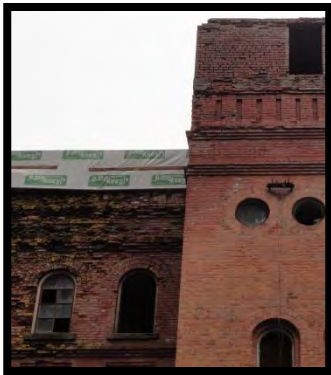
## Masonry: Red Brick

Materials: Chehalis Brick  
American Bond: 6 stretcher courses per header  
Approximate size: 8 ¼" x 2 ½" x 4"  
Condition: Variable  
Significance: Primary

The brick used on the Cellars building is in excellent shape in some places and has deteriorated in others. The worst condition is near the roofline where cornices have been removed. Brick matches the Brewhouse in color and size, which varies slightly.

- Original brick should be used for repair when possible
- Replacement brick should be of similar size, color and texture
- Repoint with hand tools to maintain joint profile
- All brick ornament, including pilasters, arches, corbelling at the cornice, projections and recessions should be retained
- If material is to be removed to create openings, concentrate on bricked in panels

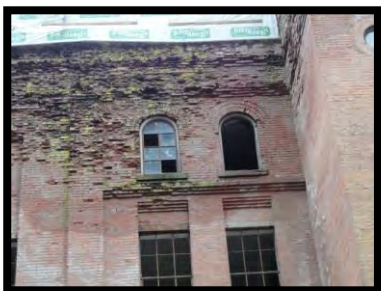
## Mortar

Materials: Unknown composition  
Condition: Variable  
Joint: Flush, half inch  
Significance: Primary

- Historic mortar should be tested to determine quantities of lime, sand and Portland cement
- Repoint with mortar similar in composition, color, texture, joint size, method of application and joint profile

<ul style="list-style-type: none"> <li>Choose a mason who's familiar with historic brick buildings and is willing to hand tool the joints before repointing</li> </ul>
<p><b>Masonry: Sandstone</b></p>

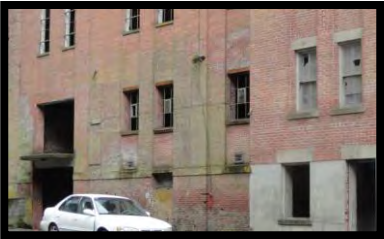
<p>Materials: Tenino Sandstone  Condition: Good  Significance: Primary</p> <p>Tenino sandstone sills are a design features that ties together buildings of the Brewhouse era.</p> <p>Recommendations:</p> <ul style="list-style-type: none"> <li>Retain all historic sandstone details</li> <li>If repair is needed, test mortar and match its composition, color, texture, joint size, method of application and joint profile</li> <li>Replacement sandstone may be available from quarries recently reopened in Tenino</li> </ul>
<p><b>Elevator Tower</b></p>

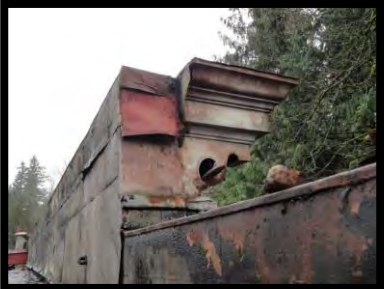
<p><b>Cornices and Brackets</b></p>

<p>Materials: Galvanized iron  Condition: Missing  Significance: Primary</p> <p>The cornices were recently removed based on their deteriorated condition. However, they were one of the design features that tied together buildings of the Brewhouse era.</p> <p>Recommendations:</p> <ul style="list-style-type: none"> <li>If possible, the removed cornices should be repaired and reused</li> <li>All new construction must be recognizably new. However, the roof emphasis was central to the original design and cornices should be incorporated into restoration plans</li> </ul>

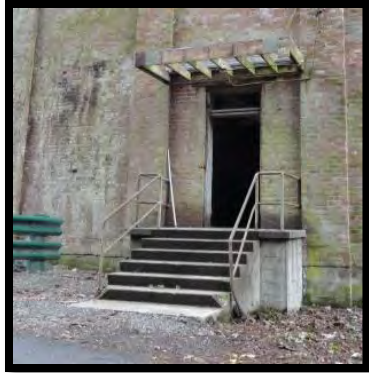
## Doors

Materials: Unknown  
Condition: Missing  
Significance: Secondary

All three doors have been removed. Historic photos do not show the design of the original doors but do show awnings and stairs on the southern façade's westerly door, as shown left. A set of plans include door details, shown below.

- Replace with wood or other historically appropriate material

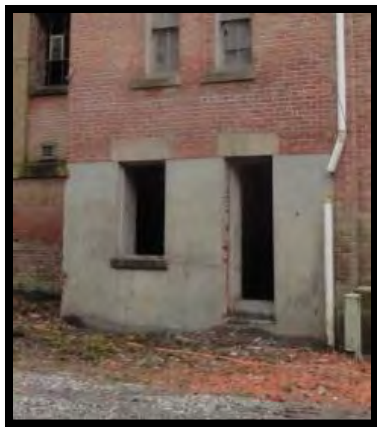
## Second Floor Windows

Materials: None  
Condition: Missing  
Significance: Primary

The grade changes drastically. No windows exist on the first floor and only one exists on the second floor next to the door on the elevator tower. Its casing is missing, as is the window. In the historic elevation drawing, this is a six-over-six sash window.

- Replace in kind using nearby industrial windows as models
- Retain sill and lintel

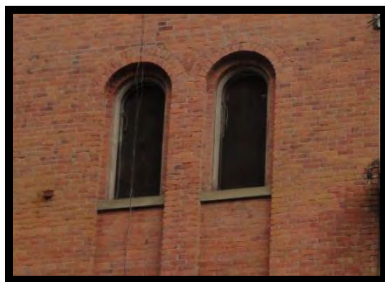
### Fourth Floor Windows

Materials: Steel  
Condition: Fair to Good  
Significance: Primary

Three types of windows are represented on the fourth floor. As on the north façade, three pairs of 15-light, triple-sash windows appear on the original warehouse. One window in the 1907 addition resembles the triple-sash, eight-light pivotal window found on lower floors. These early industrial windows are now rather rare and should be retained if at all possible. Replacement is a last resort. On the elevator tower, there's also a pair of arched windows. The windows themselves are missing but the casings remain, showing these were triple-sash windows as well.

- Retain and repair frames when possible; reglaze
- Replacement windows, when needed due to severe corrosion, should match the original fenestration, original materials, design and function.
- Retain sills and lintels
- Replacement windows for the arched openings should retain form, original materials and be operable

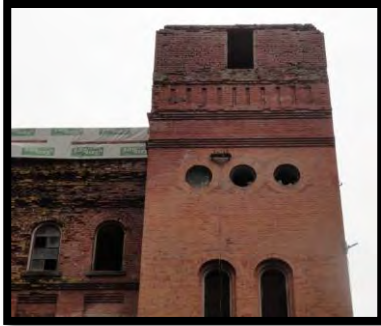
### Fifth Floor Windows

Materials: Unknown  
Condition: Missing  
Significance: Primary

Three window types are represented on the fifth floor. A pair of arched triple-sash windows exist in the 1905 Cellar. One retains only its casing. There's also a trio of round windows in the elevator tower. In the 1907 addition, a single small rectangular window retains its shutters.

- Retain and repair window casings and replace windows with operable sash windows.
- Retain arches, sills and shutters
- Retain the round windows featured in the tower

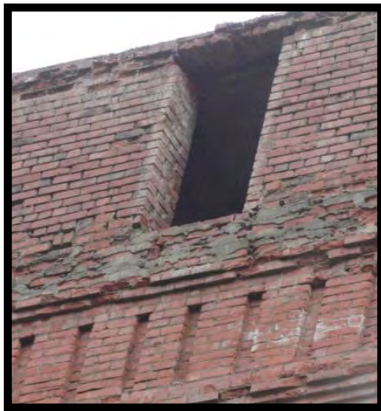
### Sixth Floor Window

Materials: Unknown  
Condition: Missing  
Significance: Primary

The opening at the top of the elevator shaft does not appear in historic plans or elevation drawings. No casing or window remains.

- Retain opening
- Replace in kind using nearby industrial windows as models

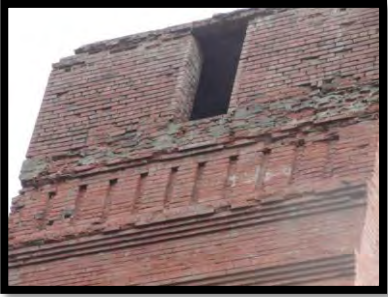
<p><b>Additional Elements: Ornamental Brickwork</b></p>

<p>Materials: Chehalis brick Condition: Fair to Good Significance: Primary</p> <p>Brick ornamentation, including corbelling, pilasters, segmental arches and recessed panels are central to this primary façade.</p> <p>Recommendations:</p> <ul style="list-style-type: none"> <li>• Retain and repair all brick ornament</li> </ul>
<p><b>Bricked-in Openings</b></p>

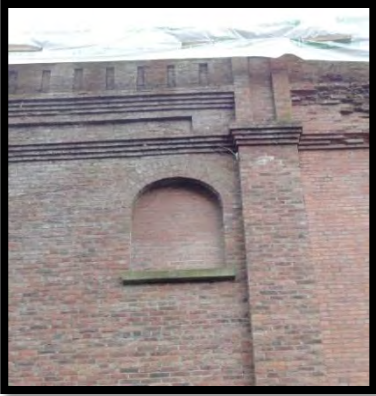
<p>Materials: Red Brick Condition: Good Significance: Primary</p> <p>A number of recessed openings have been filled with brick. Some windows retain sills and lintels and the newer brick panels include almost no header courses.</p> <p>Recommendations:</p> <ul style="list-style-type: none"> <li>• It's unknown when windows were bricked in. Either retain or reopen with new, operable windows of historically appropriate materials</li> </ul>
<p><b>Additional Elements: Elevator</b></p>

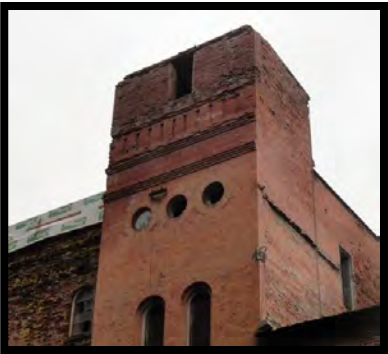
<p>Materials: Various Condition: Good Significance: Primary</p> <p>Though the elevator tower does not appear in the earliest elevation drawings, it does appear in plans and includes elements, including corbelling and arched windows, that tie it to the rest of the Brewhouse-era buildings.</p> <p>Recommendations:</p> <ul style="list-style-type: none"> <li>• Retain and reuse elevator shaft</li> <li>• Retain elongated form and roof access</li> </ul>

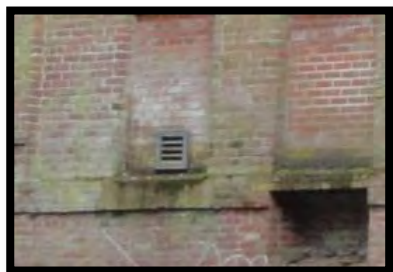
**Additional Elements: Vents**

Materials: Unknown  
Condition: Good  
Significance: Secondary

Vents visible in the exterior facades are artifacts of the building's early use.

- Retain in place or retain best examples

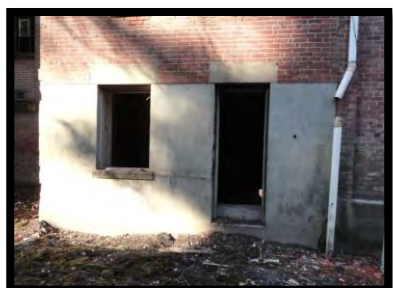
**Additional Elements:  
Treatment**

Materials: Concrete  
Condition: Good  
Significance: Secondary

It appears that the elevator tower received a secondary treatment over the brick. The timing and reason for the coating is unknown.

- Retain in place or remove by the gentlest means possible

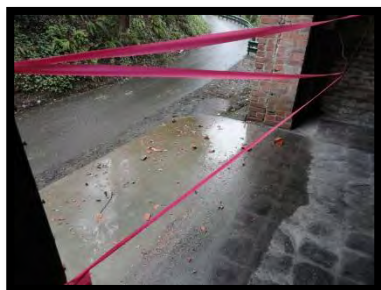
**Additional Elements:  
Apron/Opening**

Materials: Concrete  
Condition: Good  
Significance: Secondary

An apron of concrete separates two paired openings on the second and third floors. It's not known how these doors were used.

- Retain apron in place if openings are maintained

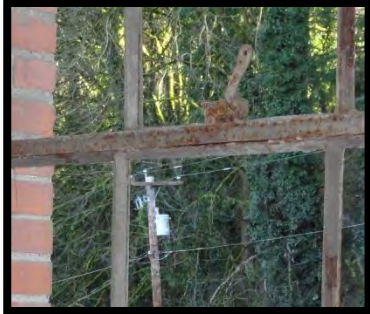
## Additional Elements: Window Hardware

Materials: Metal  
Condition: Various  
Significance: Primary

Window hardware is integral to the historic character of the window system.

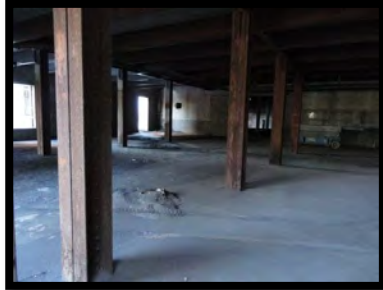
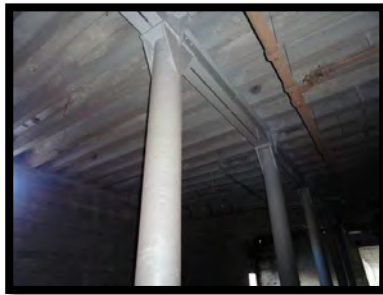
## Structure: Columns and Beams

Materials: Steel  
Condition: Should be tested  
Significance: Primary

The columns in the 1907 addition are pictured left before repainting began. Unlike in the Brewhouse, it appears that these were not enclosed. The lower photo shows the round columns in the original 1905 Cellar building.

- All structural columns should be investigated by structural engineers
- Columns should be retained in place
- Historically unpainted columns should be left unpainted; historically painted columns should remain painted
- Early paint should be tested for lead
