# Historic Structures Report

## Olympia Brewery

Prepared by Chrisanne Beckner  
In Association with Artifacts Consulting, Inc.  
On Behalf of Old Brewhouse, LLC  
April 2011

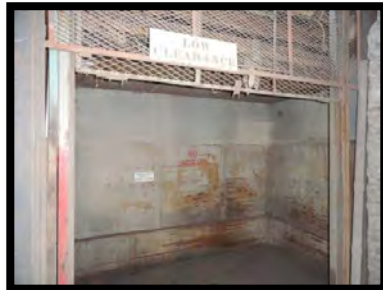
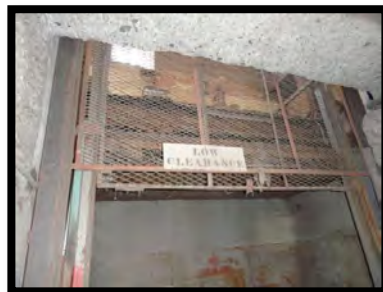
## Traffic: Elevator

Materials: Various  
Condition: Unknown  
Significance: Primary

The elevator that inhabits the tower found on the south of the original Cellars retains many of its original features. The car the gates and the machinery are in place though the cables have been cut and the elevator is no longer operable.

- Retain structural materials in place
- Restore and reuse as a working elevator, if possible

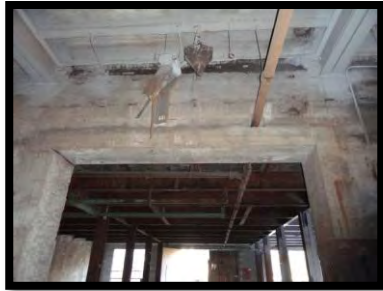
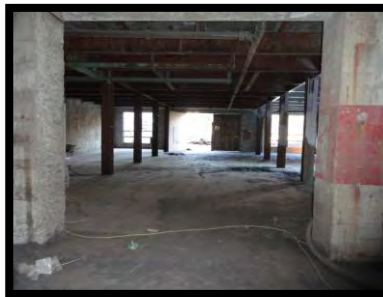
**Traffic: Doorway Between Cellars 1 and 2**

Materials: Masonry  
Condition: Good  
Significance: Primary

The openings between the Cellar buildings provide evidence of the historic traffic patterns and show the thickness of original exterior walls.

- Retain openings and leave materials in place as they are

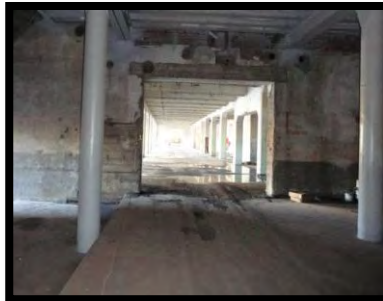
**Traffic: Doorway Between Cellars and Warehouse**

Materials: Masonry  
Condition: Good  
Significance: Primary

This opening, between the 1905 Cellar and the 1945 Warehouse, provides evidence of historic traffic patterns between the buildings.

- Retain openings and leave materials in place as they are

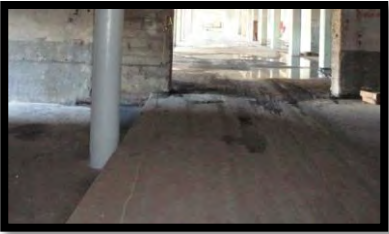
<p>Materials: Concrete  Condition: Good  Significance: Secondary</p> <p>The ramp moderates the difference in elevation between the building's two halves and allows for smooth movement of people and machines from one half to the other.</p> <p>Recommendations:</p> <ul style="list-style-type: none"> <li>• Retain in place</li> </ul>
<p><b>Finishes: Floors</b></p>

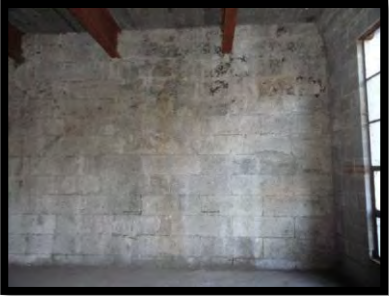
<p>Materials: Plaster  Condition: Fair to Poor  Significance: Secondary</p> <p>In most cases, the interior walls were plastered and painted. Remnants of the plaster and paint have survived harsh cleanings. Some brick walls were apparently left bare on upper floors. Some of these were once exterior walls that have been absorbed by new construction.</p> <p>Recommendations:</p> <ul style="list-style-type: none"> <li>• Paint should be tested for lead</li> <li>• Historically plastered surfaces should be repaired, retaining as much of the original materials as possible. Historically bare surfaces should remain bare.</li> </ul>

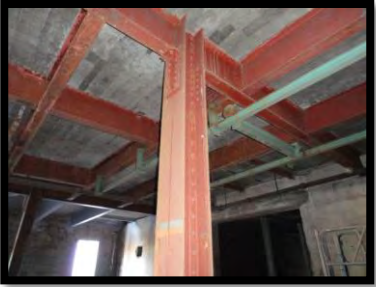
<p><b>Finishes: Ceiling</b></p>

<p>Materials: Steel Beams  Condition: Should be tested  Significance: Secondary</p> <p>Ceiling beams have been left visible inside the Cellar building, exposing the overall structure and the concrete above.</p> <p>Recommendations:</p> <ul style="list-style-type: none"> <li>• Retain open and visible structure</li> <li>• Historically painted materials should be repainted; historically unpainted materials remain unpainted</li> <li>• Historic paint should be tested for lead</li> </ul>
<p><b>Additional Elements: Electrical Panels</b></p>

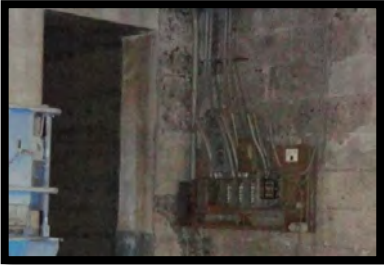
<p>Materials: Various  Condition: Good  Significance: Primary</p> <p>Evidence of original systems remain in the 1907 addition.</p> <p>Recommendations:</p> <ul style="list-style-type: none"> <li>• Retain in place as an artifact of the building's history</li> </ul>
<p><b>Additional Elements: Storage Space</b></p>

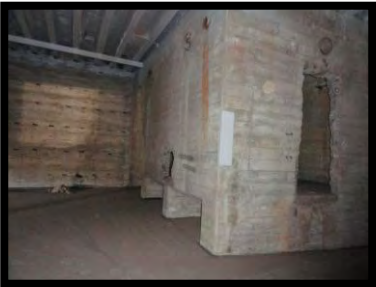
<p>Material: Concrete  Condition: Good  Significance: Secondary</p> <p>This mysterious room includes thick concrete walls, an opening and sloped bottom, visible from the exterior, as seen in the photo left. Its historic use is unknown and nothing is left of its original door.</p> <p>Recommendations:</p> <ul style="list-style-type: none"> <li>• Retain in place, if possible</li> <li>• Consider a use that would retain the shape and outline of this room</li> <li>• Pursue further research to identify historic use</li> </ul>

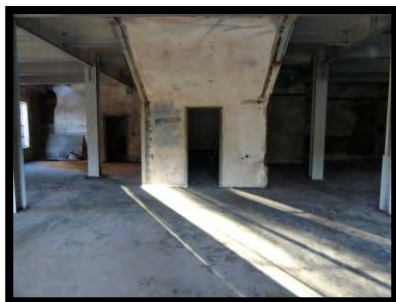
### Structure: Columns and Beams

Materials: Steel  
Condition: Good  
Significance: Primary

The second floor was one of the most public floors of the Cellar building after the remodel, including public lobbies, etc.

- Historic paint should be tested for lead
- Historically painted surfaces should remain painted; historically unpainted surfaces should remain unpainted

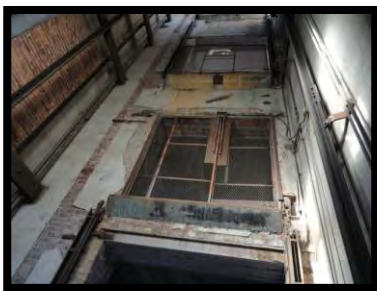
### Traffic: Elevator

Materials: Various  
Condition: Unknown  
Significance: Primary

The elevator rises through all five floors of the southern tower that terminates above the roofline.

- Retain structural materials in place
- Reuse as a working elevator, if possible

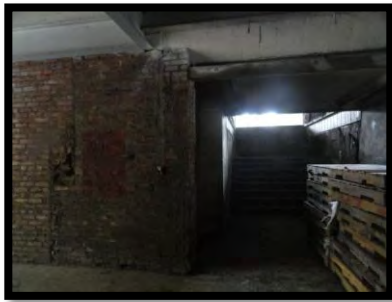
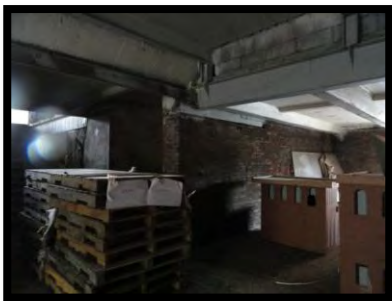
**Traffic: Doorway Between Cellars 1 and 2**

Material: Brick  
Condition: Good  
Significance: Primary

The connections between the original 1905 cellar building and the 1907 addition are still visible after the 1945 remodel and should be maintained.

- Retain openings and leave materials in place as they are

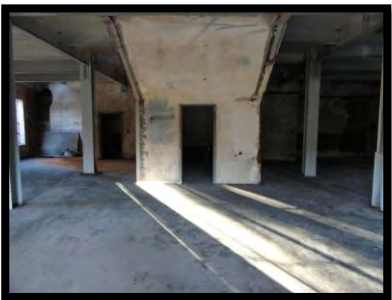
**Finishes: Floor**

Materials: Concrete  
Condition: Good  
Significance: Secondary

The unfinished concrete floor contributes to the industrial feel of these spaces but was likely previously finished. Most finishes have been stripped from floors and walls.

- Consider retaining the original concrete surface as is

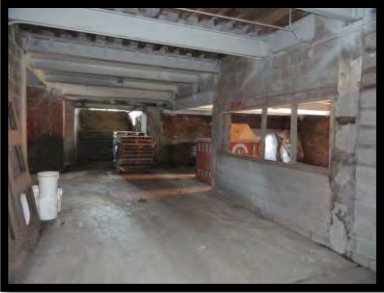
<p><b>Finishes: Wall</b></p>

<p>Materials: Plaster  Condition: Fair to Poor  Significance: Secondary</p> <p>In most cases, the interior walls were plastered and painted. Remnants of the plaster and paint have survived harsh cleanings. Some brick walls were left bare, but these tend to be exterior walls or upper floor walls that have been absorbed by new construction.</p> <p>Recommendations:</p> <ul style="list-style-type: none"> <li>• Paint should be tested for lead</li> <li>• Historically plastered surfaces should be repaired, retaining as much of the original materials as possible. Historically bare surfaces should remain bare.</li> </ul>
<p><b>Finishes: Ceiling</b></p>

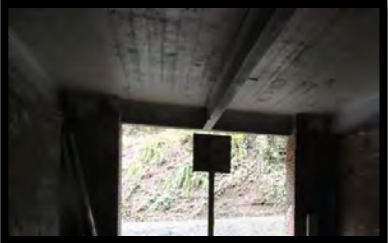
<p>Materials: Steel Beams and Concrete  Condition: Good  Significance: Secondary</p> <p>Ceiling beams have been left visible inside the Cellar building, exposing the overall structure and the concrete above.</p> <p>Recommendations:</p> <ul style="list-style-type: none"> <li>• Retain open and visible structure</li> <li>• Historically painted materials should be repainted; historically unpainted materials should remain unpainted</li> <li>• Paint should be tested for lead</li> </ul>

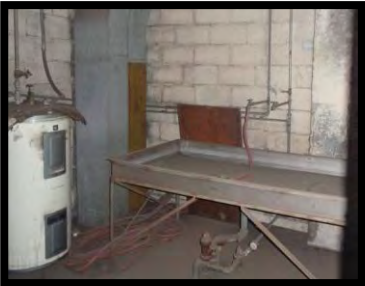
<p><b>Additional Elements: Furnishings</b></p>

<p>Materials: Various  Condition: Unknown  Significance: Secondary</p> <p>Some rooms include artifacts of the building's previous uses. The metal sink, the boiler, vents and the pipes are such artifacts.</p> <p>Recommendations:</p> <ul style="list-style-type: none"> <li>• Retain in place, if possible or reuse on site</li> </ul>

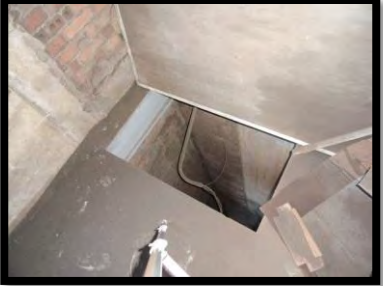
<p><b>Additional Elements: Opening</b></p>

<p>Significance: Secondary</p> <p>This opening cuts through various floors and may have surrounded systems or vents or have been used for the movement of materials between floors as in the Brewhouse. Its history is unknown</p> <p>Recommendations:</p> <ul style="list-style-type: none"> <li>• Retain in place or if it's necessary to cover the opening, materials should be recognizably new and preserve the outline of the former opening</li> </ul>
<p><b>Additional Elements: Systems</b></p>

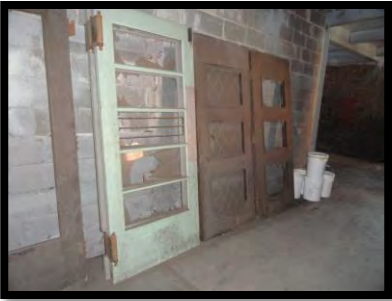
<p>Materials: Wood Condition: Fair to Good Significance: Secondary</p> <p>A number of former doors and windows have been stored in the Cellar building. It may be possible to identify their original locations and replace them.</p> <p>Recommendations:</p> <ul style="list-style-type: none"> <li>• Retain and reuse</li> <li>• Attempt to fit original doors to their original locations</li> </ul>

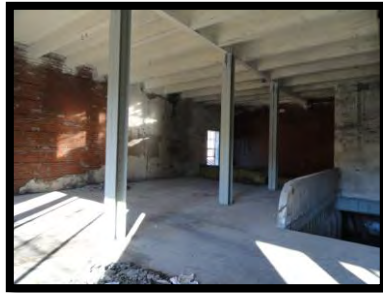
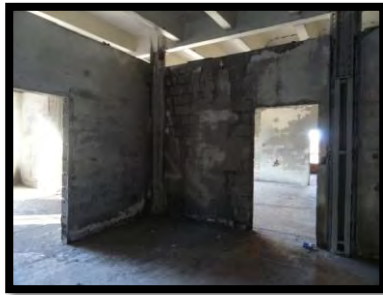
### Structure: Interior Volumes

Significance: Secondary

The interior volumes of the 1905 cellar, as shown below left, have been divided with cinder block walls. The interior volumes of the 1907 addition remain more open and the structural columns are left visible.

- Retain openness in the 1907 addition
- Either retain divisions or consider returning the 1905 Cellars to its more open historic floor plan

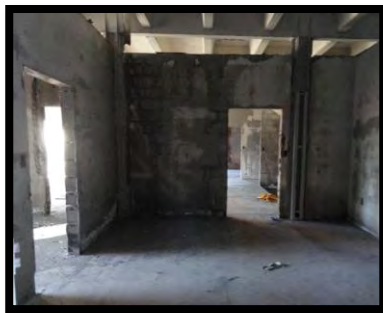
### Structure: Columns and Beams

Materials: Steel

Condition: Should be tested

- All structural systems should be investigated by engineers
- Beams and columns should be left visible and unenclosed where possible as they were original to the Cellar plan

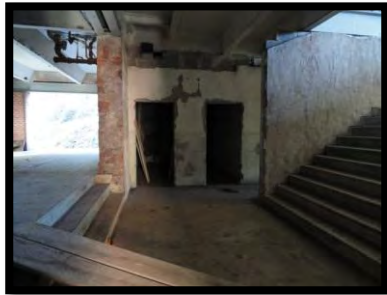
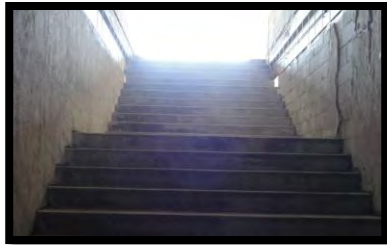
### Traffic: Stairs

Materials: Concrete  
Condition: Good  
Significance: Primary

The grand central stairs on the third floor are an addition from the 1945 plan.

- Retain in place

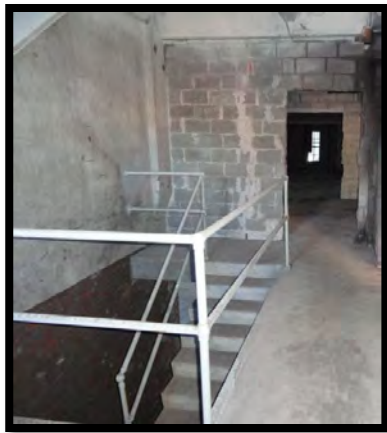
### Traffic: Secondary Stair

Materials: Concrete and Iron  
Condition: Good  
Significance: Primary

The concrete secondary stair includes a pipe railing.

- Retain in place, if possible
- If stair must be altered, reuse materials

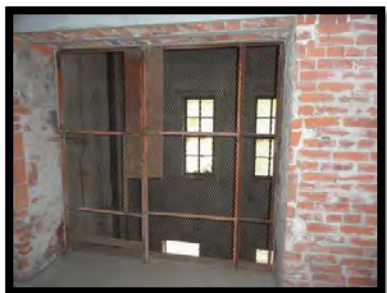
### Traffic: Elevator

Materials: Various  
Condition: Unknown  
Significance: Primary

The elevator rises throughout the building's five floors and retains its historic materials.

- Retain structural materials in place
- Reuse as a working elevator, if possible

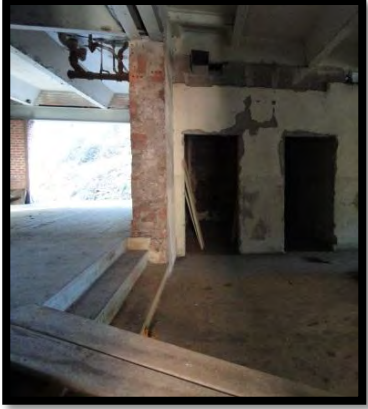
<p><b>Traffic: Doorway Between Cellar 1 and 2</b></p>

<p>Material: Brick Condition: Good Significance: Primary</p> <p>The connections between the original 1905 cellar building and the 1907 addition are still visible after the 1945 remodel and should be maintained. The change in elevation is negotiated by added stairs.</p> <p>Recommendations:</p> <ul style="list-style-type: none"> <li>• Retain openings and leave materials in place as they are</li> </ul>
<p><b>Finishes: Floor</b></p>

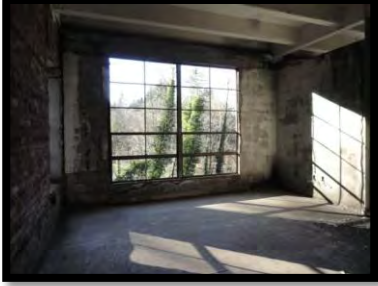
<p>Materials: Concrete Condition: Good Significance: Secondary</p> <p>The unfinished concrete floor contributes to the industrial feel of these spaces but was likely finished at some point. Most finishes have been stripped from Cellar floors and walls</p> <p>Recommendations:</p> <ul style="list-style-type: none"> <li>• Consider retaining the bare concrete as it contributes to the industrial feel of these buildings</li> </ul>

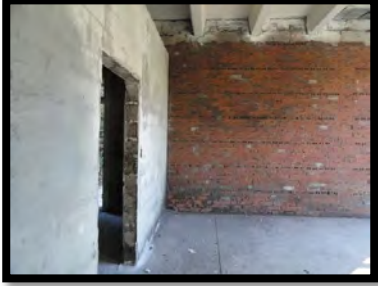
<p><b>Finishes: Wall</b></p>

<p>Materials: Plaster and Brick Condition: Fair to Poor Significance: Secondary</p> <p>In most cases, the interior walls were plastered and painted. Remnants of the plaster and paint have survived harsh cleanings. Some brick walls were left bare, as in the photo left.</p> <p>Recommendations:</p> <ul style="list-style-type: none"> <li>• Paint should be tested for lead</li> <li>• Historically plastered surfaces should be repaired, retaining as much of the original materials as possible. Historically bare surfaces should remain bare.</li> </ul>

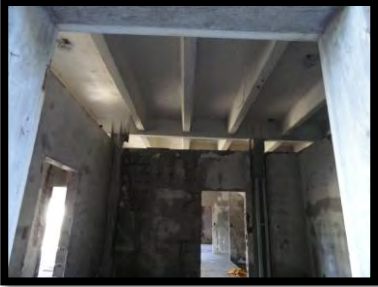
<p><b>Finishes: Ceiling</b></p>

<p>Materials: Steel Beams and Concrete  Condition: Good  Significance: Secondary</p> <p>Ceiling beams have been left visible inside the Cellar building, exposing the overall structure and the concrete above.</p> <p>Recommendations:</p> <ul style="list-style-type: none"> <li>• Retain open and visible structure</li> <li>• Historically painted materials should be repainted; historically unpainted materials should remain unpainted</li> <li>• Historic paint should be tested for lead</li> </ul>
<p><b>Additional Elements: Bathroom Fixtures</b></p>

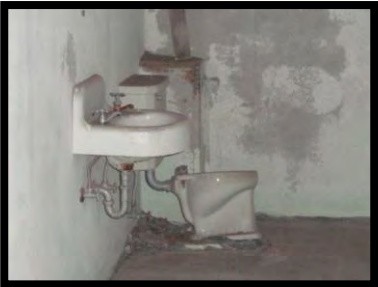
<p>Materials: Various  Condition: Poor to Good  Significance: Secondary</p> <p>Bathroom fixtures likely date to the 1945 remodel. Few of them are in good condition, but those that remain should be reused.</p> <p>Recommendations:</p> <ul style="list-style-type: none"> <li>• Retain and reuse materials, where possible</li> </ul>

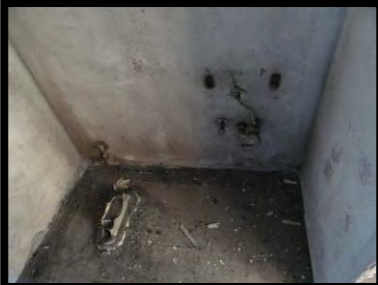
<p><b>Additional Elements: Missing Bath Fixtures</b></p>

<p>Materials: Various  Condition: Missing  Significance: N.A.</p> <p>Some bathroom fixtures, including sinks and toilets, have already been removed. If these rooms are reused as bathrooms, the historic layout should be maintained and materials replaced in kind.</p> <p>Recommendations:</p> <ul style="list-style-type: none"> <li>• Missing elements need not be replaced in kind</li> </ul>

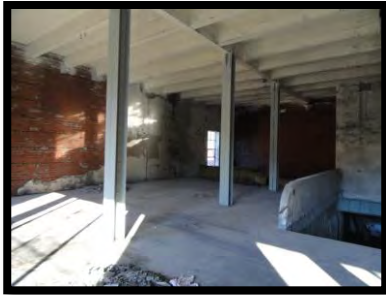
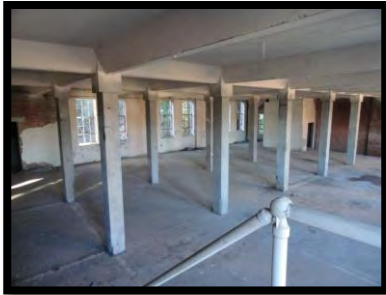
## Structure: Interior Volumes

Significance: Primary

The fourth floor is defined by open volumes punctuated by columns, similar to the original design of the Cellar building. It does not appear in historic plans, except when a systems diagram was prepared.

- Consider maintaining the open look and feel of these rooms by maintaining open volumes with visible columns and beams

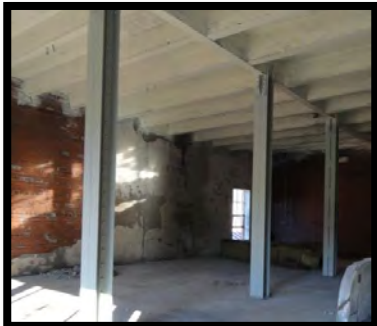
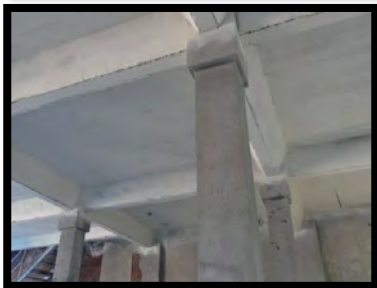
## Structure: Columns and Beams

Materials: Steel

Condition: Should be tested

- All structural columns should be investigated by structural engineers
- Columns should be retained in place
- Historically unpainted columns should be left unpainted; historically painted columns should remain painted
- Paint should be tested for lead

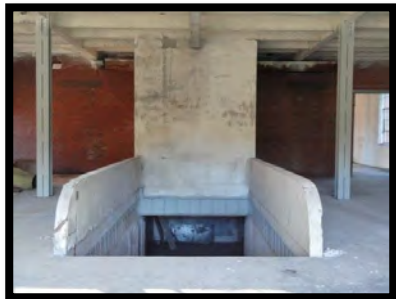
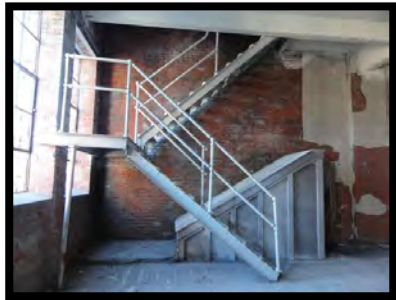
**Traffic: Stair**

Materials: Concrete  
Condition: Good  
Significance: Primary

The grand central stair on the fourth floor is an addition from the 1945 plan, as seen left.

The secondary stair, found in the northeast corner of the original cellar, is constructed with rounded wood treads, and metal railing, similar though not the same as the pipe railing in the Brewhouse.

- Retain stars in place
- If stair must be altered, reuse historic materials

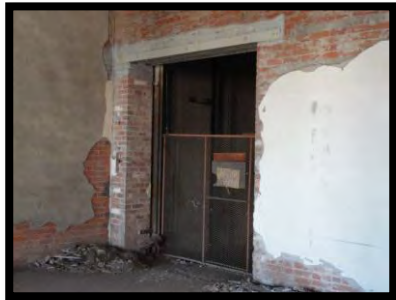
**Traffic: Elevator**

Materials: Various  
Condition: Unknown  
Significance: Primary

The elevator rises through the entire building.

- Retain structural materials in place
- Reuse as a working elevator, if possible

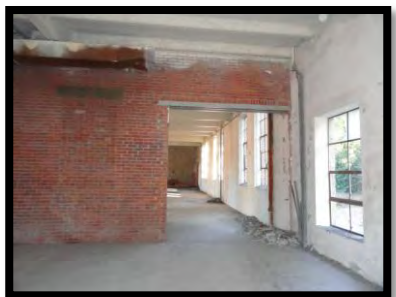
**Traffic: Doorway Between Cellar 1 and 2**

Materials: Masonry  
Condition: Good  
Significance: Primary

Openings between the cellar buildings reveal historic traffic patterns and show the original exterior elements of the 1905 Cellar.

- Retain openings and leave materials in place as they are

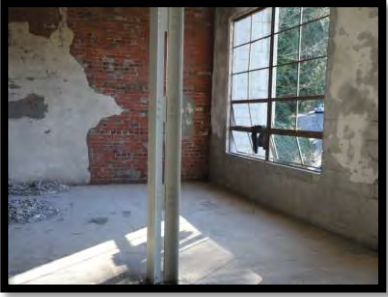
<p><b>Finishes: Floor</b></p>

<p>Materials: Concrete  Condition: Good  Significance: Secondary</p> <p>The unfinished concrete floor contributes to the industrial feel of these spaces but the floors may have been finished at one time. Most finishes have been stripped from walls and floors.</p> <p>Recommendations:</p> <ul style="list-style-type: none"> <li>• Consider retaining the bare concrete as an artifact of these buildings' original industrial use</li> </ul>
<p><b>Finishes: Wall</b></p>

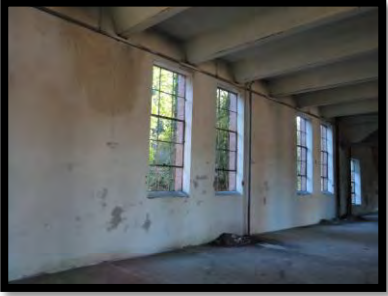
<p>Materials: Plaster and Brick  Condition: Fair to Poor  Significance: Secondary</p> <p>In most cases, the interior walls were plastered and painted. Remnants of the plaster and paint have survived harsh cleanings.</p> <p>Recommendations:</p> <ul style="list-style-type: none"> <li>• Historic paint should be tested for lead</li> <li>• Historically plastered surfaces should be repaired, retaining as much of the original materials as possible. Historically bare surfaces should remain bare.</li> </ul>

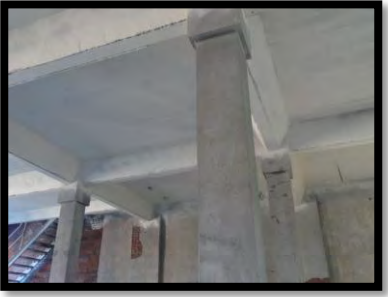
<p><b>Finishes: Ceiling</b></p>

<p>Materials: Steel Beams and Concrete  Condition: Good  Significance: Secondary</p> <p>Ceiling beams have been left visible inside the Cellar building, exposing the overall structure and the concrete above.</p> <p>Recommendations:</p> <ul style="list-style-type: none"> <li>• Retain open and visible structure</li> <li>• Historically painted materials should be repainted; historically unpainted materials should remain unpainted</li> <li>• Historic paint should be tested for lead</li> </ul>

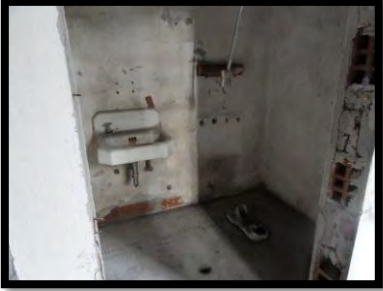
<p><b>Additional Elements: Bathroom Fixtures</b></p>

<p>Materials: Various Condition: Poor to Good Significance: Secondary</p> <p>Bathroom fixtures likely date from the 1945 remodel. Not all of them remain in place, as seen left.</p> <p>Recommendations:</p> <ul style="list-style-type: none"> <li>• Retain and reuse materials when possible</li> </ul>
<p><b>Additional Elements: Door to Warehouse</b></p>

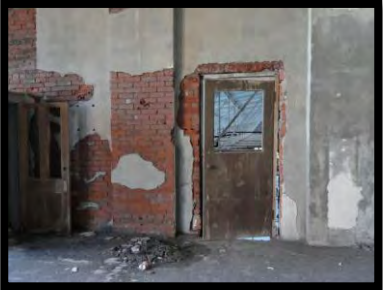
<p>Materials: Wood Condition: Fair Significance: Secondary</p> <p>This door connects the fourth floor of the Cellar to the warehouse building but no longer includes a stair that reaches down to the second floor of the warehouse. Instead it puts the user eyelevel with the trusses of the Warehouse's roof.</p> <p>Recommendations:</p> <ul style="list-style-type: none"> <li>• Retain visual access to the warehouse space even if the door must be sealed or replaced</li> </ul>
<p><b>Additional Elements: Enclosed Stairwell</b></p>

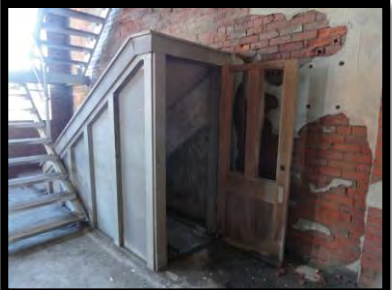
<p>Materials: Wood Condition: Fair Significance: Secondary</p> <p>A small section of the stairwell as enclosed in wood. The enclosure and the door remain.</p> <p>Recommendations:</p> <ul style="list-style-type: none"> <li>• Retain in place if possible</li> </ul>

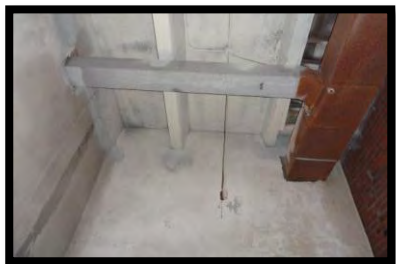
### Additional Elements: Systems

Materials: Metal  
Condition: Good  
Significance: Secondary

Remaining HVAC systems appear in various places throughout the building.

- Retain in place, if possible
- Reuse materials if possible

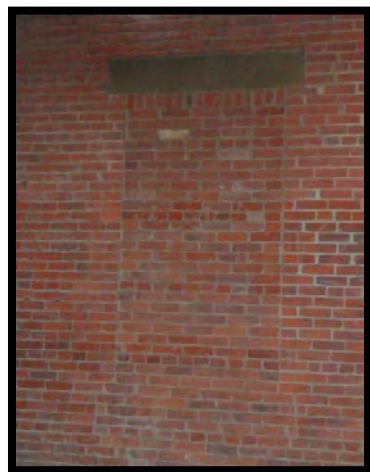
### Additional Elements: Bricked-in Panels

Materials: Red Brick  
Condition: Good  
Significance: Primary

When the 1905 Cellar building was expanded with the 1907 addition, the openings in the original exterior wall were bricked in, sometimes leaving sills and lintels in place.

- Retain in place as evidence of the original fenestration of the 1907 Cellar building
- If windows are to be opened, fill with historically appropriate materials and retain sills and lintels where they remain

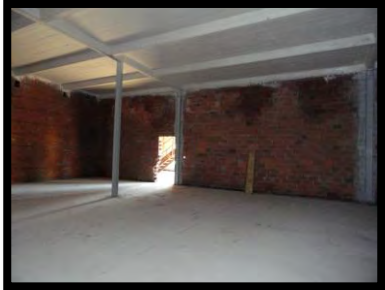
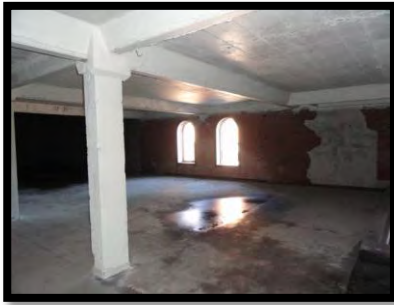
### Structure: Interior Volumes

Significance: Secondary

The fifth floor includes a western bay with stairs, as seen below, and open volumes punctuated by columns.

The photo below shows a new roof and stair constructed over what was a room open to the weather. Water infiltration is a problem on this floor, as seen in lower photos where water has pooled. In the western bay, roof leaks are still visible.

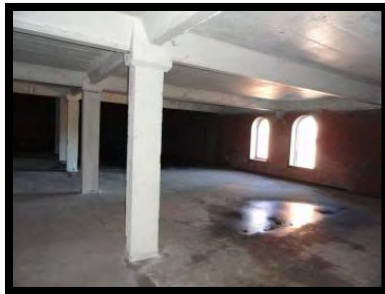
### Structure: Columns and Beams

Materials: Steel

Condition: Should be tested

- All structural columns should be investigated by structural engineers
- Columns should be retained in place
- Historically unpainted columns should be left unpainted; historically painted columns should remain painted
- Paint should be tested for lead

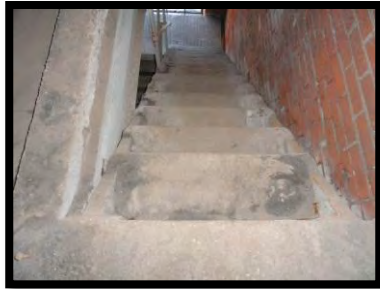
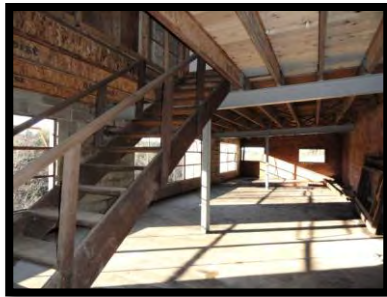
### Traffic: Stair

Materials: Concrete  
Condition: Good  
Significance: Primary

The primary stair is a concrete stair in the northeast corner of the original Cellar. It is original to the building.

- Retain original stair in place
- If finishing the new roof and stair, make sure they remain distinguishable as new construction.

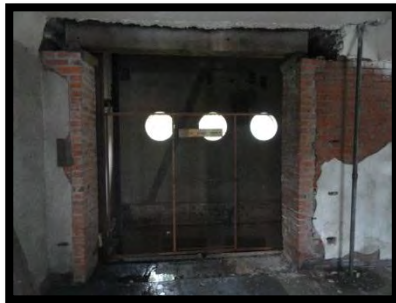
### Traffic: Elevator

Materials: Various  
Condition: Unknown  
Significance: Primary

The elevator rises through the sixth floor, where the tower is adorned with three small round windows.

- Retain structural materials in place
- Reuse as a working elevator, if possible

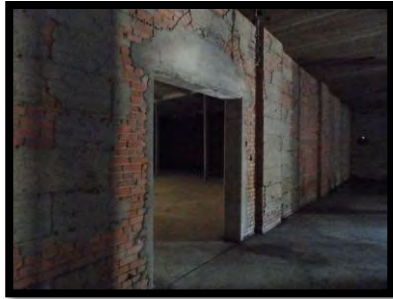
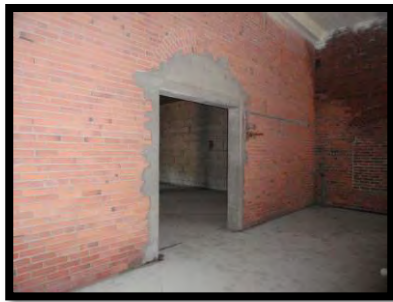
**Traffic: Doorway Between  
Cellar 1 and 2**

Materials: Masonry  
Condition: Good  
Significance: Primary

The openings between the 1905 and 1907 Cellars provide evidence of historic traffic patterns.

In this case, brick repair is visible.

- Retain openings and leave materials in place as they are
- Repair plaster on historically plastered surfaces

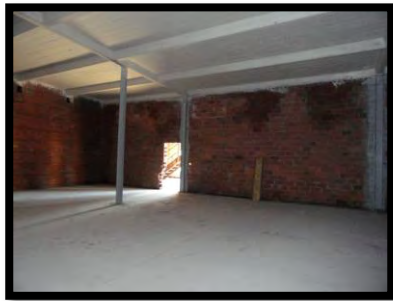
**Finishes: Floor**

Materials: Concrete  
Condition: Good  
Significance: Secondary

The unfinished concrete floor contributes to the industrial feel of these spaces but was likely covered at some point.

- Consider retaining the bare concrete surface as evidence of the industrial history of these buildings

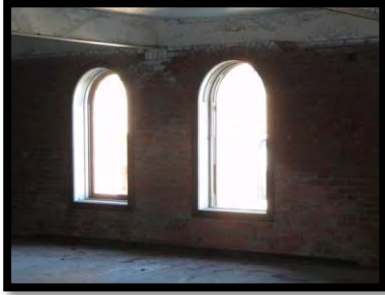
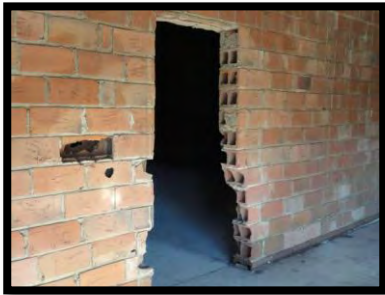
### Finishes: Wall

Materials: Plaster and Brick

Condition: Fair to Poor

- Paint should be tested for lead
- Historically plastered surfaces should be repaired, retaining as much of the original materials as possible. Historically bare surfaces should remain bare.

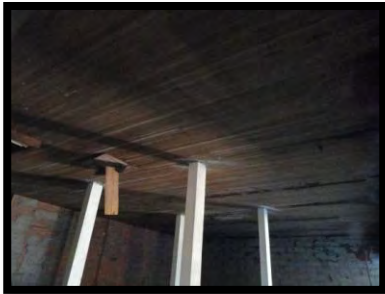
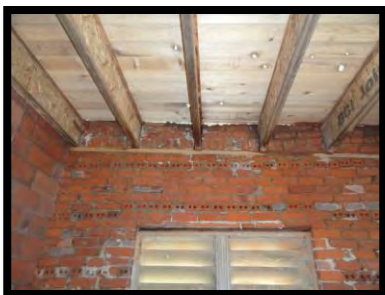
### Finishes: Ceiling

Materials: Wood

Condition: Good

- Retain open and visible structure where visible
- Historically painted materials should be repainted; historically unpainted materials should remain unpainted
- Paint should be tested for lead
- Wood veneer should be repaired and retained if possible

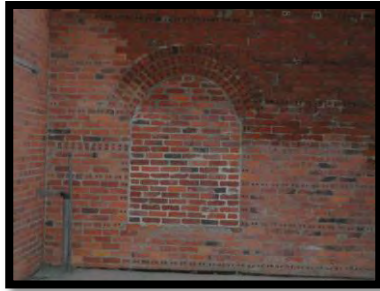
**Additional Elements: Brick Panels**

Materials: Red Brick  
Condition: Good  
Significance: Primary

When the 1905 Cellar building was expanded, the openings in the original exterior wall were bricked in, sometimes leaving sills and lintels in place.

- Retain in place as evidence of the original fenestration of the 1905 Cellar building or consider reopening and allowing visual access through the building

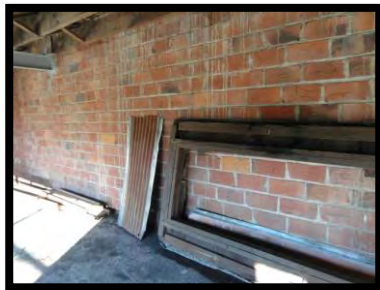
**Additional Elements: Materials**

Materials: Various  
Condition: Various  
Significance: Secondary

As on other floors, materials have been stored away from their original locations. If it's possible to restore them for use in their original locations, that would be ideal.

- Retain and reuse

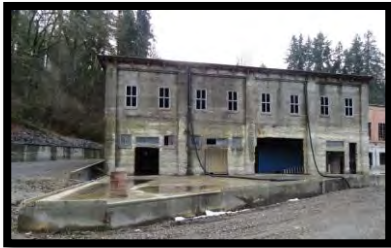
## North Elevation

The current North Elevation closely matches the original elevation drawing prepared in 1907, suggesting the exterior has received some alterations, but only to the lower opening in the third of four bays, as shown below. Other elements, including fenestration, brackets and materials remain in place.

From the photo below left, it's clear that a pad has been poured at an angle around the exterior of the building, defining the boundaries of the site and guiding vehicular access around the Keg House.

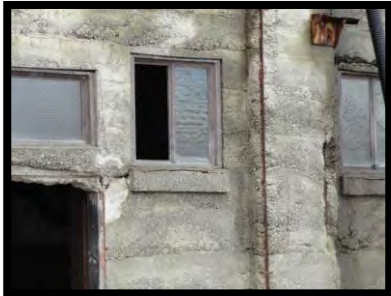
## Structure

Materials: Reinforced Concrete

Condition: Fair

- Concrete should be tested to identify causes of deterioration
- Repair and retain in place
- This material was historically left uncovered and should remain uncovered

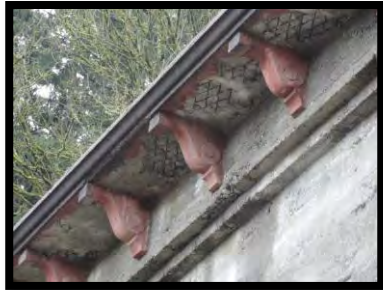
### Cornices and Brackets

Materials: Galvanized Iron

Condition: Good

- Retain in place
- These are likely the best remaining examples of original brackets and may be useful as models for reconstruction

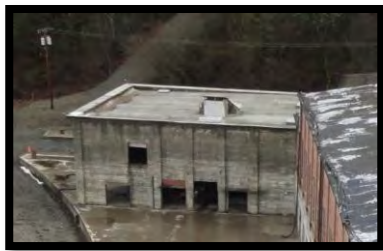
### Roof

Materials: Composition

Condition: Good

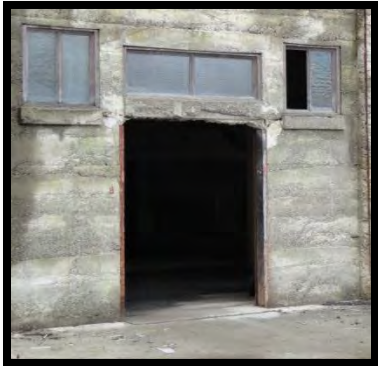
1

Materials: Unknown  
Condition: Missing  
Significance: Primary

The first floor of the building includes a series of five openings, one per bay, and two in the western bay, shown left. Three of these doors retain their metal casings, though the doors themselves are missing, as seen in the photo 2 below left.

- If possible, retain and reuse the three consistent openings that match original plans and retain their casings
- In the case of the enlarged opening, consider returning it to its original shape and size to restore the symmetry of the north facade
- In the case of the bathroom door in photo 4, either replace the door and transom or fill the opening, leaving evidence of new versus historic construction.

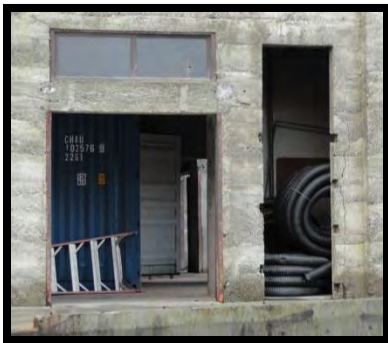
3

The western bay includes two openings, a door that matches those in photo 2 and a secondary door that was originally topped with a transom window. This was an exterior door to a bathroom likely used by multiple buildings in the complex. This door is missing both its casing and its transom window.

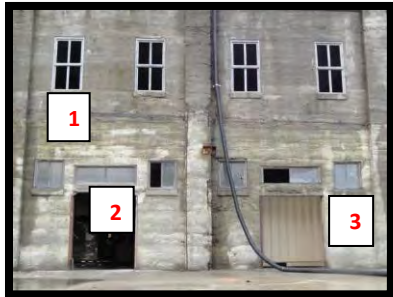
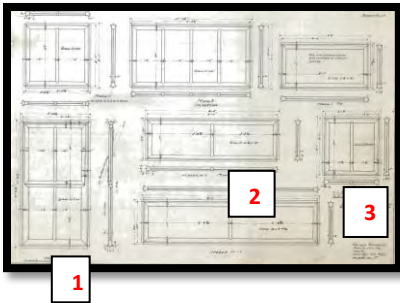
## Windows

Materials: Galvanized Iron

Condition: Good

Three window types are represented on the north façade. The numbers below each window type correspond to details found in original plans, below.

- Windows are in good condition and should be retained
- Lower windows were glazed with fire glass, which should be retained
- Upper windows, which have lost their lights, may be reglazed with clear glass

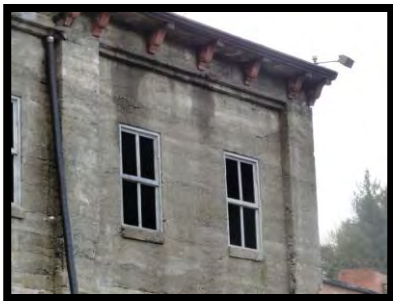
## Additional Elements: Ornamentation

Materials: Reinforced Concrete

Condition: Fair to Good

- Repair and retain in place

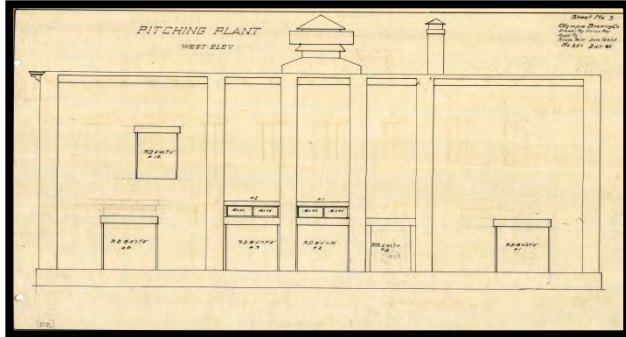
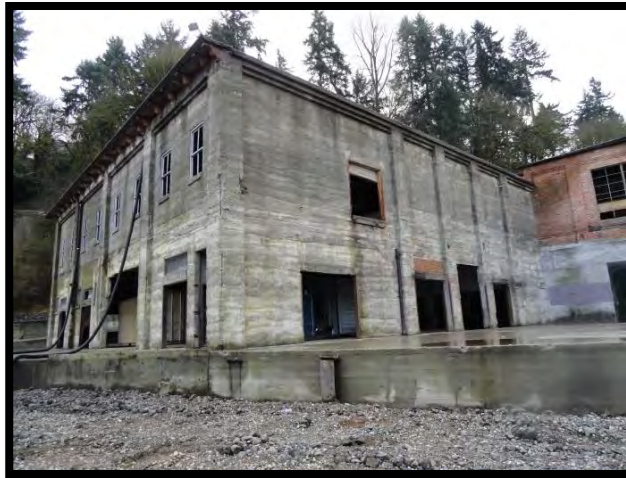
## West Elevation

The West elevation resembles the historic elevation drawing, left. The pilasters that define the bays are in place, the openings are in place, and the metal door on the second floor is in place.

The primary alterations took place on the south elevation. Behind the façade of the two-story warehouse, added in 1945, the intact form of the Keg House remains. Its southern end was absorbed rather than removed.

From this elevation, it's also clear that the pad that now provides a promenade that attaches all remaining buildings, completely encompasses the footprint of the Keg House.

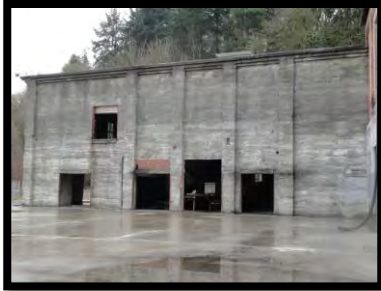
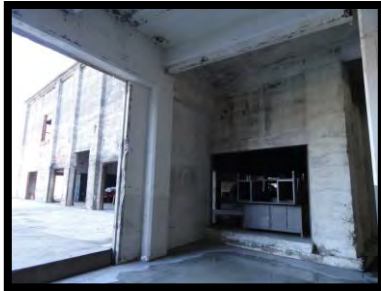
### Structure

Materials: Reinforced Concrete  
Condition: Fair to Good  
Significance: Primary

In the photo left, rebar is occasionally visible through deteriorating concrete. However, this elevation, sheltered from the weather, appears in good condition.

- Repair and retain in place
- This material was historically left uncovered and should remain uncovered

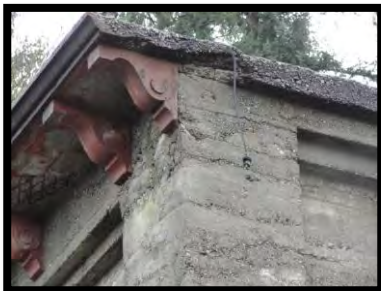
### Cornices and Brackets

Materials: Galvanized Iron  
Condition: Missing  
Significance: N.A.

Cornice and brackets appear never to have been installed on the western elevation. In the photos left and above, the corbelling and the minimal eave are visible.

- Do not add cornice or brackets, which would give a false sense of history

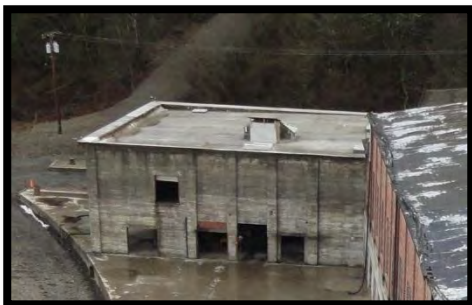
### Roof

Materials: Composition  
Condition: Good  
Significance: Secondary

On this elevation, the ventilator is most visible. Based on historic plans, the ventilator has been partially dismantled.

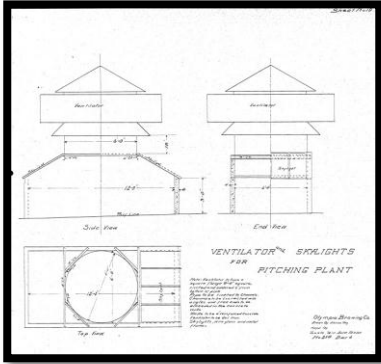
Materials: Galvanized Iron, Wire Glass, Metal Frames  
Condition: Unknown  
Significance: Primary

Skylights and ventilators were included in original plans for the Keg House. From the interior, the openings are visible but have been boarded up, except in the case of the large ventilator most visible on this elevation.

- Restore and retain in place

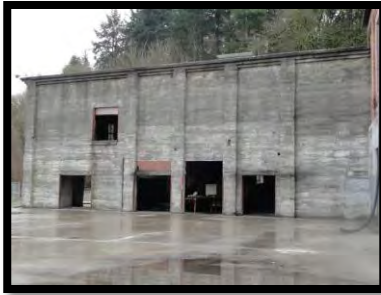
Materials: Unknown  
Condition: Missing in some cases  
Significance: Primary

There are five doors visible on the western elevation. Three are eight feet wide, and two are six feet, as shown in the elevation drawing below left. The single second-story opening retains its rolling door. The others retain only their metal casings. This is also true for the southerly door, which has been absorbed into the Warehouse.

- If possible, retain and reuse the openings that match original plans and retain their casings
- Retain rolling door on second floor
- Remake doors of historically appropriate material
- Retain lintels

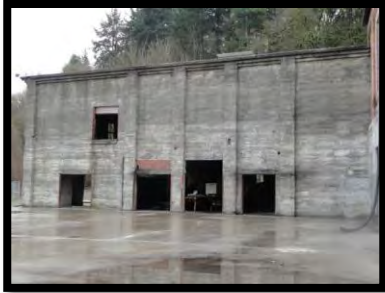
Materials: Galvanized Iron

Condition: Missing

Only two windows were installed on the west elevation above two of the doors. One has been bricked in and the other is missing and retains only its opening.

- Retain the bricked in panel or return to original fenestration
- Replace missing windows with historically appropriate materials, using plans as possible models

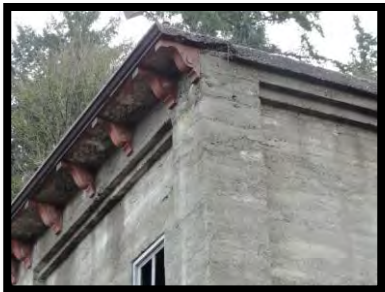
Materials: Reinforced Concrete

Condition: Fair to Good

- Repair and retain all exterior ornament in place

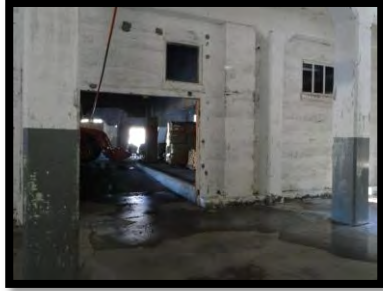
Materials: Reinforced Concrete

Condition: Fair to Good

- Repair and retain in place
- This material was historically left uncovered and should remain uncovered

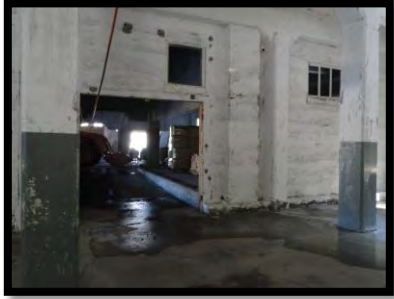
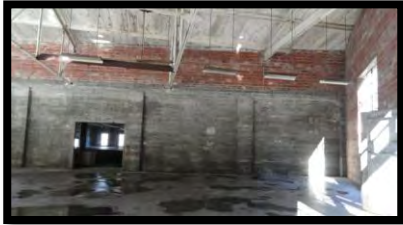
Materials: Unknown  
Condition: Missing  
Significance: Secondary

Doors were not planned for the south elevation, but one opening has been added to the first floor, left, and one has been added to the second floor, below left.

- Retain these two enlarged openings. They have been here for at least 50 years and provide the only access to the Warehouse from the interior of the Keg House.

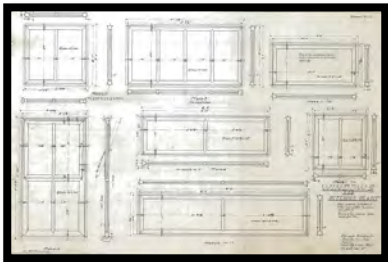
Materials: Galvanized Iron  
Condition: Fair  
Significance: Secondary

Two window types were represented on the south elevation. None appear on the second floor, as shown left, and only two appear on the first floor. Two other windows on the lower floor have been filled.

- Where window frames remain, they should be reglazed
- Where casings alone remain, windows should be replicated. Fixed windows should be replaced with fixed windows in historically appropriate materials
- Filled windows may be restored or left as is

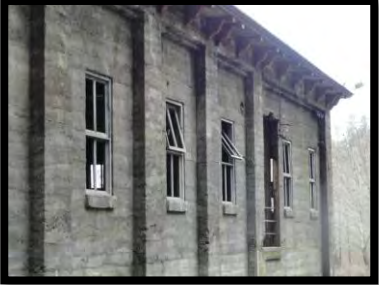
<p>Materials: Reinforced Concrete  Condition: Fair to Good  Significance: Primary</p> <p>As seen left, the defined pilasters and corbelling at the roofline are the primary ornamental details. The east elevation, though it's hidden from much of the complex, was highly visible as the site was approached from an access road that wrapped the eastern wall of the Keg House.</p> <p>Recommendations:</p> <ul style="list-style-type: none"> <li>• Repair and retain in place</li> <li>• This material was historically left uncovered and should remain uncovered</li> </ul>
<p><b>Cornices and Brackets</b></p>

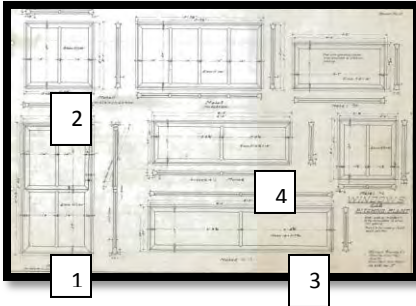
Materials: Galvanized Iron

Condition: Good

- Window frames are in good condition and should be retained
- Windows, most of which have lost their lights, may be reglazed with clear glass

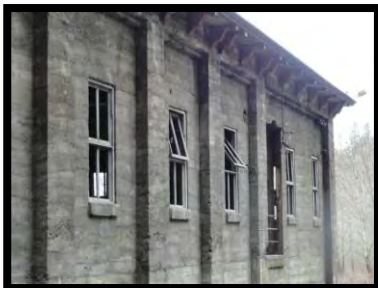
Materials: Reinforced Concrete

Condition: Fair to Good

- Repair and retain in place

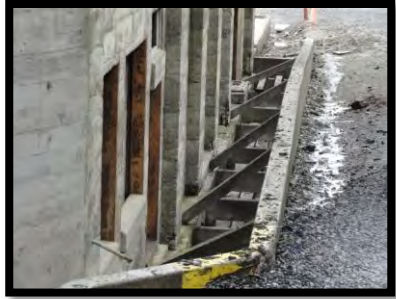
Materials: Wood  
Condition: Good  
Significance: Primary

The sluice that allows for runoff does not appear in plans but was likely added to deal with wet conditions. Currently, it helps shed water away from the building's foundation.

- Retain in place as an artifact of water control technology onsite

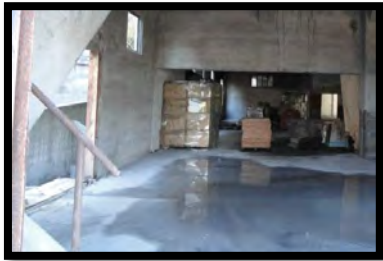
Materials: Concrete  
Condition: Good  
Significance: Secondary

Drains, chimneys, and a barrel elevator are indicated on historic plans, along with a pitching machine. None of these materials remain, nor does the floor surface show any sign of them. The concrete floor is likely not original but its age is unknown.

- Retain in place
- Historically uncovered materials should remain uncovered

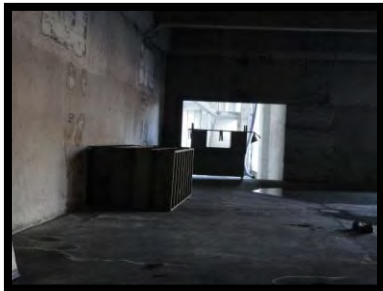
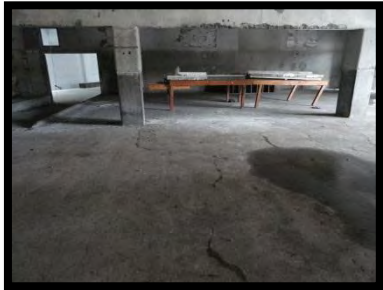
Materials: Concrete  
Condition: Good  
Significance: Secondary

The southern wall includes evidence of filled windows, as seen left, but the wall surfaces are otherwise in good condition.

- Nothing remains of any paint or other coating on the walls. Historically unpainted materials should remain unpainted
- Columns retain paint on lower halves. Historically painted materials should remain painted

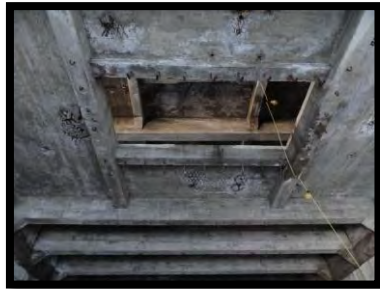
The opening between the first and second floors includes a large hole that leads to the ventilator on the building's roof. There are also metal connectors that remain in place and likely supported the pitching machinery that's since been removed.

- Though openings are not easy to retain in floors and ceilings, consider securing the opening but leaving it visible to be interpreted in place

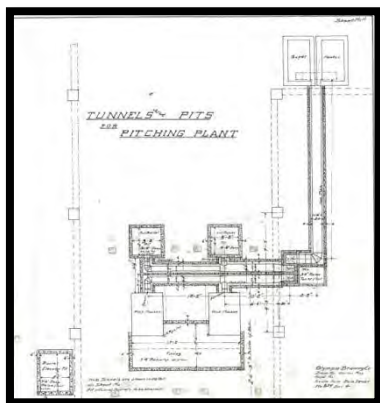
The Keg House plans include references to tunnels and pits, and the sketch, left, details some of these elements. They no longer exist within the building but underground resources may exist in place.

- Be aware, during construction, of the possibility of running into underground resources

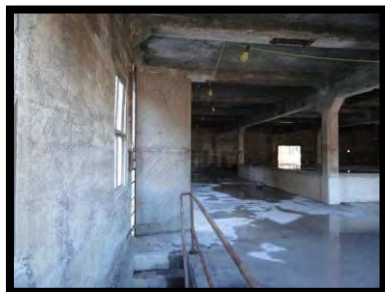
**Finishes: Wall**

Materials: Concrete  
Condition: Good  
Significance: Secondary

The rough, unfinished walls appear to have been left unpainted and unplastered.

Recommendations:

- Historically unfinished materials should remain unfinished

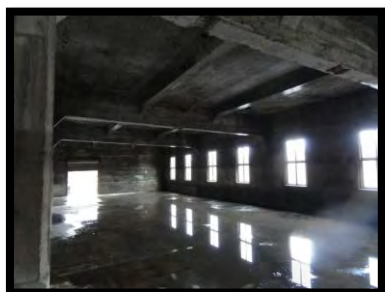
**Finishes: Ceiling**

Materials: Concrete  
Condition: Fair to Good  
Significance: Secondary

The ceiling beams have been left visible.

Recommendations:

- Repair and retain in place
- Historically unfinished materials should remain unfinished

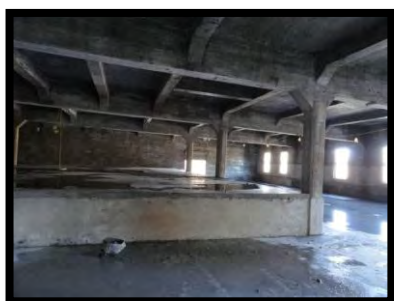
**Additional Elements:  
Platform**

Materials: Concrete  
Condition: Good  
Significance: Secondary

The platform is evidence of the building's historic use but does not, in itself, retain primary significance

Recommendations:

- Leave in place, if possible

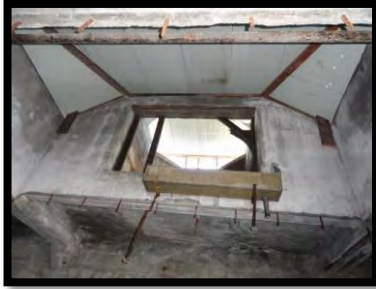
**Additional Elements:  
Ventilator**

Materials: Various  
Condition: Good  
Significance: Primary

The photo left was taken from beneath the ventilator looking up through the opening in the roof. This historic element of the Keg House defines its former use as a pitching plant.

Recommendations:

- Should be retained

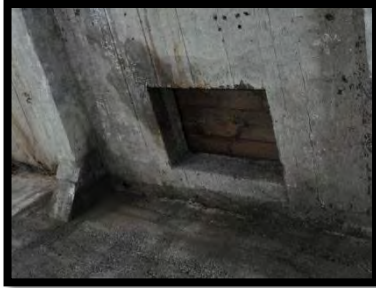
**Additional Elements:  
Skylights**

Materials: Unknown  
Condition: Missing  
Significance: Secondary

The openings associated with four skylights have been boarded up. The lights themselves are missing.

Recommendations:

- Return to former condition

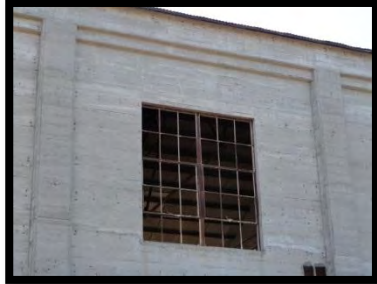
## Construction

Materials: Board-formed concrete

Condition: Good

The exterior of the storage building includes visible seams from the board molds used to shape the concrete, which appears to be in generally good condition.

Recommendations:

- Retain the unfinished surface
- Retain all exterior ornament, including the chamfered pilasters and corbeling

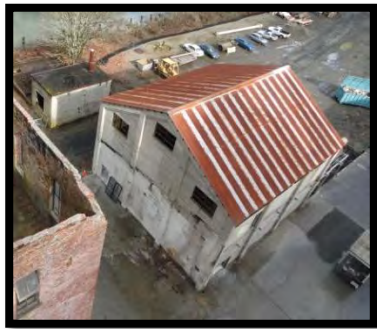
## Roof

Materials: Corrugated Galvanized Steel

Condition: Unknown

Recommendations:

- Repair and retain or replace in kind
- As the surface was originally painted white, it can be repainted white. It can also be left as is if it remains in good condition

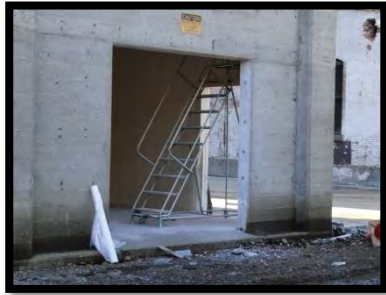
## Doors

Materials: Missing  
Condition: Missing  
Significance: Primary

The openings themselves are significant to the building's original design, but all evidence of original doors is missing on this elevation. However, a single door on the southern façade may provide a model for new doors. Those double doors are made of wood.

### Recommendations:

- Retain openings if possible
- Build doors or panels of historically appropriate materials

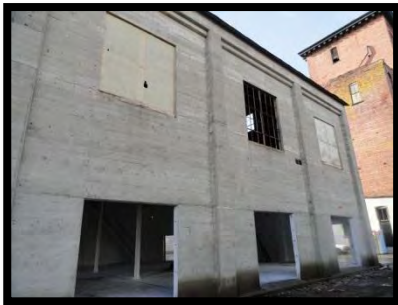
## Windows

Materials: Metal  
Condition: Good; missing glass  
Significance: Primary

The northern elevation includes three pairs of identical windows. These industrial windows are boarded up in the two outer bays but the frames remain in place. Each window includes one fixed upper sash of six lights, a central awning sash of six lights, and a lower fixed sash of three lights. Each pair of windows is separated by narrow mullions.

### Recommendations:

- Reglaze and retain in place unless corrosion makes window replacement necessary
- If replacement windows are necessary, they should match the existing fenestration, materials, design and function. Replacement windows should be operable where the originals were operable and should include true divided lights.

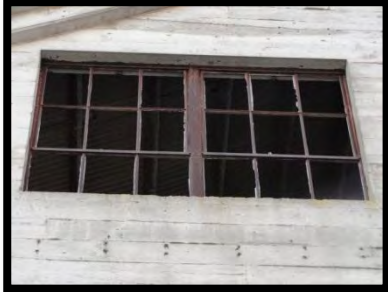
## Construction

Materials: Board-formed concrete

Condition: Good

The exterior of the storage building includes visible seams from the board molds used to shape the concrete, which appears to be in generally good condition.

Recommendations:

- Retain the unfinished surface
- Retain all exterior ornament, including the chamfered pilasters and corbeling

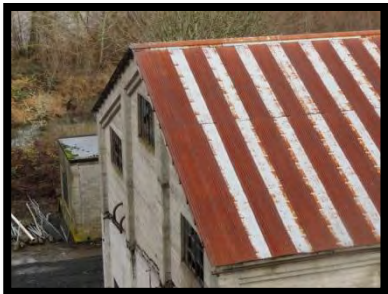
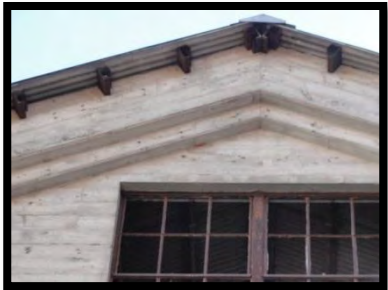
## Roof

Materials: Corrugated Galvanized Steel

Condition: Good

Recommendations:

- Repair and retain or replace in kind
- As the surface was originally painted white, it can be repainted white. It can also be left striped if it remains in good condition
- Retain visible, projecting purlins

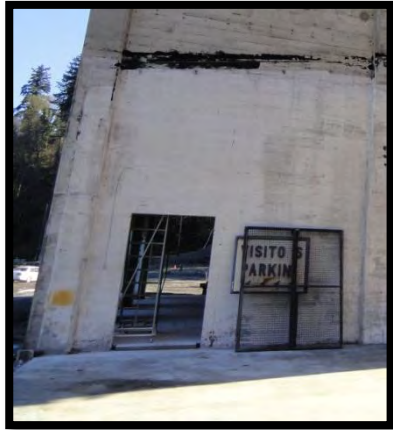
## Door

Materials: Missing  
Condition: Missing  
Significance: Secondary

This door is smaller than others in the building and may be original to the building or possibly added to connect the storage building to the recently removed infill building. It is the only missing door that retains portions of its casing. In fact, it retains remnants of multiple door casings, all of which were made of wood.

### Recommendations:

- Leave opening in place, if possible
- Replace door with historically appropriate materials
