# Historic Structures Report

## Olympia Brewery

Prepared by Chrisanne Beckner  
In Association with Artifacts Consulting, Inc.  
On Behalf of Old Brewhouse, LLC  
April 2011

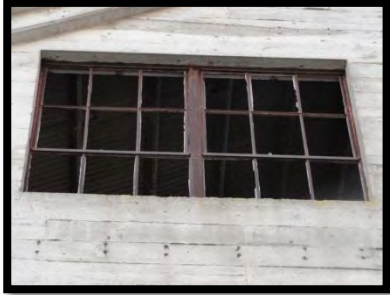
## Windows

Materials: Metal

Condition: Level of corrosion unknown

Recommendations:

- Reglaze and retain in place unless corrosion makes window replacement necessary
- If replacement windows are necessary, they should match the existing fenestration, materials, design and function. Replacement windows should be operable where the originals were operable and should include true divided lights.

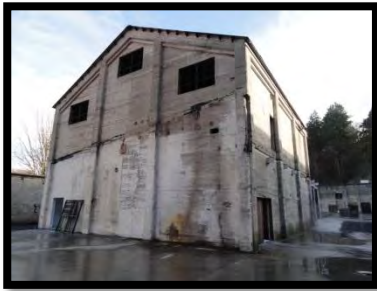
## Additional Elements: Ornament

Materials: Concrete

Condition: Good

The primary evidence that the Tumwater Paper Mill was echoing the original design of the brewery buildings is found in the concrete exterior, the chamfered pilasters and the corbelling at the roofline.

Recommendations:

- Retain all exterior ornament, including the three bays and the chamfering on the columns, seen left

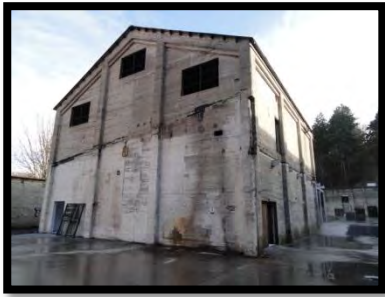
### Additional Elements: Finish

Materials: Paint, sealant, flashing

Condition: N.A.

Recommendations:

- Paint and sealant may be retained in place or removed by the gentlest means possible

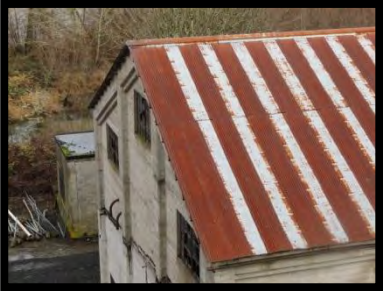
<p>Materials: Corrugated Galvanized Steel  Condition: Unknown  Significance: Secondary</p> <p>The corrugated metal roof appears to be sound, as there's no leakage visible within the building. It's not known when it was installed. The roof appears white in a hand-tinted postcard.</p> <p>Recommendations:</p> <ul style="list-style-type: none"> <li>• Repair and retain or replace in kind</li> <li>• As the surface was originally painted white, it can be repainted white. It can also be left striped if it remains in good condition</li> </ul>

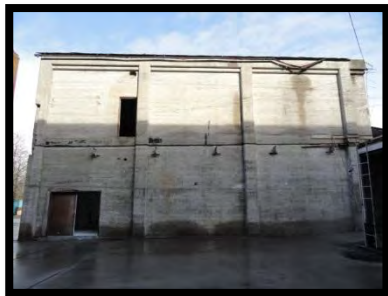
## Additional Elements: Ornament

Materials: Concrete  
Condition: Good  
Significance: Primary

The primary evidence that the Tumwater Paper Mill was echoing the original design of the brewery buildings is found in the concrete exterior, the chamfered pilasters and the corbelling at the roofline.

### Recommendations:

- Retain all exterior ornament, including the three bays and the chamfering on the columns, seen left

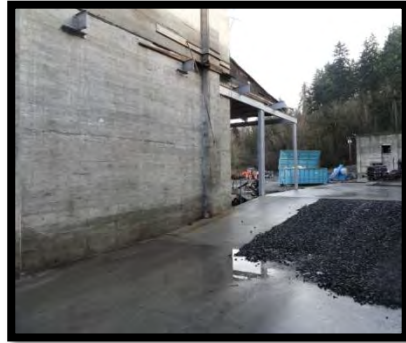
### Additional Elements: Ramps

Materials: Concrete  
Condition: Good  
Significance: Minimal

Two ramps impact the exterior of the southern façade. The first, left, negotiates a small rise into the storage building. The second, below left, negotiates a drop in elevation from one part of the concrete promenade to another. This ramp obscures a small part of the storage building's southeast corner.

Recommendations:

- Retain both ramps in place unless alterations to the promenade are necessary

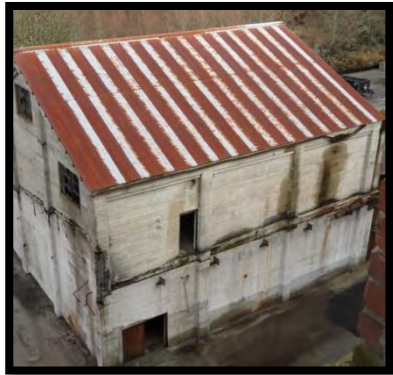
### Additional Elements: Finish and Supports

Materials: Paint, Sealant, Metal  
Condition: N.A.  
Significance: Minimal

The white paint on the first story and the remnants of sealant and flashing show where this wall was once integrated into the infill structure between the Storage Building and the Warehouse to the south. There are also protruding beams.

Recommendations:

- May be retained in place or removed by the gentlest means possible

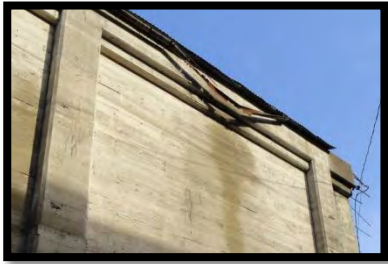
**Additional Elements: Gutter**

Materials: Metal  
Condition: Poor  
Significance: Minimal

A gutter system once helped protect the building from weather. The gutter system is greatly deteriorated.

Recommendations:

- Remove and replace

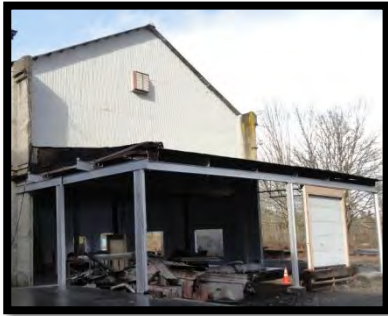
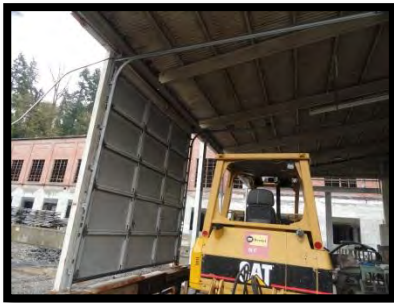
## Construction

Materials: Corrugated Steel  
Condition: Good  
Significance: Secondary

The top floor is enclosed with recently painted corrugated sheet steel. The structural system of the former addition remains in place but the corrugated metal panels have been removed. An overhead door remains but it does not appear in historic mid-century photos and is not original to the building.

### Recommendations:

- If enclosing the building is the goal, identify the new construction as non-historic
- If removing the addition is necessary, consider enclosing the space with historically appropriate materials
- If finishing the building in concrete is the goal, ensure that the east wall does not give a false sense of history

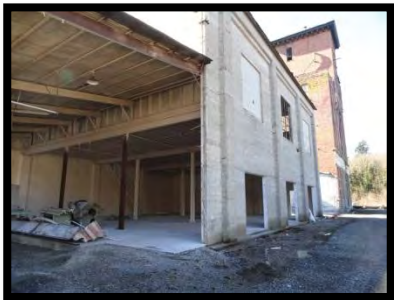
## Roof

Materials: Corrugated Galvanized Steel  
Condition: Good  
Significance: Secondary

The metal roof on the storage building is echoed in the roof of the former addition, which is also corrugated metal. Purlins appear under a narrow eave on the gable end.

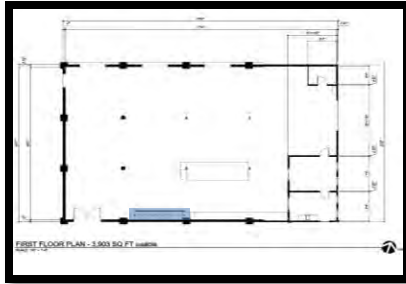
### Structure: Interior Volumes

Significance: Secondary

This floor plan, drawn up by Urbanadd Architects and Ryan Rhodes Designs, shows an addition on the eastern portion of the building that has since been removed. The structure of the addition remains in place, but interior and exterior walls have been removed.

Recommendations:

- Retain sense of openness, if possible

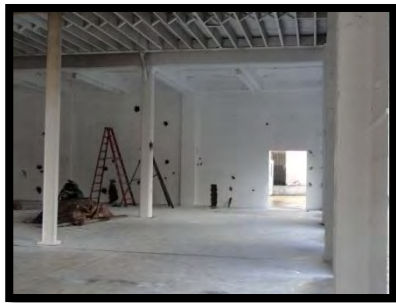
### Structure: Columns and Beams

Materials: Steel and Concrete

Condition: Good

Recommendations:

- Retain in place

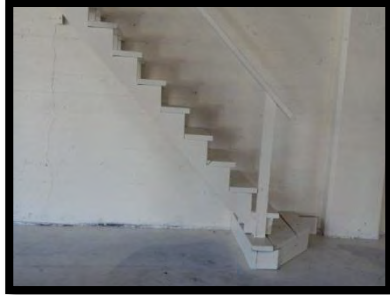
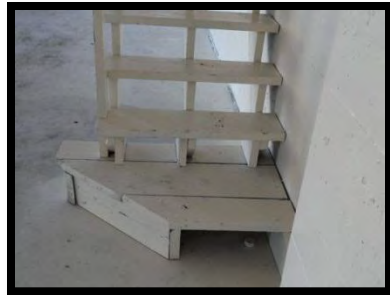
### Traffic: Stair

Materials: Wood  
Condition: Good  
Significance: Secondary

The open-riser stair on the south wall is the only access between the building's two floors. Treads, rails, carriage and platform are all wood, recently painted.

#### Recommendations:

- Retain in place

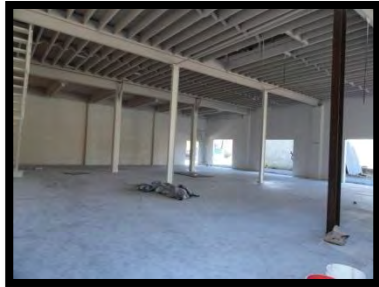
### Finishes: Floors

Materials: Painted Concrete  
Condition: Good  
Significance: Minimal

The storage building's floor is a recently painted concrete surface. Photos from before the recent repainting show a darker surface.

#### Recommendations:

- Retain in place or repaint

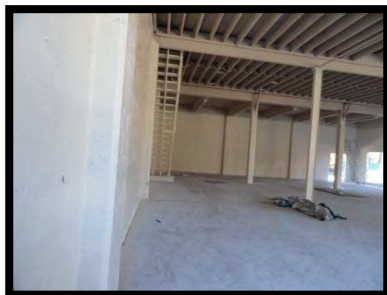
### Finishes: Walls

Materials: Painted Concrete  
Condition: Good  
Significance: Minimal

The wall surfaces were recently painted but match the color matches the most recent surface coat.

#### Recommendation:

- Maintain in place or repaint

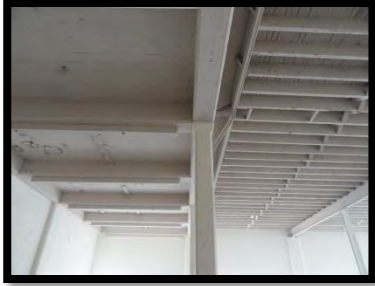
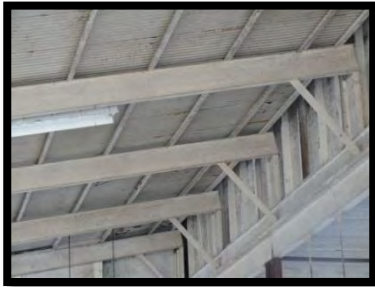
## Finishes: Ceiling

Materials: Wood and Concrete/Steel

Condition: Good

Recommendations:

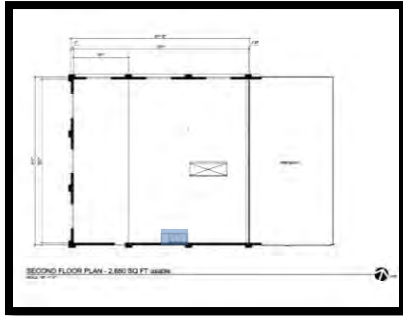
### Structure: Interior Volumes

Significance: Secondary

Recommendations:

- If possible, retain the sense of openness and the visibility of trussing and other systems

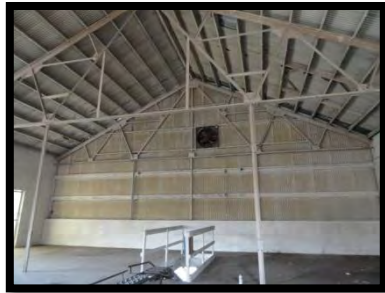
### Structure: Columns and Beams

Materials: Metal  
Condition: Good  
Significance: Primary

The roofing system, Fink or pitched Fink trusses, have been left visible, along with two supporting members.

Recommendations:

- All structural columns should be investigated by structural engineers
- Columns should be retained in place
- Historically unpainted columns should be left unpainted; historically painted columns should remain painted

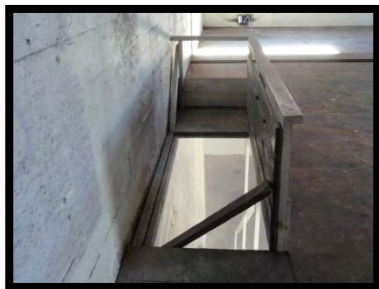
### Traffic: Stair

Materials: Wood  
Condition: Good  
Significance: Secondary

The open-riser stair on the south wall provides the only access between the building's two floors. Treads, rails, carriage and platform are all wood, recently painted.

Recommendations:

- Retain in place, if possible
- If the stair must be altered, retain door for use in another location

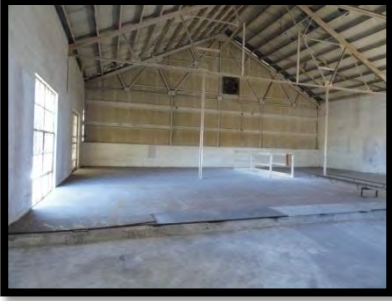
<p><b>Finishes: Floors</b></p>

<p>Materials: Painted Concrete and Wood  Condition: Good  Significance: Secondary</p> <p>The second floor includes two different floor types, a concrete floor on the western section and a plywood floor on the eastern section.</p> <p>Recommendations:</p> <ul style="list-style-type: none"> <li>• Retain in place if possible</li> </ul>
<p><b>Finishes: Walls</b></p>

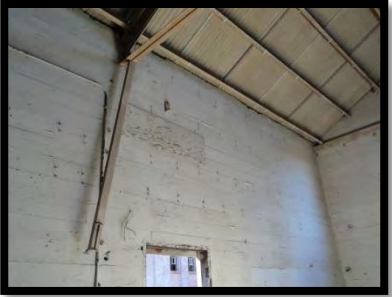
<p>Materials: Painted Concrete and Corrugated Metal  Condition: Good  Significance: Secondary</p> <p>The wall surfaces were recently painted to match the former color.</p> <p>Recommendation:</p> <ul style="list-style-type: none"> <li>• Maintain in place or repaint</li> </ul>
<p><b>Finishes: Ceiling</b></p>

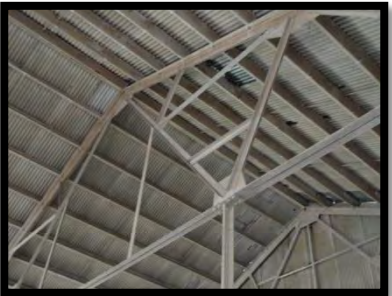
<p>Materials: Wood  Condition: Good  Significance: Primary</p> <p>The corrugated sheet steel and the Fink truss have recently been repainted white, though this is also the color associated with the building interior in contemporary photos.</p> <p>Recommendations:</p> <ul style="list-style-type: none"> <li>• Retain in place</li> <li>• Do not cover or encase structure</li> </ul>

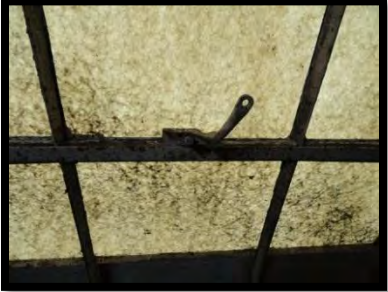
<p><b>Additional Elements: Window Hardware</b></p>

<p>Materials: Metal  Condition: Fair to Good  Significance: Secondary</p> <p>Window hardware is a character defining element of industrial windows and should be retained when possible.</p> <p>Recommendations:</p> <ul style="list-style-type: none"> <li>• Retain in place, if possible, or replace in kind if corrosion makes replacement necessary</li> </ul>
<p><b>Additional Elements: Conveyor Belt</b></p>

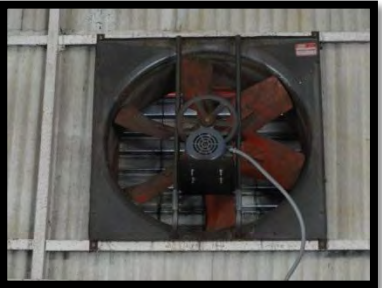
<p><b>Additional Elements: Fan</b></p>

<p>Materials: Various  Condition: Unknown  Significance: Secondary</p> <p>A fan is installed prominently on the eastern wall of the building, an artifact of its earlier industrial use.</p> <p>Recommendations:</p> <ul style="list-style-type: none"> <li>• Retain if possible</li> <li>• If it must be removed, reuse on site</li> </ul>

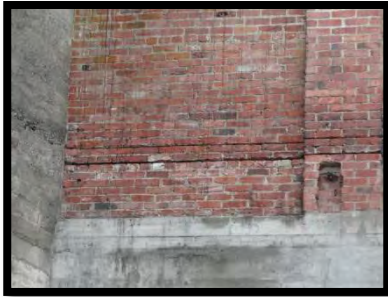
## Masonry

Materials: Red Brick

American Bond: 6 stretcher courses per header

Condition: Fair to Good

The brick on the warehouse is in better condition than on brewery era buildings. The north elevation is sheltered from weather. The course is somewhat inconsistent due to the amount of area devoted to windows, pilasters and panels.

Recommendation:

- Use original brick for repairs if needed
- Replacement brick, if needed, should be of a similar size, color and texture
- Repoint with hand tools to maintain joint profile
- All brick ornament, including corbelling at the cornice, pilasters, projections and recessions should be retained

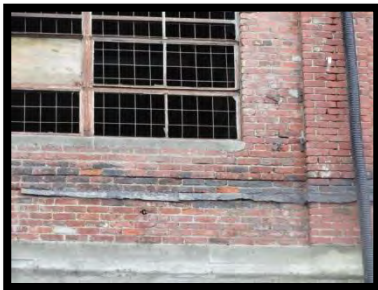
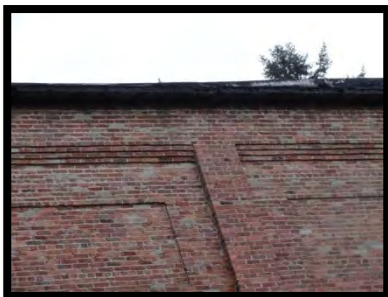
## Mortar

Materials: Composition Unknown

Condition: Good

The mortar seems most deteriorated on projecting pilasters.

Recommendations:

New mortar should match the requirements identified by the National Park Service in Preservation Brief 2, found in the appendix:

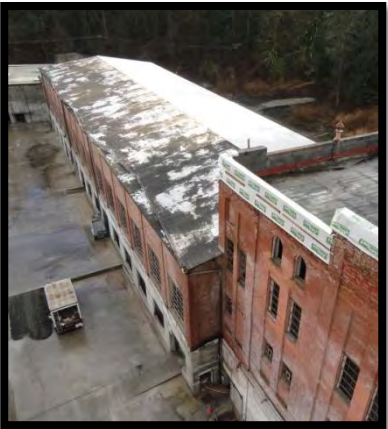
<p>Materials: Various  Condition: Unknown  Significance: Primary</p> <p>The roof on the warehouse is constructed of two materials. The shallow gable includes a composition roof on the northern slope and corrugated galvanized sheet steel on the southern slope. The northern slope appears to be in a more deteriorated condition. The gutter system has been displaced.</p> <p>Recommendations:</p> <ul style="list-style-type: none"> <li>Retain in place</li> <li>Restore composition roof on southern slope, if preferred</li> <li>Repair or replace gutter system to protect historical materials</li> </ul>

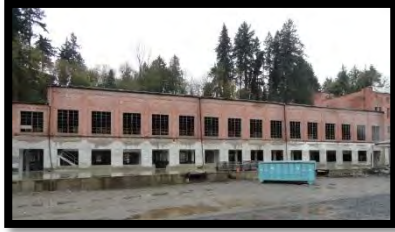
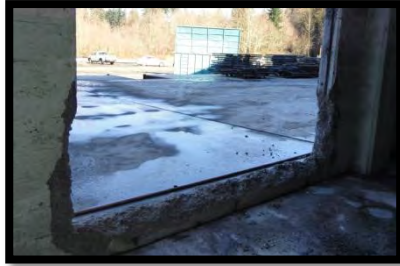
## Doors

Materials: Missing  
Condition: Missing  
Significance: Openings are primary

Five of the large window openings on the bottom floor have been converted into doorways. No casings or windows remain. On historic plans and in historic photos, all openings are treated identically as windows.

### Recommendations:

- Repair and retain openings that can be reused
- Convert unused doors to windows based on original fenestration. Replace windows in kind

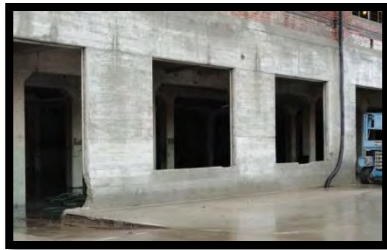
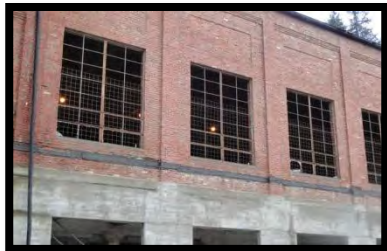
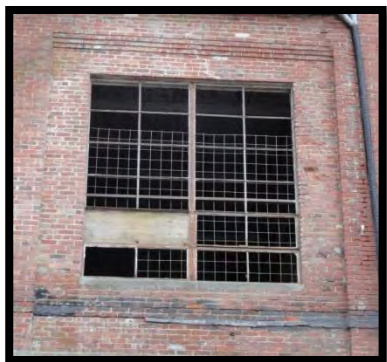
## Windows

Materials: Steel, where intact  
Condition: Good, where intact  
Significance: Primary

The windows on the bottom floor, left, include neither the casings nor the windows themselves. Only the openings remain.

### Recommendations:

- Replacement windows on the bottom floor should be recognizably new but historically appropriate, made of similar materials and echoing the industrial look and feel of the second story windows.
- The identical openings on the second story are perhaps the most character defining features of the north facade. The industrial windows should be retained and reglazed

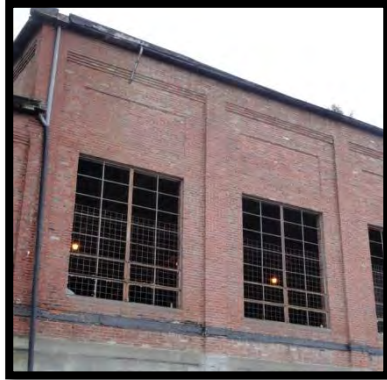
**Additional Elements:  
Ornamental Brick Work**

Materials: Red Brick  
Condition: Good  
Significance: Primary

If the windows are the most defining feature, the surrounding brickwork emphasizes the symmetry of the original design, dividing the façade into bays and emphasizing those bays with shallow pilasters, inset panels, and corbelling near the roofline.

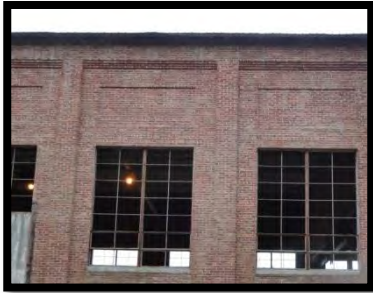
## Masonry

Materials: Red Brick  
American Bond: 6 stretcher courses per header  
Approximate size: 8 ¼" x 2 ½" x 4"  
Condition: Fair to Good  
Significance: Primary

The brick on the warehouse is in better condition than on brewery era buildings. The course is inconsistent due to the amount of space devoted to windows, pilasters and panels that interrupt the American bond.

### Recommendation:

- Use original brick for repairs if needed
- Replacement brick, if needed, should be of a similar size, color and texture
- Repoint with hand tools to maintain joint profile
- All brick ornament, including corbelling at the cornice, pilasters, projections and recessions should be retained

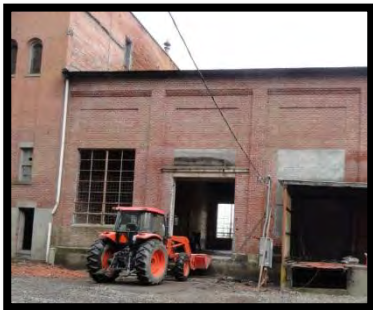
## Mortar

Materials: Composition Unknown  
Condition: Good  
Significance: Primary

The mortar seems to be in good condition on the south façade.

### Recommendations:

### Further Recommendations:

- Historic mortar should be tested to determine quantities of lime, sand and Portland cement for adequate matching
- Repoint with mortar similar in composition, color, texture, joint size, method of application and joint profile
- Choose a mason who's familiar with historic brick

buildings and is willing to hand tool the joints before repointing
<p><b>Concrete</b></p>

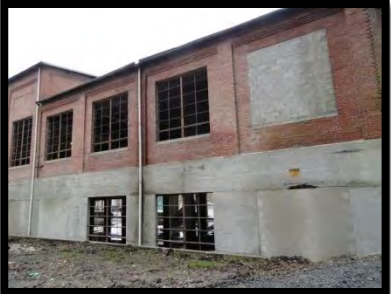
<p>Materials: Concrete  Condition: Good  Significance: Primary</p> <p>Board formed concrete was used inside and out on the first floor and is visible here on the south facade. It also was used to fill openings, as seen in the photo left.</p> <p>Recommendations:</p> <ul style="list-style-type: none"> <li>• Retain in place</li> <li>• Clean by the gentlest means possible</li> <li>• Remove and restore original fenestration where possible</li> </ul>
<p><b>Roof</b></p>

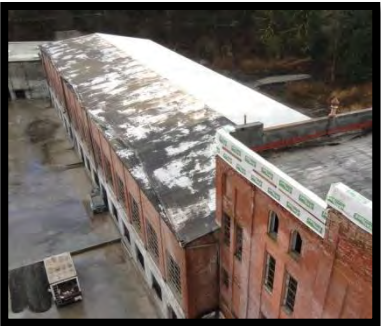
<p>Materials: Various  Condition: Unknown  Significance: Primary</p> <p>The roof on the warehouse is made up of two materials. The shallow gable includes a composition roof on the northern slope and corrugated galvanized sheet steel on the southern slope. The southern slope has likely been reroofed as historic photos do not show corrugated metal on the roof.</p> <p>Recommendations:</p> <ul style="list-style-type: none"> <li>• Retain in place or reroof</li> </ul>

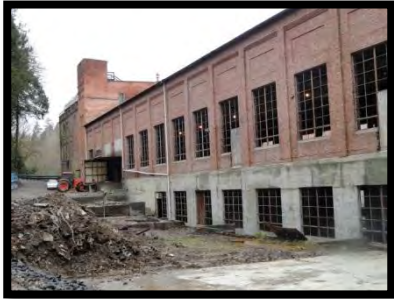
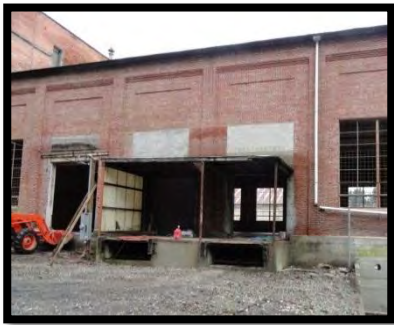
## Doors

Materials: Metal  
Condition: Good  
Significance: Secondary

Three doors have been cut into the southern facade. Two of them are now secured with metal rolling doors and the third with an overhead door. These doors and openings are not original to the building but clearly were related to its industrial use. Machinery, possibly for winching, has been installed outside the metal doors and topped with metal grates protected by a temporary roof.

### Recommendations:

- Retain in place or replace with historically appropriate materials
- Doors may be removed to reestablish the original fenestration

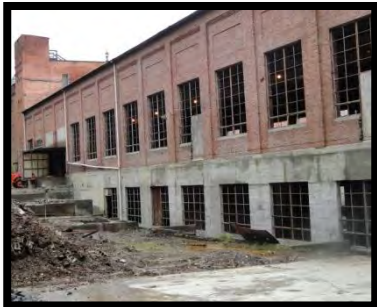
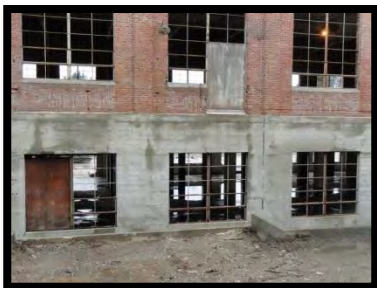
## Windows

Materials: Steel, where intact  
Condition: Good, where intact  
Significance: Primary

The openings on the bottom floor include windows similar to those on the north façade but smaller. These windows consist of paired, six-light, fixed windows atop two sets of paired apron windows. Some window openings have been blocked in.

### Recommendations:

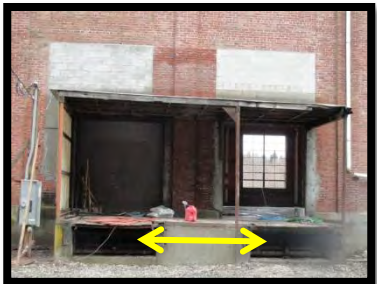
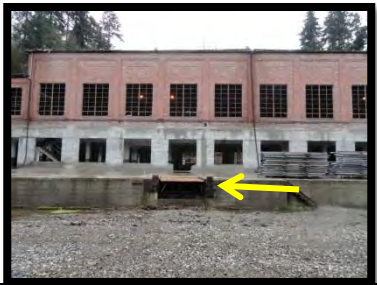
**Additional Elements:  
Exterior Machinery**

Materials: Various  
Condition: Unknown  
Significance: Secondary

The machinery found outside the south façade was used for an unknown purpose. Historic plans refer to a large 500-pound press near this location, as well as a water tank and well underneath the building near this location. The machinery may be related to these or other uses. It's worth noting that a similar opening with similar machinery appears on the north side of the building under the promenade. It is indicated in the photo below left.

- Retain in place or, after determining the age and function through further research, remove and restore original openings on the south elevation

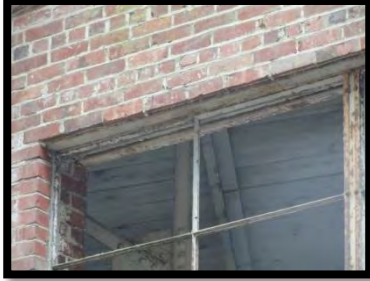
## Masonry

Materials: Red Brick  
American Bond: 6 stretcher courses per header  
Approximate size: 8 ¼" x 2 ½" x 4"  
Condition: Fair to Good  
Significance: Primary

The brick on the exterior of the warehouse is in better condition than on brewery era buildings.

- Use original brick for repairs if needed
- Replacement brick, if needed, should be of a similar size, color and texture
- Repoint with hand tools to maintain joint profile
- All brick ornament, including corbelling at the cornice, pilasters, projections and recessions should be retained

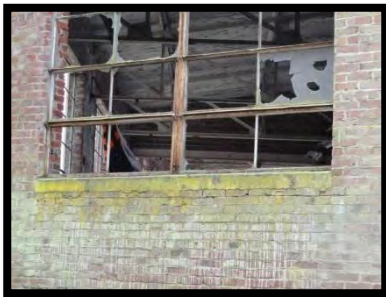
## Mortar

Materials: Composition Unknown  
Condition: Good  
Significance: Primary

The mortar is in fairly good condition, but weather has stressed some joints.

- Historic mortar should be tested to determine quantities of lime, sand and Portland cement for adequate matching
- Repoint with mortar similar in composition, color, texture, joint size, application and joint profile

<ul style="list-style-type: none"> <li>Choose a mason who's familiar with historic brick buildings and is willing to hand tool the joints before repointing</li> </ul>
<p><b>Concrete</b></p>

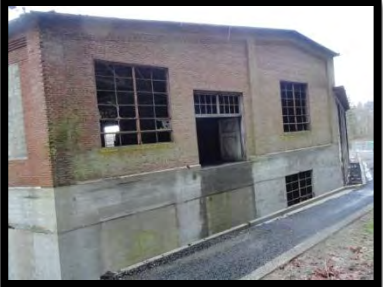
<p>Materials: Concrete  Condition: Good  Significance: Primary</p> <p>As on other elevations, the bottom floor is made of board-formed concrete.</p> <p>Recommendations:</p> <ul style="list-style-type: none"> <li>Retain in place</li> <li>Clean by the gentlest means possible</li> </ul>
<p><b>Doors</b></p>

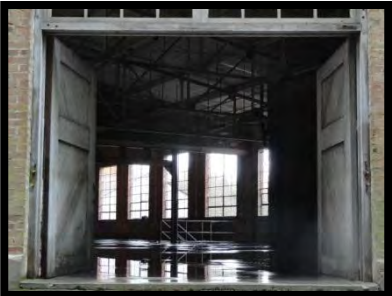
<p>Materials: Wood  Condition: Good  Significance: Secondary</p> <p>These two wooden doors are the only wooden doors in the warehouse and some of the few remaining doors of any material. Their age is unknown.</p> <p>Recommendations:</p> <ul style="list-style-type: none"> <li>Retain in place</li> </ul>
<p><b>Windows</b></p>

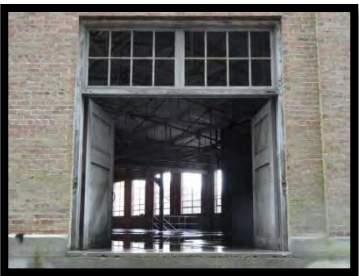
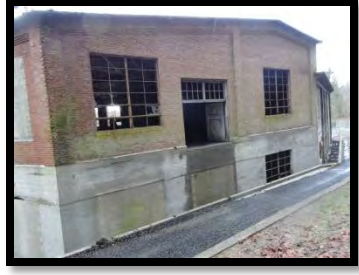
<p>Materials: Wood and Steel  Condition: Good  Significance: Primary</p> <p>There are two types of windows on the east elevation. The paired eight-light wood windows, seen left, are unusual and unique to the building. While other windows are metal and distinctly industrial, these transom windows, separated by a narrow wood mullion are graceful enough to connote a public entrance. This second floor entry, however, is above ground and not easily accessible, as seen in the photo below.</p> <p>The metal windows on either side of the door are eight light fixed windows over operable awning windows, as on other elevations of the Warehouse. Two of the window sets are on the second floor, and one set is on the lower floor. Other window openings have been filled with concrete block.</p>

<p>Recommendations:</p> <ul style="list-style-type: none"> <li>• Retain and reglaze all windows</li> </ul>
<p><b>Additional Elements: Ornamental Brick Work</b></p>

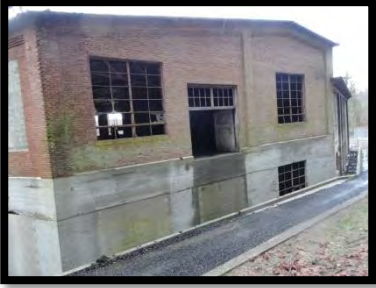
<p>Materials: Red Brick Condition: Good Significance: Primary</p> <p>The brickwork is one of the most distinguishing features of the warehouse, though its pattern on this elevation is not consistent with the symmetry found on other elevations.</p> <p>Recommendations:</p> <ul style="list-style-type: none"> <li>• Retain all ornamental brick work, including pilasters and corbelling</li> </ul>

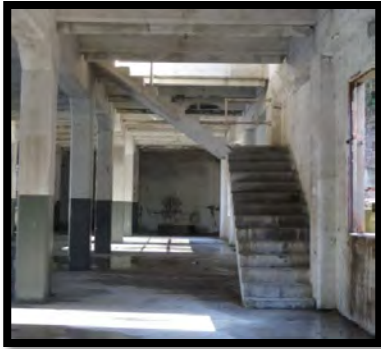
### Traffic: Stairs

Materials: Concrete  
Condition: Varied  
Significance: Secondary

There are three stairs between the first and second floors. The two concrete, quarter-turn stairs near the eastern edge of the building are very plain. One of the two has no handrail.

The third stair, a half-turn stair near the entrance to the Cellar building, is in poorer condition. Its rail is in place but broken and its steps are disintegrating and need repair.

- Retain stairs in place, if possible
- Repair historic materials

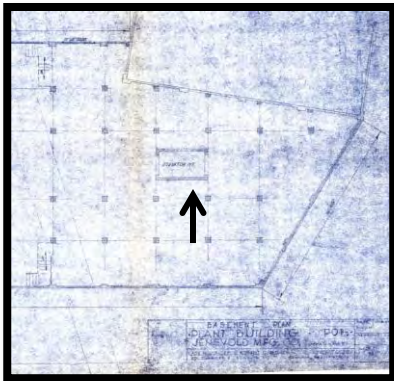
### Traffic: Elevator

Materials: Concrete  
Condition: N.A.  
Significance: Minimal

Though there is no elevator in the building now, the original historic plans call for an elevator pit in the eastern section of the building, as seen left. This space is currently marked by a visible outline in the concrete.

- The pad may be a remnant of the original lift and may be left visible or covered

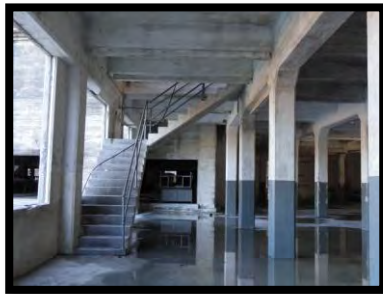
### Surfaces: Wall

Material: Painted Concrete  
Condition: Good  
Significance: Secondary

The walls have likely been repainted, but they appear to match the paint found in historic photos. The lower halves of columns are clearly darker than the tops in these photos. The pattern also echoes the Brewhouse interior, which is appropriate.

- Retain in place or repaint
- If columns are obscured by interior walls, leave them as visible as possible, along with beams

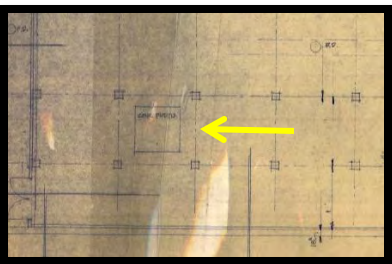
<p>Materials: Concrete  Condition: Good  Significance: Secondary</p> <p>Rising from floor to ceiling is a large reinforced concrete block that appears on early plans but is not explained. On the floor above was installed a 500-pound press, and this column of concrete may have been installed to support the floor underneath it.</p> <p>Recommendations:</p> <ul style="list-style-type: none"> <li>• Consider investigating and removing column, or leaving in place</li> </ul>

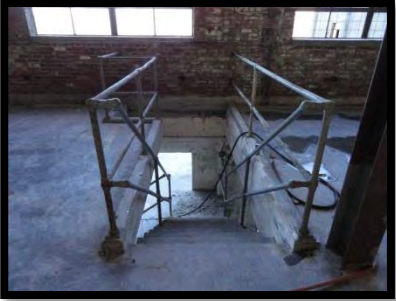
<p>Materials: Concrete and Metal Rail Condition: Fair Significance: Secondary</p> <p>The stairs that rise from the first floor are surrounded by railings on the second floor.</p> <p>Recommendations:</p> <ul style="list-style-type: none"> <li>• Retain stairs and railings in place, if possible</li> <li>• Repair and retain original materials, where possible</li> </ul>

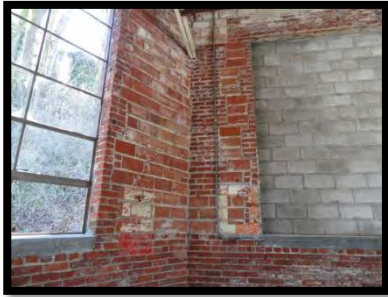
### Surfaces: Wall

Material: Brick/Block  
Condition: Good  
Significance: Primary

While the first floor is encased in concrete, the second floor is built of red brick. However, while the exterior surface is uniform, the interior shows repairs and brick replacements that differ in size and shape. There are also window openings that have been filled with concrete block.

- Retain replacement bricks in place, if possible
- Uncover and return to the original fenestration. Windows should be replaced in kind

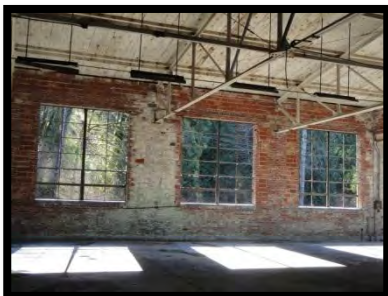
### Additional Elements: Electronics

Materials: Metal  
Condition: Fair  
Significance: Secondary

The remaining electrical systems within the building reveal its age and its original industrial use. Though most of the installed lighting has been removed, these remaining elements should be retained.

- Retain in place

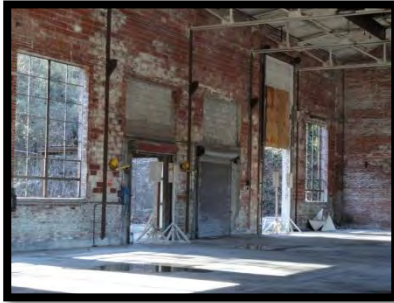
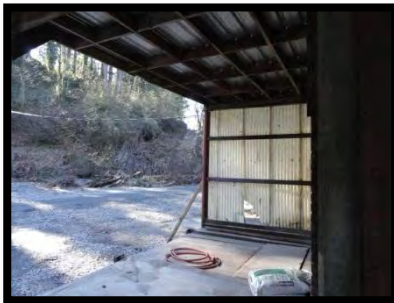
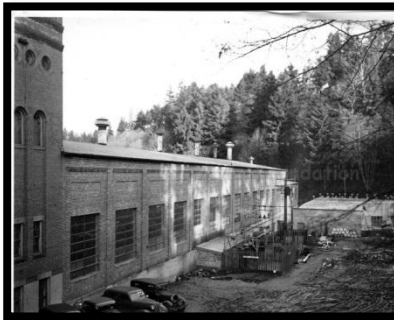
## Additional Elements: Openings

Materials: Various  
Condition: Good  
Significance: Secondary

The opening near the connection with the Cellar building includes two rolling doors topped by blocked in windows. A third opening is topped with an overhead door. Two of the doors share access to a metal platform. The platform is covered and is accessible from just above ground near the access road to the site.

- Retain in place as an artifact of the building's industrial past, or remove doors and return to the original fenestration

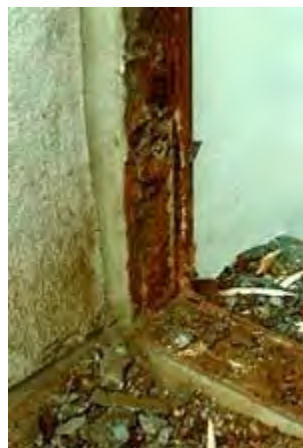
A severely deteriorated frame, such as this, can be replaced in kind. Photo:

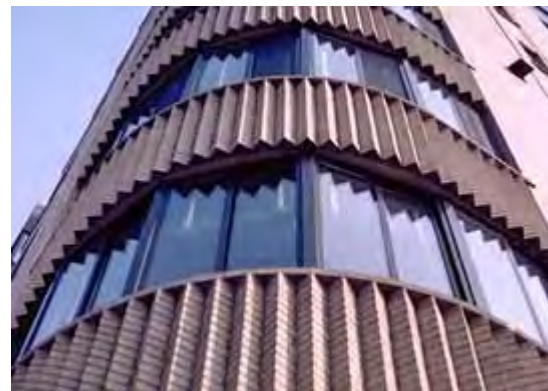
The historic steel sash (see photo above) was removed and replaced with modern aluminum sash, resulting in a negative visual impact on the building's historic character. Photo: NPS files.

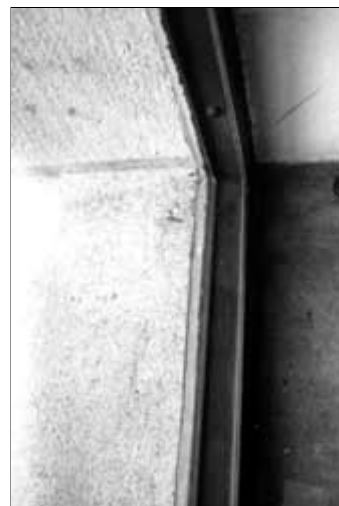
**This is a successful replacement in kind of the deteriorated frame shown above. Photo: Henry Chambers, AIA.**
