HIGHWAY ACCIDENT REPORT

COLLISION BETWEEN METROLINK TRAIN 901 AND
MERCURY TRANSPORTATION, INC., TRACTOR-COMBINATION
VEHICLE AT HIGHWAY-RAILROAD GRADE CROSSING
IN GLENDALE, CALIFORNIA
ON JANUARY 28, 2000

**NTSB/HAR-01/02
PB2001-916202
Notation 7410
Adopted November 27, 2001**

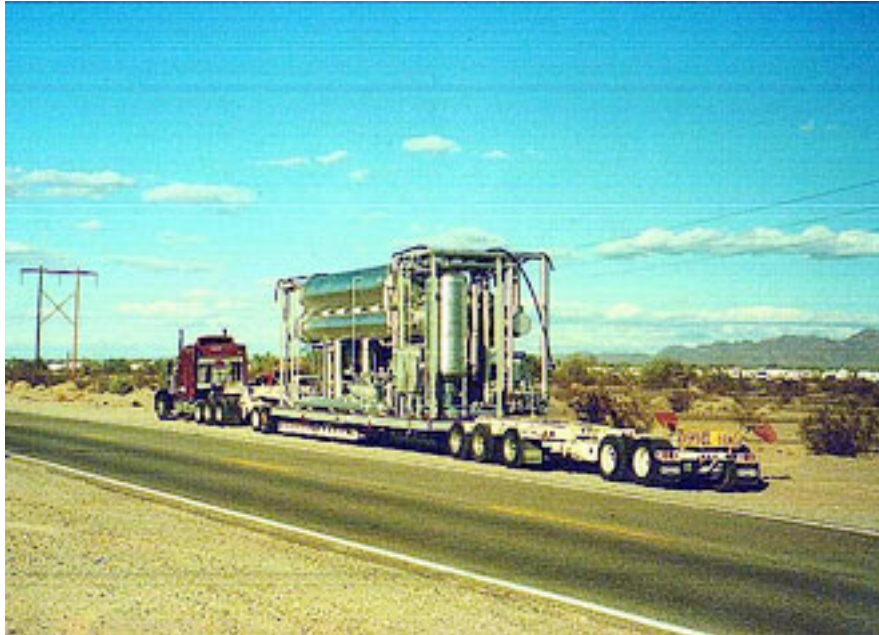
The tractor-combination vehicle measured 135 feet long, 15 feet wide, and 18 feet 6 inches high with a ground clearance of approximately 6 inches (see figure 2); the gross vehicle weight was 226,000 pounds.¹ (See appendix B for terms relating to oversize/overweight loads.) The load, valued at \$1.5 million, was being transported from

Figure 2. Photograph of the tractor-combination vehicle before the accident. *(Photograph source: Mercury Transportation, Inc.)*

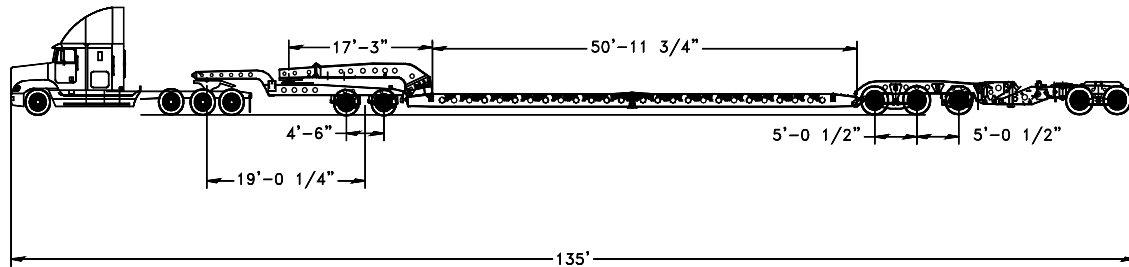
The truck consisted of a 1997 Peterbilt tractor and a 1992 Aspen semitrailer configured with a two-axle jeep, a three-axle low-boy semitrailer, and another two-axle jeep. (See figure 13.) The semitrailer was equipped with a hydraulic lift with a 13-horsepower motor. The tractor-combination vehicle was leased from Townsend Transportation in Buda, Texas.

Figure 13. Schematic of truck.
