Re: Third Five-Year Review, Luke Air Force Base, Arizona, July 2012

Final Third Five-Year Review Report

Luke Air Force Base, Arizona

July 2012

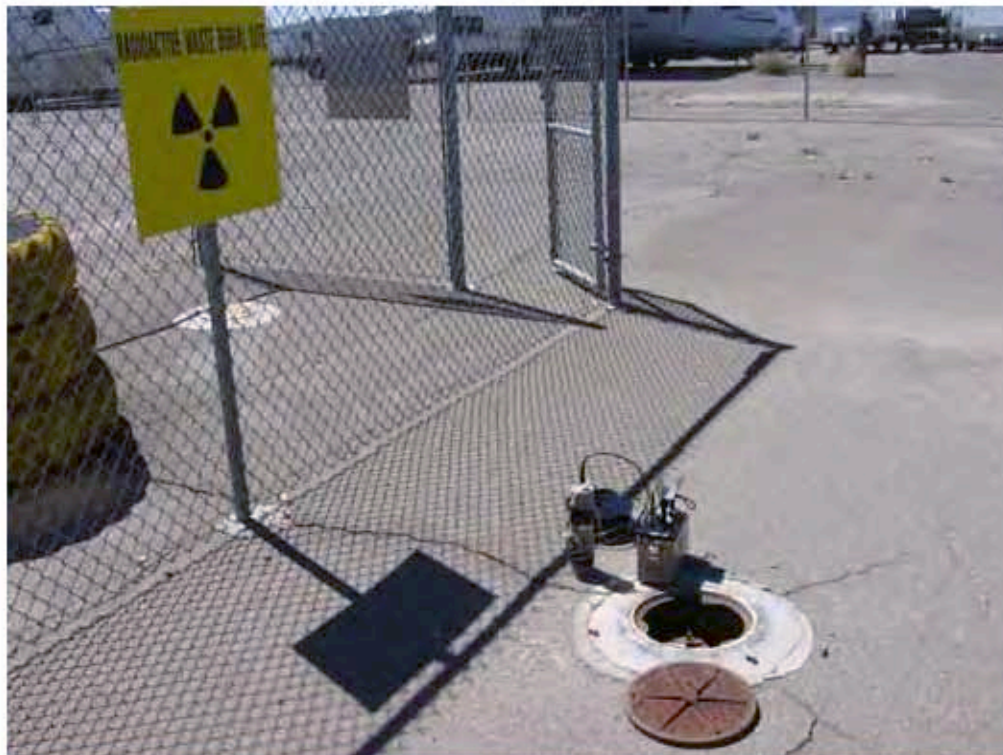
Photograph 2: The Ludlum Model 2221 portable scaler/ratemeter and Model 44-10 scintillator probe next to monitoring point MP-4.

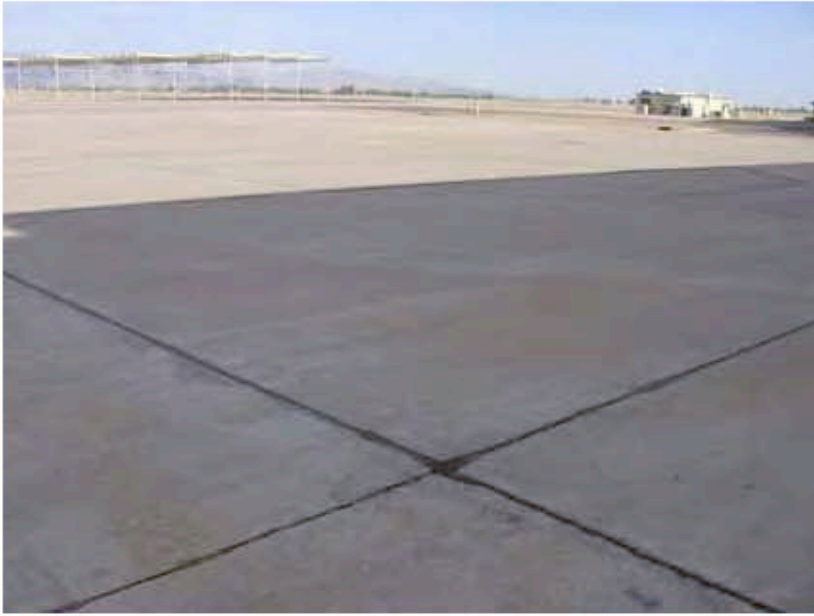
Photograph 1: Start of one of the transects walked during the 2009 cap inspection, standing next to Building 993 looking west across the cap.
