From: Eeley, Scott (A.)
Sent: Wednesday, December 02, 2009 12:59 PM
To: Espinoza, Bob (R.J.); Bergeron, Leon (F.L.)
Cc: Davis, Craig (C.B.); Dixon, Mark (M.R.); Ricks, Kevin (K.J.); Horbal, Colin (C.P.); Polasek, John (J.A.); McDonagh, Scot (S.M.); Pekarscik, Brian (B.); Mohan, Robert (R.); Smith, Ryan (R.E.); Hale, Curt (B.C.); Armesto, Carlos (.); Dumler, Jeff (J.D.); Rudd, David (D.); McAllister, Derek (D.); Fulton, Brien (B.L.); Kromberg, Arnold (A.W.)
Subject: RE: 6.4 Pump & Injectors
Attachments: Stackchart.ppt

Subject: 6.4L: WIF detection operation and HP fuel system failure.
Importance: High

From: Castleberry, Larry (L.)
Sent: Wednesday, February 04, 2009 11:54 AM
To: Pumford, Ken (K.G.); Fulton, Brien (B.L.); Haven, Keith (K.)
Subject: Emailing: P473 HP Pump Corrosion.ppt

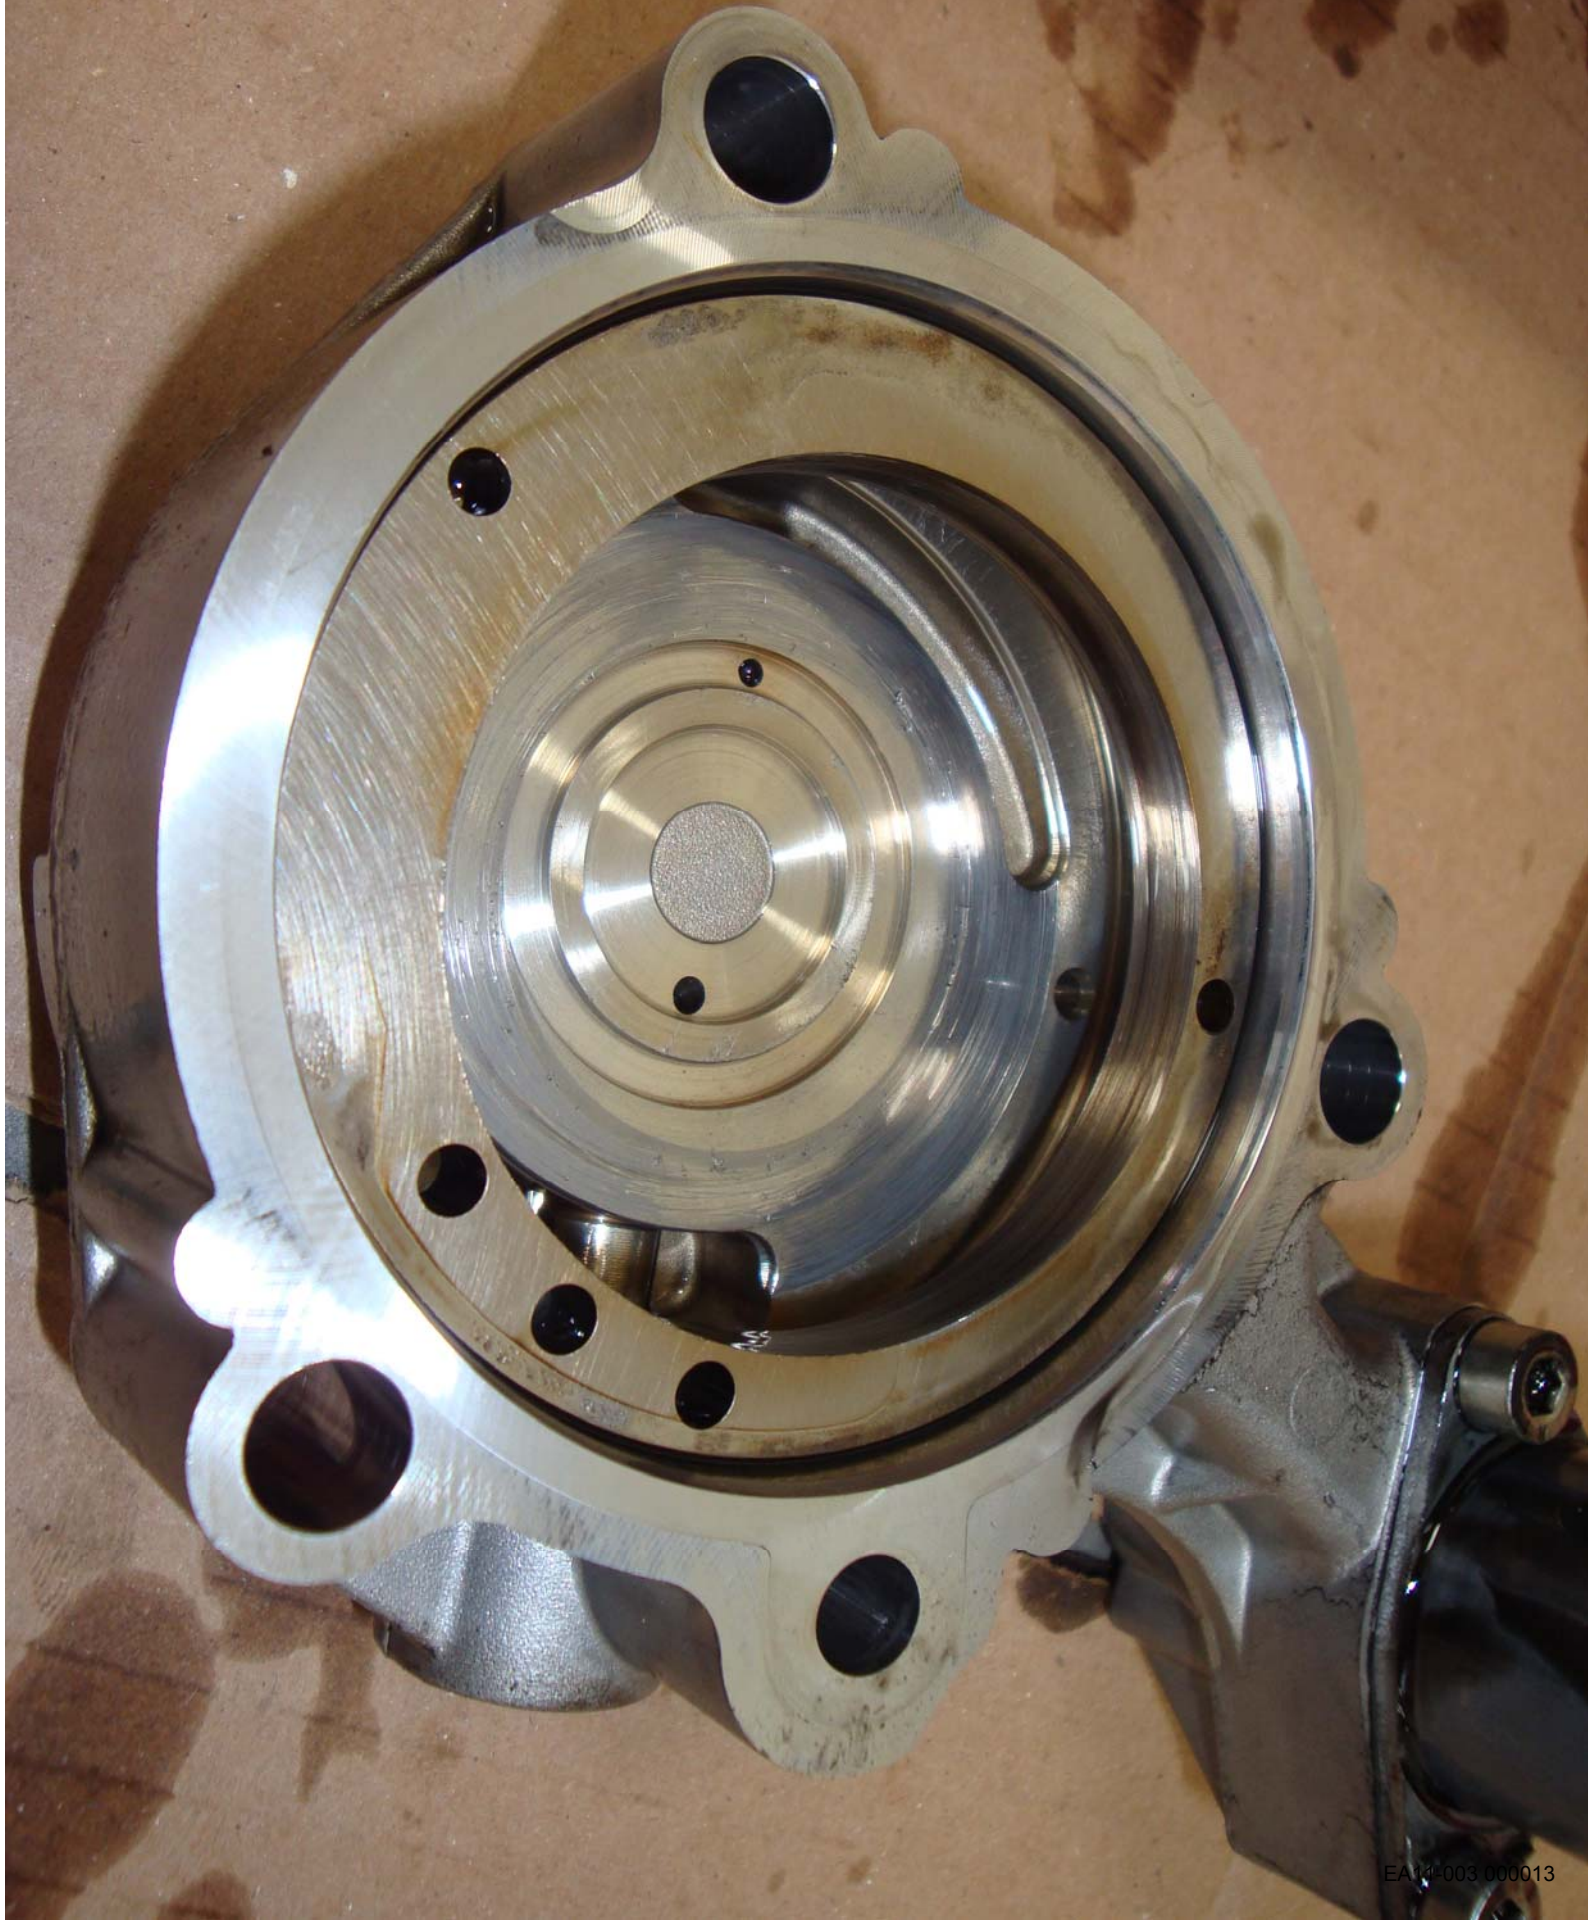
A visual analysis of a picture of a failed 6.4L diesel High-Pressure Fuel Pumps from Mexico shows galling in the ITP housing. This suggest a lubrication issue. We've requested that fuel samples be taken from vehicles that exhibit this type of wear. Our counterpart in Mexico has agreed to take samples and have them analyzed. He needs to know what to look for. Can you help by sending us the diesel Fuel Test Standards and Fuel Requirements; e.g., viscosity and lubricity vs. temperature? The attached JPG is a picture of the galling.

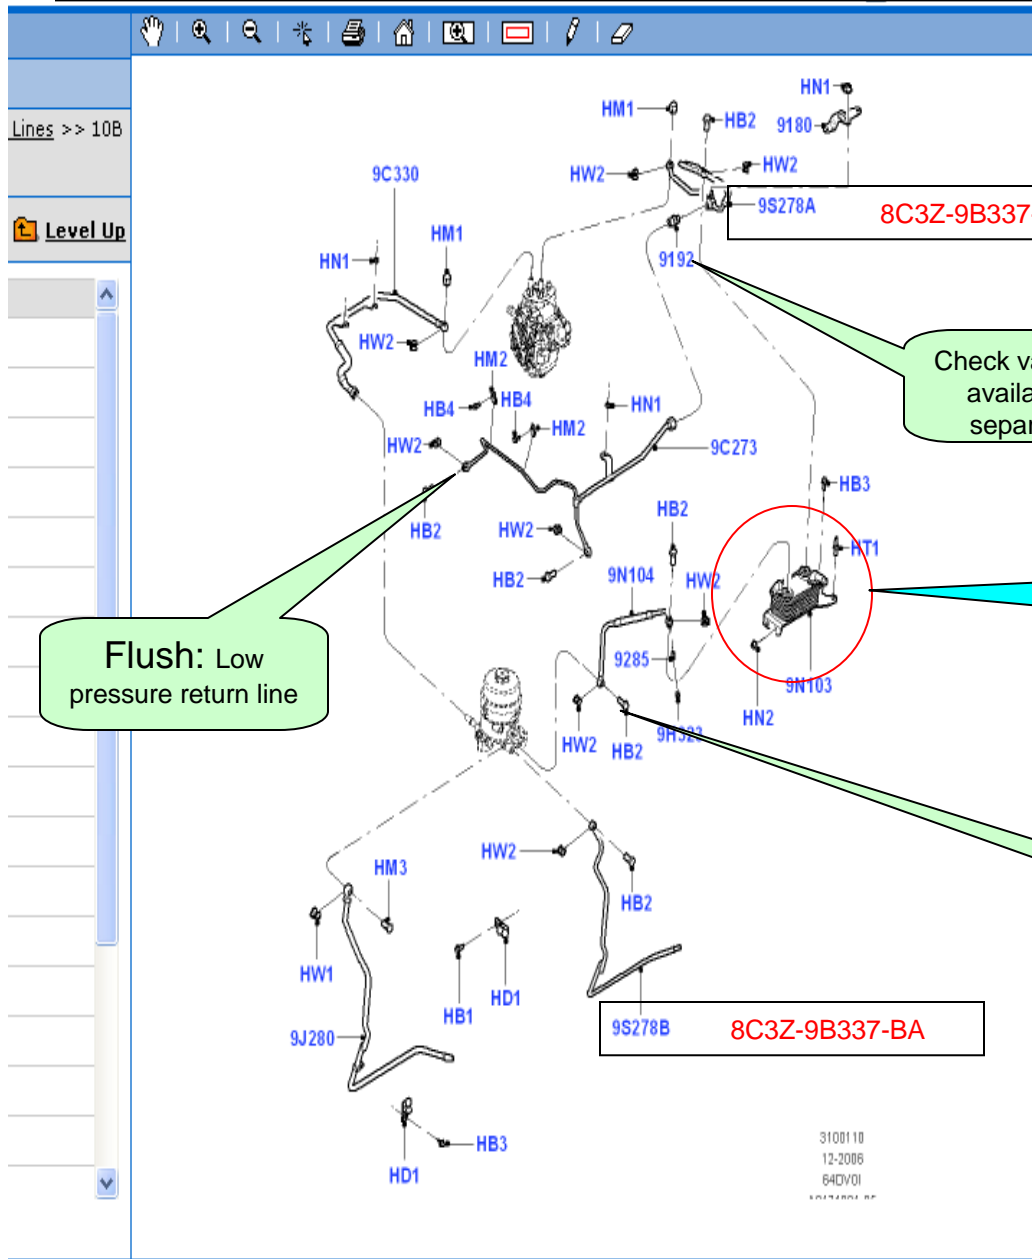
Flush: Low pressure return line

Addition to instruction current SSM if for low pressure line, Do NOT reuse if : rust internally on the banjo fittings/flaking, Sealing surface – Is concave/deformed then do not reuse

Parts to be Replaced/Flushed- 6.4L when there is metal contamination per step 28.

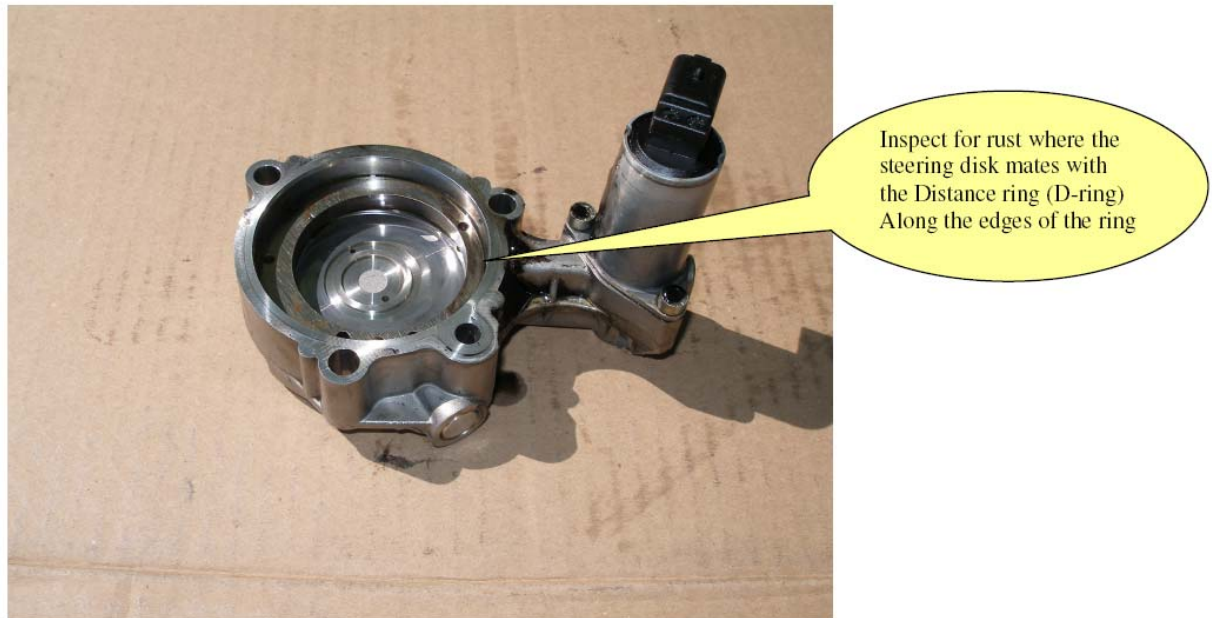
- iv) Inspect for rust where the steering disk mates with the distance ring on the ITP cover

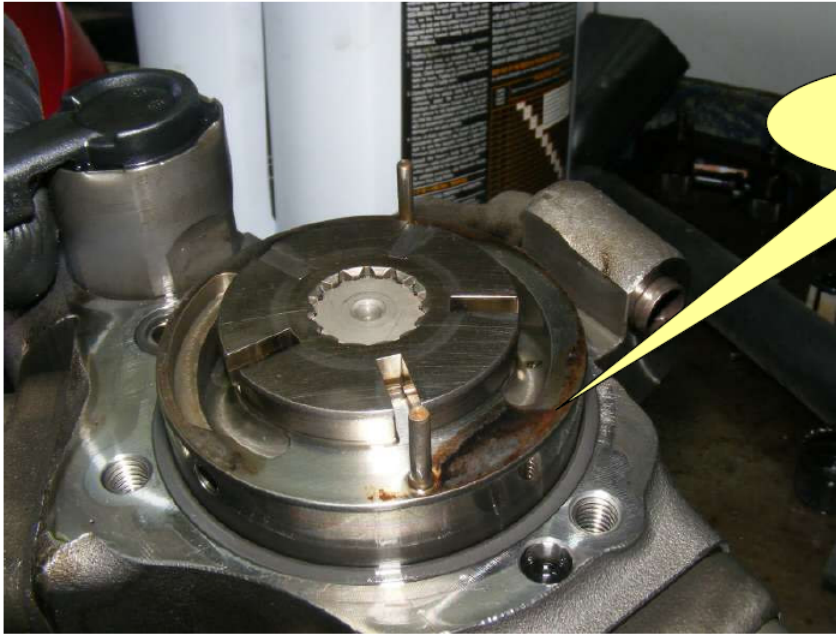
v) Inspect for rust where the steering disk mates with the distance ring on the HPP side of the mating surface.

Inspect for rust where the steering disk mates with the Distance ring (D-ring)

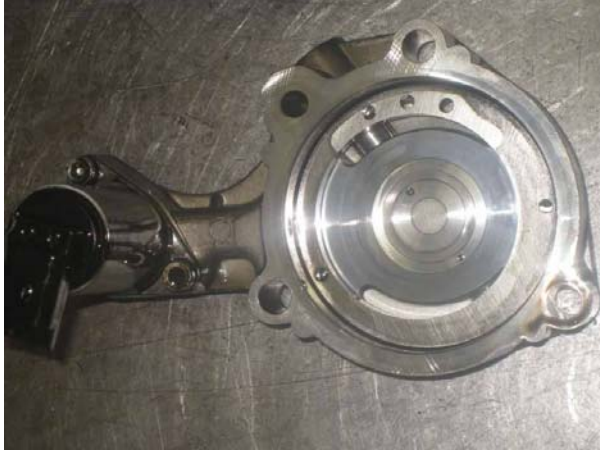
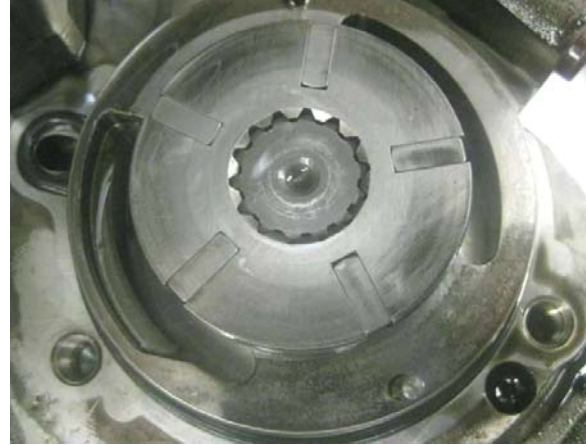
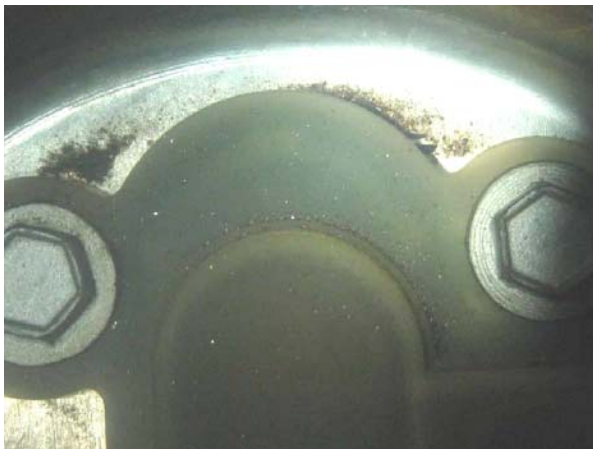
Example of No corrosion on fuel facing surfaces: No water : 74,136 Miles

Debris but no corrosion in the secondary fuel filter housing, debris in housing is not corroded.

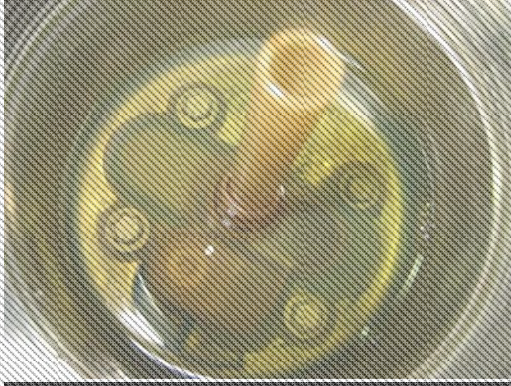
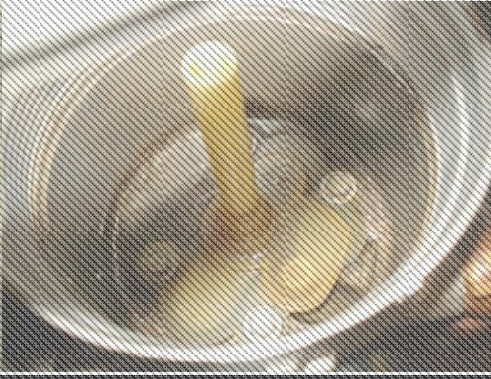
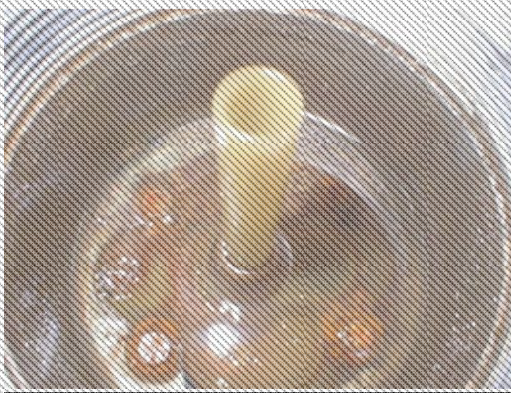
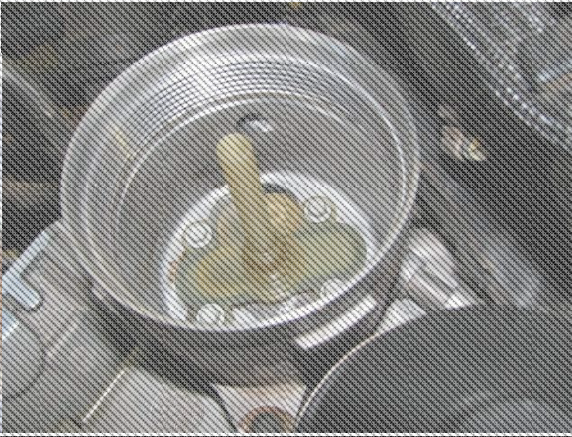
Examples of Corrosion in Secondary Fuel filter housing

Replace the following components when metallic debris is found at the fuel injectors tubes when performing Step 28 Fuel System Debris Check in the PCED Hard Start No Start Diagnostics.

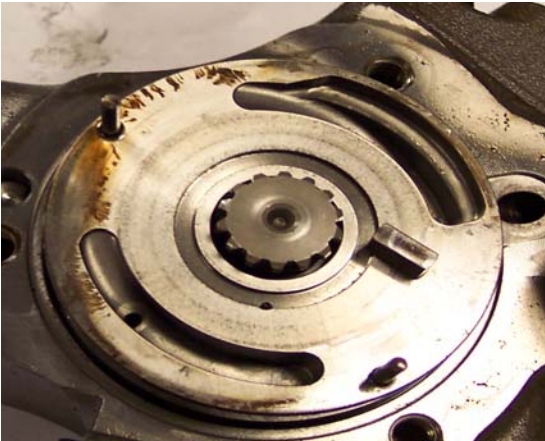
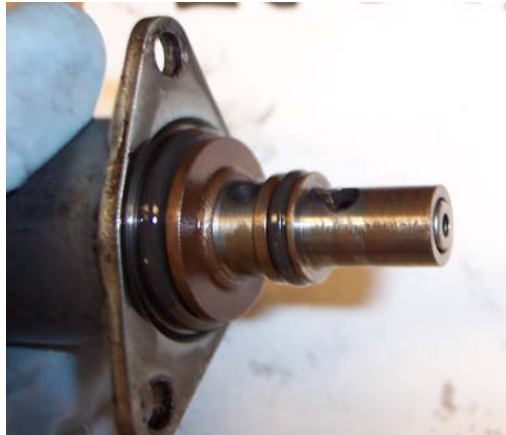
Should excessive water enter the fuel system, corrosion and damage are not far behind. In many case, the entire high pressure fuel system will have to be replaced.

Excessive water in the fuel led to this corrosion in the High Pressure Fuel Pump Internal Transfer Pump and on the Fuel Volume Control Valve

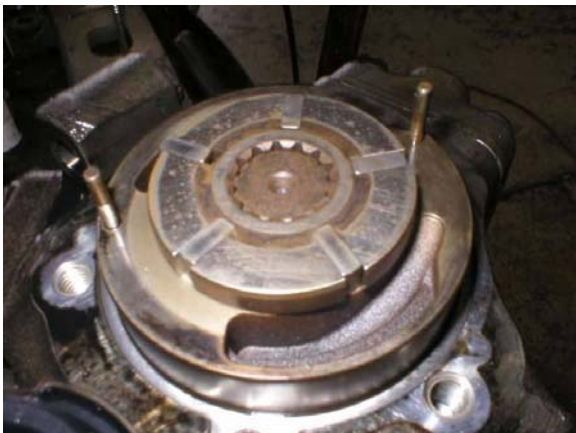
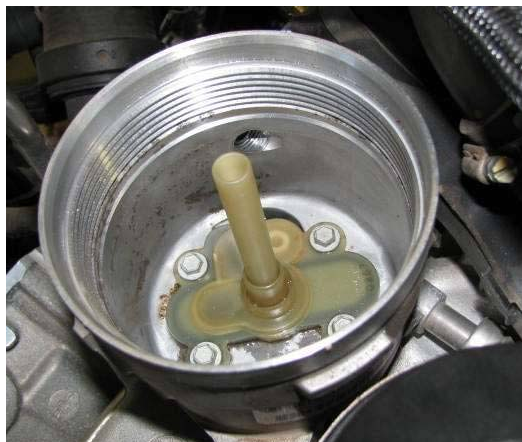
This corrosion in the High Pressure Fuel Pump internal transfer Pump and Secondary Fuel Filter Housing developed from excessive water in fuel

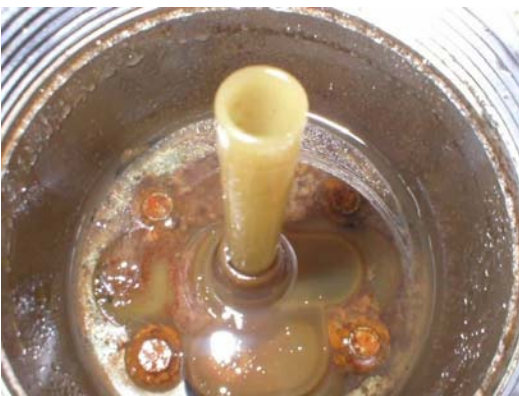
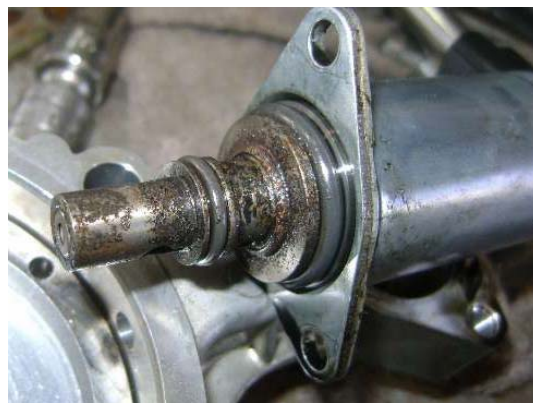
Corrosive fungus, algae and bacterial growth in secondary fuel filter housing and high pressure pump volume control valve.

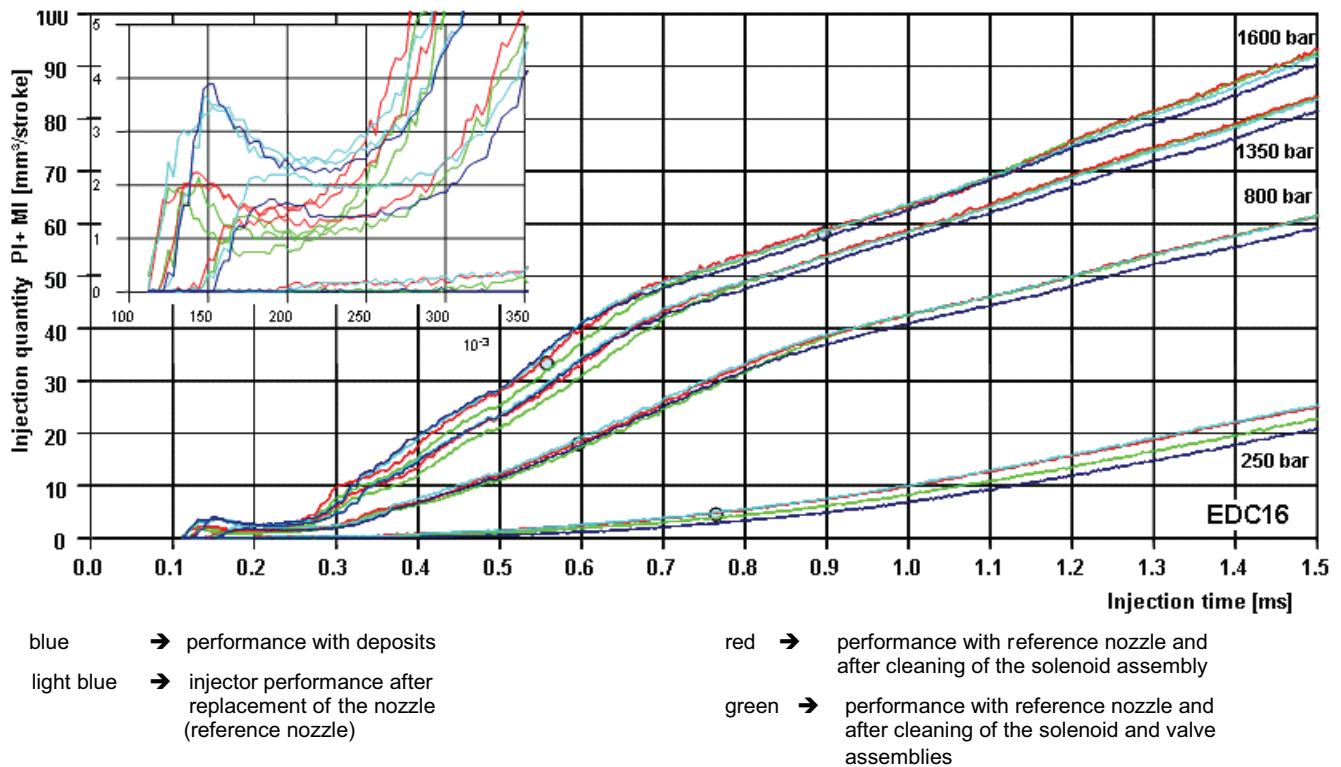
Fig. 1: Influence of Deposits on CR Injector Performance

In fig. 1 the injection quantity map for a common rail injector is shown. Due to deposit formation inside the injector the pilot injection quantity is twice as much as expected (dark blue line). Change of the nozzle to a reference nozzle did not reduce the injection quantity, proving that the deposits are not located in the spray holes of the nozzle (light blue line). After additional cleaning of internal components from the solenoid assembly (red line) or of both the solenoid and valve assemblies (green line) the original injection behaviour is restored.

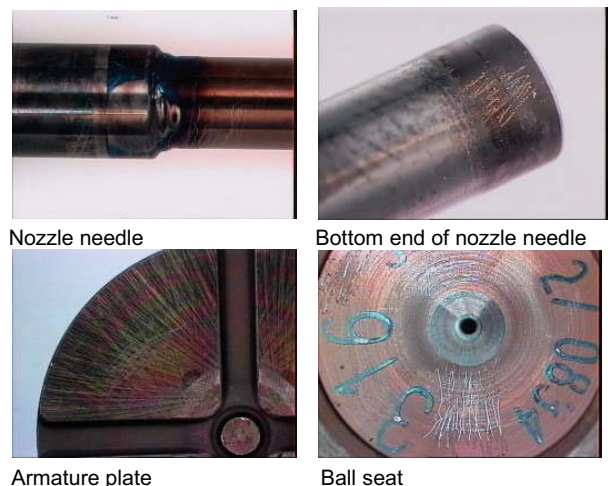
Fig.2: Injector parts with typical deposit formation

Disassembled injectors taken from engines in the field whose performance had attracted attention due to improper emission performance revealed significant deposits at the armature plate and guide, at the plunger guide and slots and at the nozzle needle. In fig. 2 injector components with typical deposit build-up are shown. It can be readily understood that such deposits, for example those at the bottom end of the nozzle needle where the clearance between the needle guide and the nozzle body is only 2 to 3 micrometer, can slow down the injector dynamics and delay the closing of the needle, with maximum effect at short injection times.

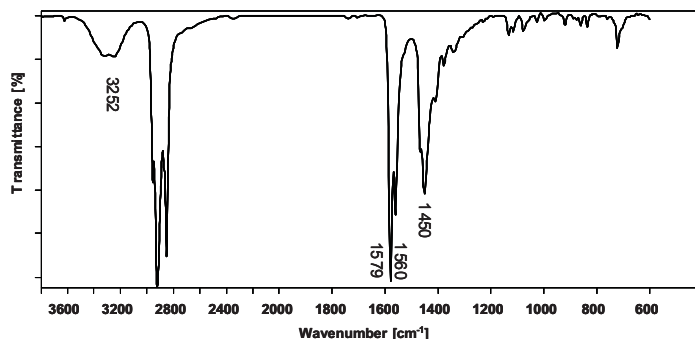
Fig. 3 shows an infrared spectrum obtained by Fourier Transform Infra Red (FTIR) analysis of this type of internal injector deposit which has recently been found in injector complaints in both Southern Europe and North America. The FTIR spectrum closely correlates with that for sodium C18 fatty acid soap. Scanning electron microscopy and micro-analysis results are given in fig. 4 and show the presence of sodium.

Fig. 3: Infrared spectrum of sodium fatty acid soap deposits as found on nozzle needles

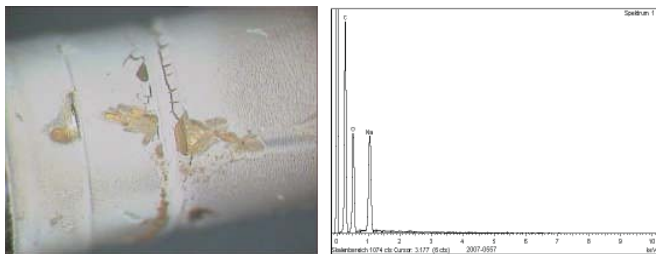
Fig. 4: Micro-analysis results of sodium fatty acid soap deposits as found on nozzle needles.

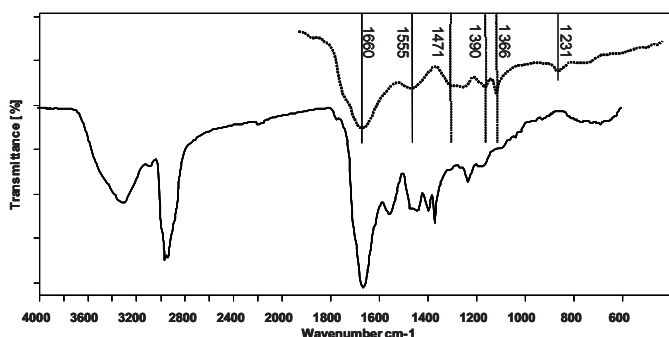
The FTIR of the deposits provides most useful information (fig. 5). Deposits of this type of material collected from different injectors always display the same FTIR fingerprint, allowing the conclusion that the material is homogeneous and not a varying mixture of different compounds dependant on various influences.

Fig. 5: Infrared spectrum of the organic polymeric internal injector deposits; Vibrations at 1471, 1390, 1366 and 1231 cm^{-1} are assigned to PIB and at 1660 and 1555 cm^{-1} to amide.

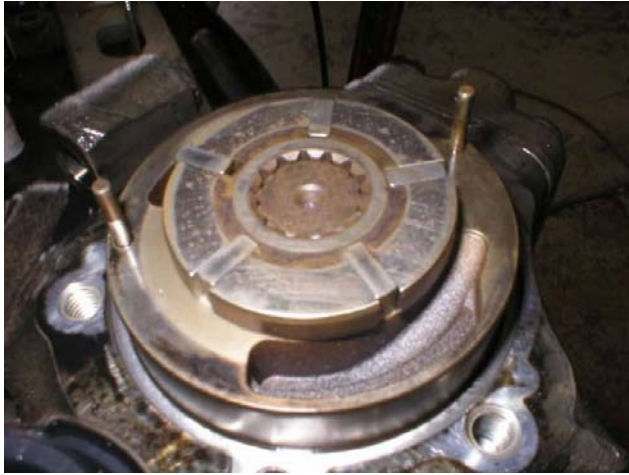
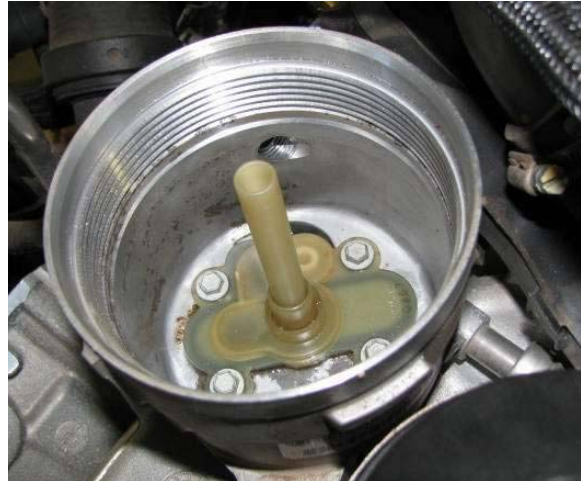
If the water is not drained or if the filters are not changed or if fuel additives with water dispersants or emulsifier are used your fuel system will eventually look like this. And the whole high pressure fuel system will have to be replaced.

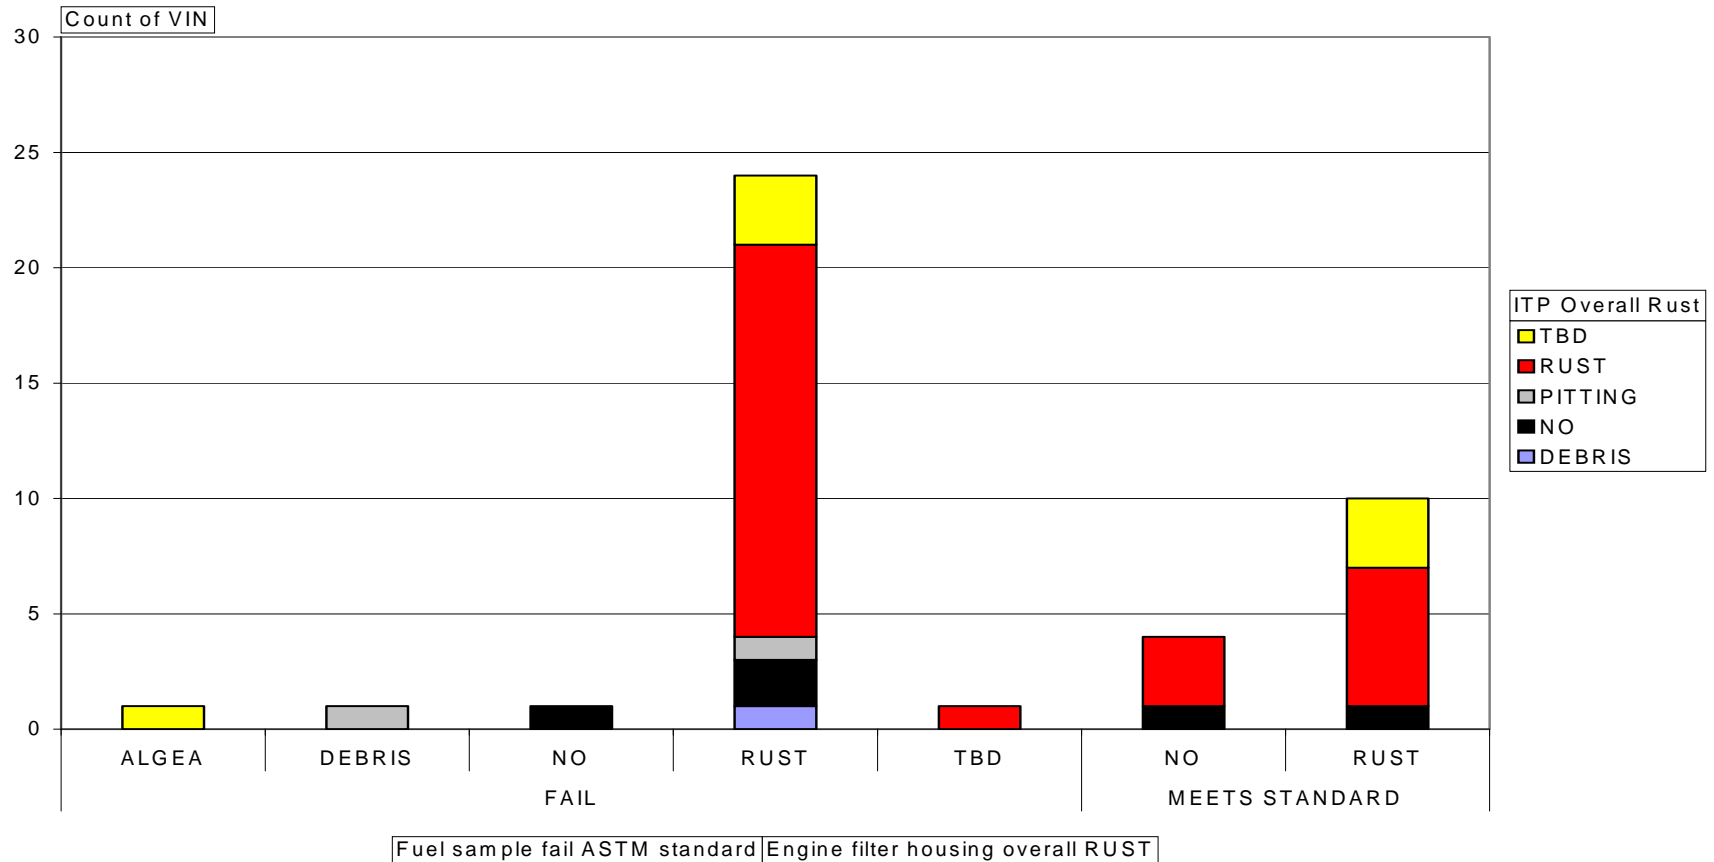
Fuel Analysis – Housing – ITP

60 % (17/28) Fuel sample Fails ASTM standard, there is rust in the housing and rust in the ITP

64% (9/14) fuel sample Meets ASTM standard, there is rust in the housing and rust in the ITP

TBD included in the divisor therefore % may increase after part received and reviewed

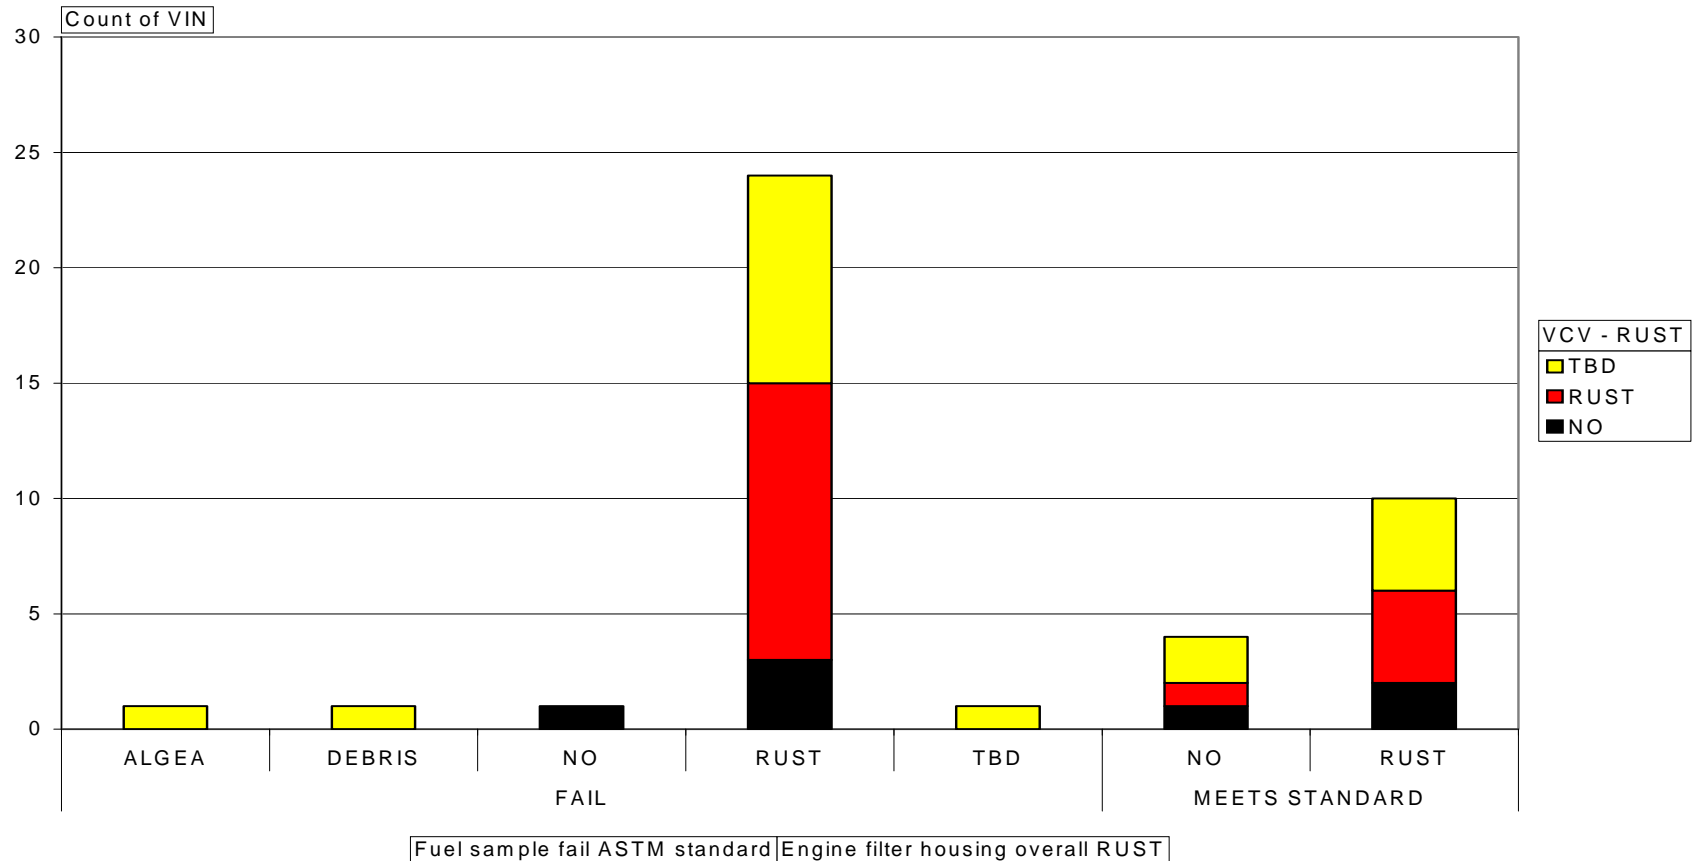
Fuel Analysis – Housing – VCV

42 % (12/28) Fuel sample Fails ASTM standard, there is rust in the housing and rust in the VCV

35% (5/14) fuel sample Meets ASTM standard, there is rust in the housing and rust in the VCV

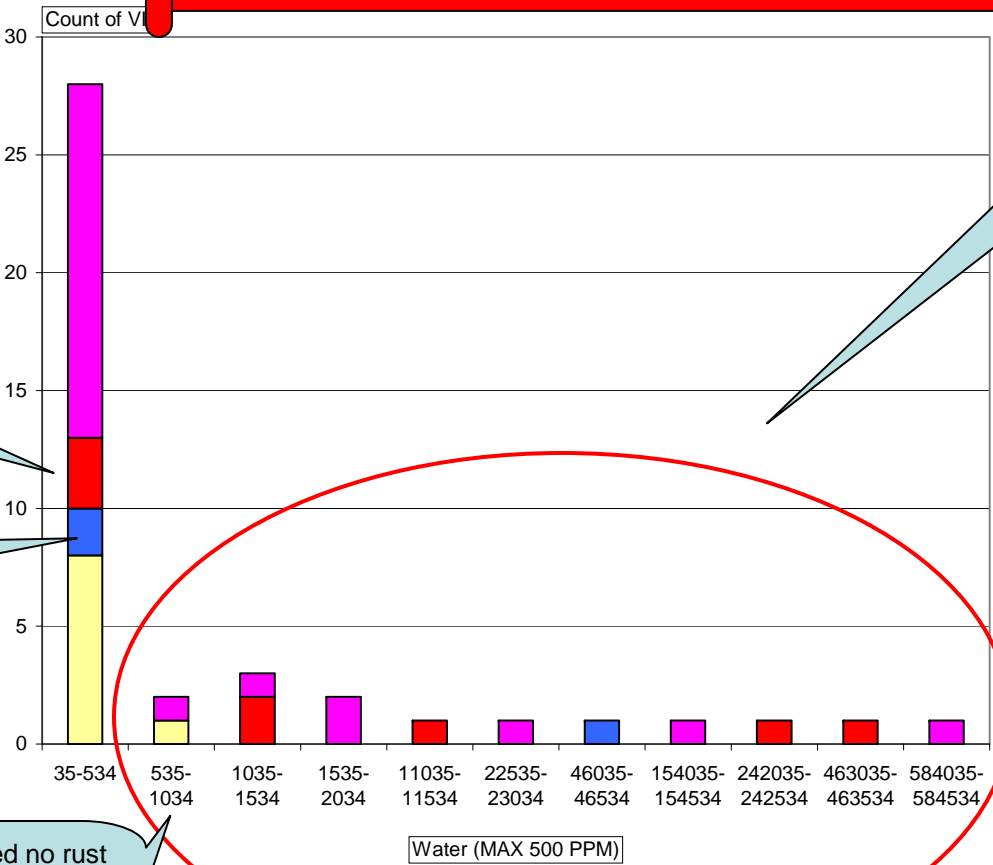
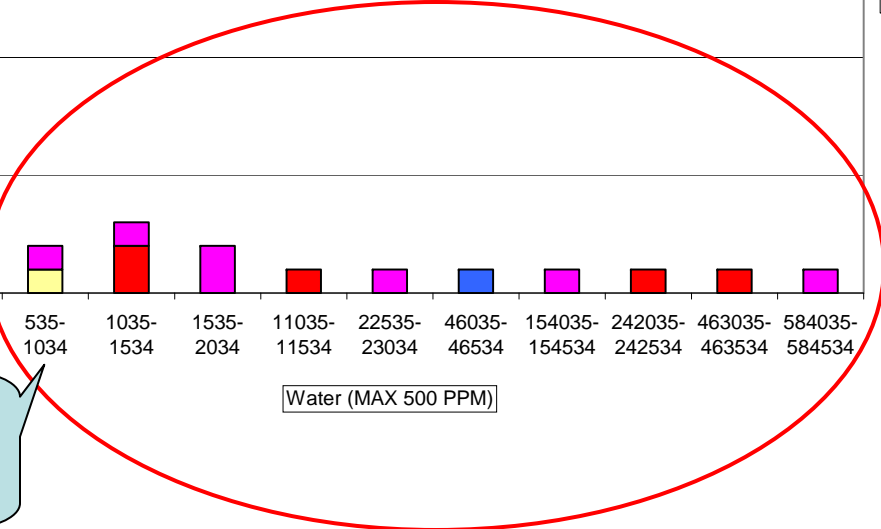
Selection Criteria vs Water in Fuel

Water >500 ppm
all cases had rust in the housing

Water <500 ppm
64% had rust in the housing

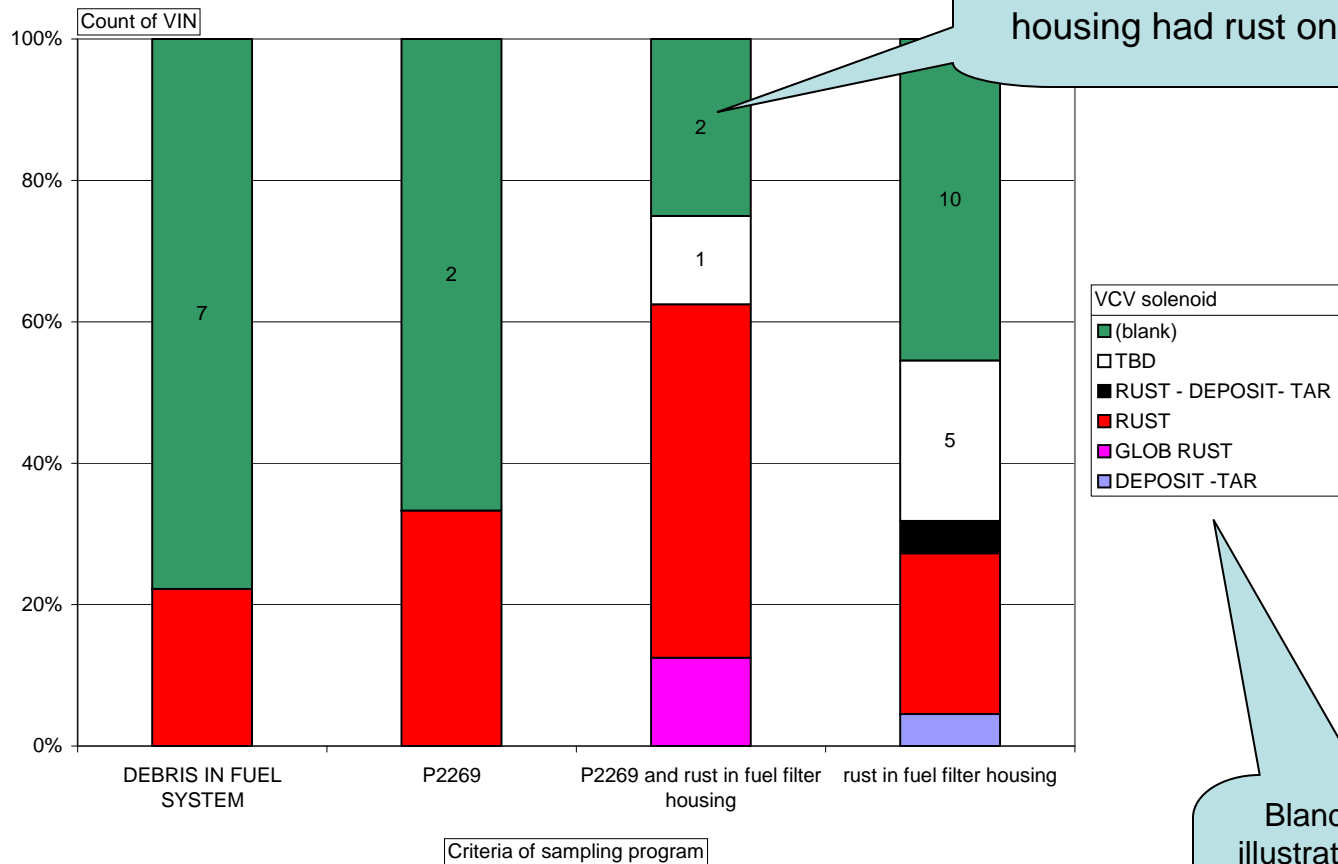
Selection Criteria vs % with Rust on VCV

62% P2269 and rust in the housing had rust on the VCV

Bland no verbiage illustrating rust picture not clearly showing rust. Part needs to be reviewed upon receipt at WPAC

Mini study: housing and VCV submerged in standing water :
 5 days –slight rust on housing fasteners and slight rust on VCV,
 15 days slight rust on housing fasteners , VCV completely covered in rust
 Expectation would be to always have rust on VCV if housing has rust :

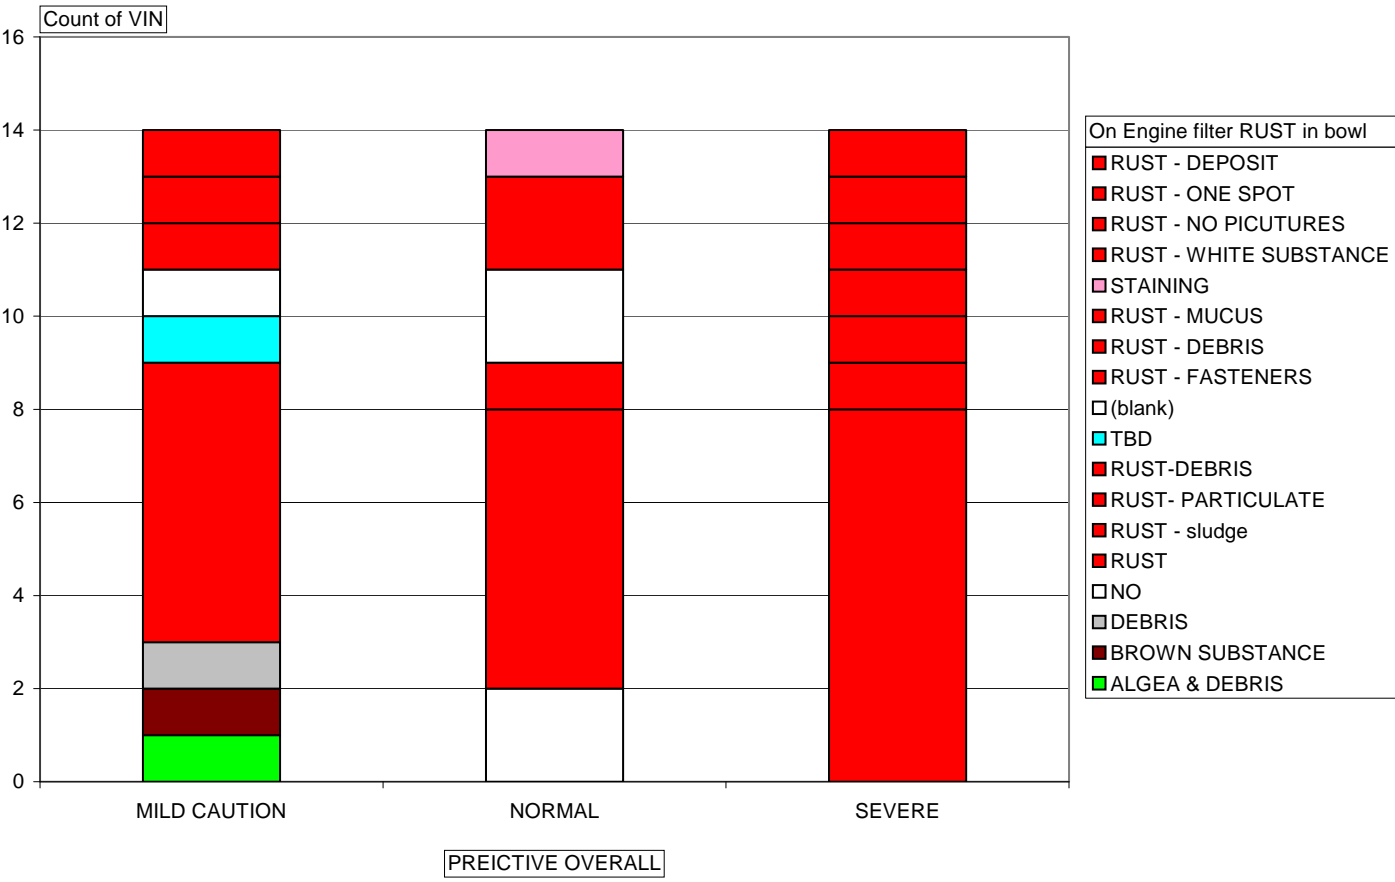
Rust in Housing vs Fuel Sample Overall Criteria

Rust in Housing and Mild or Severe Caution = 60% of all samples would be rejected

Mild or Severe Caution and NO rust in housing = 7% (difference)

Normal fuel = 33%, Rust in Housing and Normal fuel = 24%

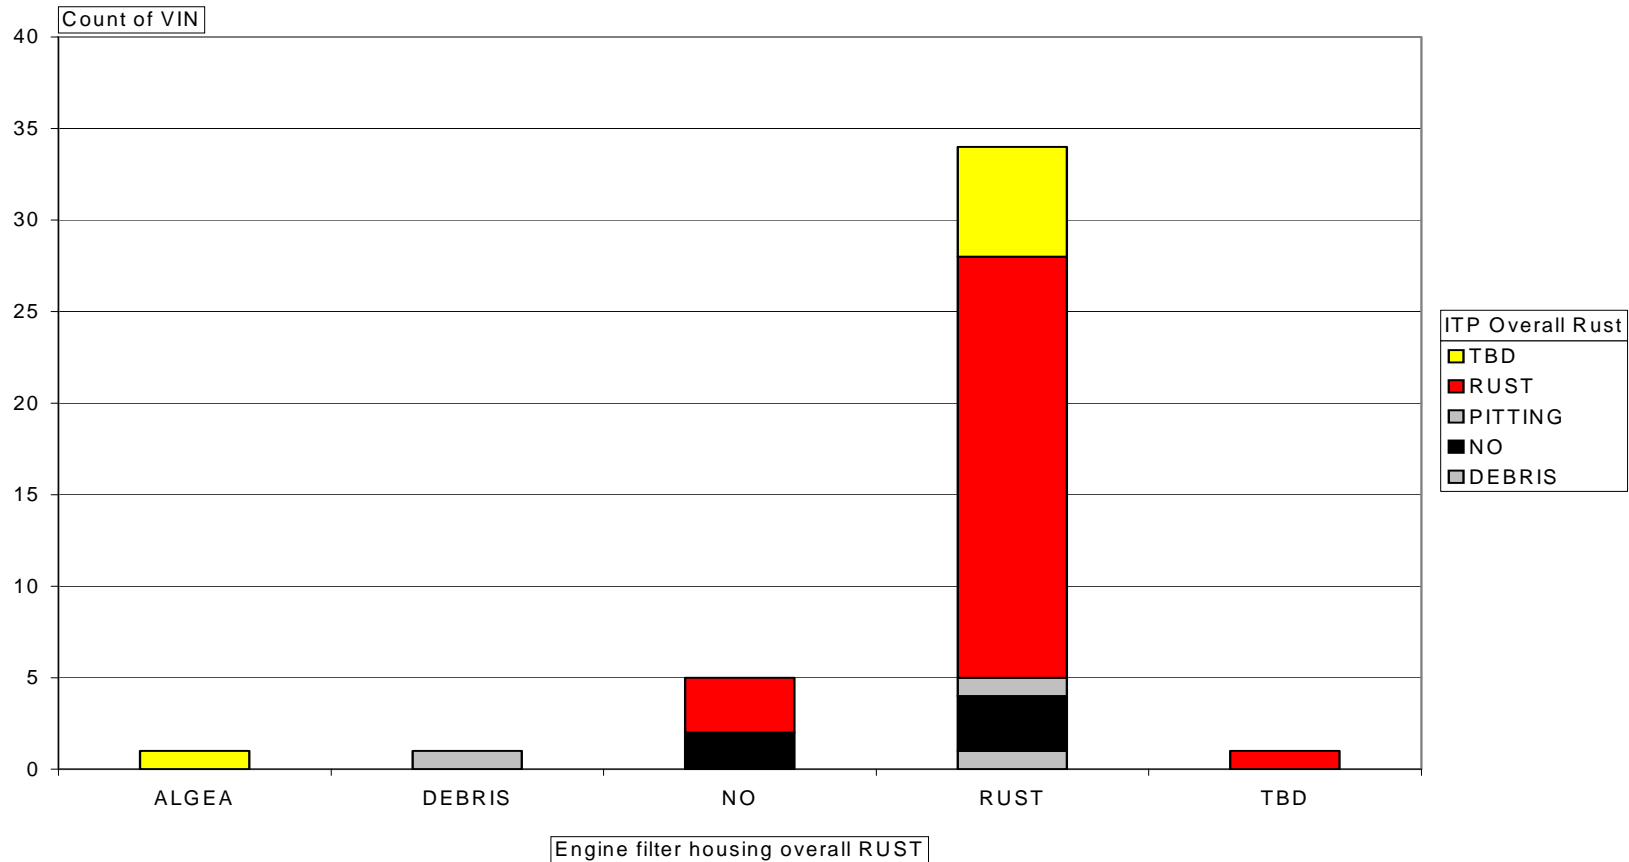
Rust on Housing vs Rust on ITP

(3/5) 60% there is NO rust on filter housing but there is rust in the ITP (1:P2269 mild caution, 1:P0088 pass)

(23/34) 67% when there is rust on the housing there IS Rust on the ITP

(3/34) 11% rust in housing and no rust in ITP (1:P2269 tbd rust, 1:P0088 rust tank & VCV rust, 1:P0088

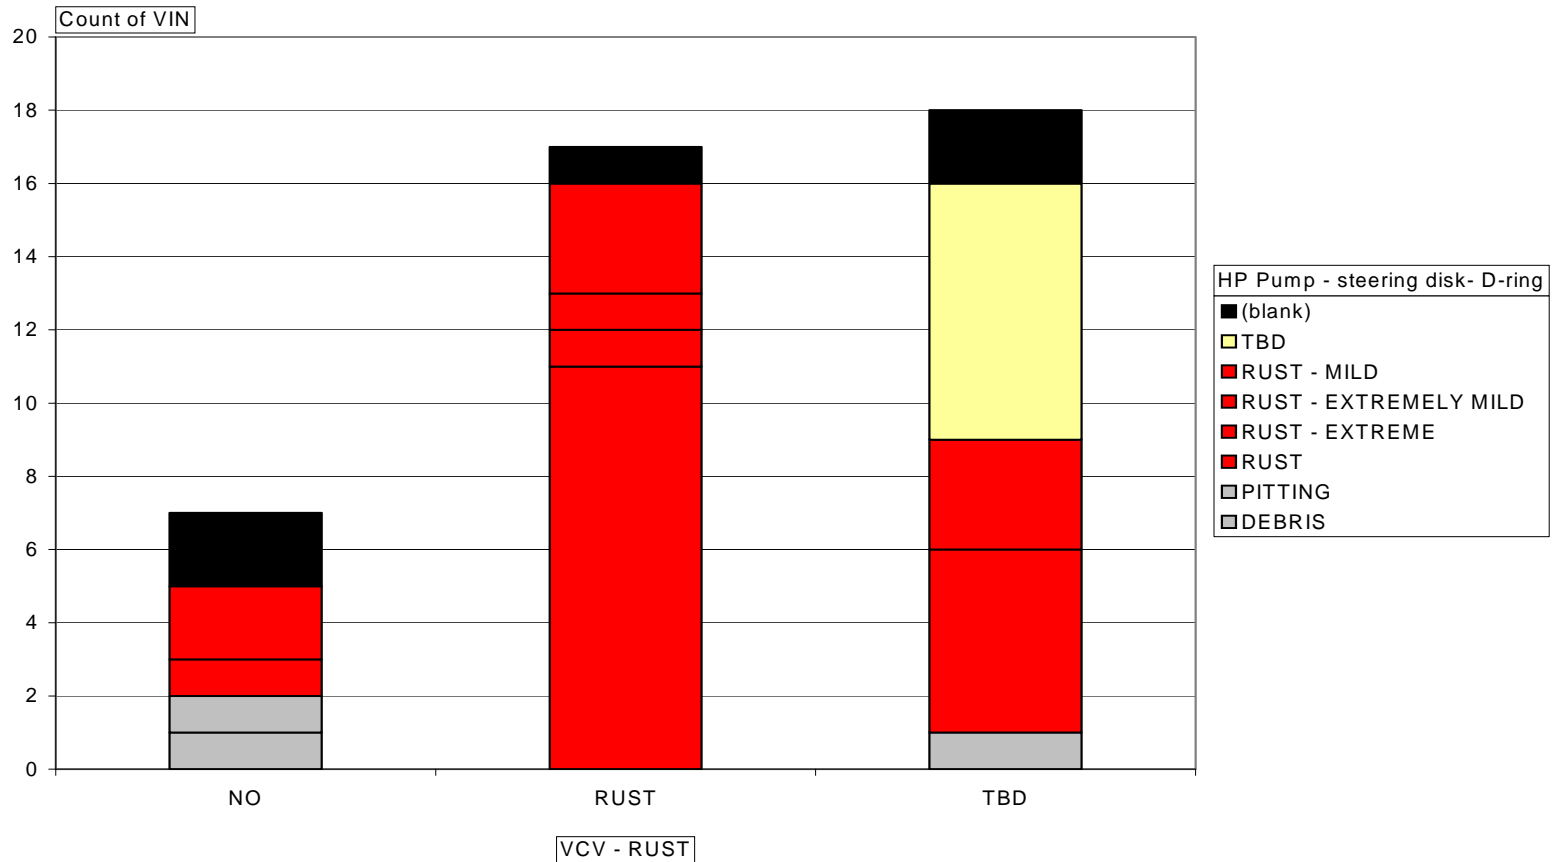
Rust on VCV vs Rust on ITP

If the VCV Has Rust then 88% of the time the ITP has rust

If the VCV does not have rust then 57% ITP has rust
