From: Eeley, Scott (A.)
Sent: Wednesday, December 02, 2009 12:59 PM
To: Espinoza, Bob (R.J.); Bergeron, Leon (F.L.)
Cc: Davis, Craig (C.B.); Dixon, Mark (M.R.); Ricks, Kevin (K.J.); Horbal, Colin (C.P.); Polasek, John (J.A.); McDonagh, Scot (S.M.); Pekarscik, Brian (B.); Mohan, Robert (R.); Smith, Ryan (R.E.); Hale, Curt (B.C.); Armesto, Carlos (.); Dumler, Jeff (J.D.); Rudd, David (D.); McAllister, Derek (D.); Fulton, Brien (B.L.); Kromberg, Arnold (A.W.)
Subject: RE: 6.4 Pump & Injectors
Attachments: Stackchart.ppt

Subject: 6.4L: WIF detection operation and HP fuel system failure.
Importance: High

From: Castleberry, Larry (L.)
Sent: Wednesday, February 04, 2009 11:54 AM
To: Pumford, Ken (K.G.); Fulton, Brien (B.L.); Haven, Keith (K.)
Subject: Emailing: P473 HP Pump Corrosion.ppt

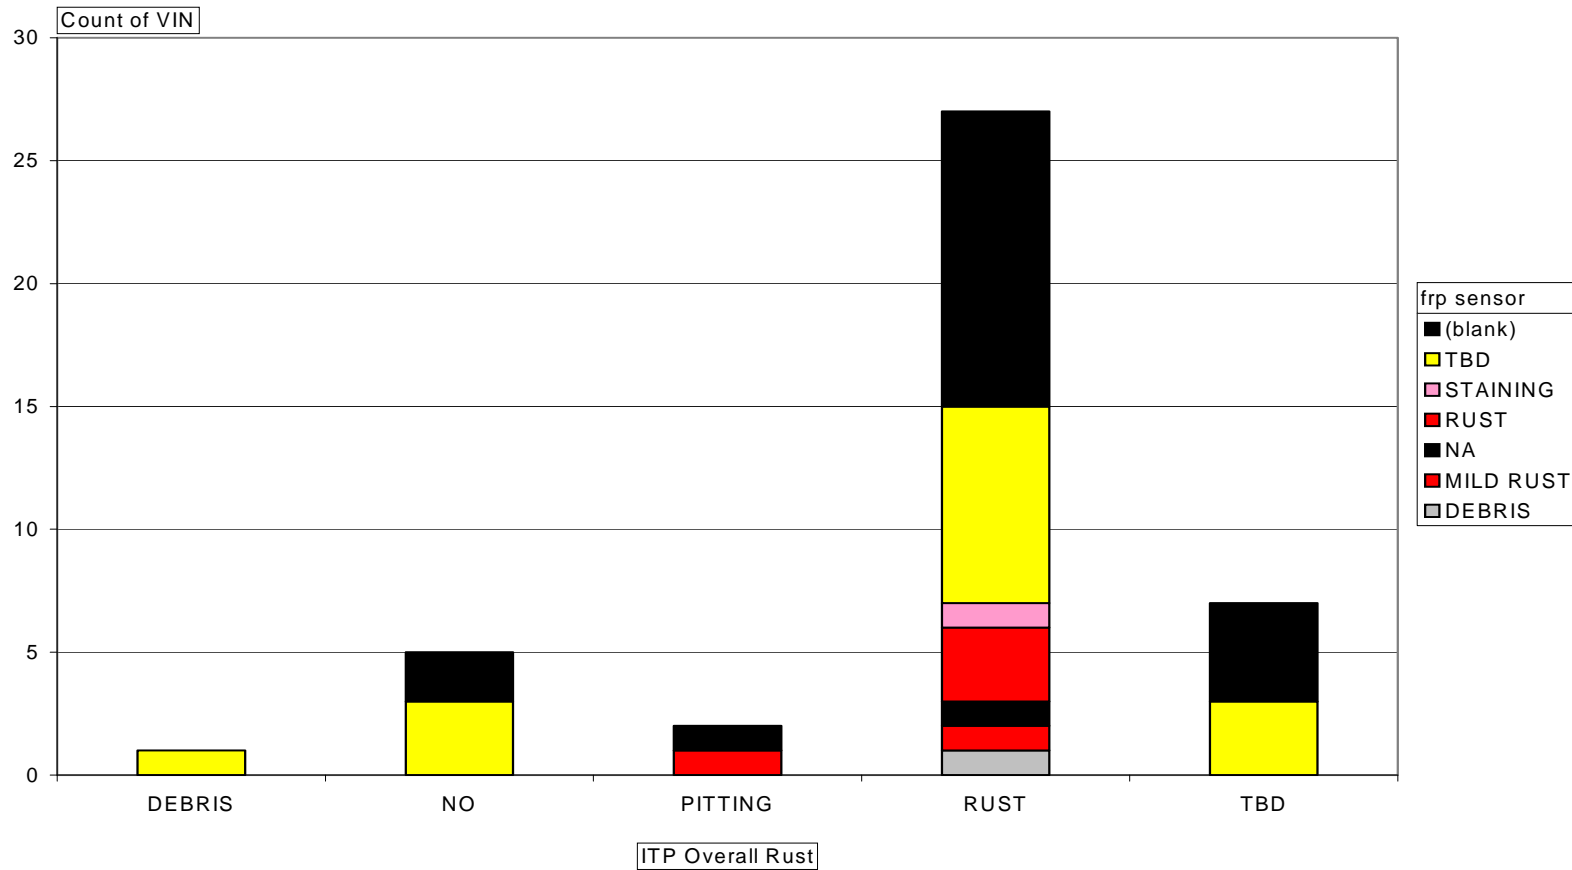
Rust on ITP vs Rust on FRP

**When the HPP ITP has rust - 48% FRP does not have rust
29% to be determined**

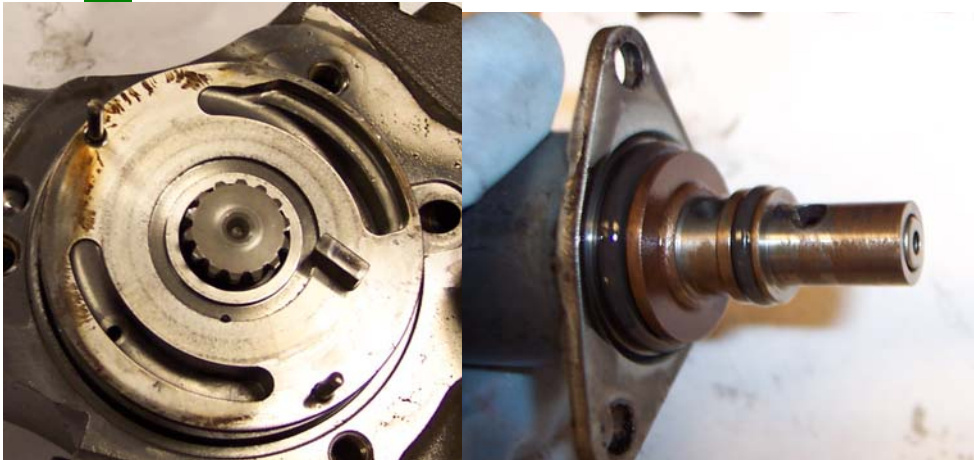
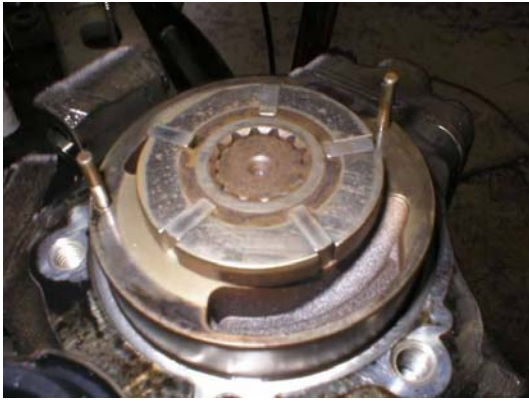
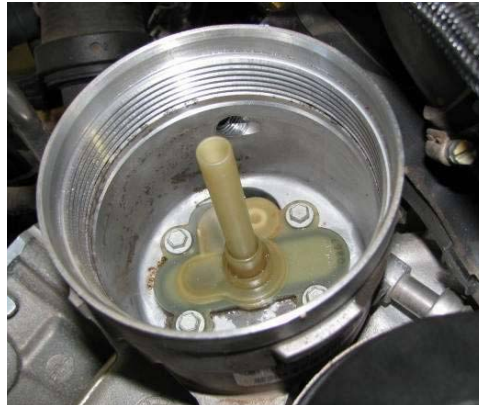
The pictures below give specific examples of what happens to an engine's internal components when water enters the system. In extreme cases, the entire high pressure fuel system had to be replaced. Water may have entered the system in a multitude of ways:

- Water was not drained when required
- Extended maintenance intervals caused fuel filters to become overly restricted
- Use of an aftermarket fuel additive with water dispersants or emulsifiers allowed water to bypass the fuel filters

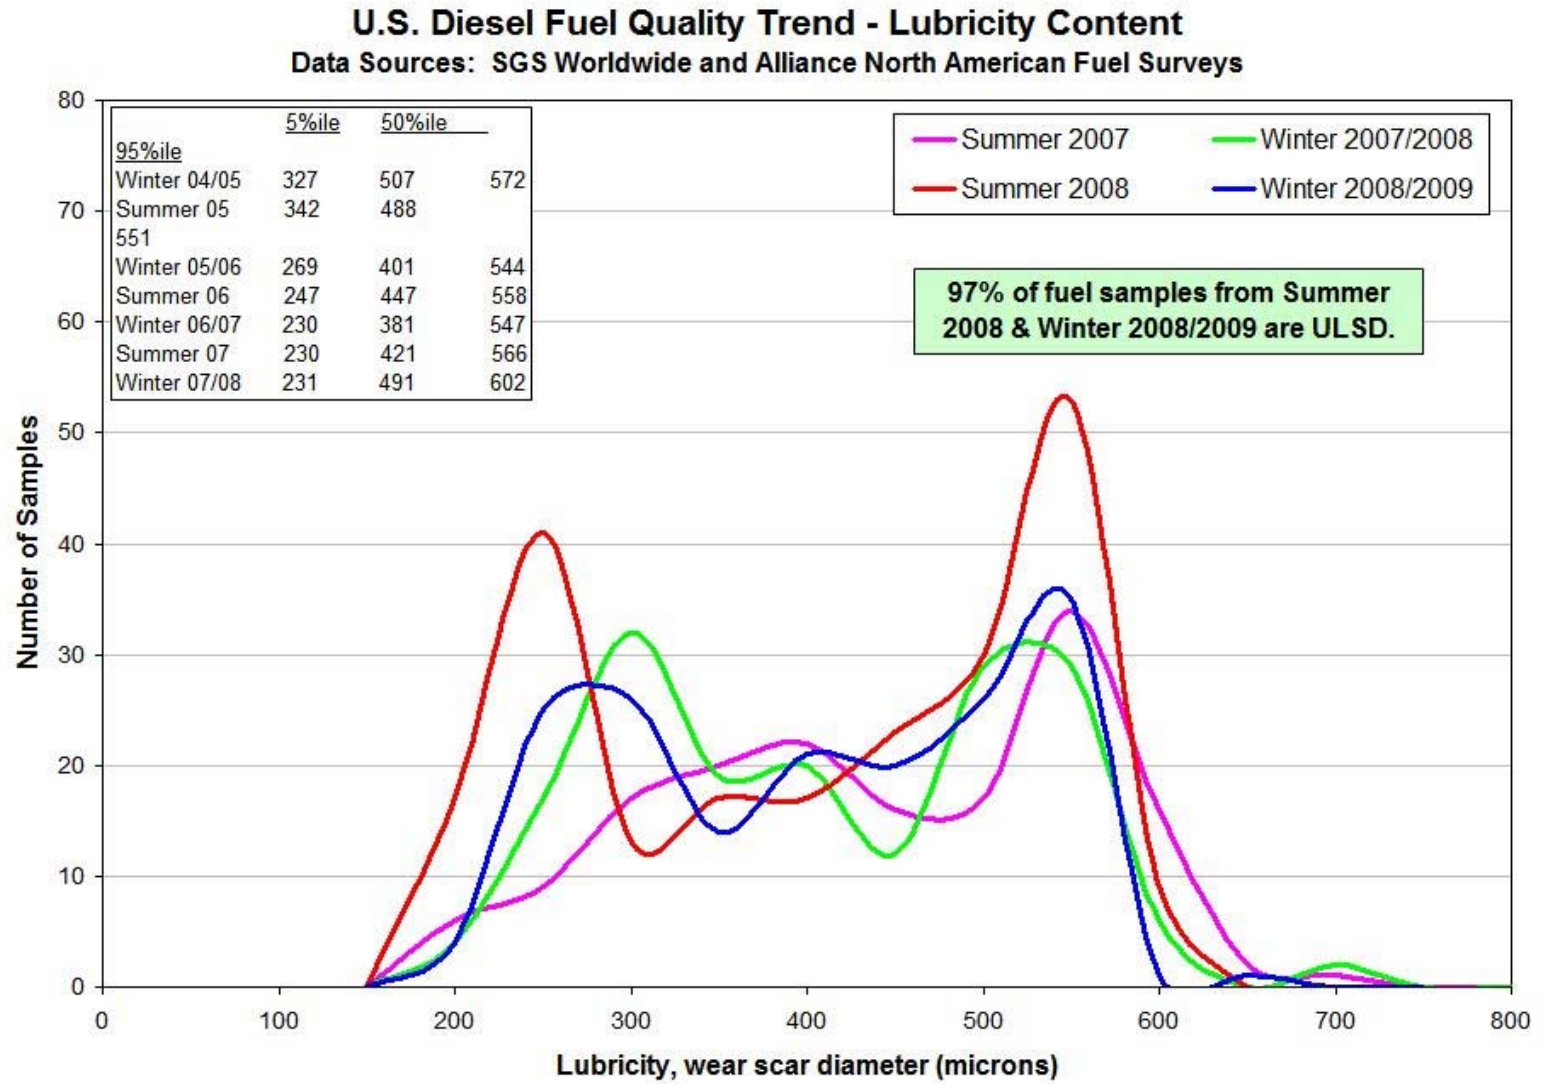
Here is an updated graph with the Summer 2008 and Winter 2008/2009 lubricity data. 97% of the fuel samples were ULSD.

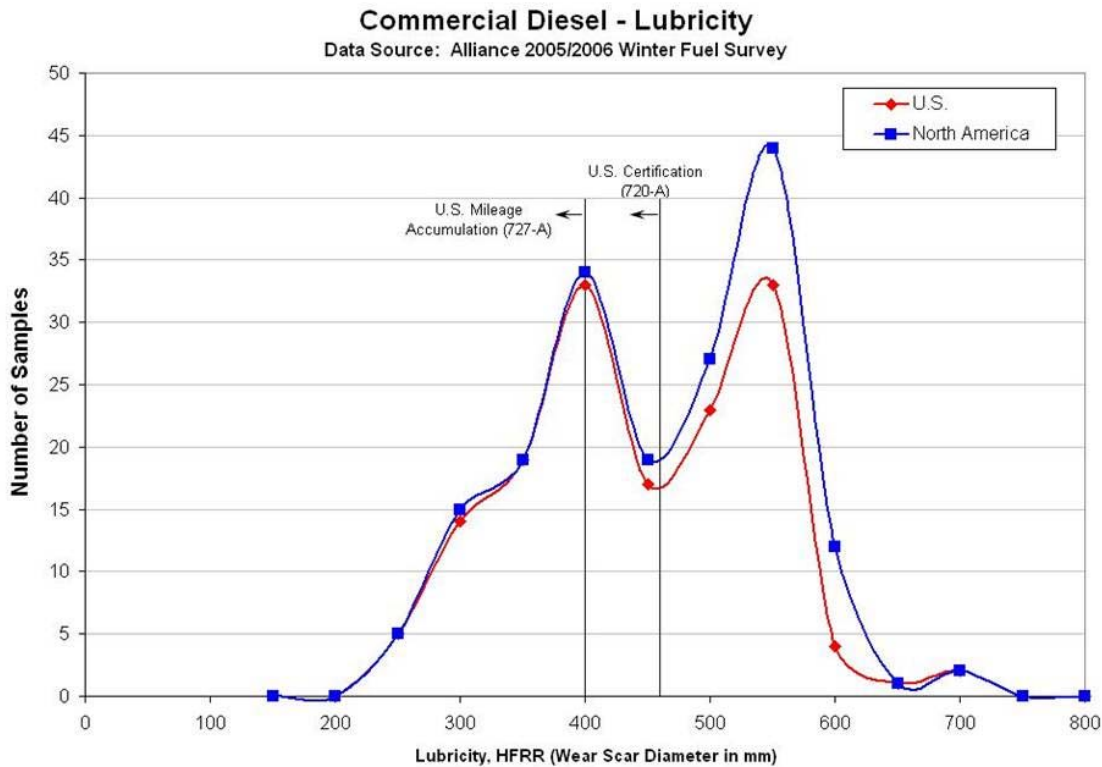
You need to be aware of the current fuel lubricity levels, this chart is old, but we have lots of fuel above 520 um

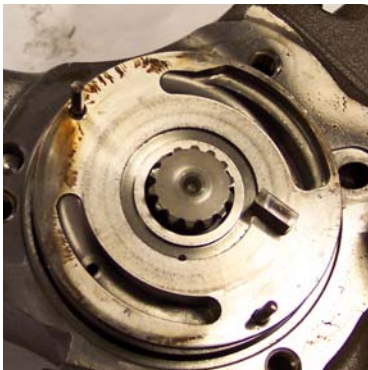
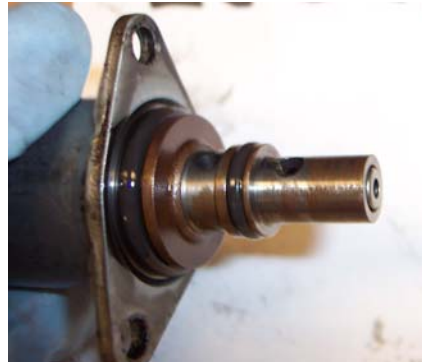
Should excessive water enter the fuel system, corrosion and damage are not far behind. In many cases, the entire high pressure fuel system will have to be replaced.

Excessive water in the fuel led to this corrosion in the High Pressure Fuel Pump Internal Transfer Pump and on the Fuel Volume Control Valve.

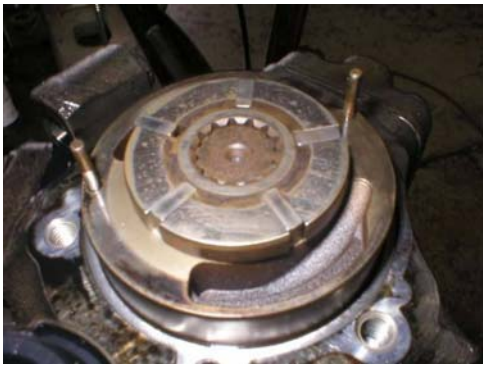
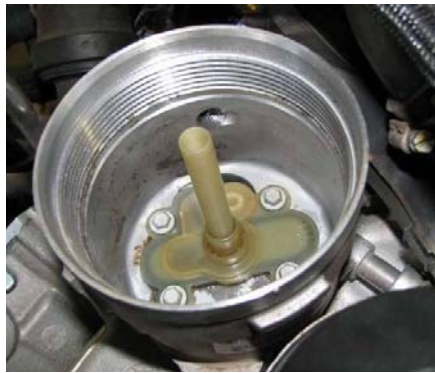
This corrosion in the High Pressure Fuel Pump internal transfer Pump and Secondary Fuel Filter Housing developed from excessive water in fuel

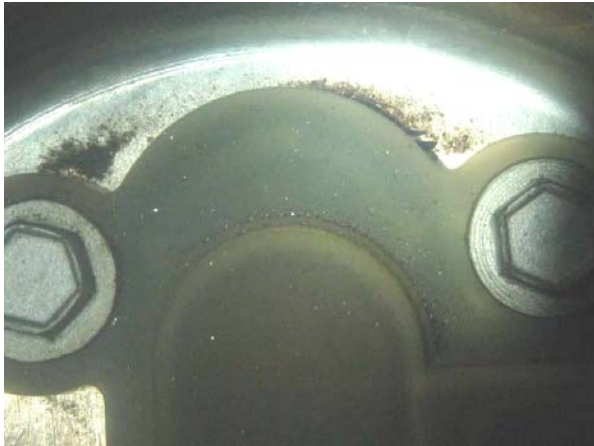
(ED10289 : 74136 miles)

No Rust in Housing No rust on pump or VCV – debris in system

WARRANTABLE

Cetane Index (MIN 40)	Water (MAX 500 PPM)	API Gravity	Bacteria	Fungus	Acid Number (TAN max in biodiesel =0.8)	>4 UJM LIMIT - 10000	>6UM LIMIT (5000)	>14UM LIMIT (320)	biodiesel	PREICTIVE OVERAL
48.55	81	39.6	neg	neg	na	6975	2480	315	1% OR LESS	NORMAL

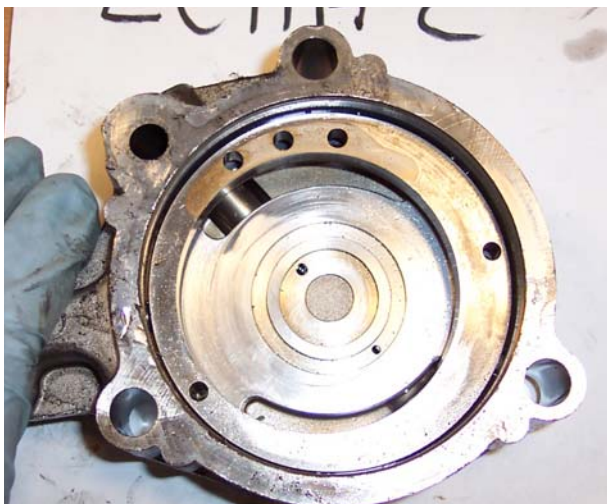
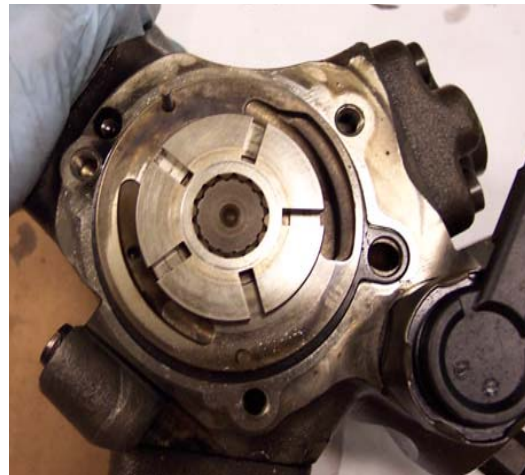
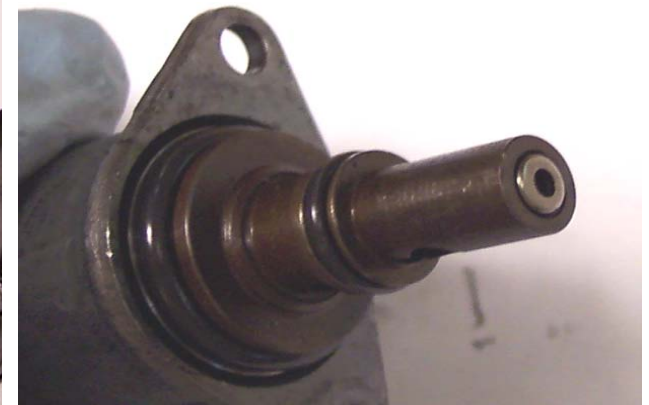
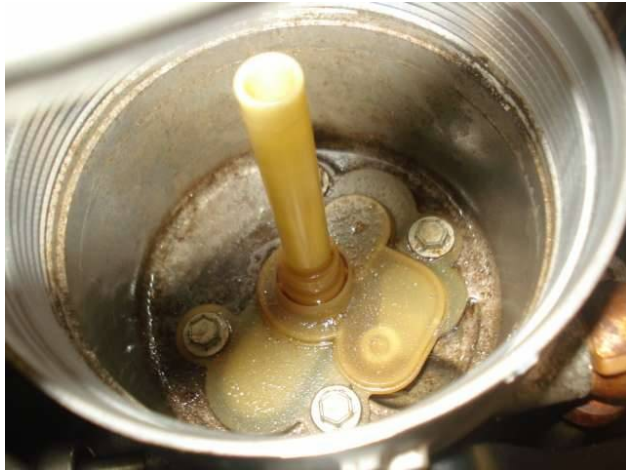
Rust on Housing: No Rust on Inj,
Rust on HP and VCV (EC52768, 75095 miles)

Cetane Index (MIN 40)	Water (MAX 500 PPM)	API Gravity	Bacteria	Fungus	Acid Number (TAN max in biodiesel =0.8)	>4 UIM LIMIT - 10000	>6UIM LIMIT (5000)	>14UIM LIMIT(320)	biodiesel	PREICTIVE OVERAL
51.53	70	39.5	HEA VY	neg	0.01	3862	1167	104	none	SEVERE

NOT WARRANTABLE

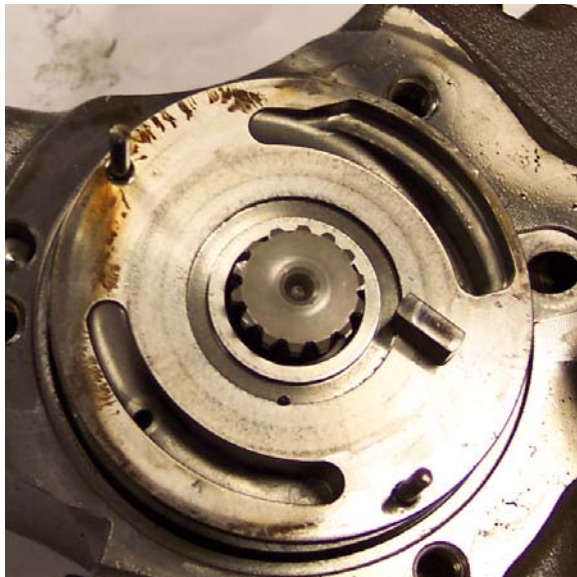
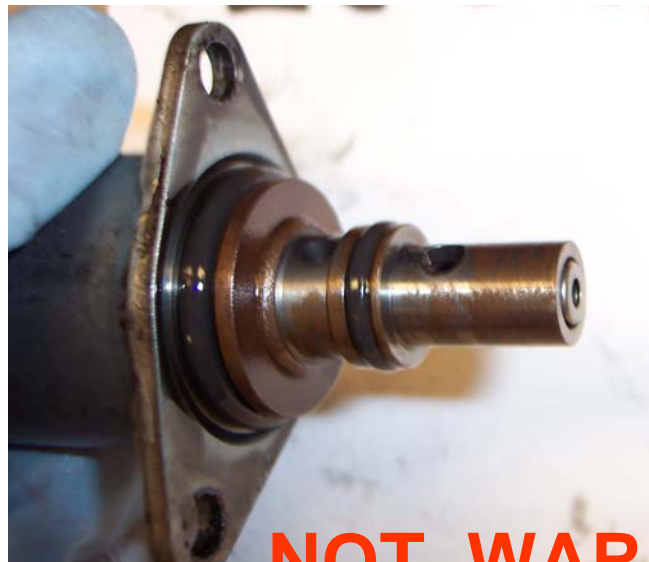
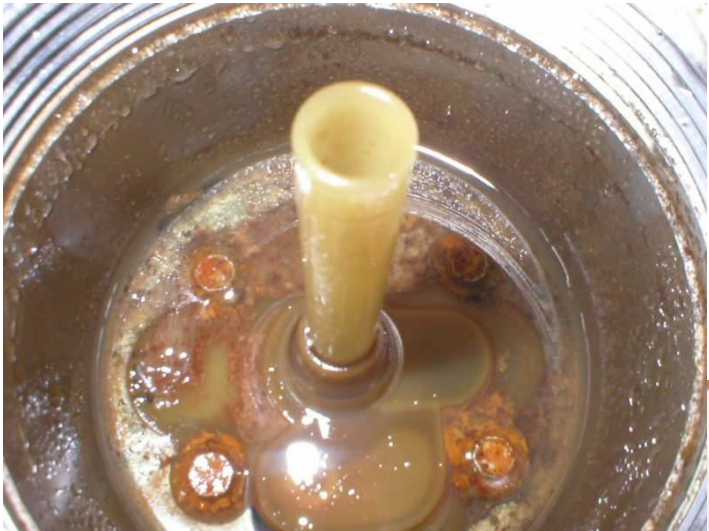
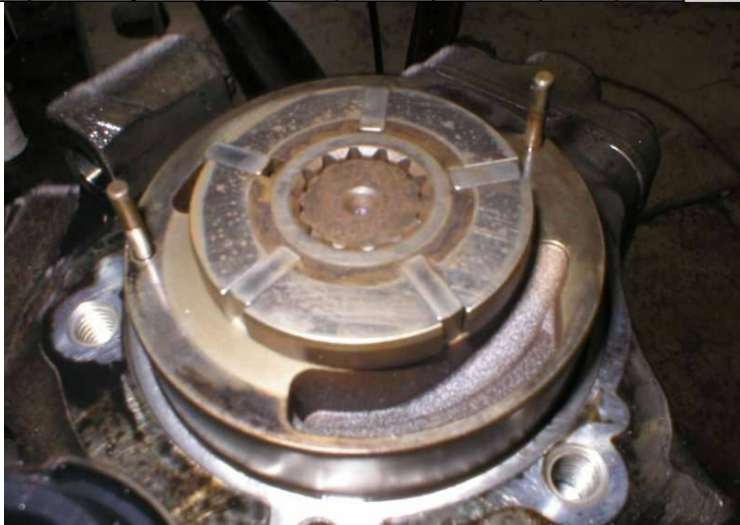
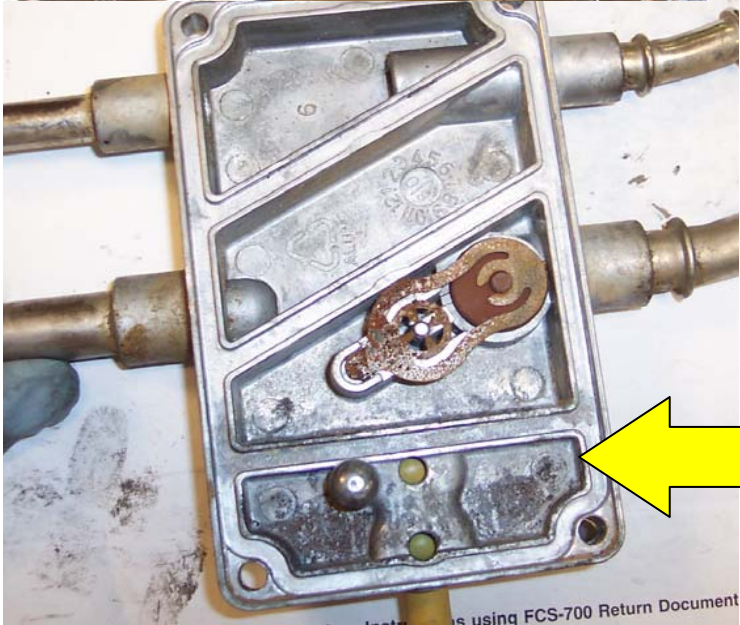
P2269 —rust inj and VCV 1066 ppm water, slight bacteria and fungus, acid number 0.06 (EB 40414: 69159)

Cetane Index (MIN 40)	Water (MAX 500 PPM)	API Gravity	Bacteria	Fungus	Acid Number (TAN max in biodiesel =0.8)	>4 UIM LIMIT - 10000	>6UIM LIMIT (5000)	>14UIM LIMIT(320)	biodiesel	PREICTIVE OVERAL
48	1066	36.6	SLIG HT	SLIG HT	0.06	2059	1121	191	1% OR LESS	MILD CAUTION

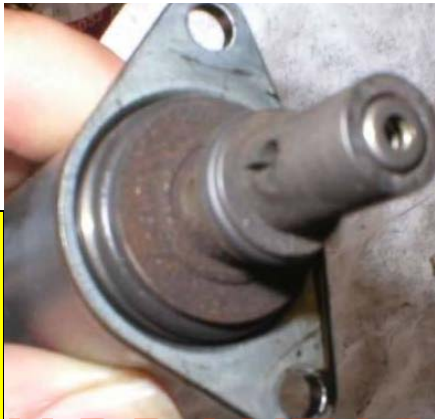
Water rust line in HFCM

NOT WARRANTABLE

Originally reported no rust in housing pictures illustrate rust/corrosion in small quantity

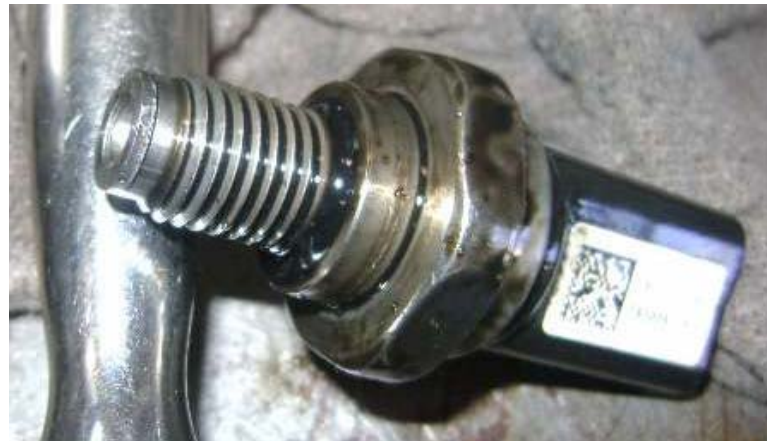
Rust in housing assessment at Dealer (EB16628:39191 miles)

Cetane Index (MIN 40)	Water (MAX 500 PPM)	API Gravity	Bacteria	Fungus	Acid Number (TAN max in biodiesel =0.8)	>4 UJM LIMIT - 10000	>6UM LIMIT (5000)	>14UM LIMIT(320)	biodiesel	PREICTIVE OVERAL
45.19	2013	34.8	HEA VY	MOD ERAT E	0.06	8698	4736	806	1% OR LESS	SEVERE

NOT WARRANTABLE

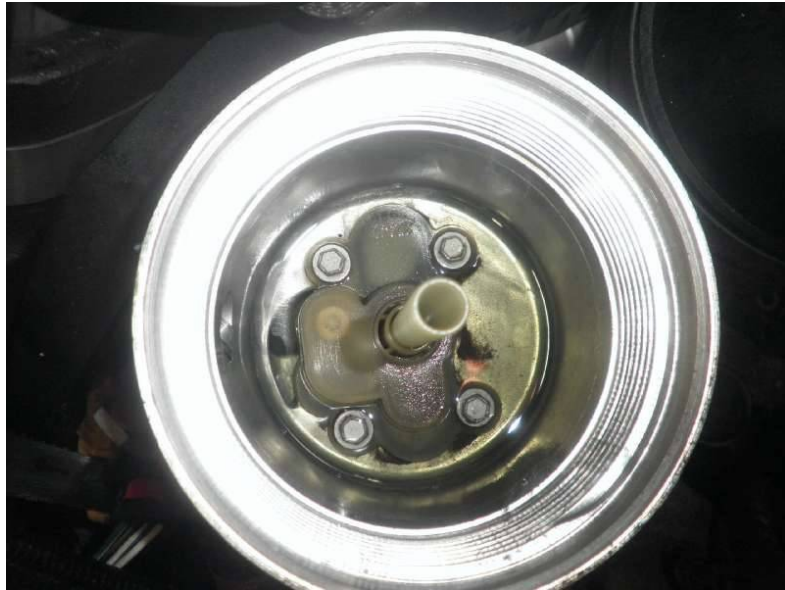
Tank had rust

(4- had rust only 1 black inj) (EE19618 :12664 miles)

Cetane Index (MIN 40)	Water (MAX 500 PPM)	API Gravity	Bacteria	Fungus	Acid Number (TAN max in biodiesel =0.8)	>4 UM LIMIT - 10000	>6UM LIMIT (5000)	>14UM LIMIT(320)	biodiesel	PREICTIVE OVERALL
45.86	126	36.57	neg	neg	0.1	28860	6708	733	1% OR LESS	MILD CAUTION

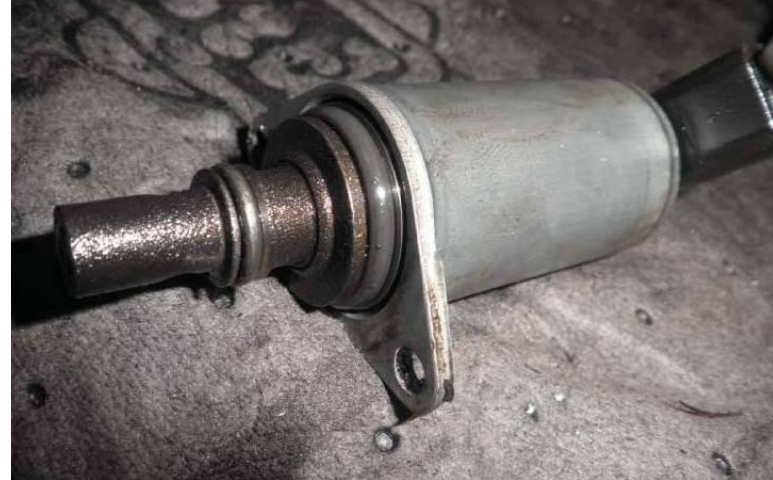
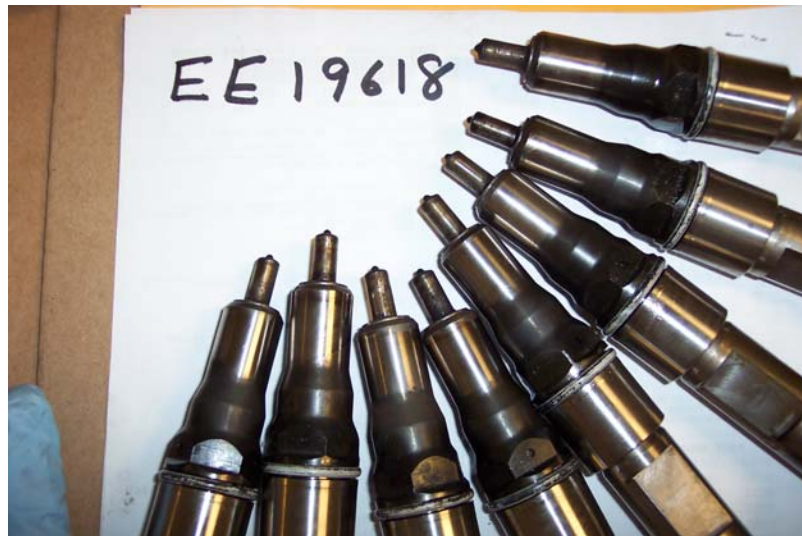
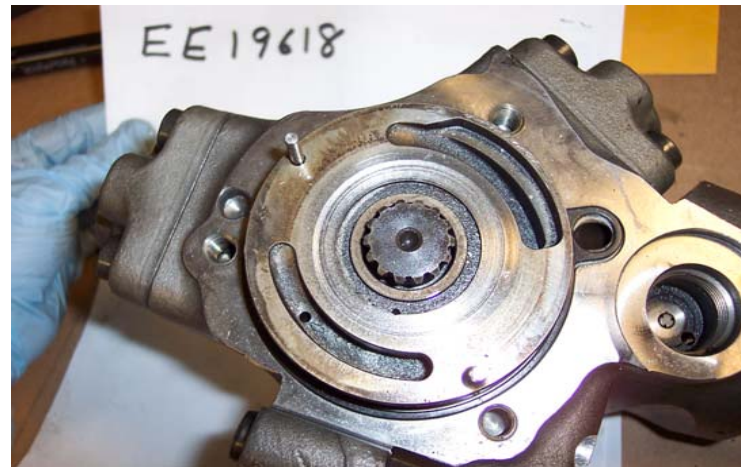
NOT PUMP CAUSAL

Blackend Inj (4 cases out of 42)

(EA60042 5919 miles) (ED44165 : 46676)
 (EE 19618 : 12664 miles) (EB40414 : 69159 miles)

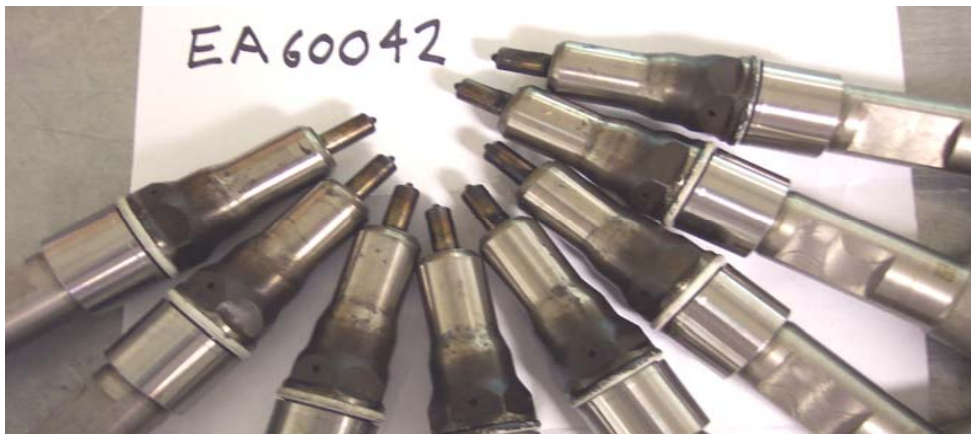
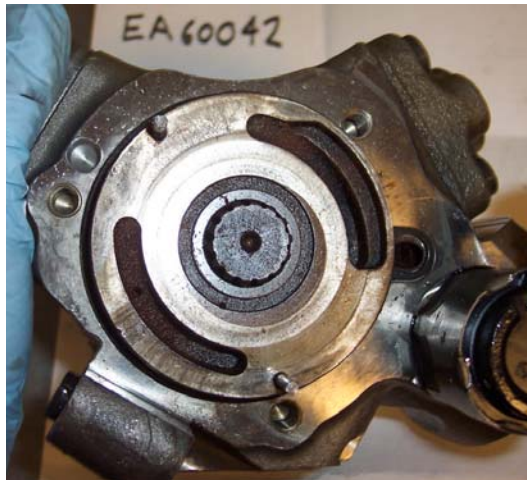
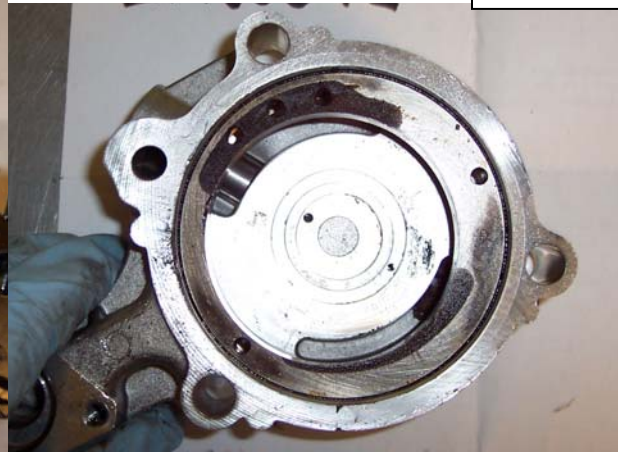
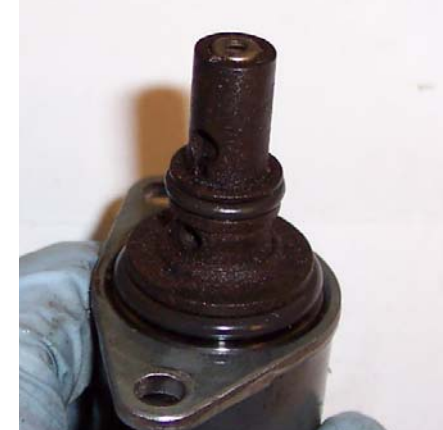
Cetane Index (MIN 40)	Water (MAX 500 PPM)	API Gravity	Bacteria	Fungus	Acid Number (TAN max in biodiesel =0.8)	>4 UJM LIMIT - 10000	>6UM LIMIT (5000)	>14UM LIMIT (320)	biodiesel	PREICTIVE OVERAL
48.23	1074	36.5	neg	neg	0.07	158	86	15	1% OR LESS	MILD CAUTION

NOT WARRANTABLE

ON 09/24/2009 TRUCK CAME IN WITH WATER IN FUEL LIGHT ON HAD TO DRAIN AND CLEAN,TANK,LINES AND REPLACED FUEL FILTERS BECAUSE FUEL HAD WATER IN IT DUE TO BROKE FUEL FILLER CAP REPLACED TWO FUEL INJECTORS THEN BUT WHEN THE CAP GOT REPLACED THIS RESOLVED WATER INTRUSION CONCERN DILUTED FUEL CLOUDY BUT NO WATER SEPERATION UPON REVIEWING THE SERVICE HISTORY OF THIS VEHICLE BE AWARE THE VEHICLE, **LESS THAN 500 MILES AGO, RECIEVED A COMPLETE HIGH PRESSURE FUEL SYSTEM REPLACEMENT.** THE FUEL LOOKED CLOUDY THEN. DURING THAT REPAIR, A SAMPLE WAS SENT OUT FOR TESTING AND CAME BACK NORMAL. **WHATEVER FUEL IS IN THIS TRUCK DOES NOT LOOK LIKE NORMAL DIESEL FUEL.** I WOULD LIKE TO SPEAK WITH SOMEONE ABOUT THIS TRUCK BEFORE A REPAIR IS
