CALIFORNIA GEOLOGY

Coastal Landslides Caused By The October 17, 1989 Earthquake

Santa Cruz County, California

NATHANIEL PLANT and GARY B. GRIGGS

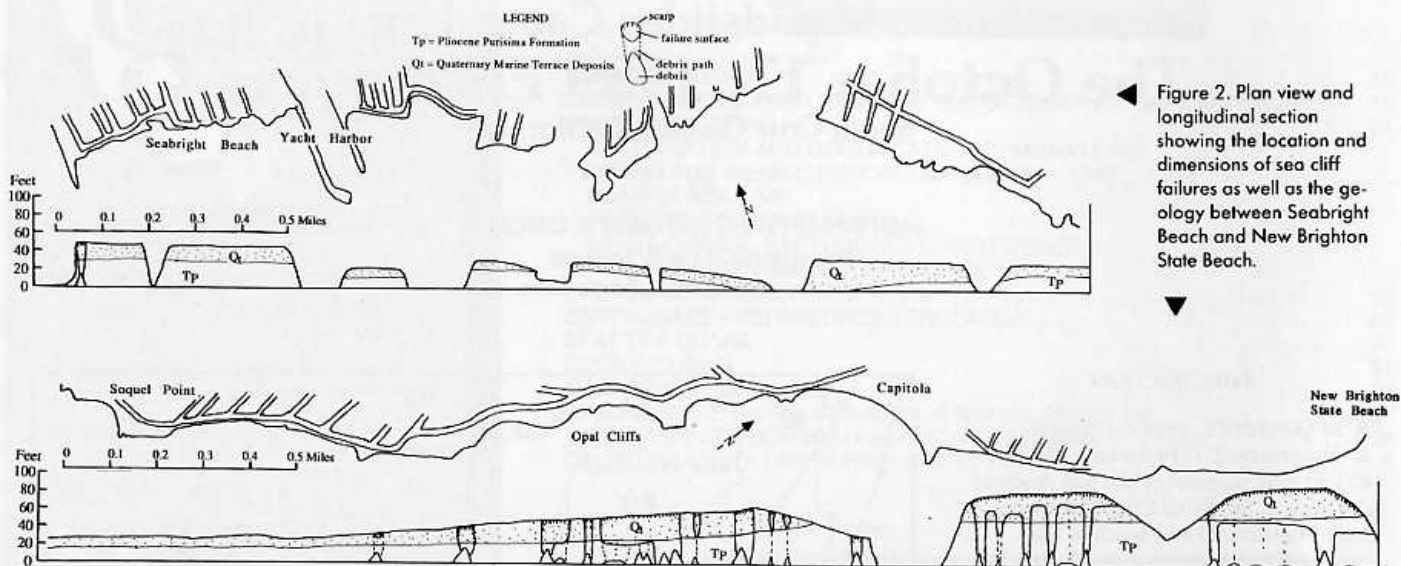
Figure 2. Plan view and longitudinal section showing the location and dimensions of sea cliff failures as well as the geology between Seabright Beach and New Brighton State Beach.

Between Seabright Beach and New Brighton State Beach (Figure 2), sea cliffs are cut into a marine terrace that is up to 75 feet (25 m) high. This terrace consists of an uplifted wave-cut bedrock platform that is overlain by several feet of terrace deposits (Figure 3). The wave cut platform is in a thickly bedded to massive siltstone with prominent shell lags* (Pliocene Purisima Formation). Even though the Purisima Formation is well indurated,

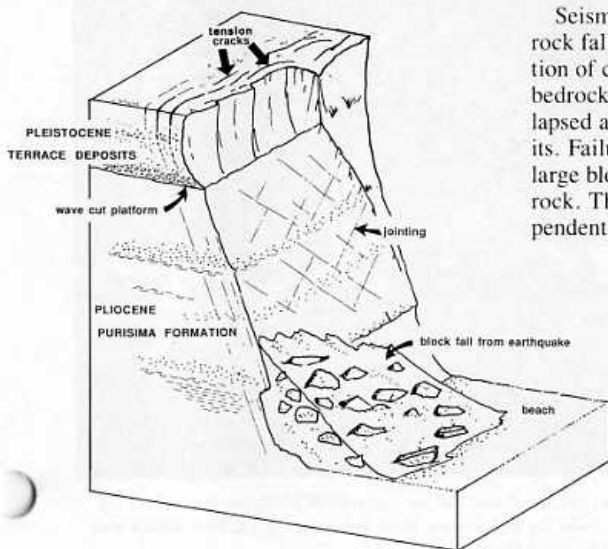
Figure 3. Block diagram showing sea cliff structure and typical failure style in sea cliffs underlain by well-jointed Pliocene Purisima Formation siltstone. Note the tension cracks in the Pleistocene terrace deposits and undercut sea cliff.

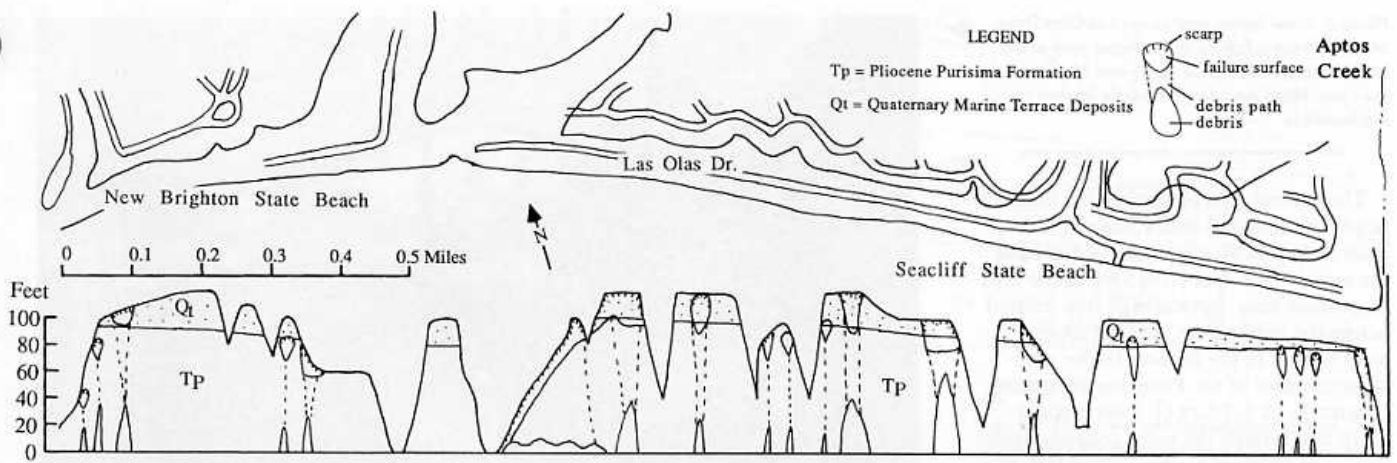
Seismic shaking initiated two types of failure here. Translation* (uniform movement) along a joint or weathering surface produced many large slides up to 180 feet wide (60 m wide) that originated in the upper 36 feet (12 m) of the sea cliff (Photo 4). The scarps of these slides tend to cut vertically through the Quaternary terrace deposits and then flatten as they approach the Purisima Formation (Figure 5). Deep tension cracks cut through the terrace deposits (Photo 5) and soils 3-18 feet (1-6 m) landward of many of the scarps; depth of cracks tends to increase with the size of the scarp (Figure 6). Some intact blocks and much loose soil cascaded down the face of the cliff, forming 60 foot (20 m) high coalescing talus cones that partially buried some automobiles and blocked access to homes (Photo 6).

Photo 4. Extensive sea cliff failure above Las Olas Drive. Failure occurred in the upper 36 feet (12 m) of the cliff and loose material cascaded down the steep slope. Note the many houses both above and below the landslide that are jeopardized by slope failure.

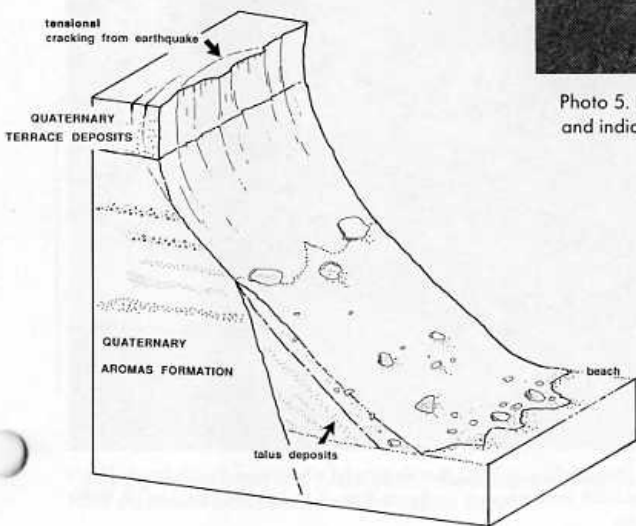
Figure 5. Block diagram showing structure and typical failure style in sea cliffs underlain by sandstone member of the Pliocene Purisima Formation. Note that the failure occurred in the upper portion of the cliff and material cascaded down the steep slope.

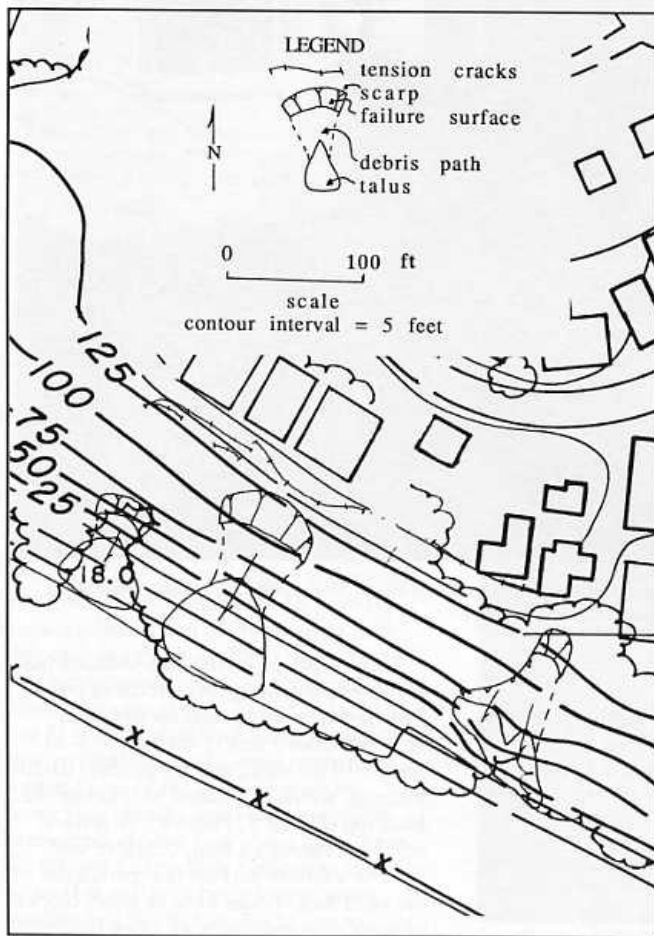
Figure 6. Details of sea cliff failures and tension cracks. Note the prevalence of tension cracks near the large failure.

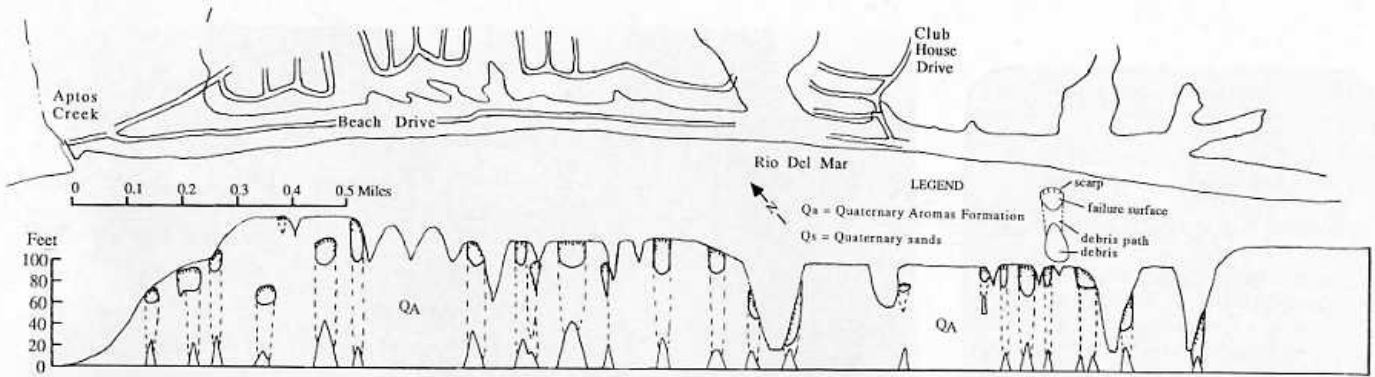
Between Aptos Creek and Rio del Mar, semi-consolidated eolian and fluvial sands of the Pleistocene Aromas Formation form 75-120 foot (25-40 m) high, steep cliffs (Figure 7). The upper 6-15 feet (2-5 m) are more cohesive than the underlying partly consolidated and weakly cemented sands. Sea walls and revetments that protect the back-beach development also protect the cliff toe from wave induced erosion. However, the bluffs continue to fail periodically, as they did in the 100-year storm in January 1982 that caused considerable property

▲
Figure 7. Plan view and longitudinal section showing the location and dimensions of sea cliff failures and the geology between Aptos Creek and Rio Del Mar.

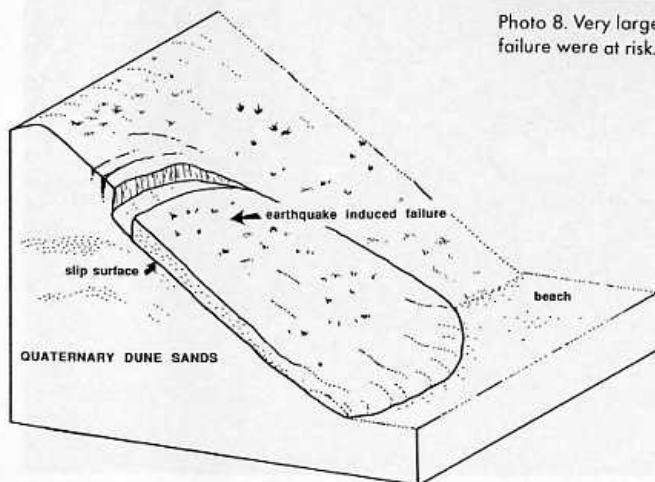
Three types of earthquake-induced failures prevailed along this stretch of coast. The first type was a shallow dry sand flow less than 3 feet (1 m) deep, 15-30 feet (5-10 m) wide, and 30-60 feet (10-20 m) long, which originated well below the bluff top (Figure 8, Photo 8). A vertical scarp cut through a thin, cohesive soil layer to a failure surface that paralleled the bluff face. Loose sand or small blocks of more cohesive material, often held together by roots, slid along this surface and then ramped over the less steep talus deposits at the base of the slope.

Figure 8. Block diagram of dry sand flow in weakly consolidated dunes. Note the tension cracks in the cohesive surface layer.

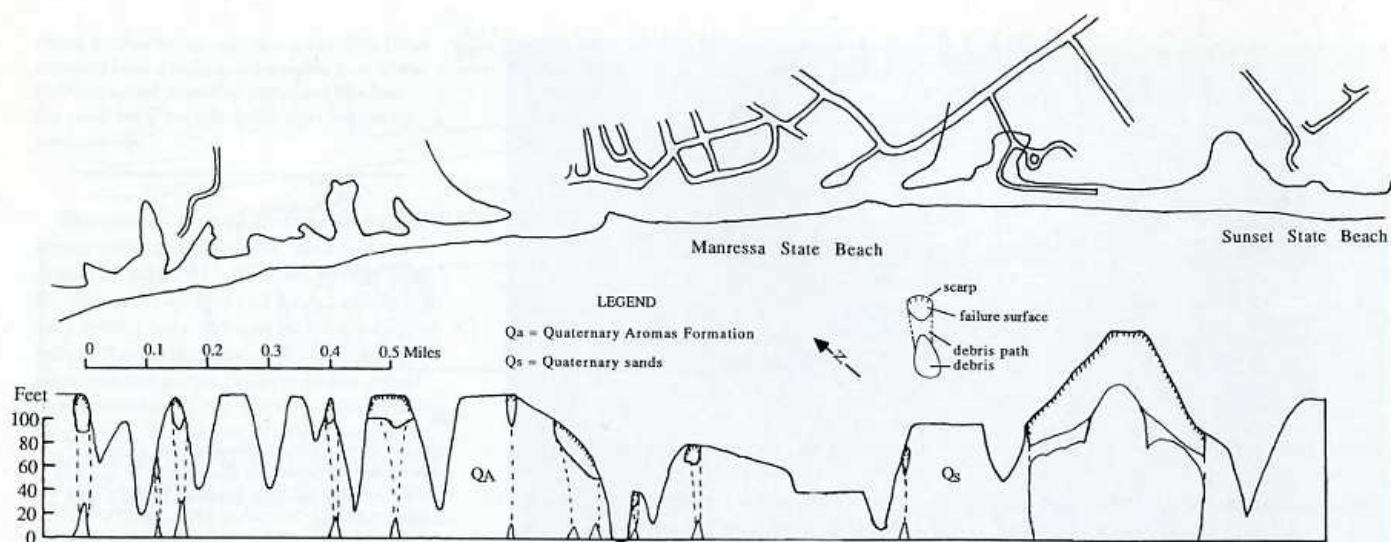
The third type of earthquake failure is a translational slide. South of Manressa State Beach (Figure 9), sands composing the cliffs are less consolidated and the cliffs are therefore less stable. This stretch of cliffs is fronted by a wide protective beach. During the earthquake, a very large translational slide, 300 feet (100 m) wide and 6-9 feet (2-3 m) deep, undermined 15-30 feet (5-10 m) of the cliff top above the Place de Mer development (Figure 8, Photo 8). Large intact blocks toppled from the upper 15 feet (5 m) of slope while intact patches of soil, held together by roots, and loose sand slid down the slope to a roadway. One house and its retaining wall system were undercut by the slope collapse in this area; the house had to be demolished.

Further to the south, the coastal bluffs in the Sunset State Beach area (Figure 9) consist of weakly consolidated Pleistocene dunes (Wisconsin age; Dupré, 1975) which have been stabilized by vegetation. Homes have been built on the eroding edge of this ancient dune complex. Slope

Figure 9. Plan view and longitudinal section showing the location and dimensions of sea cliff failures and geology between Rio Del Mar and Sunset State Beach.
