# The restoration of my 1966 Chevrolet Corvair Corsa 140 hp 4 speed.

Acquired January 2014.

The restoration, as shown in this document, is complete. I now have the confidence to drive this car anywhere, without the worry of a breakdown. At this time I think this car is reliable and safe to drive.

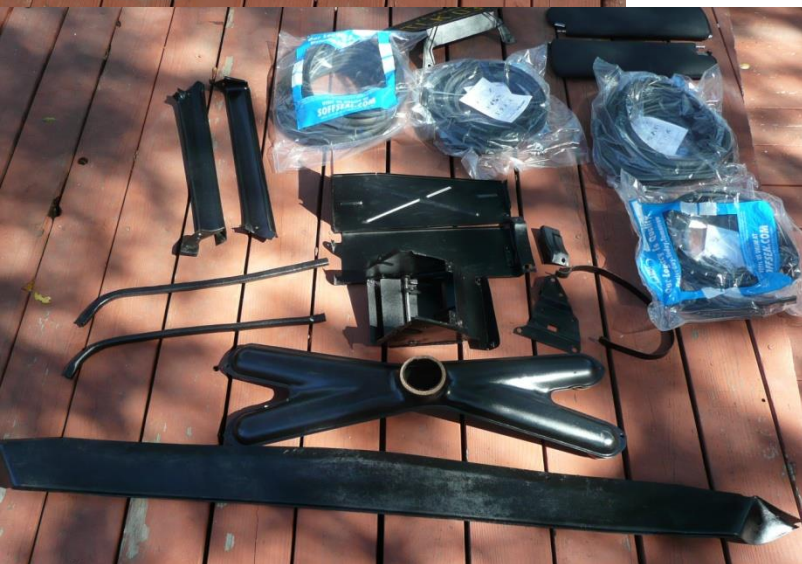
Refurbished parts Top photo shows rear shelf I fabricated with plywood sandwiched between a sound deadening material. Original GM used tar paper under cardboard for the rear shelf. Remainder are additional items I have cleaned and painted in prep for going back into the Corvair. View at 200%

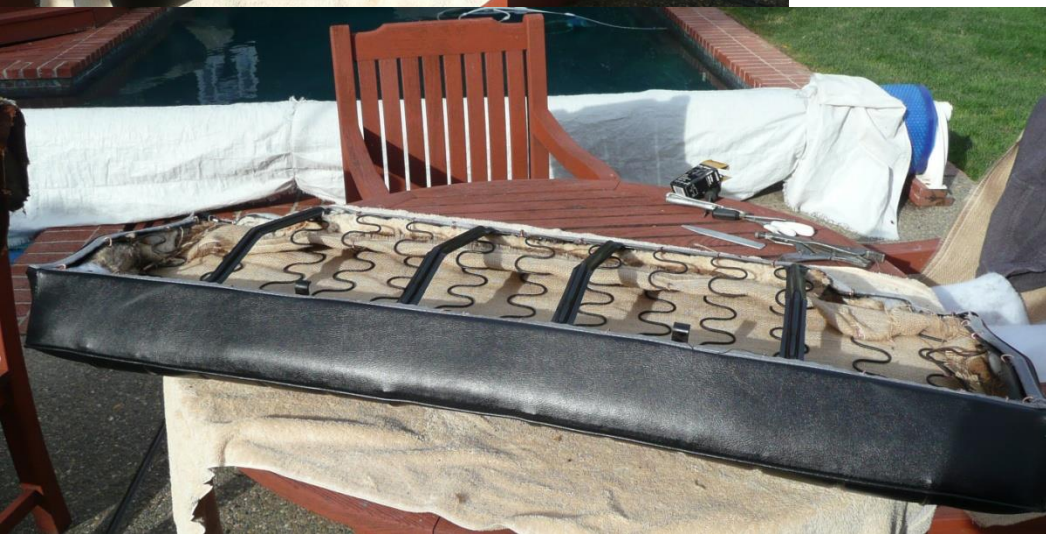
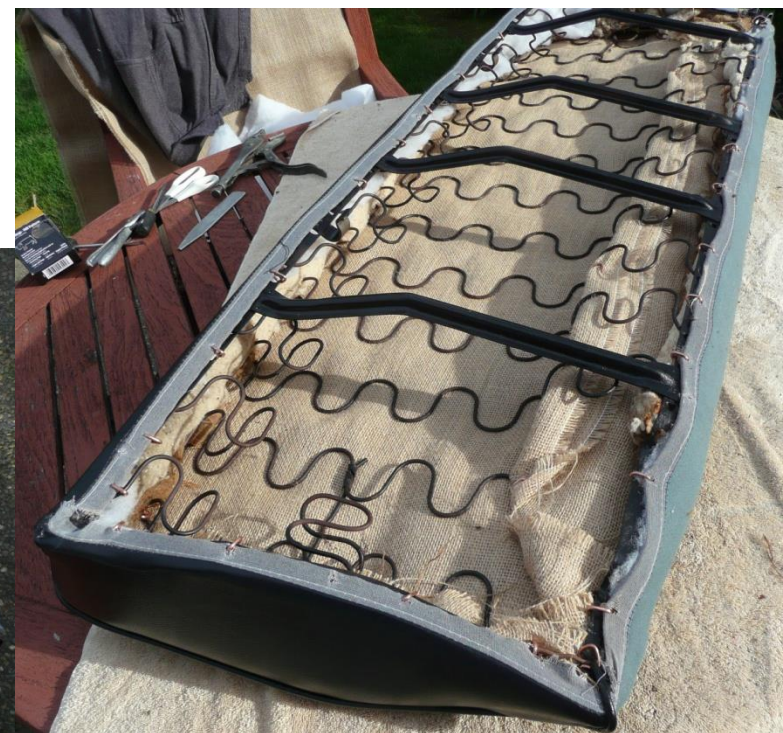
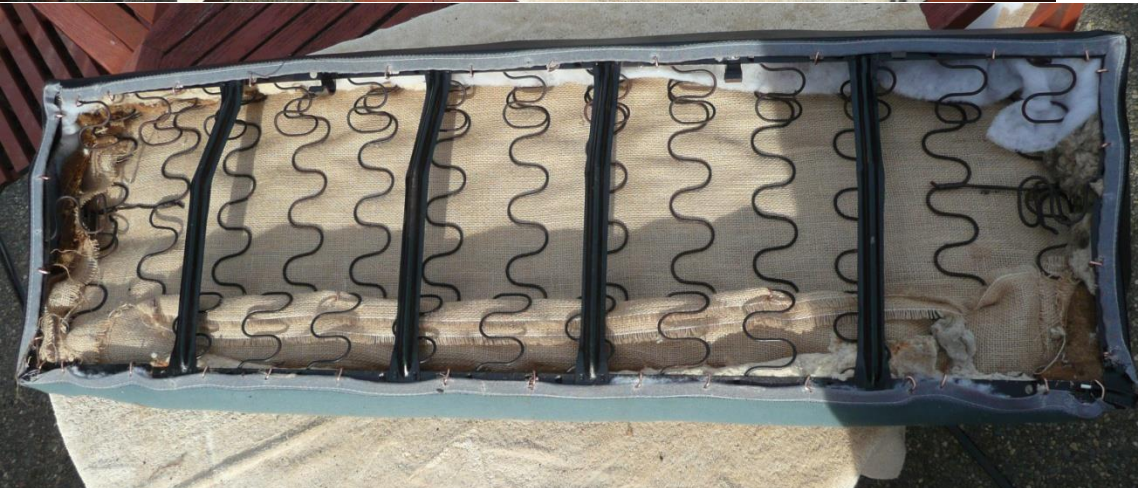
3/8/14 Progress report.

I finished the rear seat bottom. A very difficult task, the material is stretched so tight it hurt my hands putting in each hog ring.

I am pleased with the way it turned out after three hours of stretching. Tomorrow the rear seat back, first I need to disassemble the seat back before the stretching begins.

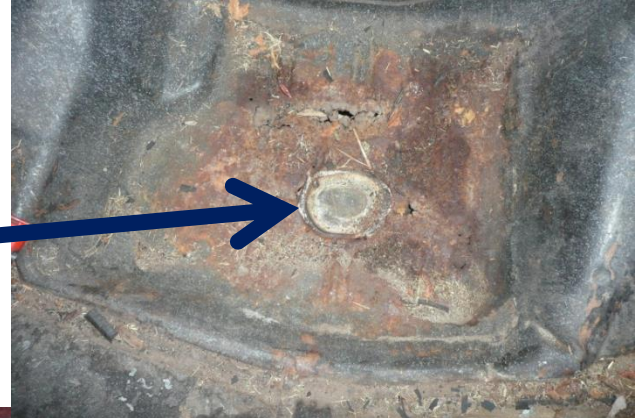
Trunk Bottom To be cut out and a new bottom (supplied) to be welded in.

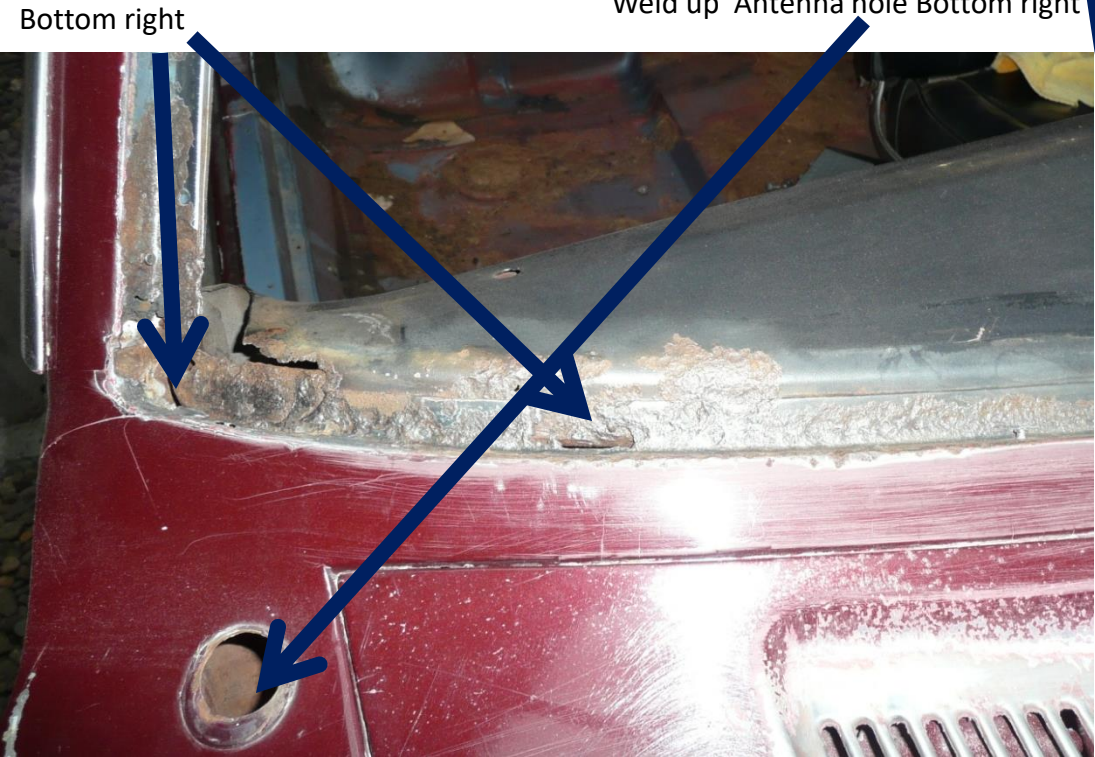
Weld up Antenna hole Bottom right

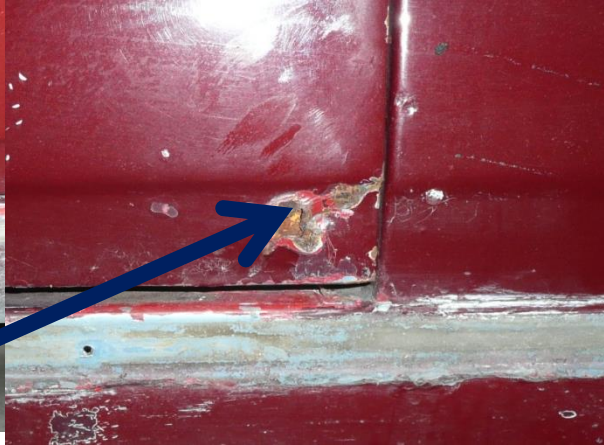
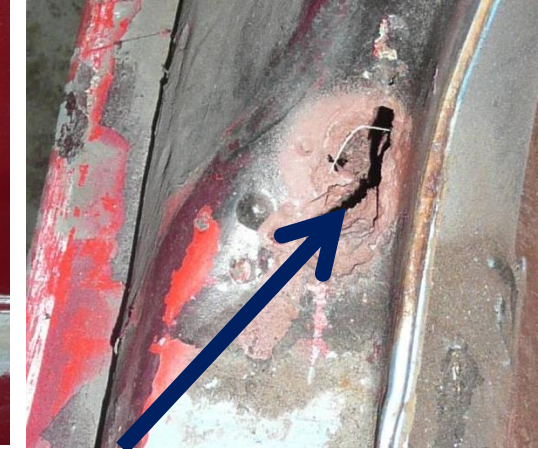
Left front Door Sill Rust Repair

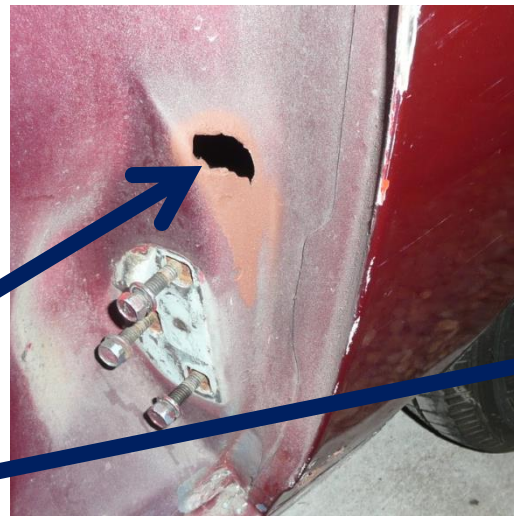
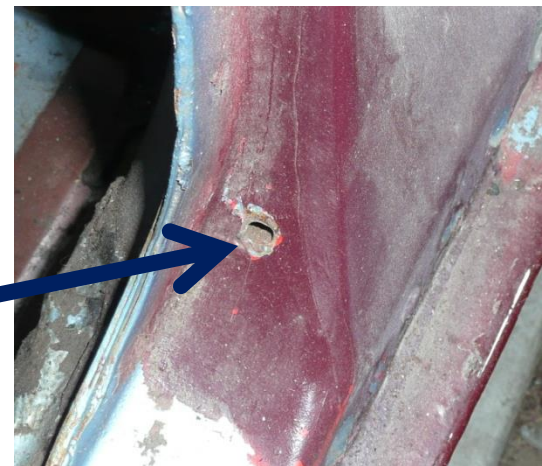
Back Window Frame Rust Repair

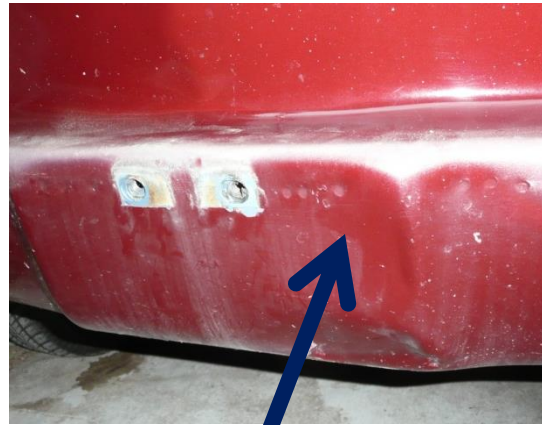
Front nose Dent Repair

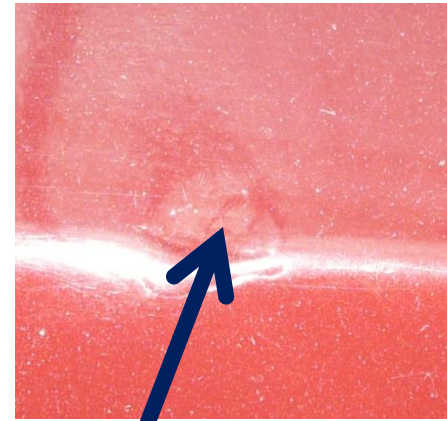
Top left rear fender Dent Repair

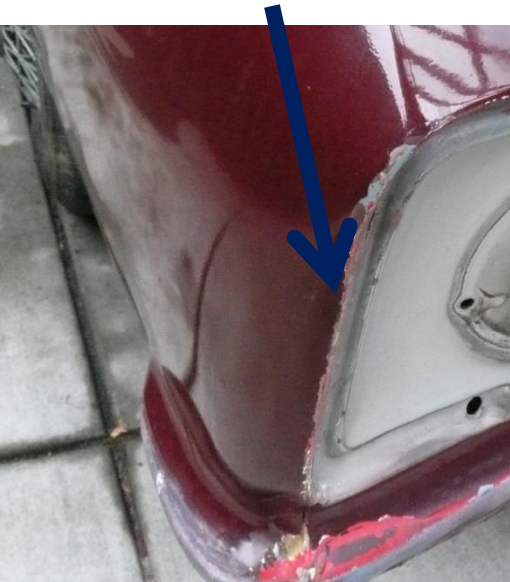
Left rear fender Dent Repair

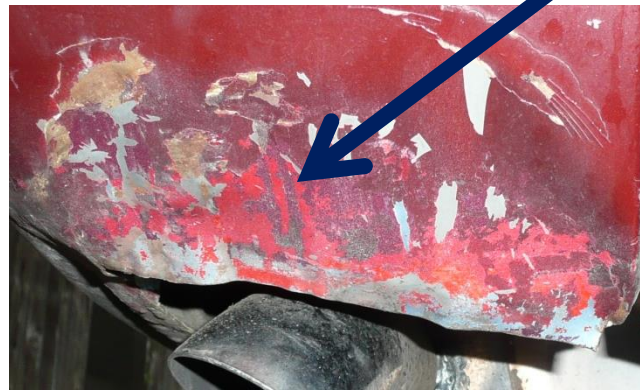
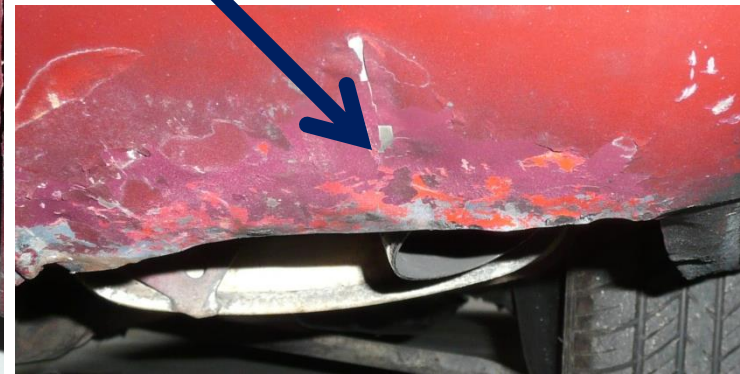
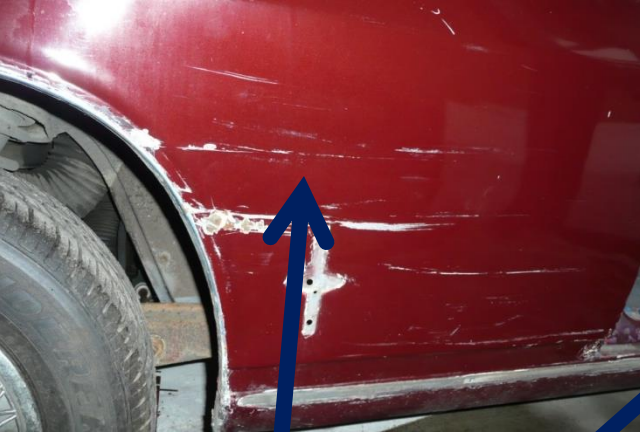
Left and right rear skirt Dent Repair

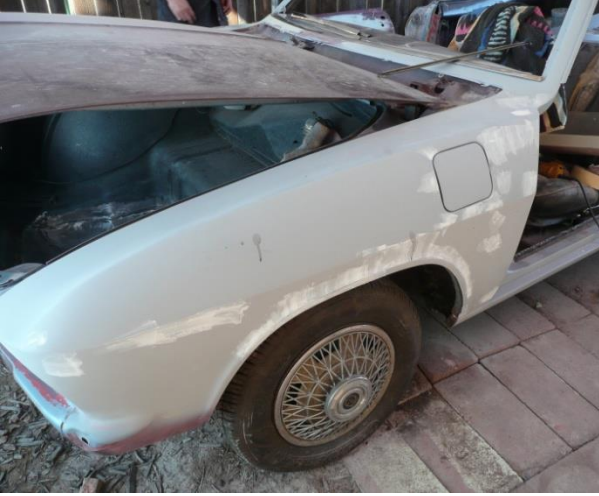
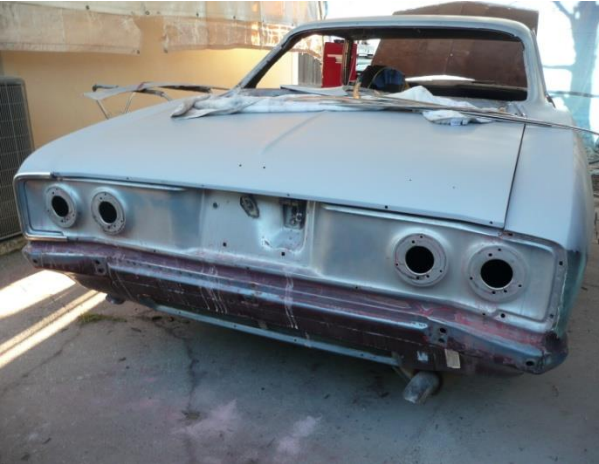
Corvair progress report. The metal work is coming to an end. The photos show some of the new metal pieces that were added to repair rust . In the 48 years the car has been around wet weather has produced some small pockets of rust. All these areas had to be removed and new metal welded in place. Once this is done the final body prep will begin. All in prep for new paint.

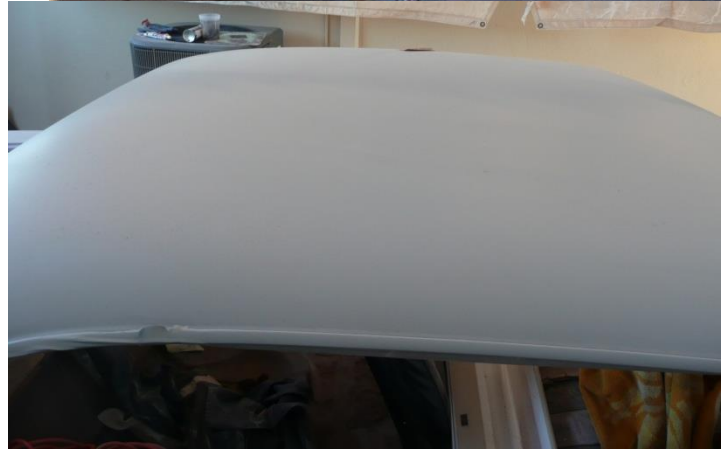
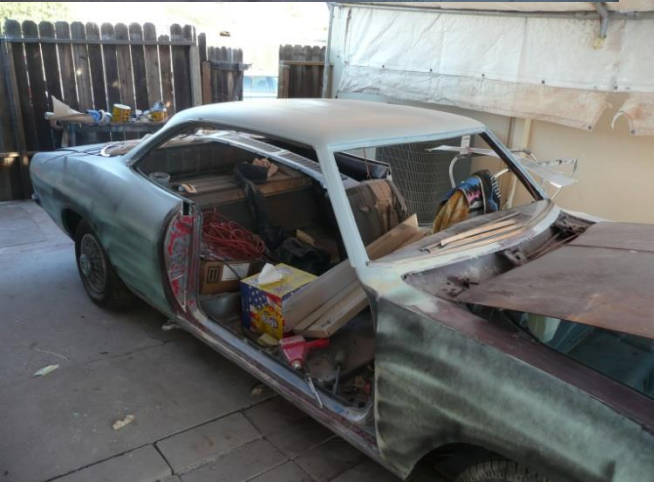
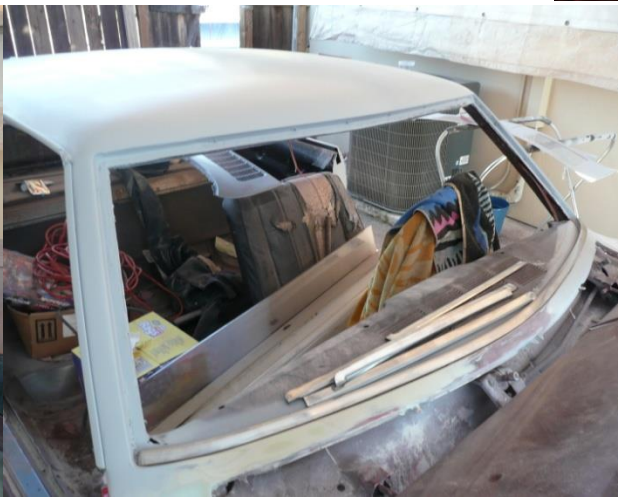
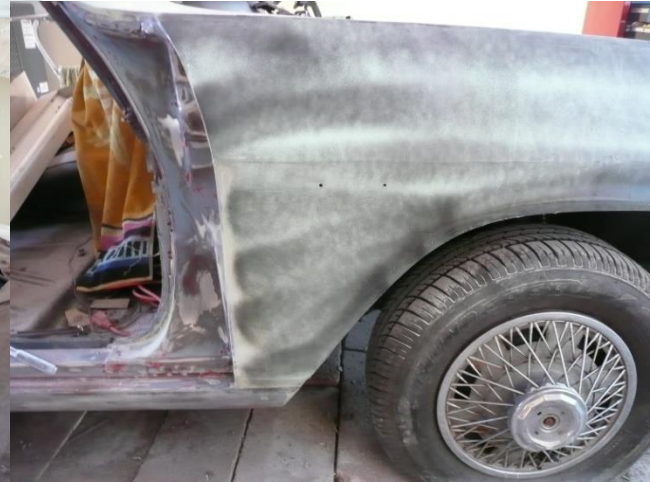
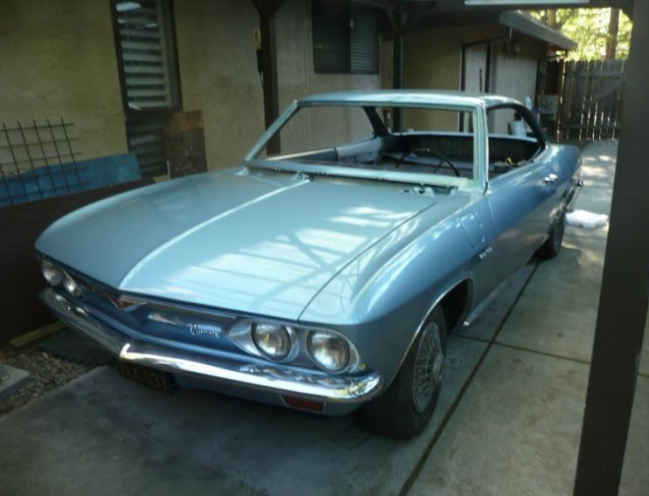
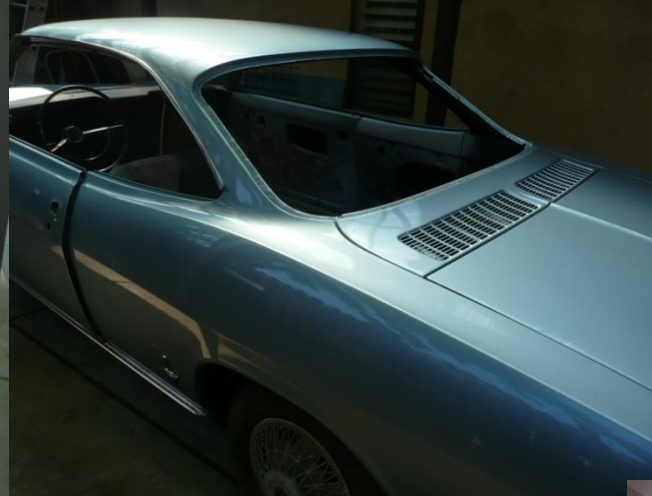
I went to see the progress on the car today. Good news, It looks like we will go to paint in around two weeks. This is what we have so far, the car needs a little tweaking around the front window.

I took the trim over to do a dry run and found a few places where we need to refine the radius on the window cutout.

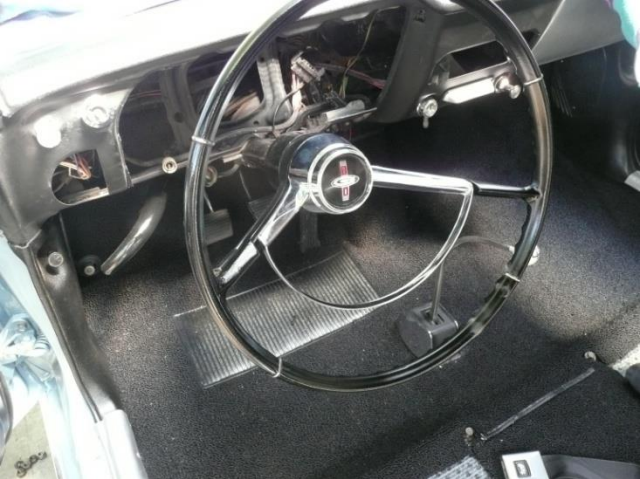
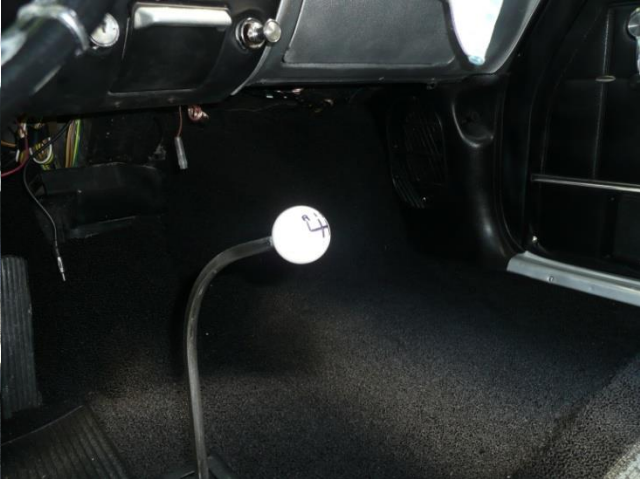
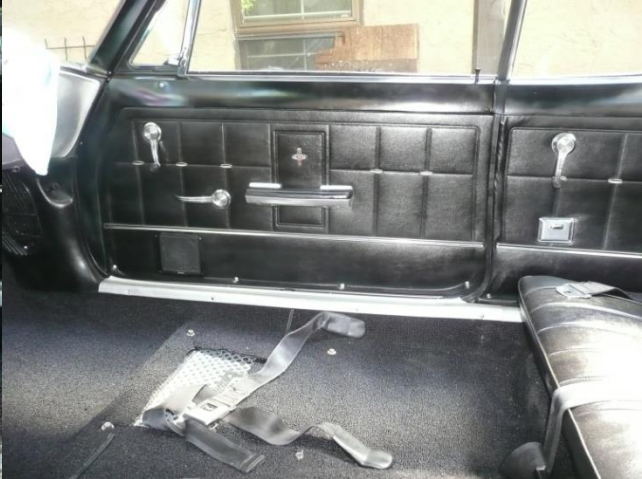
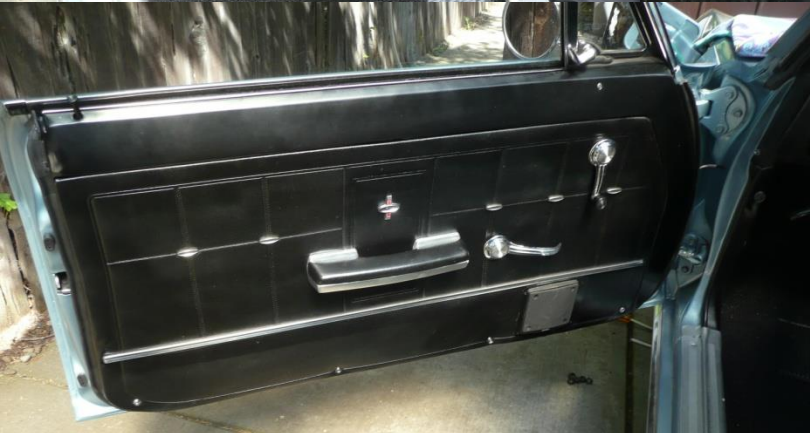
Progress Report 12: Completed the interior except for installing the seats and instrument panel. Installed the bow tie outside mirror.

Removed the steering wheel cleaned and painted it. Took the wheel off and lubed the directional mechanism. Removed all four wheels, cleaned and painted them prior to mounting the white wall tires.

Inspected the brakes and found them rebuilt with new drums, linings and wheel cylinders.

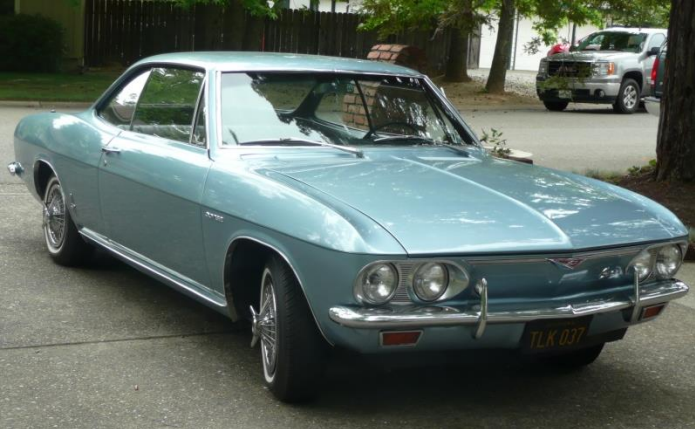
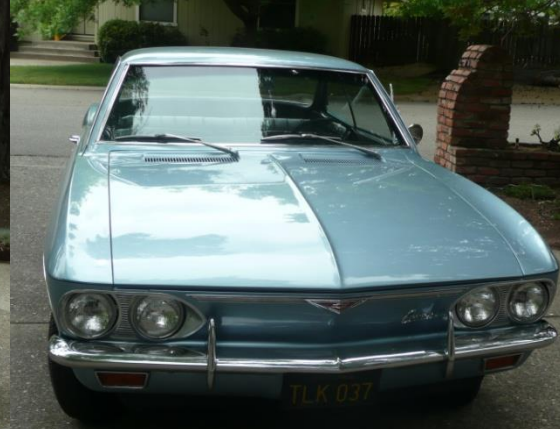
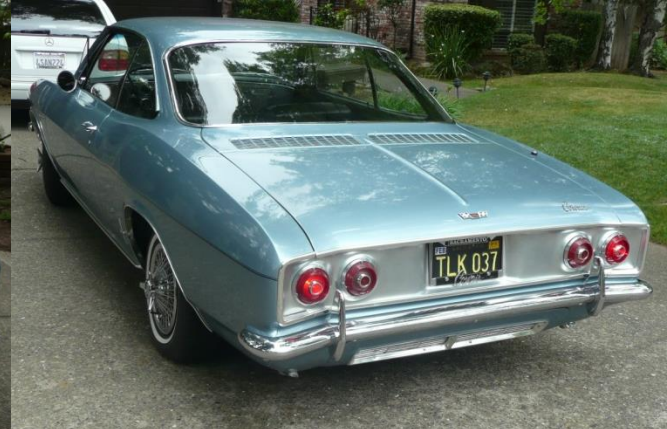
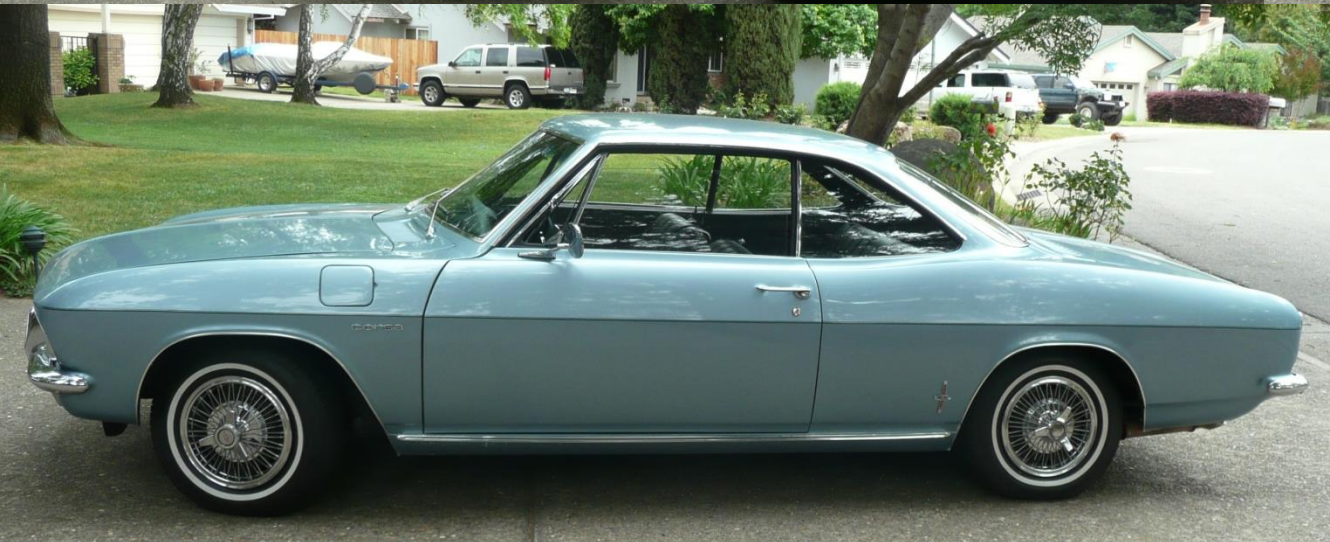
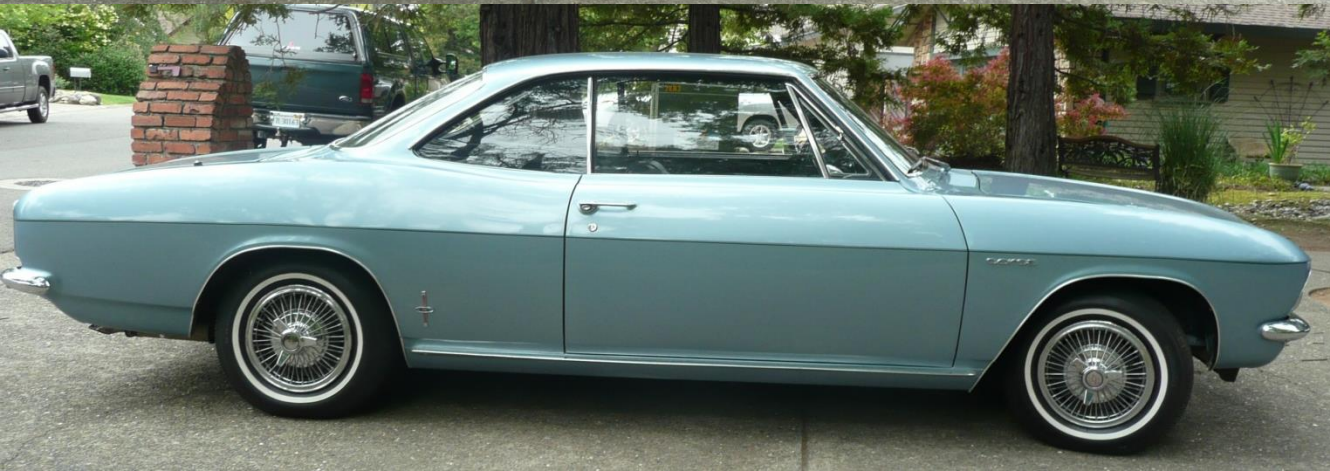
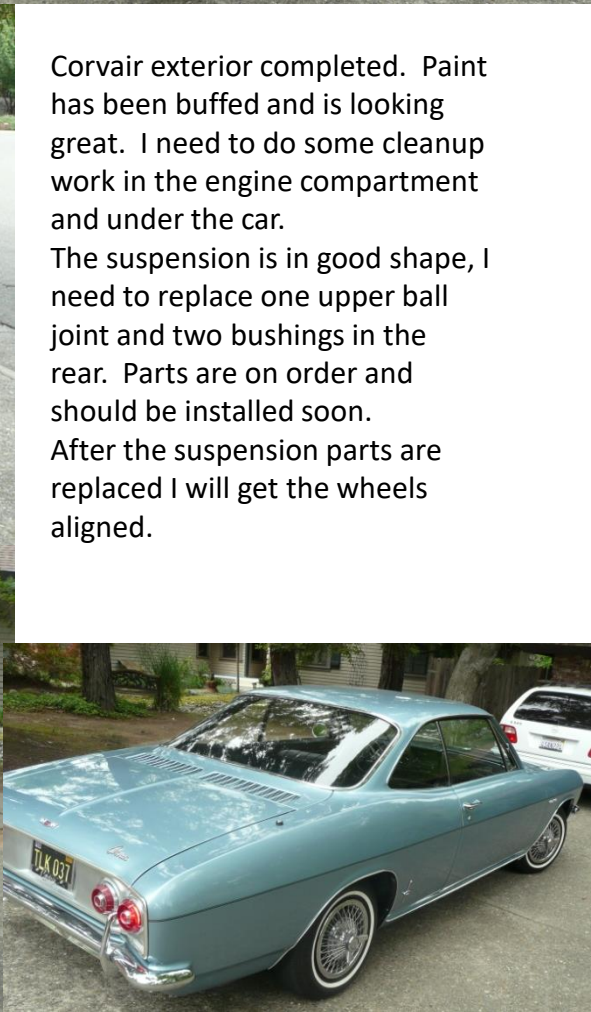
Corvair exterior completed. Paint has been buffed and is looking great. I need to do some cleanup work in the engine compartment and under the car.

The suspension is in good shape, I need to replace one upper ball joint and two bushings in the rear. Parts are on order and should be installed soon.

After the suspension parts are replaced I will get the wheels aligned.

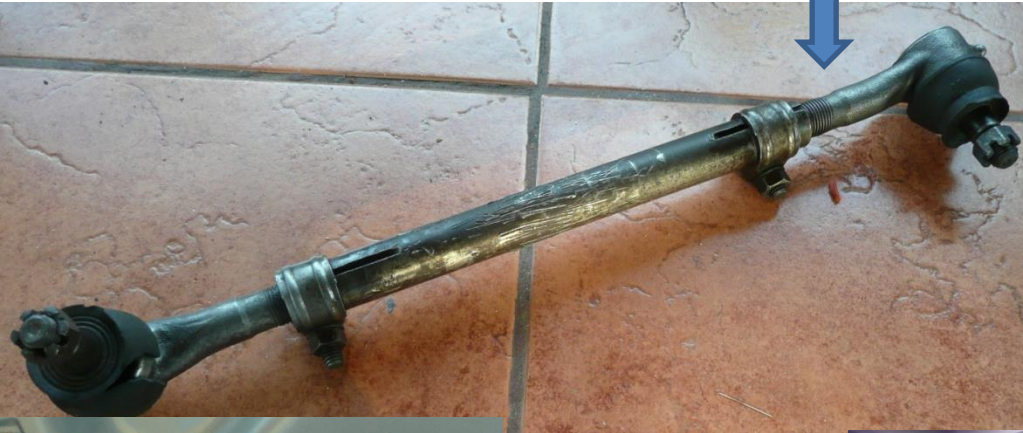
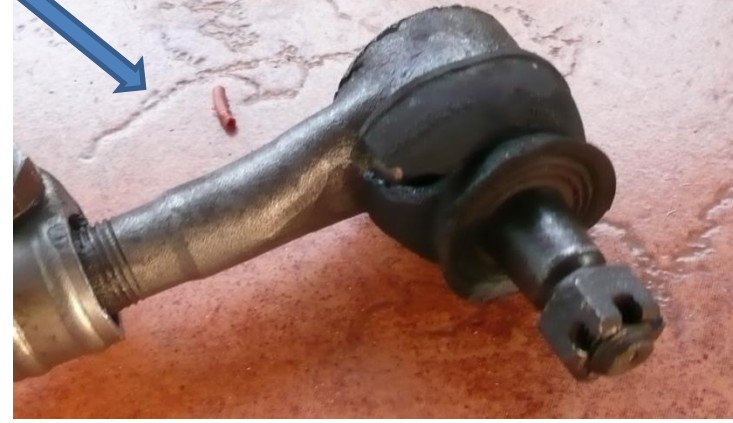
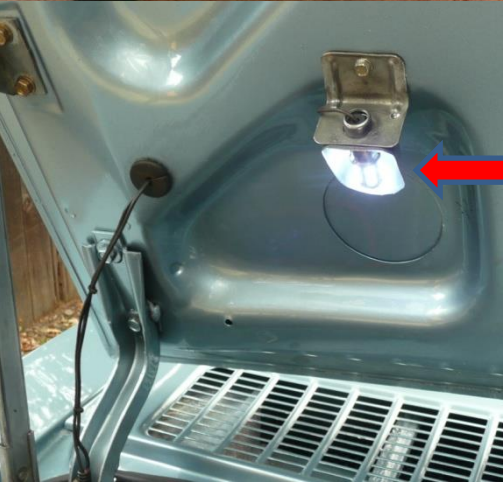
Replaced right side Tie Rod

18. Right side secondary carburetor was warped and leaked gas. Replaced carb.
19. Replaced right side upper and lower ball joints.
20. Replaced right side tie rod.

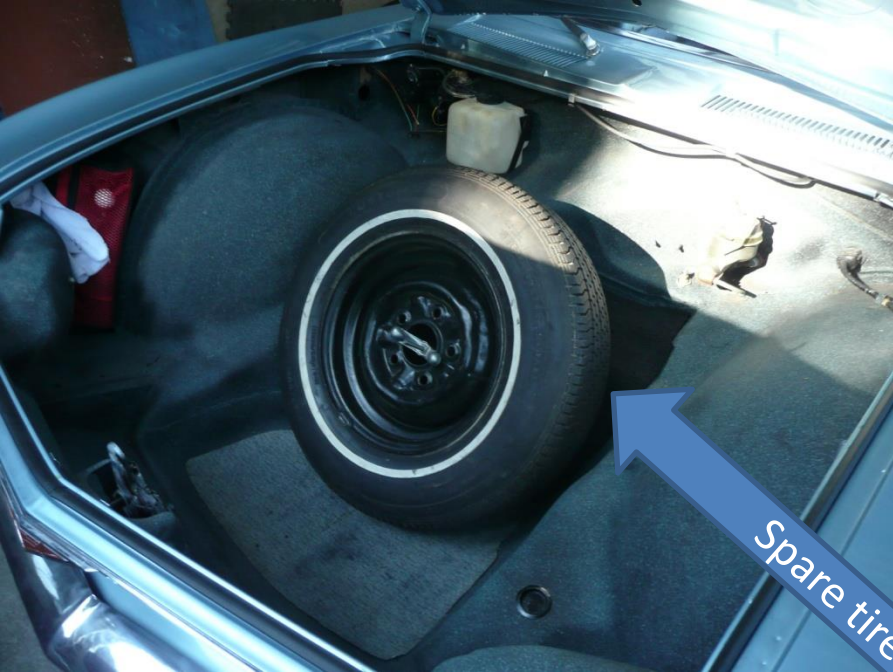
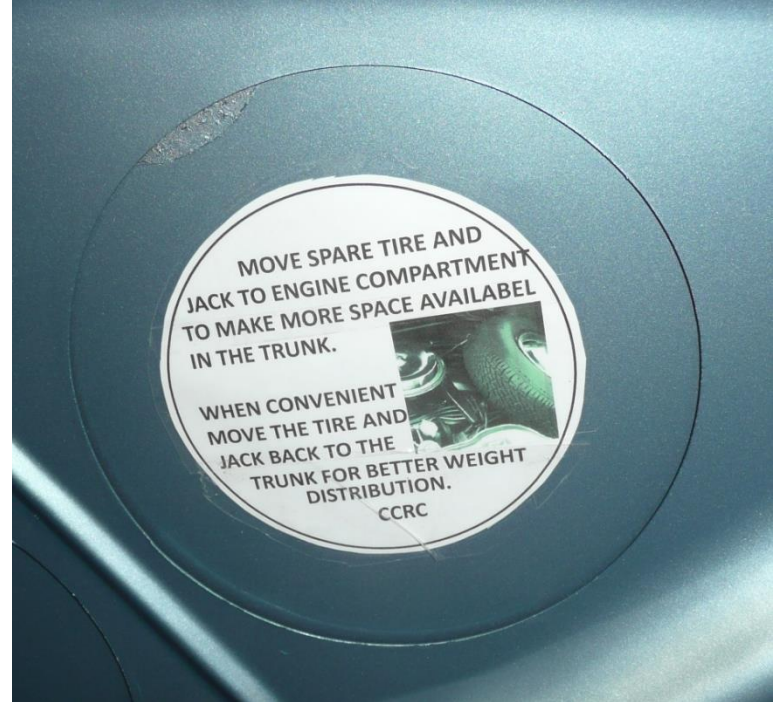
Mounted a spare tire mount to the trunk area. This is a factory alternative location for the spare tire and the jack. The factory mounted the tire and jack in this location when an air conditioner was installed in a car.

In this instance I wanted to shift the weight of the spare tire and jack forward for better weight distribution.

By leaving the spare tire mount in the engine compartment I have the option of moving the spare and jack back for added trunk space. This also makes engine access easier.

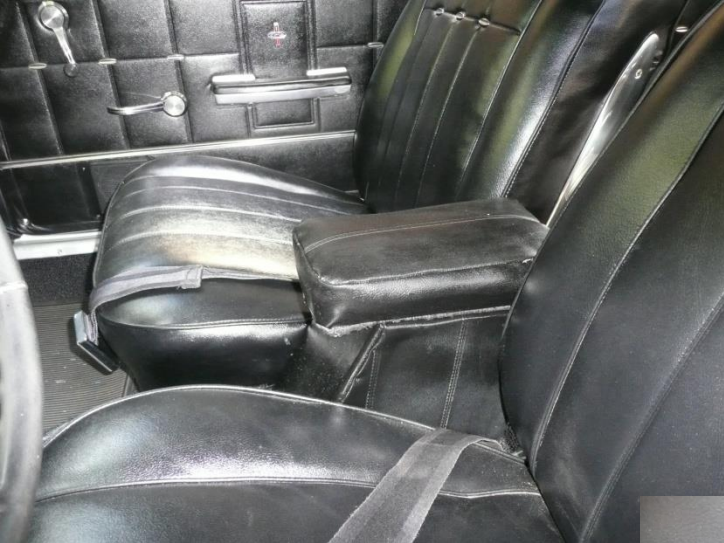
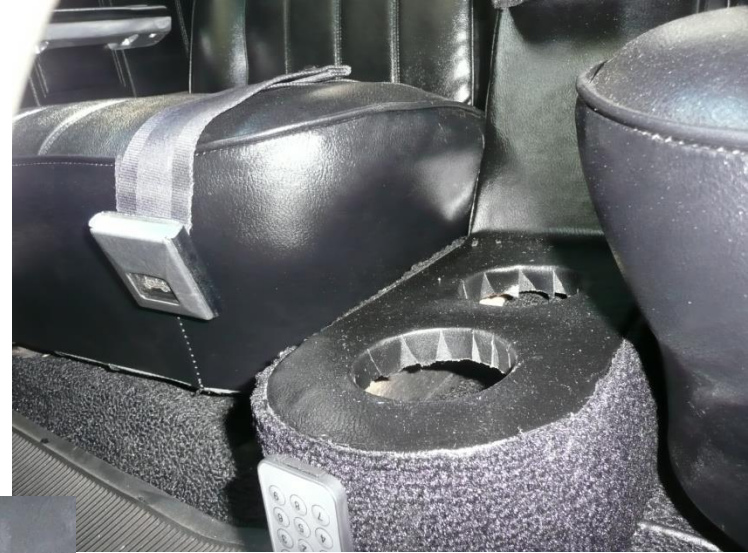
One of a kind center console. Made from material salvaged from the old seats and some scrap carpet material.

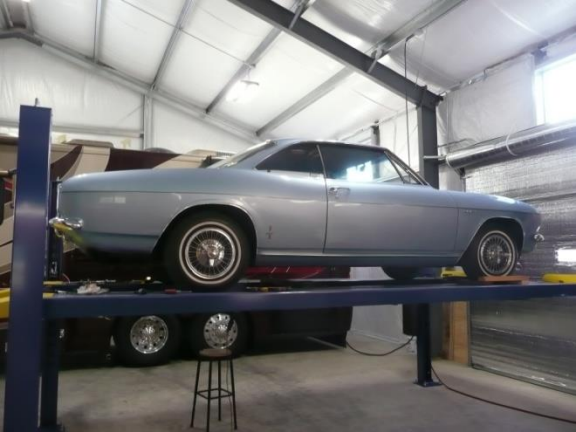
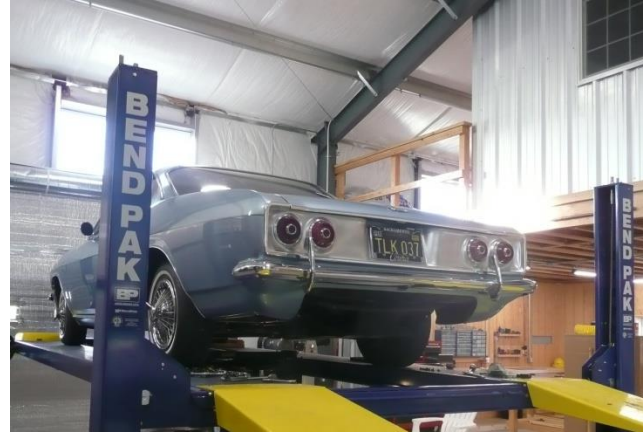
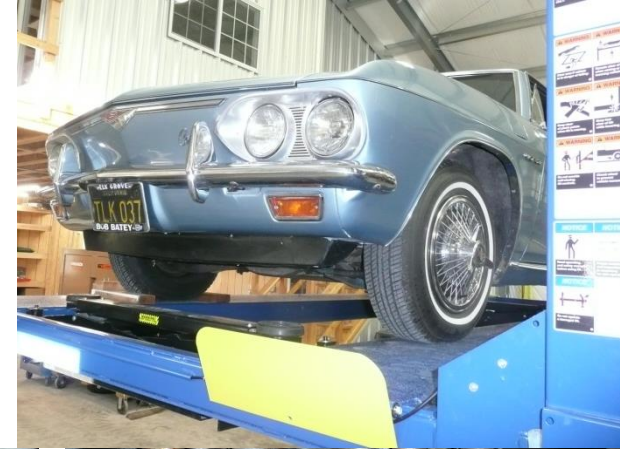
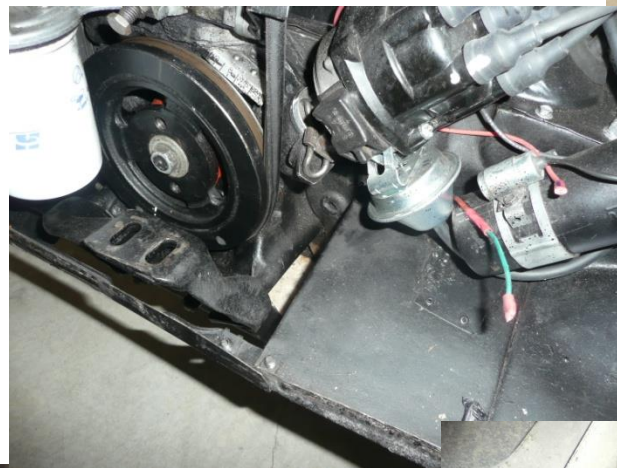
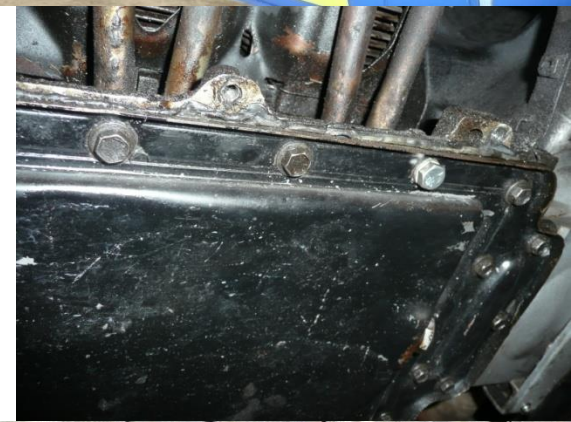
Engine removal to fix some poor workmanship and change the transaxle. A general cleanup with new transaxle mounts and shift tube bushings. New bell housing seal and trailing arm bushings. Stripped threads in pan need repair, Exhaust manifold hold down studs were also installed.

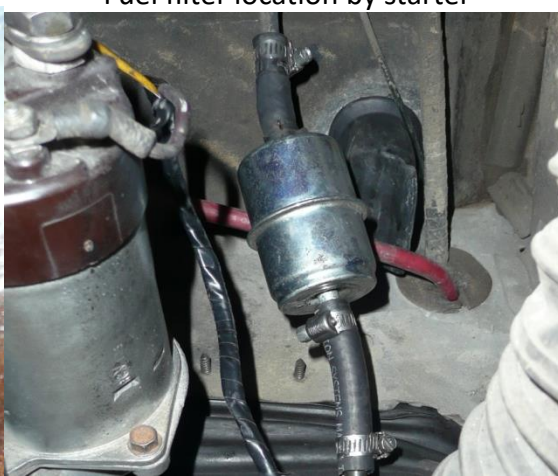
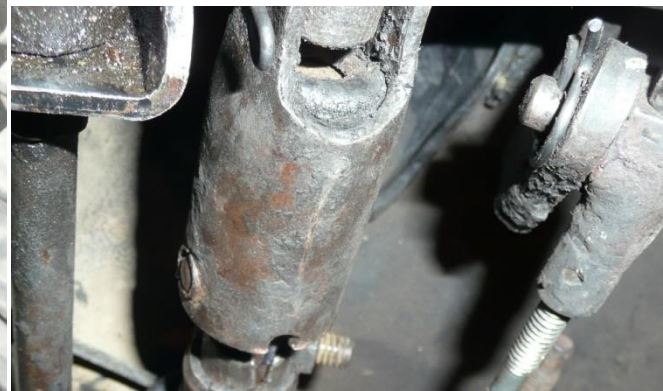
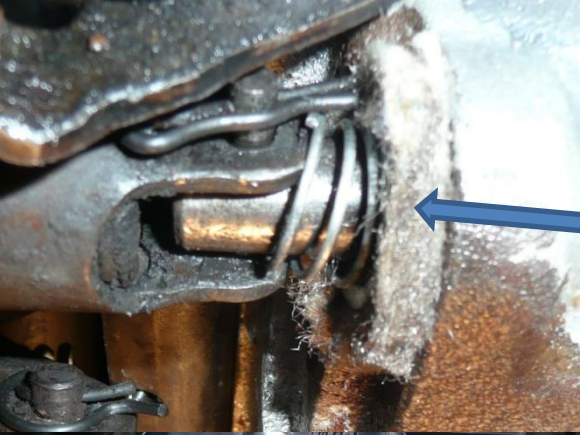
Control shaft and clutch pivot

Felt spring and washer were added to the transaxle input control shaft to prevent drips

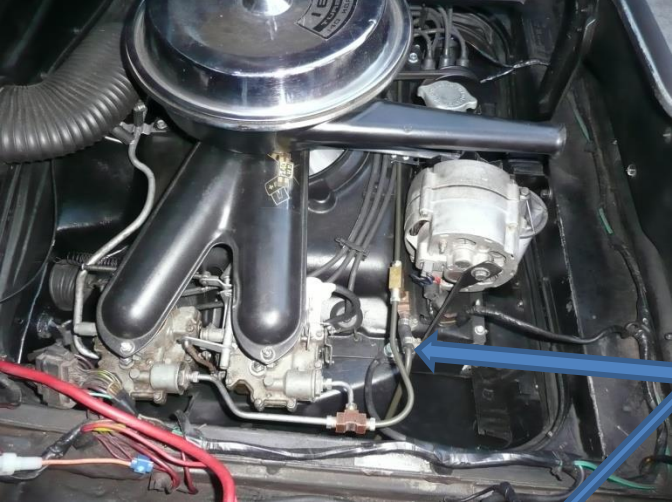
Engine compartment cleaned painted and new bolts were installed to hold down the shrouds

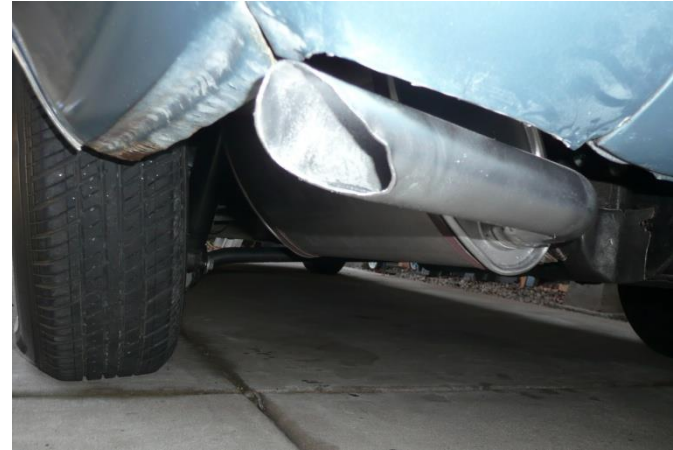
Refinished rear grill.  
Adjusted the chrome trim where it meets the engine lid. Made tubing vents for both sides of battery.  
Installed a new left side muffler.

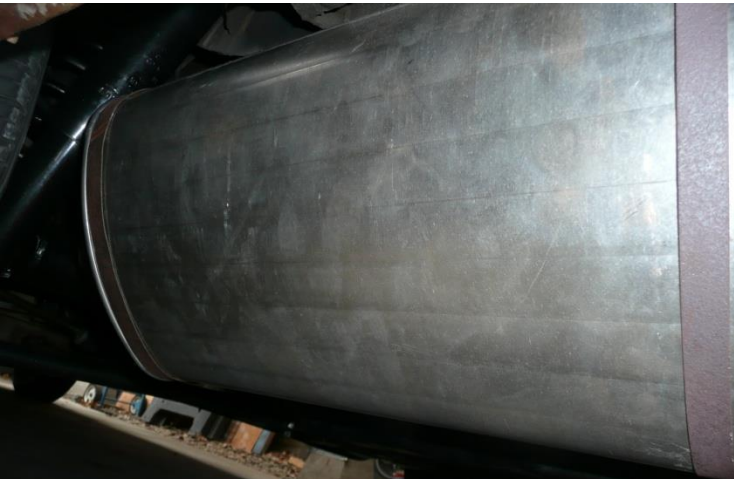
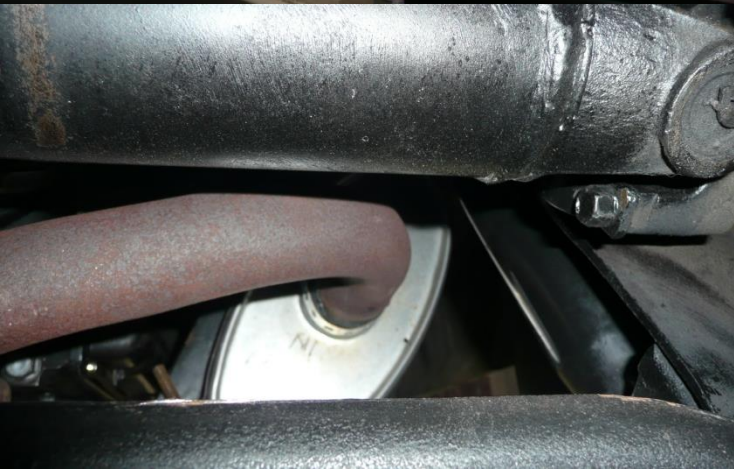
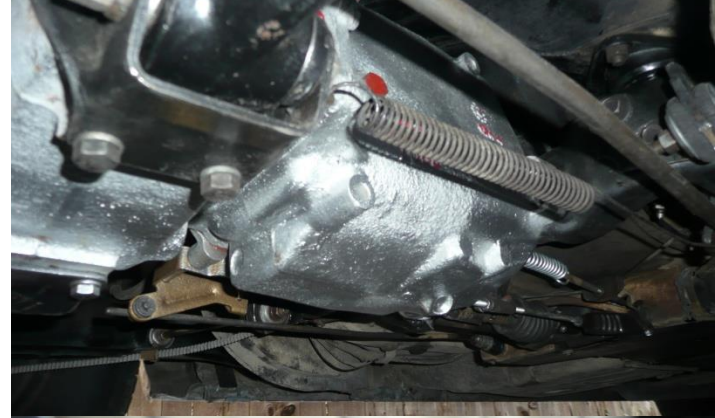
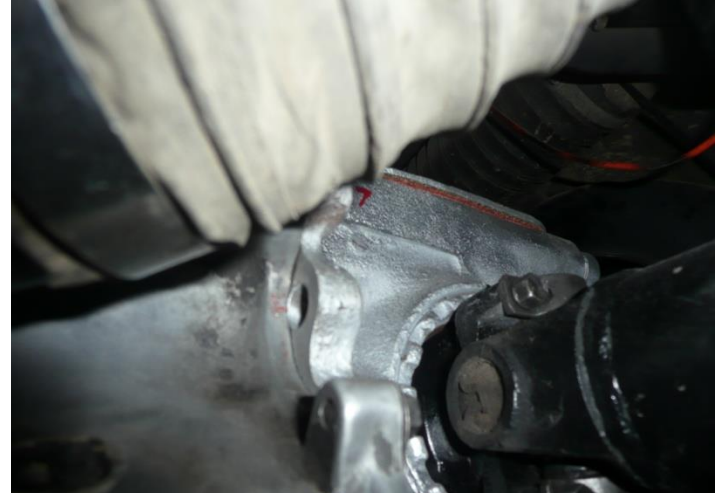
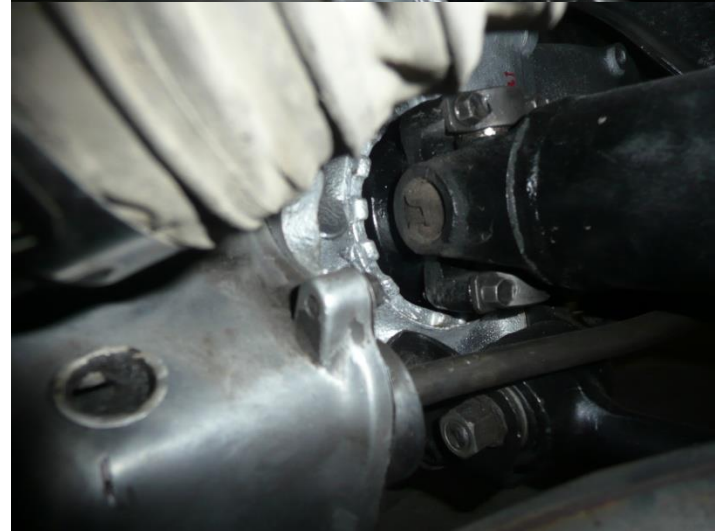
Transaxle mounted in vehicle, right side universal joint was not seated at the transaxle. Reseated the universal joint in the saddle.

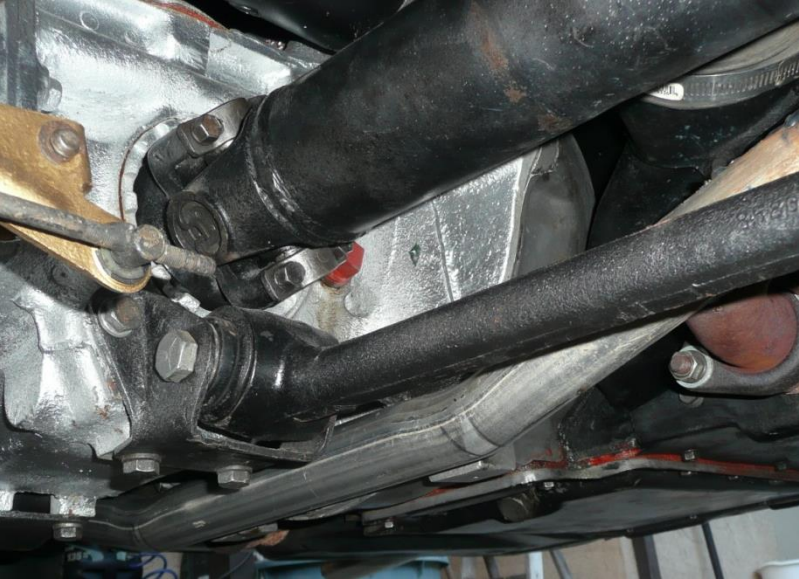
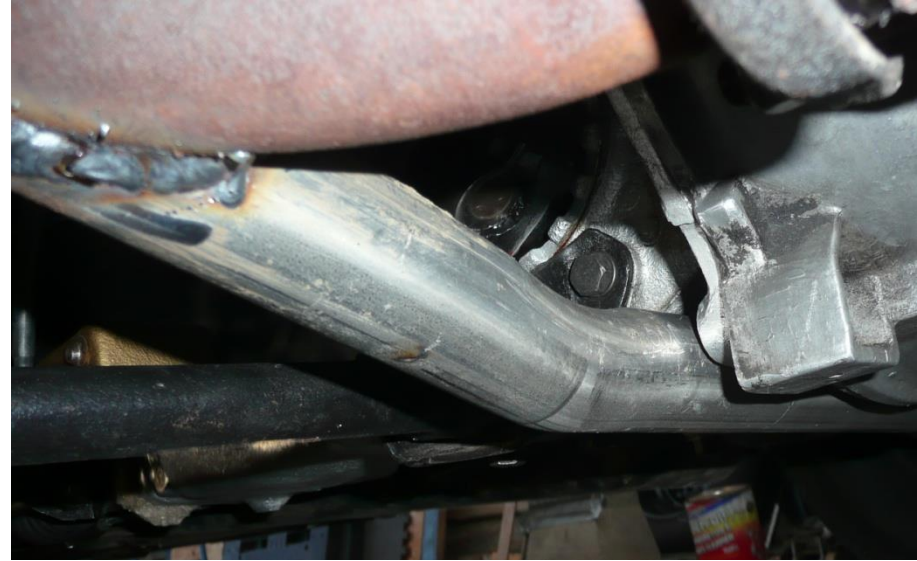
Equalizer pipe installed between the right and left exhausts "U" pipes. I wanted to preserve the ground clearance so the pipe runs up where the stock crossover went. This pipe doubles the frequency in each muffler and decreases the noise level of the exhaust system.

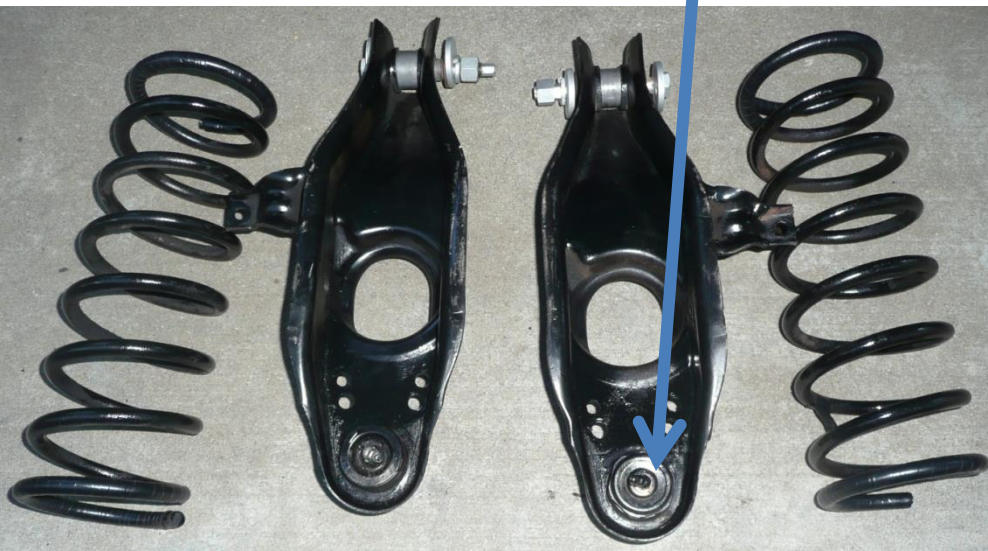
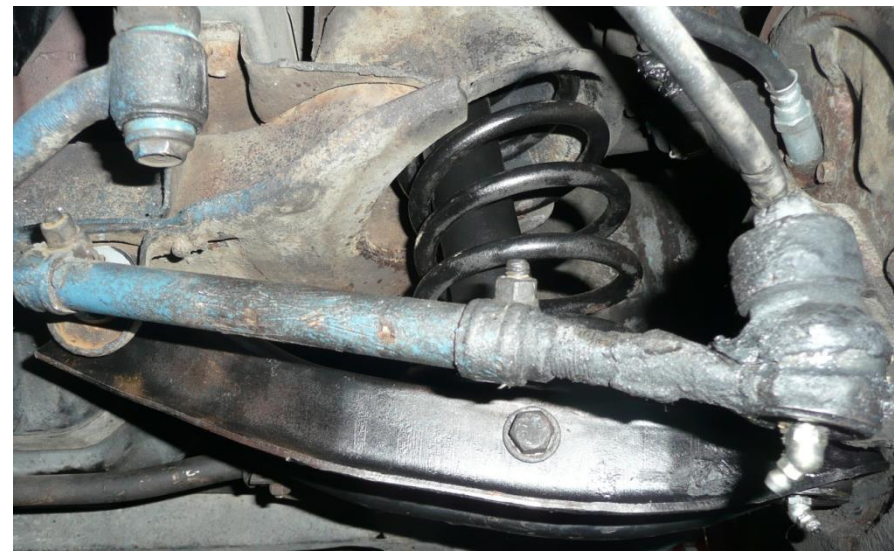
Removed and refurbished the lower front "A" arms.  
Replaced the inner bushings along with the ball joint  
on the right arm.
