# The restoration of my 1966 Chevrolet Corvair Corsa 140 hp 4 speed.

Acquired January 2014.

The restoration, as shown in this document, is complete. I now have the confidence to drive this car anywhere, without the worry of a breakdown. At this time I think this car is reliable and safe to drive.

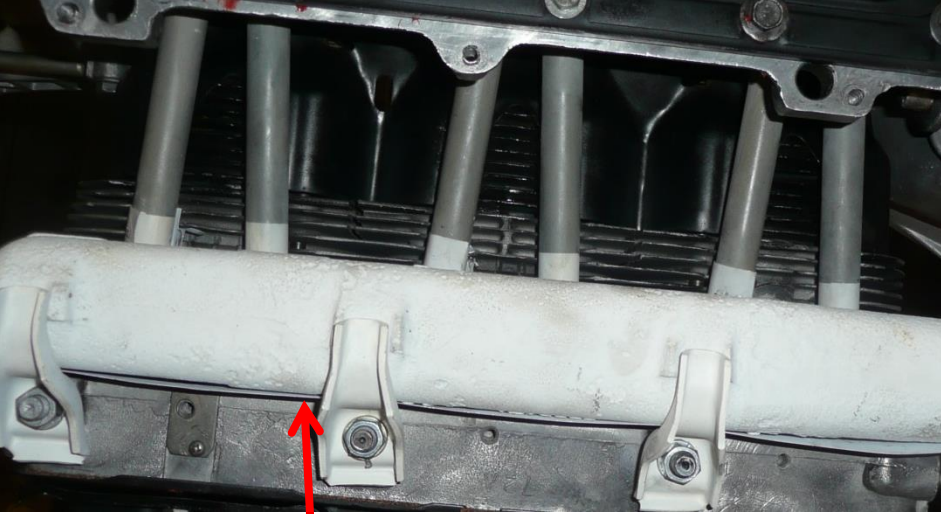
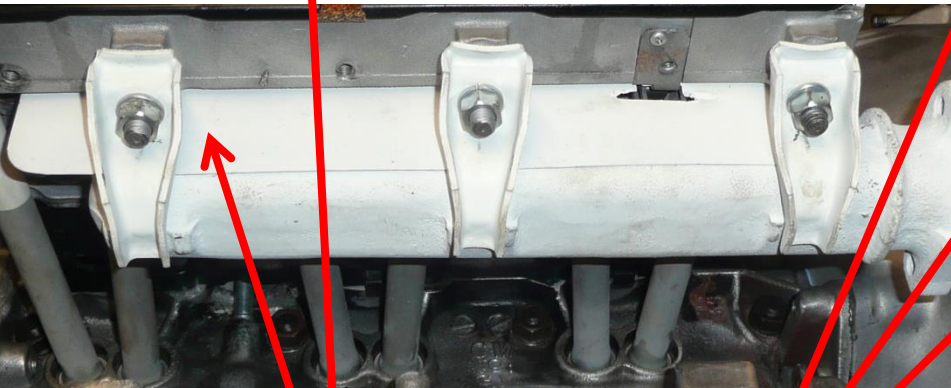
Exhaust Manifold heat shields, self fabricated

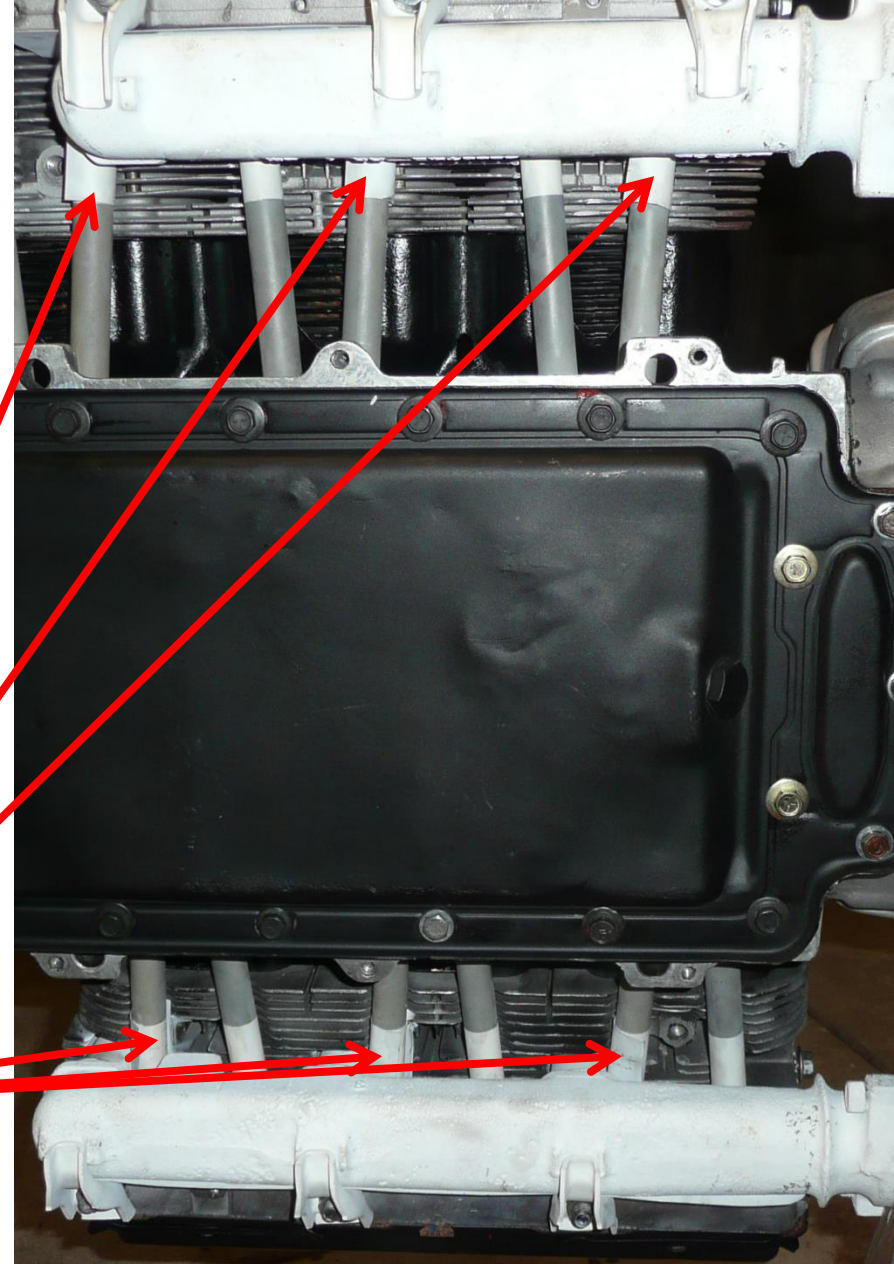
Pushrod tubes heat shields, self fabricated

Heat shields reduce the heat transferred to the oil returning to the crankcase from the heads. Exhaust manifolds and exhaust tubes are painted with VHT white paint to reduce heat radiated into the heads.

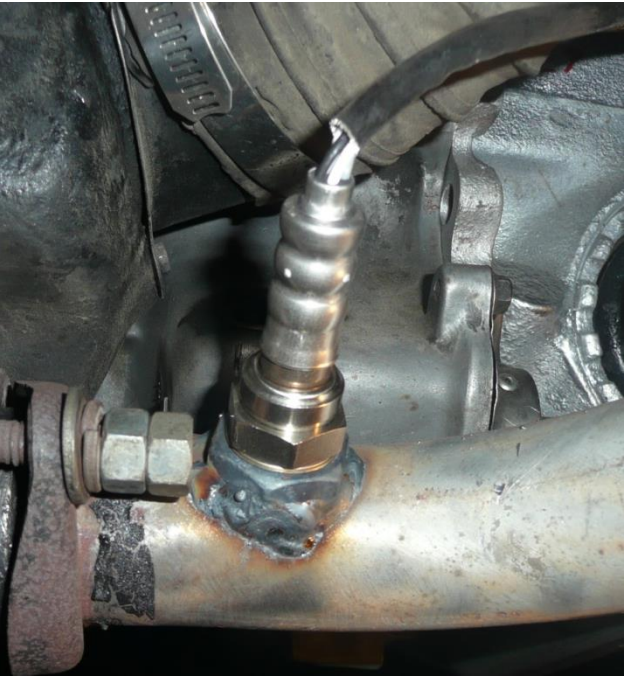
O2 Sensor at head of right exhaust pipe

The fuel ratio gauge along with the O2 sensors allows the proper calibration of each carburetor for main jet selection and adjustment of the air bleed screw. A perfect ratio is 14.5 parts of air to one part of fuel. This gauge also monitors the battery voltage and displays it for a short time every 15 minutes.

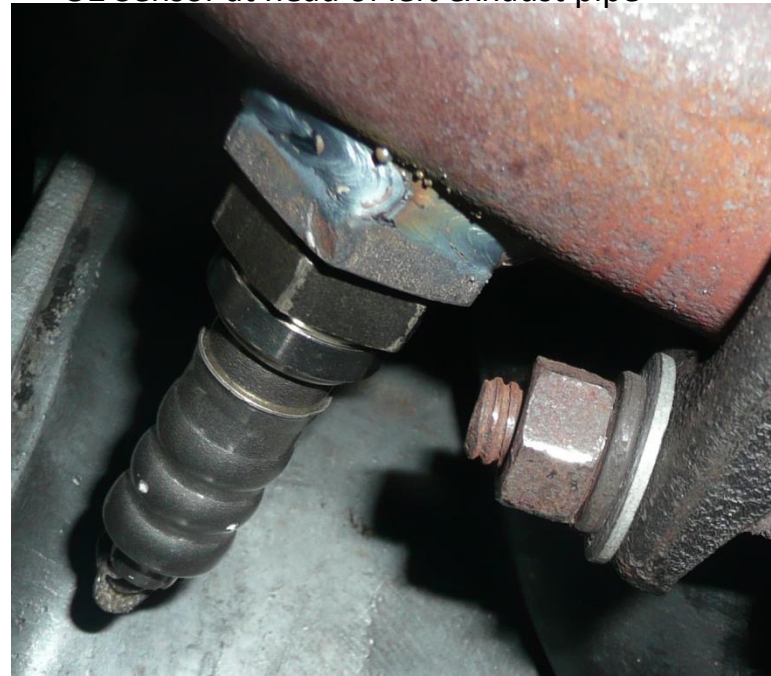
O2 Sensor at head of left exhaust pipe

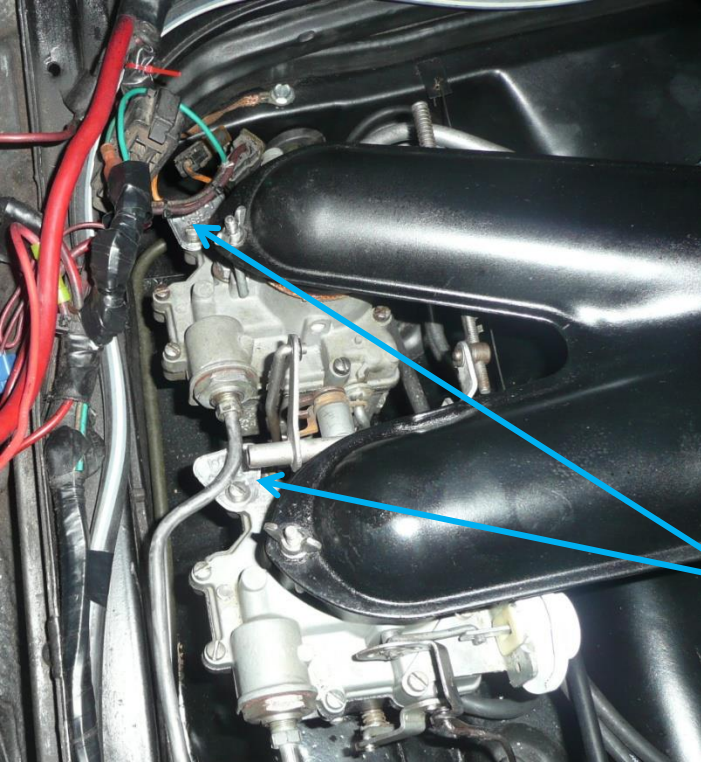
Engine running on all four rebuilt carburetors. The primaries have the idol jets enlarged to .031"

Both primaries are running a rich fuel/air ratio. Will try to rectify by reducing the idol jet size.

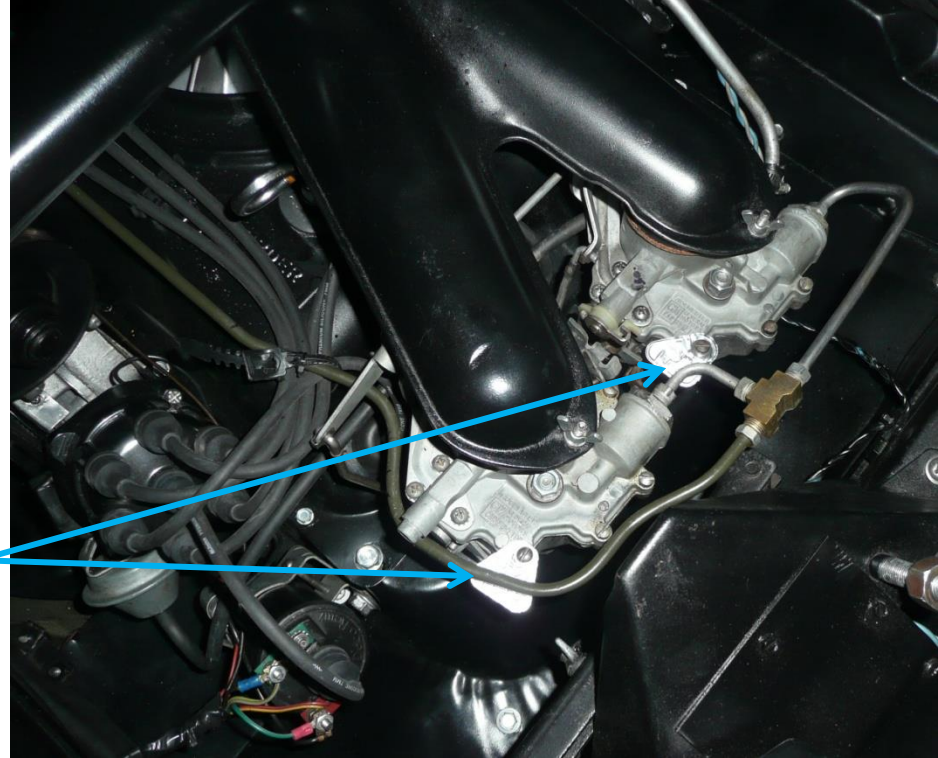
Copper Conductor high voltage ignition wires. Required to run a capacitive discharge ignition system

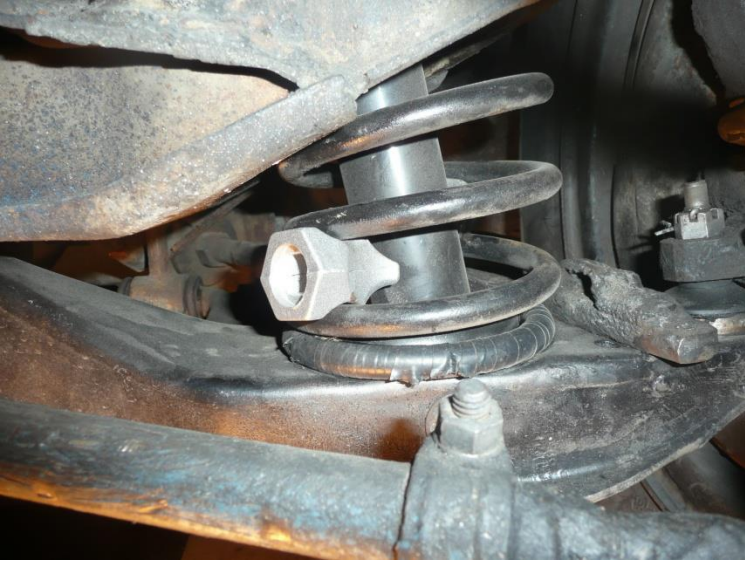
Front left  
spring.

The car sagged on the left side with most occurring at the rear. The left rear was  $3/4$  " low when compared to the right hand side. All four corners are now at 25" height measured at the wheel arch above the axle +/- a  $1/4$ " now.

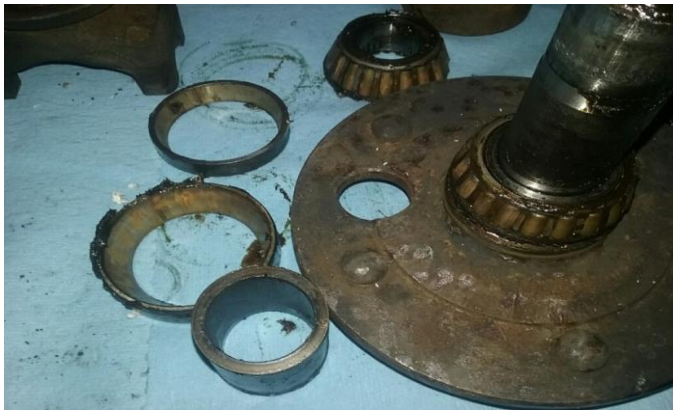
Upon disassembly and inspection Steve found the left side bearings had rust on both the rollers and races. The bearings were close to failure. The right side hub was from a 1965 car and had been replaced some ware during the cars lifetime. The assembly was good on grease and would have run for some time.

Left side hub 1966 version with rust.

Last project to improve reliability is to rebuild the rear hubs. The hubs were removed and shipped to Rear Engine Specialists in Golden Colorado. Steve Goodman agreed to rebuild the hubs to new specifications.

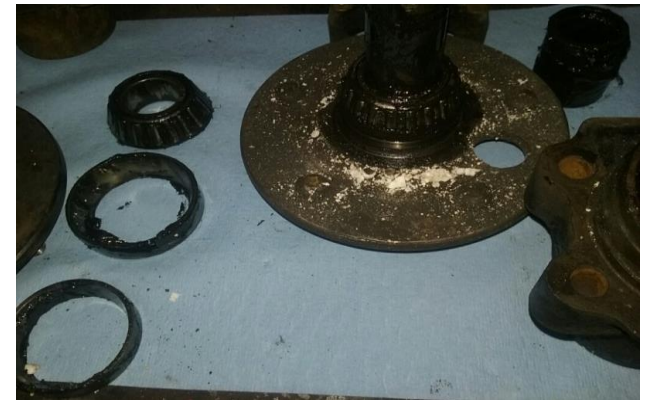
Right side hub 1965 version OK

Steve will replace the 1965 yoke with a 1966 style and supply the bolts and straps with the returned hubs.

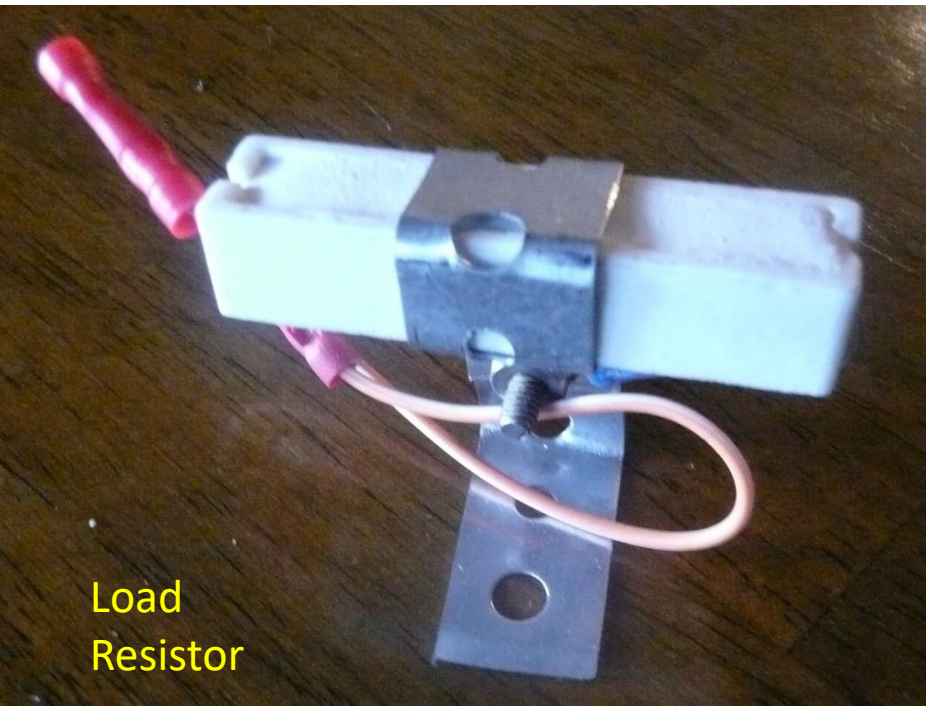
Load Resistor

After installing LED lights in the instrument panel the instrument dimmer switch did not work. A load resistor, that simulates the current draw of the incandescent lights, was added to allow the dimmer to function

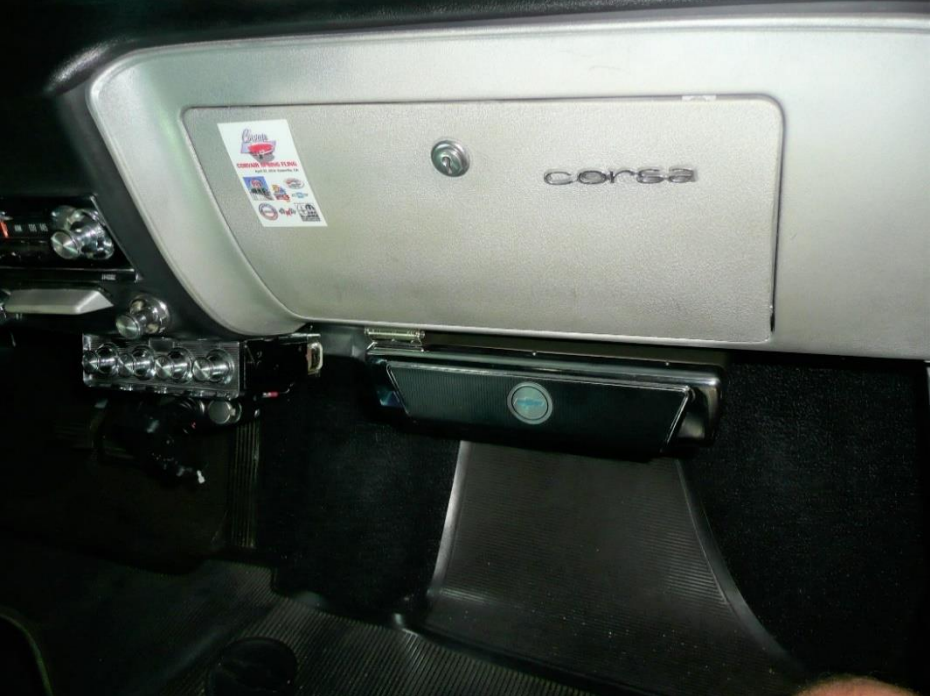
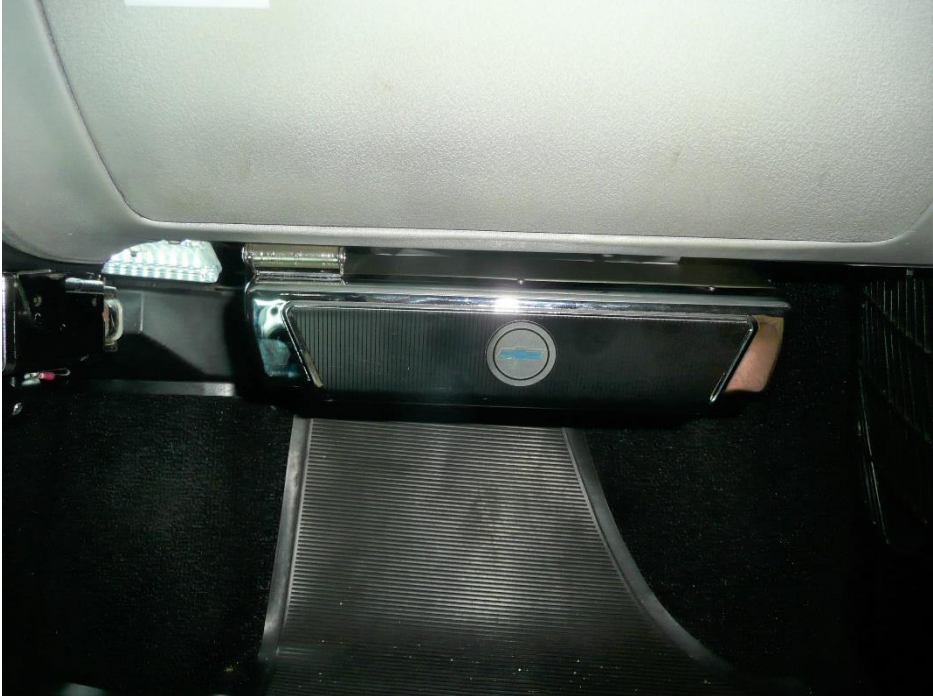
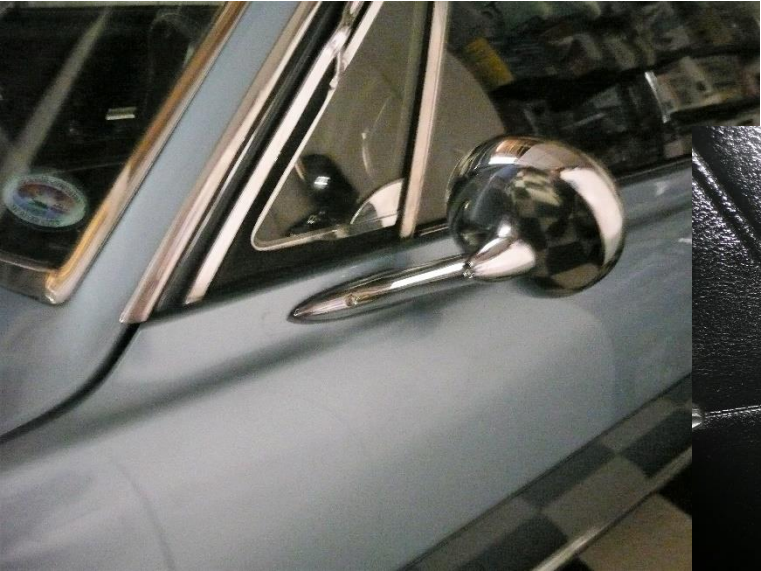
Tissue dispenser installed in alternate location, normal installation is under ashtray.  
The Multiplex Adaptor is installed in that location.

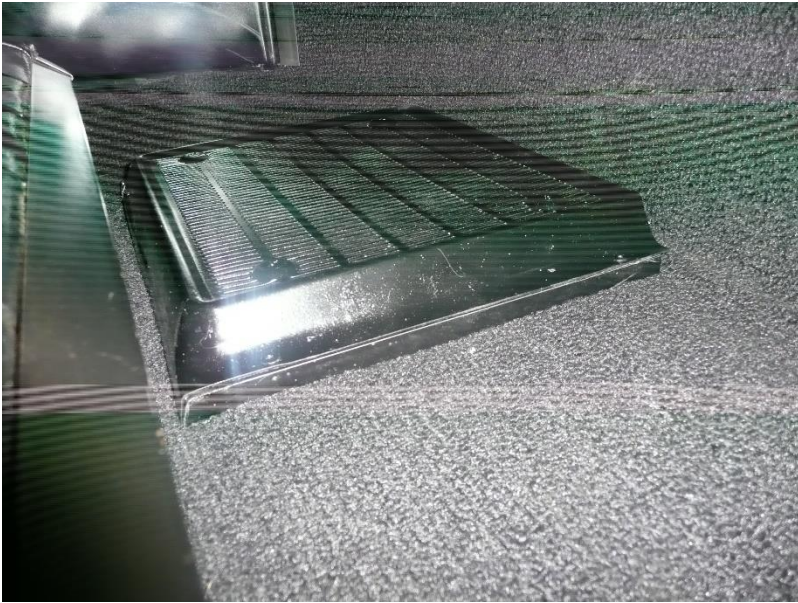
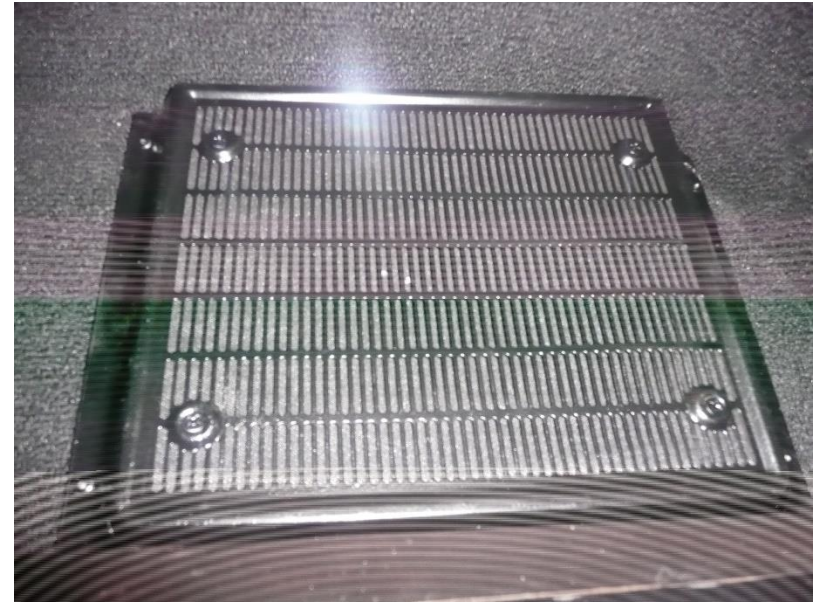
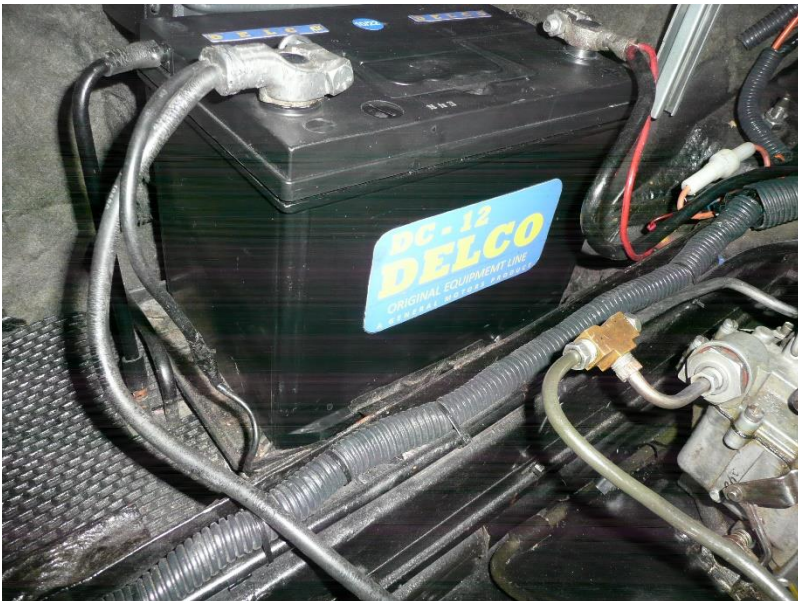
Installed OEM grills on the two rear speakers. One of these was original to the car and was centered on the shelf below the rear window. I located a second and placed them over both speakers I had mounted in the rear shelf.
