HOTEL BUCKMINSTER

BOSTON LANDMARKS COMMISSION

STUDY REPORT

Hotel Buckminster
635-645 Beacon Street, Boston, Massachusetts

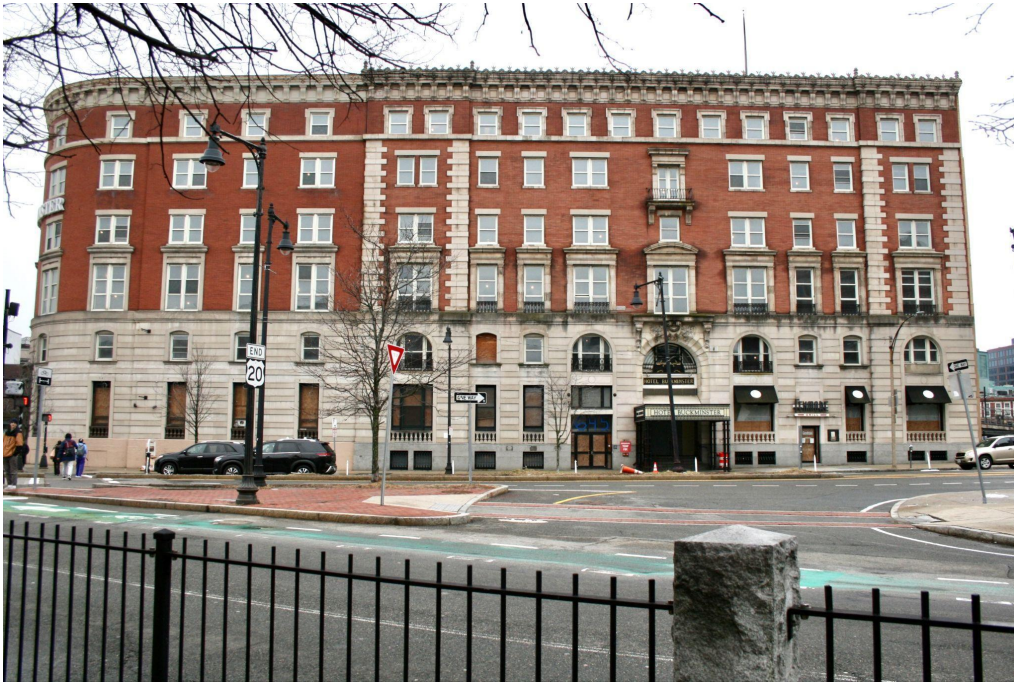
Figure 2. Beacon Street elevation, view southeast from Commonwealth Avenue. March 2023.

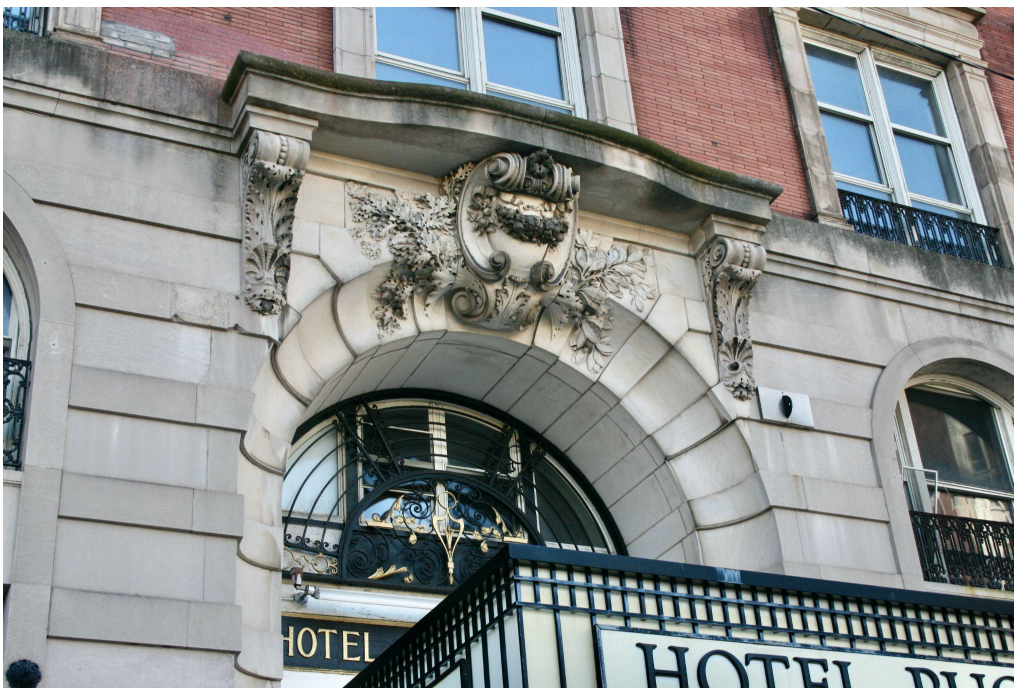
Figure 3. Beacon Street elevation, transom over main entrance. March 2023.

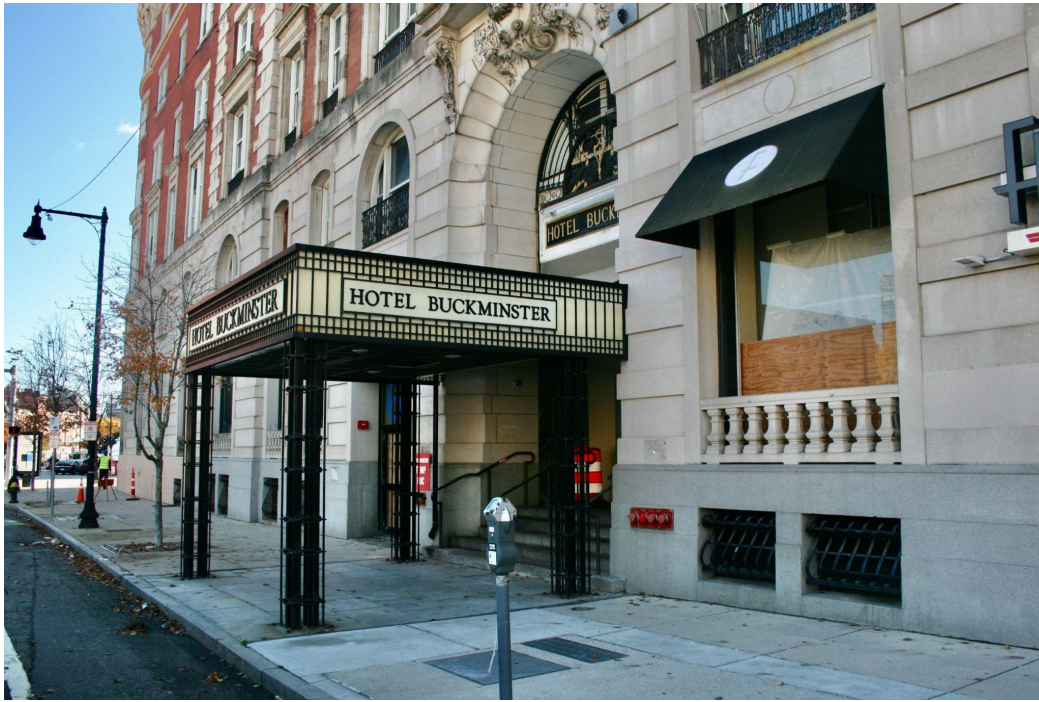
Figure 4. Beacon Street elevation, main entrance. March 2023.

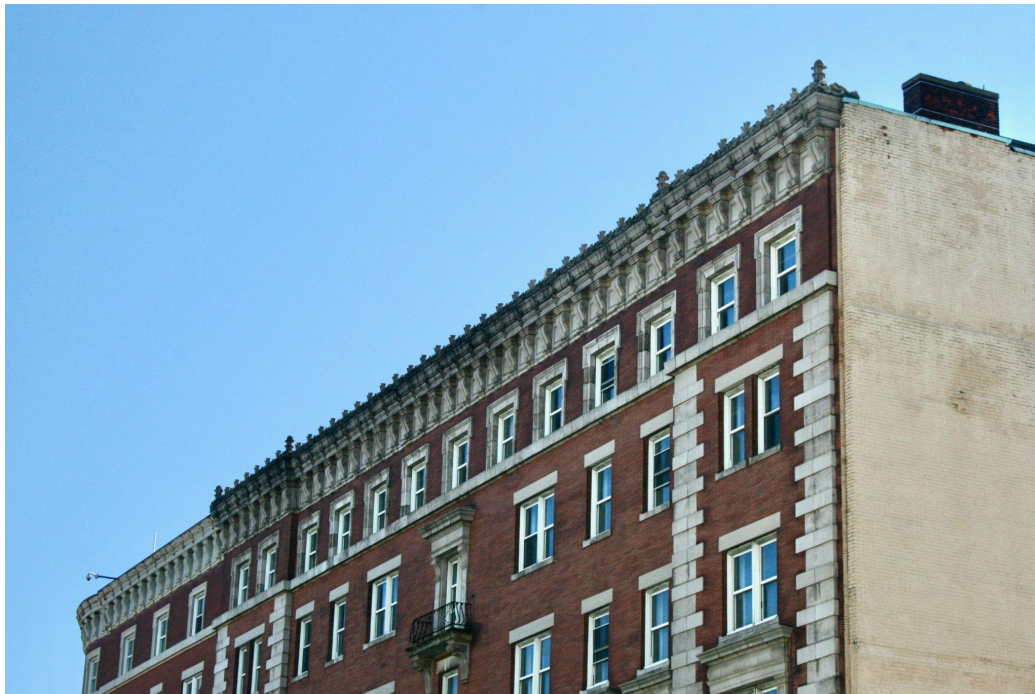
Figure 5. Beacon Street elevation, entablature detail. October 2022.

consoles framing paneled metopes on the frieze, topped with fleur-de-lis motifs in bas relief on the cornice above, and cresting providing further visual interest at the roofline. In the absence of the original building permit from city records, the entablature material has not been confirmed, but appears to be terra-cotta or possibly cast stone; closer inspection of the entablature is recommended.

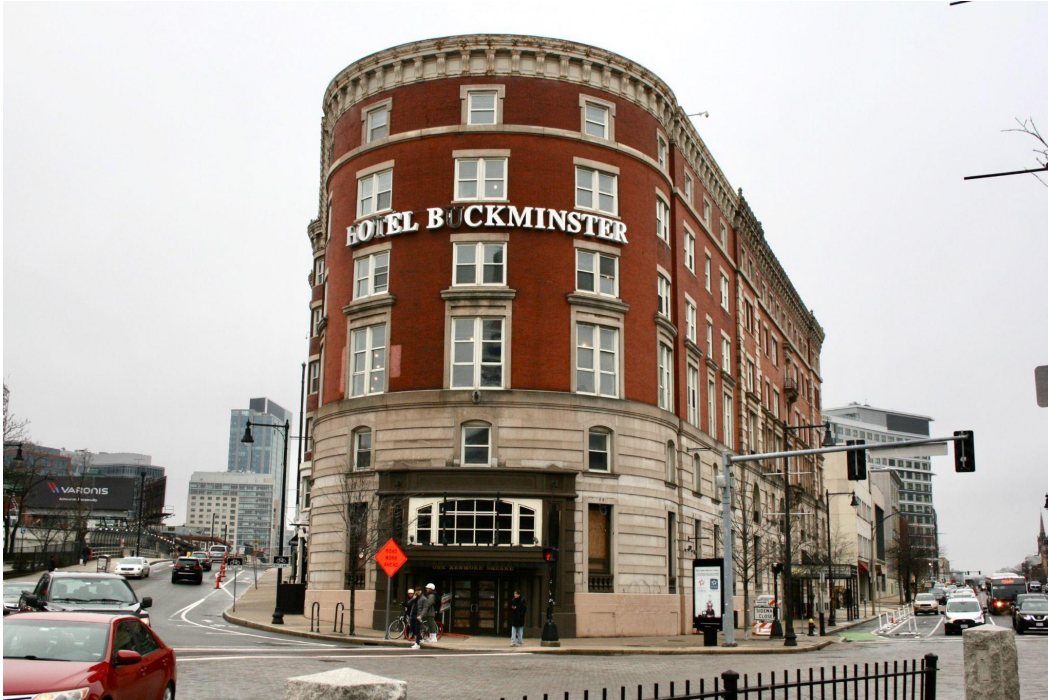
Figure 6. View southwest from Kenmore Square (Beacon Street on right). March 2023.

Like the hotel facade on Beacon Street, the Kenmore Square elevation (**Figure 6**) is strictly symmetrical, with five bays wrapping the rounded corner and an additional four bays extending down the Beacon Street and Brookline Avenue elevations, respectively. The rusticated stone base and stone belt course at the sixth story, both treatments seen on the Beacon Street elevation, carry around the corner but do not continue down the Brookline Avenue elevation (Figure 7). Replicating the design used elsewhere on the building, the entablature here is executed in metal; cresting at the top was removed in 1938 (**Figure 8**). Windows on the rounded corner display the same hierarchy of ornament seen on Beacon Street. Remodeling of the hotel in 1937 added a modest single-bay center entrance to this elevation (William Bradford Sprout Jr., architect) that was subsequently enlarged in 1946 to accommodate the first restaurant tenant at this corner. The current entrance, incorporating pilasters, paired columns, a suspended awning, transom, and a contemporary steel and glass door system, dates to the occupancy of the most recent restaurant tenant from the early 1990s to ca. 2020. A neon “spectacular sign” occupied the roof above this elevation from 1936 until the 1980s.

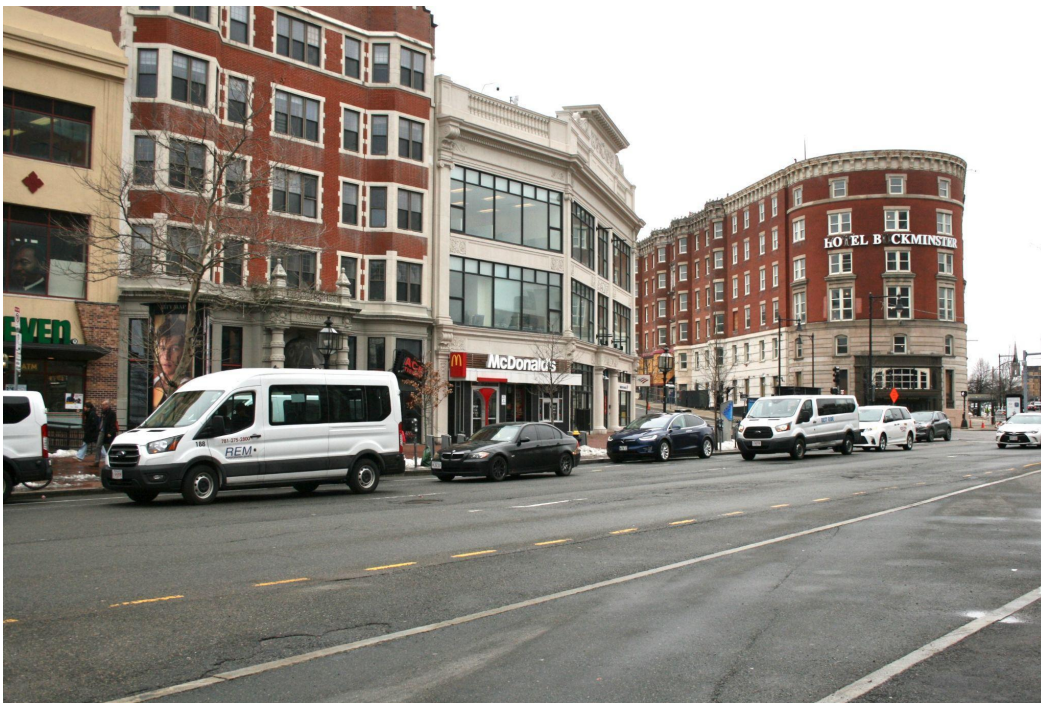
Figure 7. View southwest from Commonwealth Avenue. March 2023.

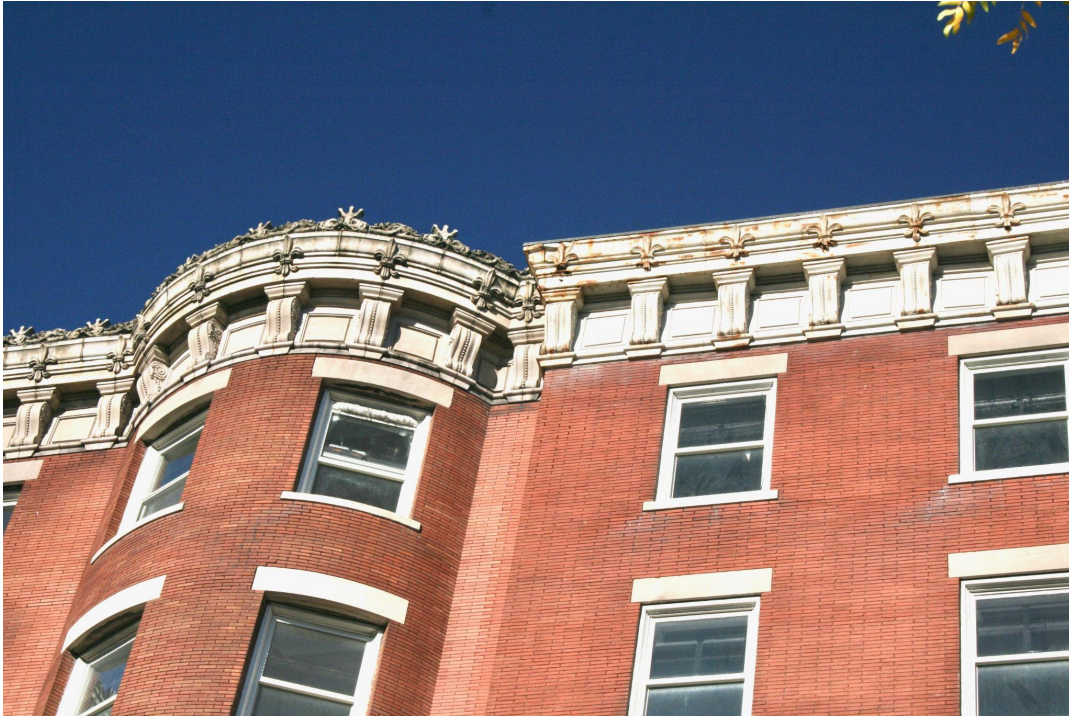
Figure 8. Entablature detail, Brookline Avenue elevation: 1897 (left) and 1902 (right). October 2022.

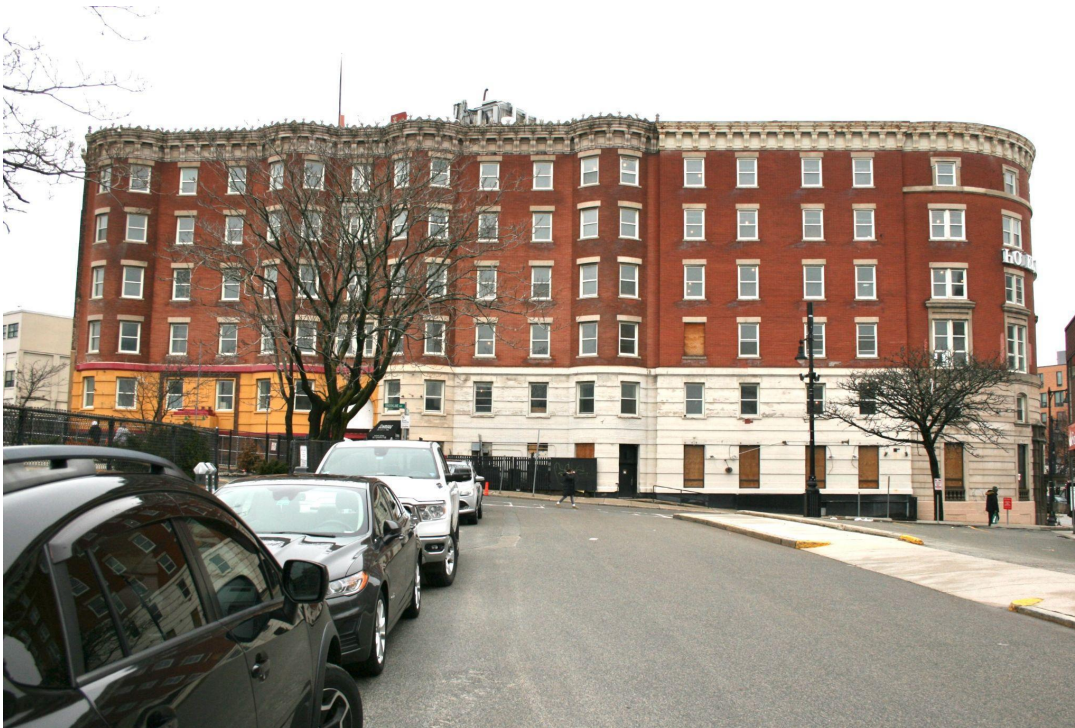
Figure 9. Brookline Avenue elevation, view northwest from Newbury Street. March 2023.

The Brookline Avenue or rear elevation (**Figure 9**) displays Roman brick walls, limestone ornament, and the same roofline entablature design seen on the Beacon Street and Kenmore Square elevations, here formed of terra-cotta or cast stone (see above) and retaining the cresting. A stone belt course defines the top of the rusticated two-story base, though the base is clad not in stone but Roman brick, which has been painted since 1969. Five-story stacks of bow windows in the first, fourth, sixth, and ninth bays impart a less formal character to this elevation (Figure 10). Centered among the bays of bow windows is the hotel’s original rear entrance, later converted to a storefront (Figure 11). The entrance bay retains its original brick surround with oversized arched transom and a cartouche above, along with an inset standing seam metal canopy from the last tenant. On this elevation, pedimented stone surrounds are confined to windows above the entrance, while remaining windows display simple flat lintels and sills. Remnants of 1930s cast stone ornament, now painted, survive at the former broadcasting studio entrance of 21 Brookline Avenue, at the southern end of this elevation (**Figure 12**). A narrow Art Deco-style chevron border frames what was originally a stepped entrance frontispiece of two full stories, with a band of horizontal grooves denoting the frieze above the entrance in a streamlined Moderne manner. Brick recessed ornamental panels above and flanking this entrance also survive. In 1962–1963, the street grade of Brookline Avenue was raised roughly three to four feet (compare **Figures 12 and 18**), rendering this entrance unusable and reducing the height of its flanking windows. Two other entrances were created from ground-floor windows on this elevation in the late 20th century.

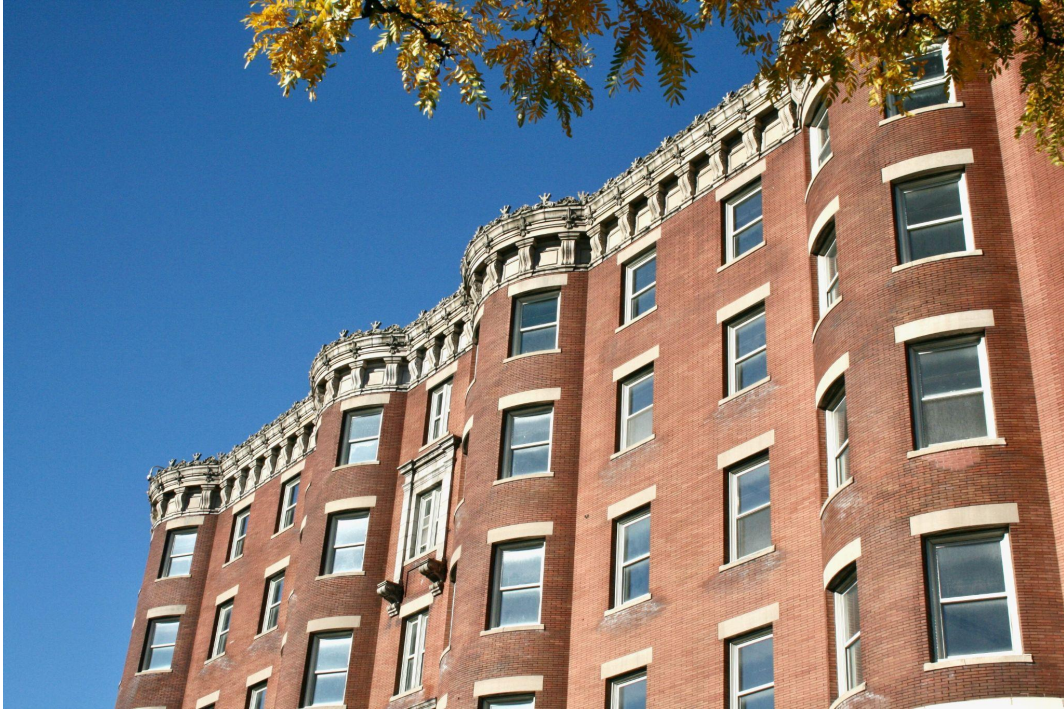
Figure 10. Brookline Avenue elevation, detail of bow windows. October 2022.

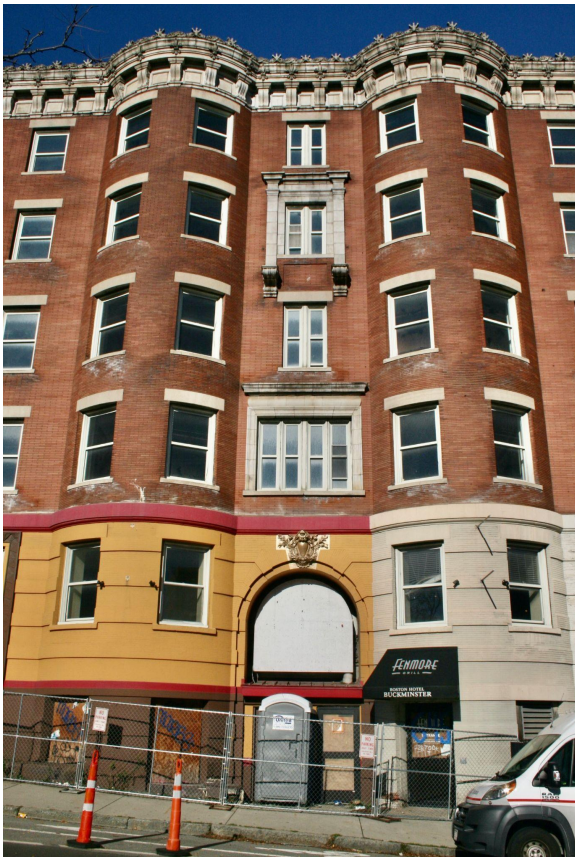
Figure 11. Brookline Avenue elevation, detail of main entrance bay. October 2022.

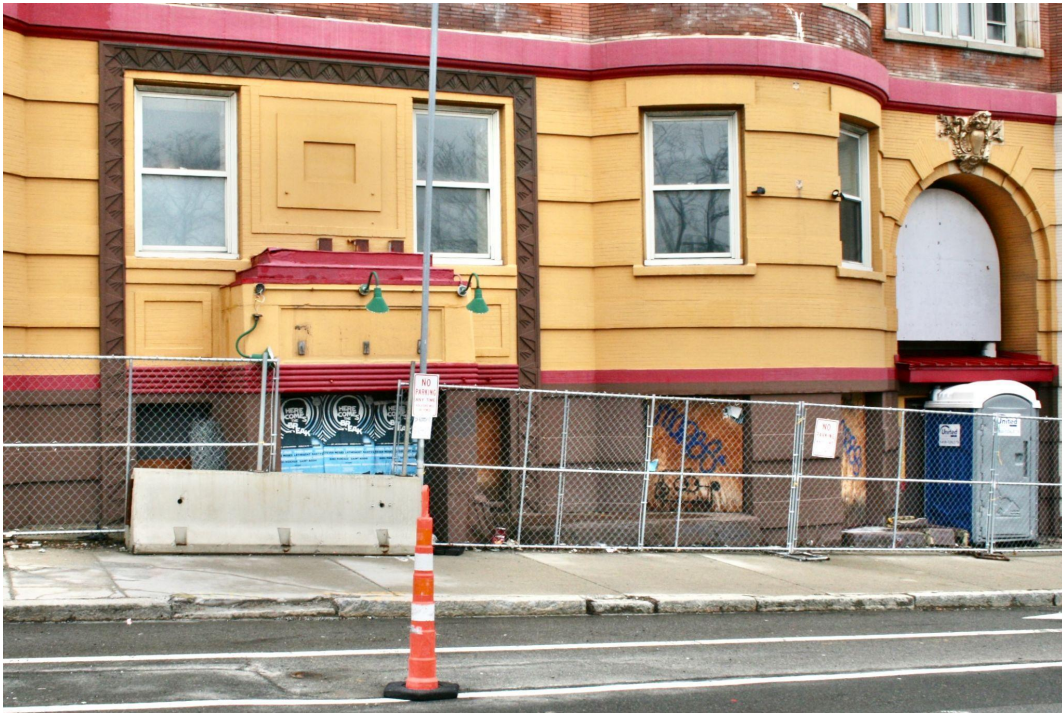
Figure 12. Brookline Avenue elevation, broadcasting (left) and hotel entrances. March 2023.

Figure 18. Brookline Avenue entrances for the Yankee and Colonial Networks (left) and the Hotel Buckminster (right). Photograph appears to date to the hotel's occupation by the U. S. Army Service Forces First Service Command (1942-1946). Comparison with Figure 12 illustrates the change in the street grade of Brookline Avenue, due to construction in 1963 of a new Brookline Avenue bridge over the Massachusetts Turnpike Extension.

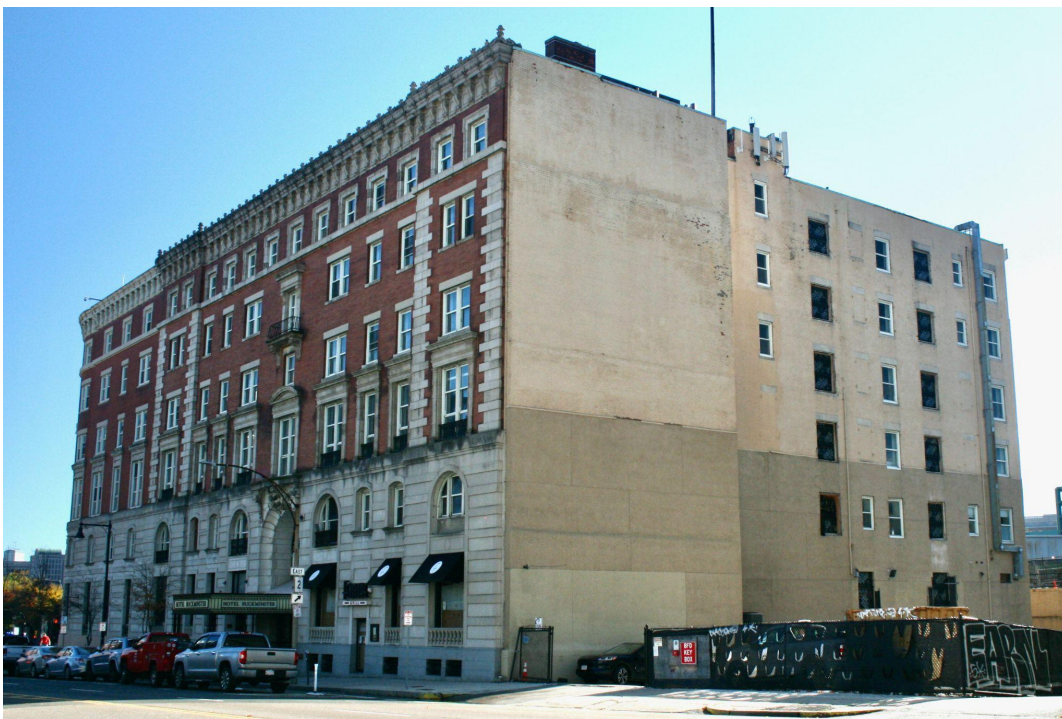
Figure 13. Beacon Street (left) and southwest elevations, view east. October 2022.

Due to the vacant condition of the Buckminster, ground-level windows and doors are boarded over. The southwest elevation is an unfinished brick wall, currently clad on the first two stories with what appears to be cement or fiber cement panels intended to resemble stucco (**Figure 13**).

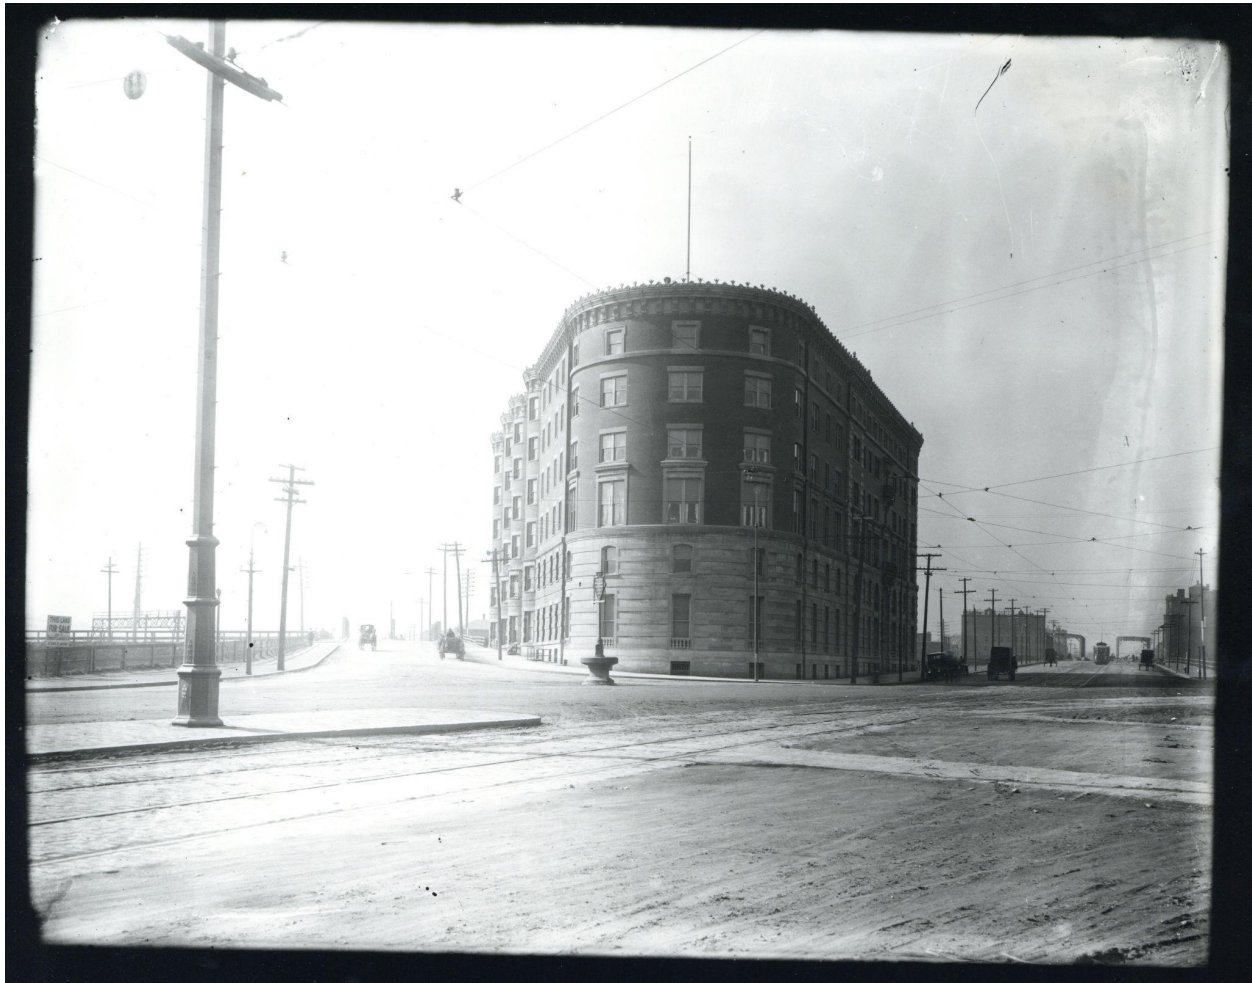
Figure 14. View southwest from Beacon Street (ca. 1912), with Brookline Avenue (left) and Beacon Street (right) elevations. Photograph predates the naming of this intersection with Commonwealth Avenue as Governor Square, later known as Kenmore Square.

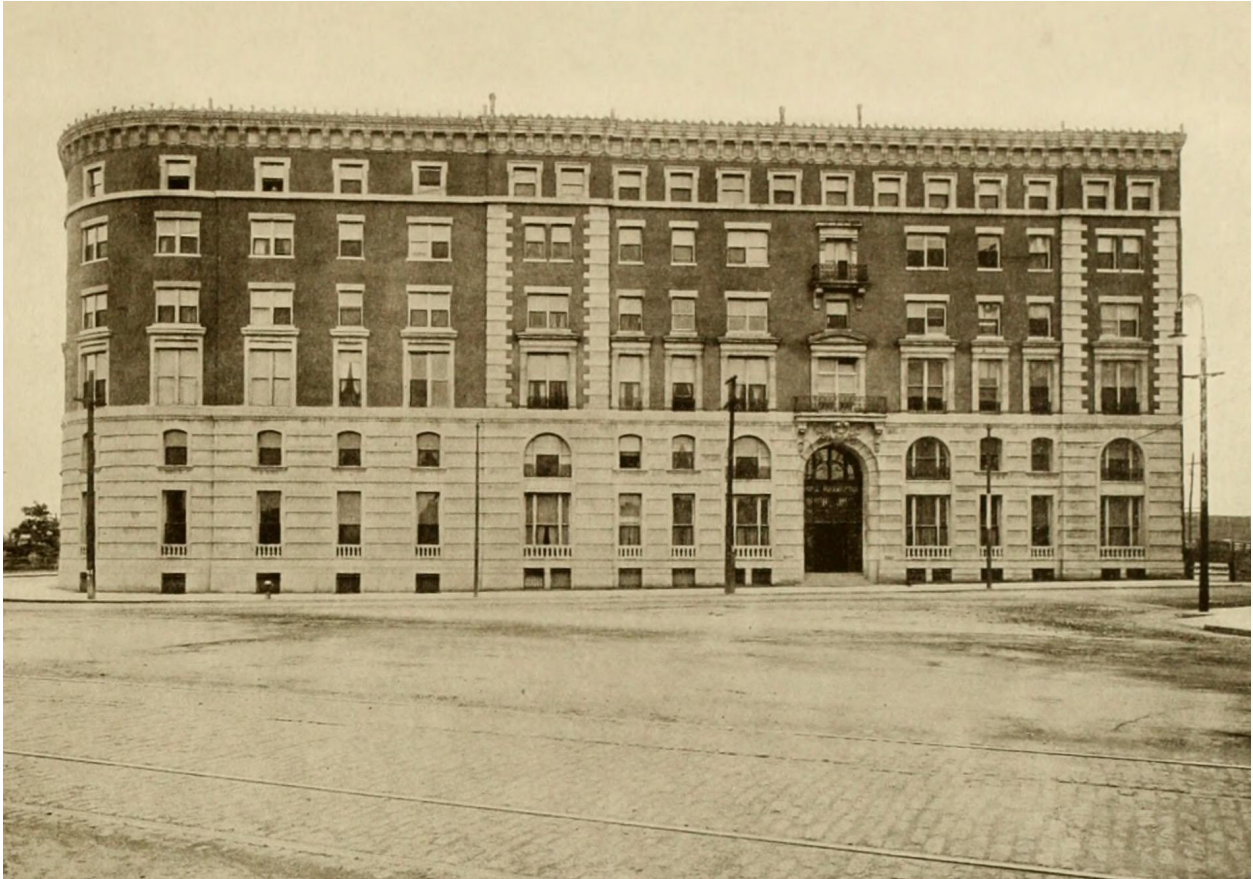
Figure 15. Beacon Street elevation (1914). View southeast from Commonwealth Avenue.

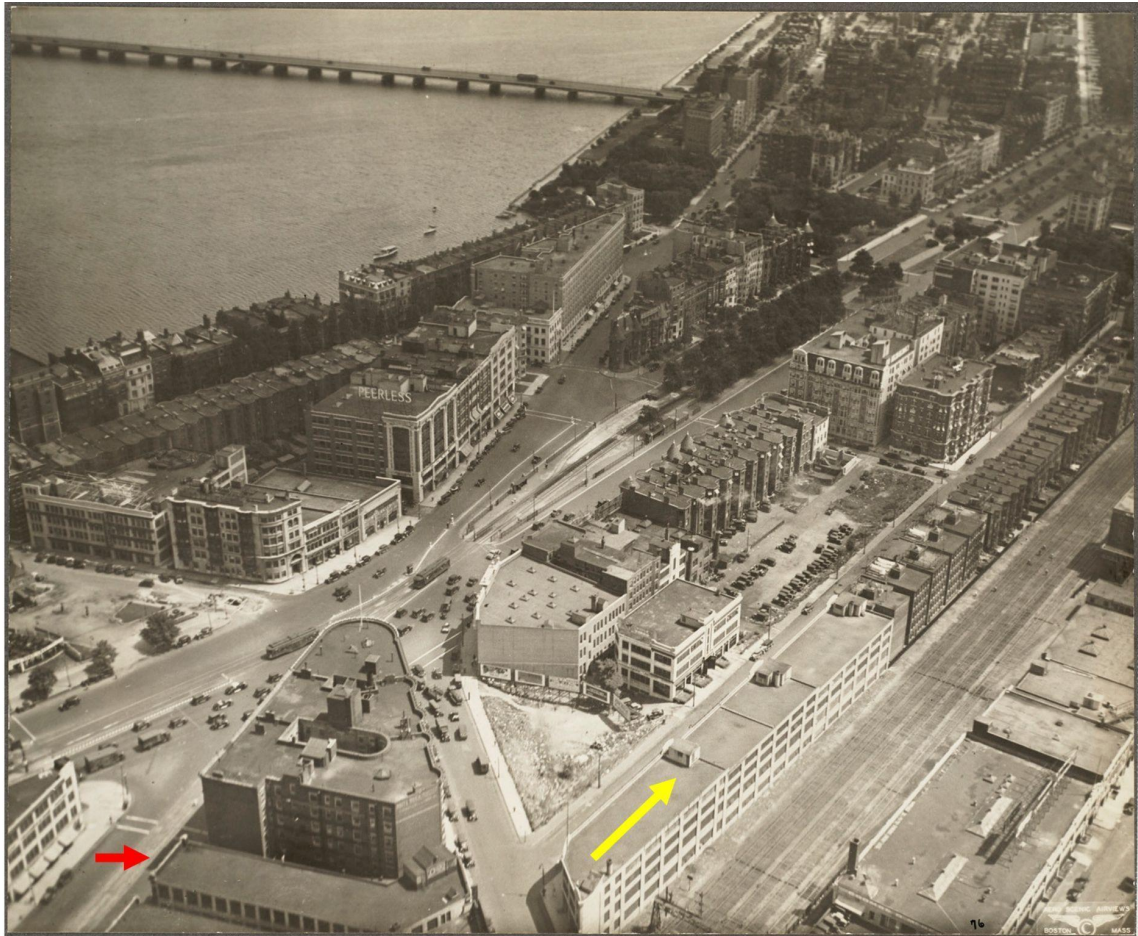
Figure 16. Aerial view (1929) northeast through the Kenmore Square area, showing the Hotel Buckminster in the left foreground. The building abutting the southwest elevation of the Buckminster (red arrow), demolished in 2003, is shown at its original one-story height. All buildings lining the south side of Newbury Street (yellow arrow) would be demolished ca. 1963 for construction of the Massachusetts Turnpike Extension.

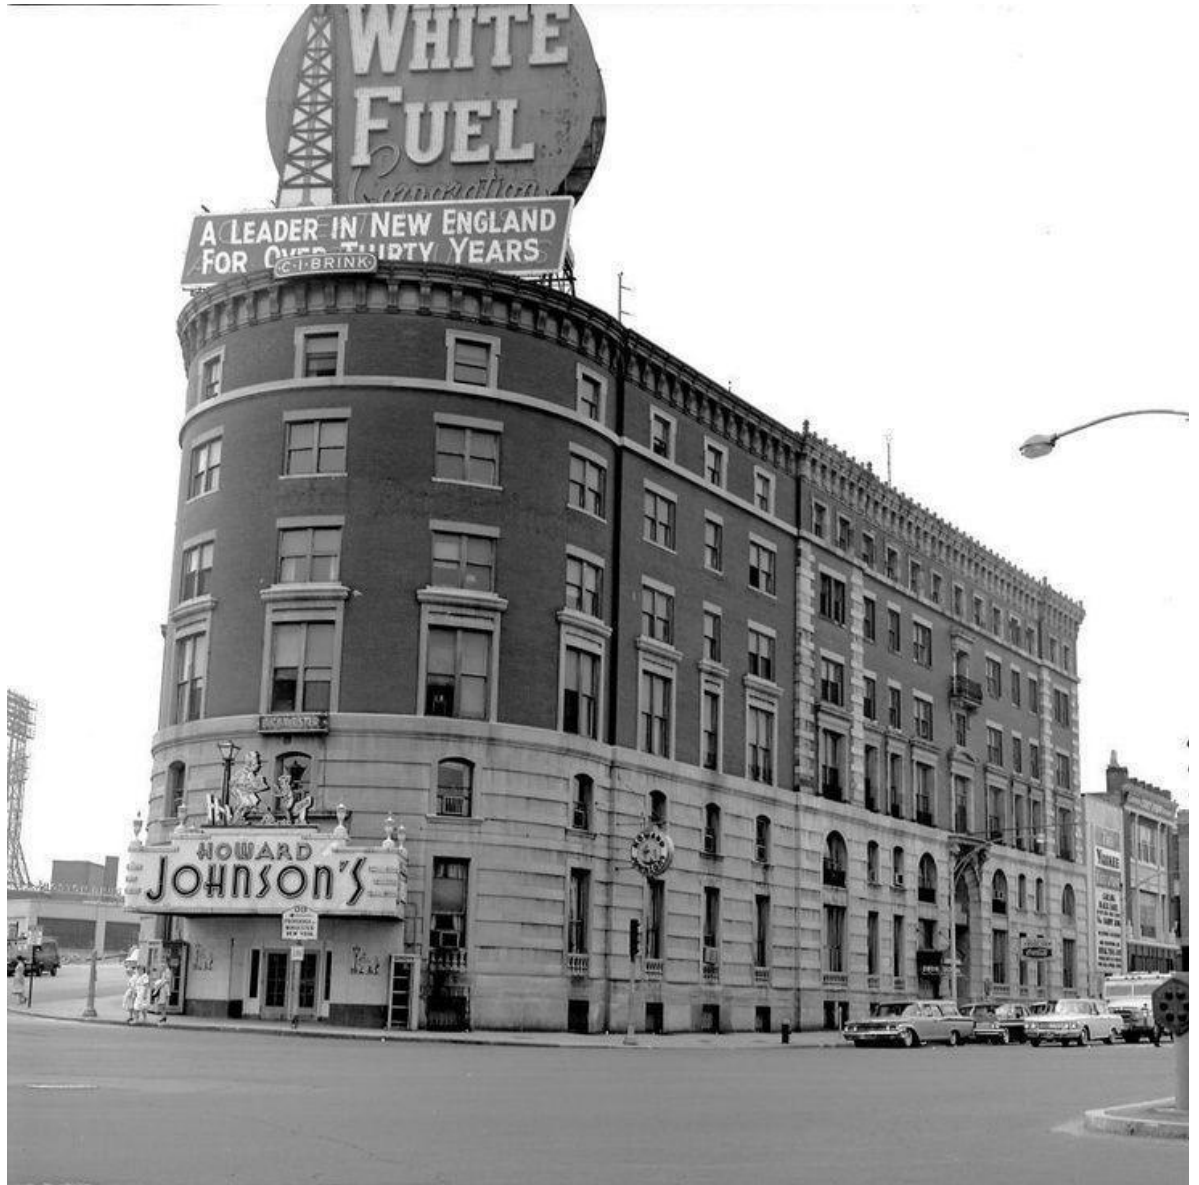
Figure 19. Undated (early 1960s) view south from Commonwealth Avenue, showing neon signs of Howard Johnson's restaurant and White Fuel Corporation on Kenmore Square elevation. Image from Boston Public Library.

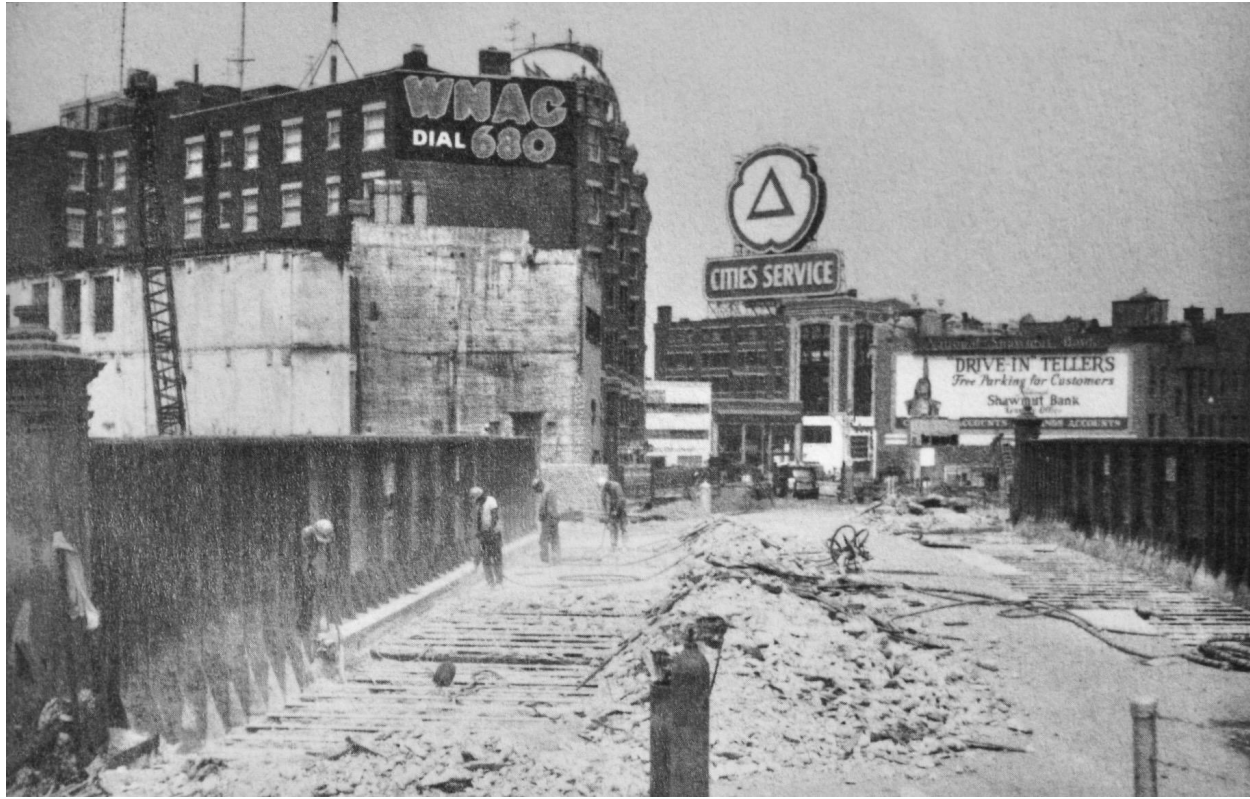
Figure 20. View northeast on Brookline Avenue toward Kenmore Square during demolition of the old Brookline Avenue bridge over the New York Central (Boston & Albany) Railroad (summer 1963). Hotel Buckminster is on the left, bearing a wall sign for radio station WNAC. Construction of a new bridge to span the Massachusetts Turnpike Extension raised the street grade on Brookline Avenue.
