Re: Third Five-Year Review, Luke Air Force Base, Arizona, July 2012

Final Third Five-Year Review Report

Luke Air Force Base, Arizona

July 2012

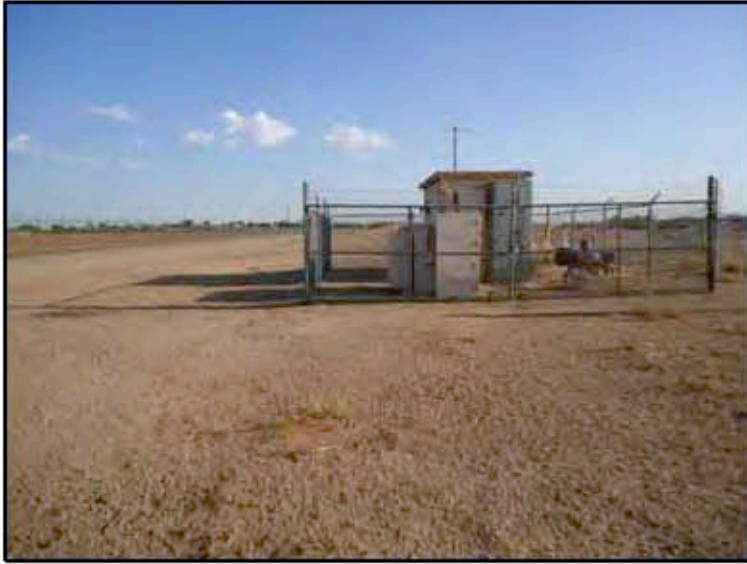
6. GENERAL SITE CONDITIONS	
Abandoned well located at south end of the site; north end of site is used for Antiterrorism Security Operations (ATSO) for preparedness training

DP-13: Abandoned well at south end of site

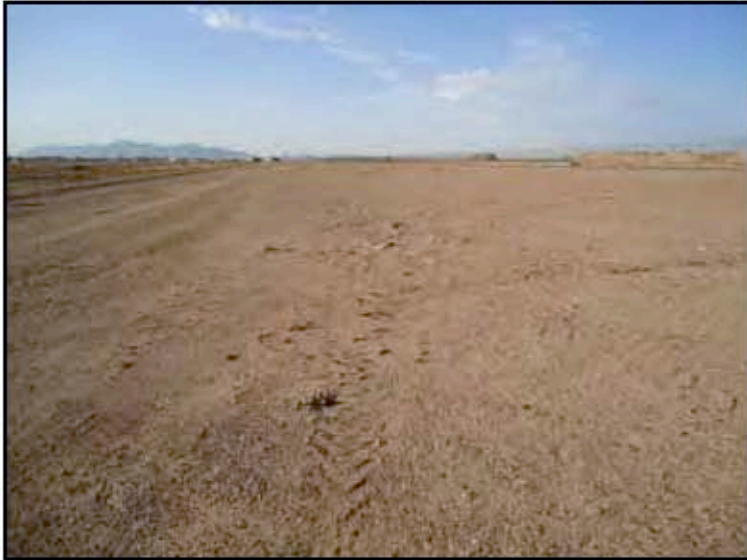
DP-13: At south end looking north

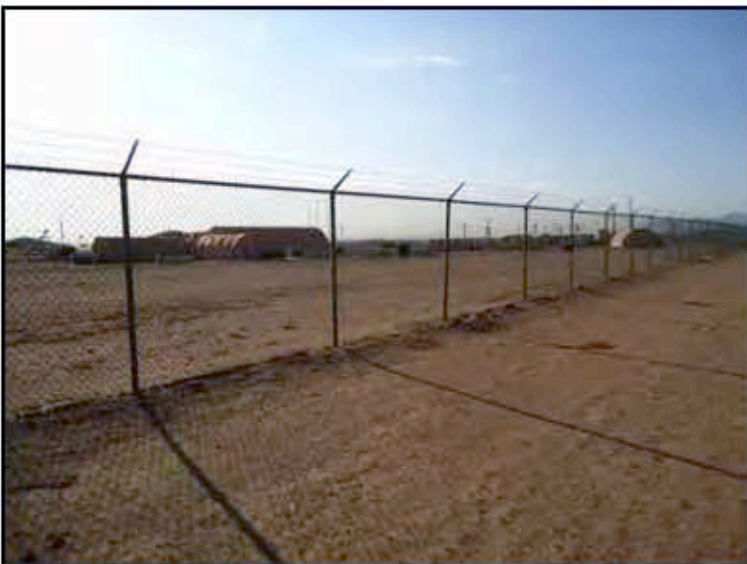
DP13: North portion used for Antiterrorism Security Operations (ATSO) training

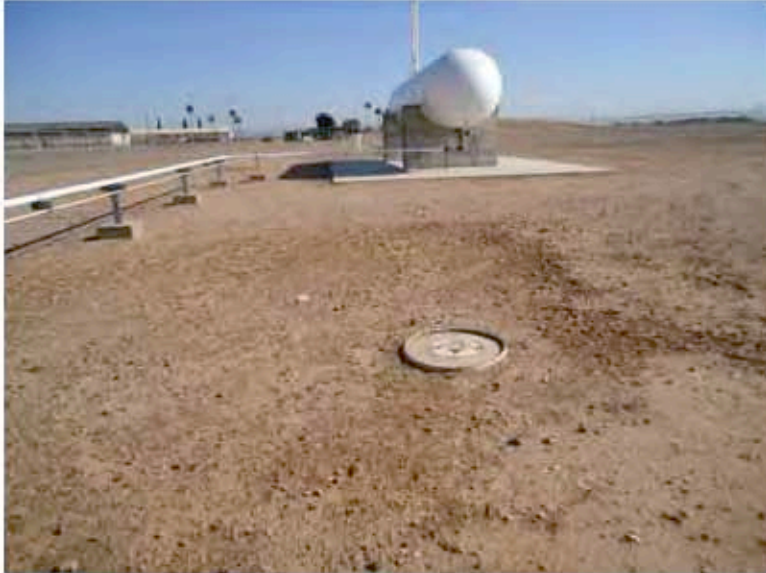
6. GENERAL SITE CONDITIONS	
Active fire training pits are no longer in the eastern portion of FT-07E; monitoring wells are located within fenced area containing propane tank; new monitoring wells were installed in 2008

FT-07E: Monitoring well near propane tank at FT-07E

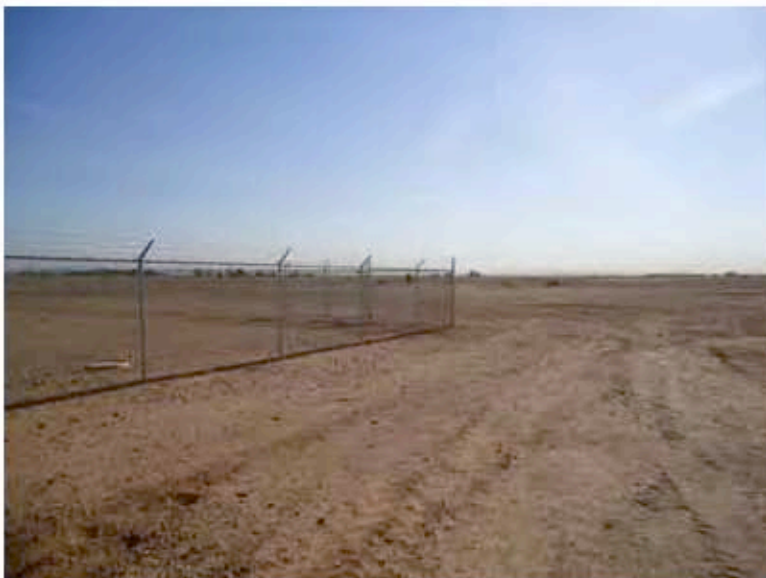
FT-07E: Looking east near the FT-07E monitoring wells.

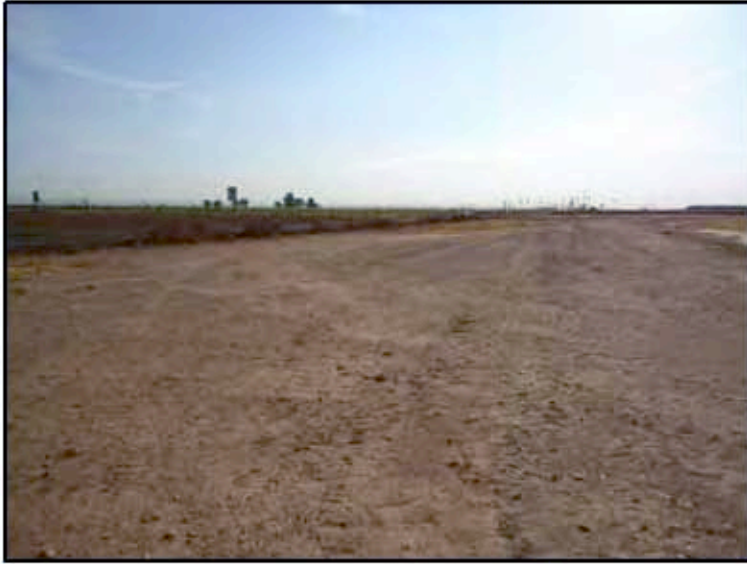
LF14: Looking east
towards northeast corner
of Base

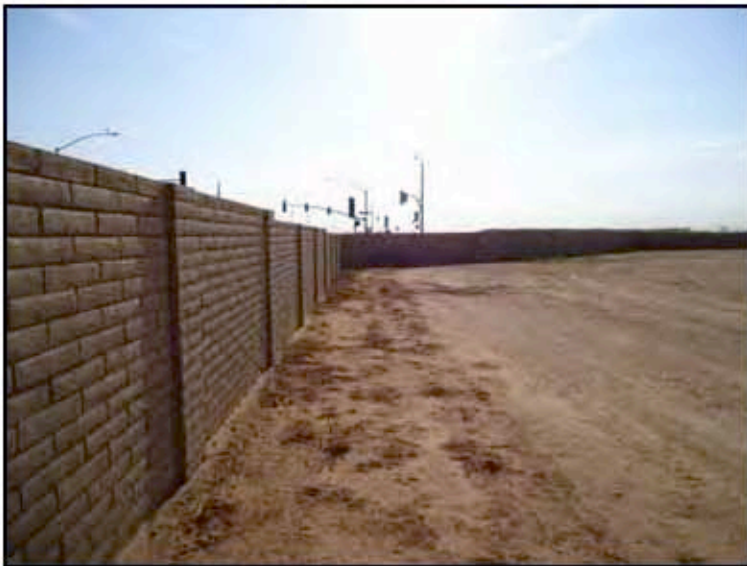
LF-14: Corner of
Northern Avenue and
Litchfield Road

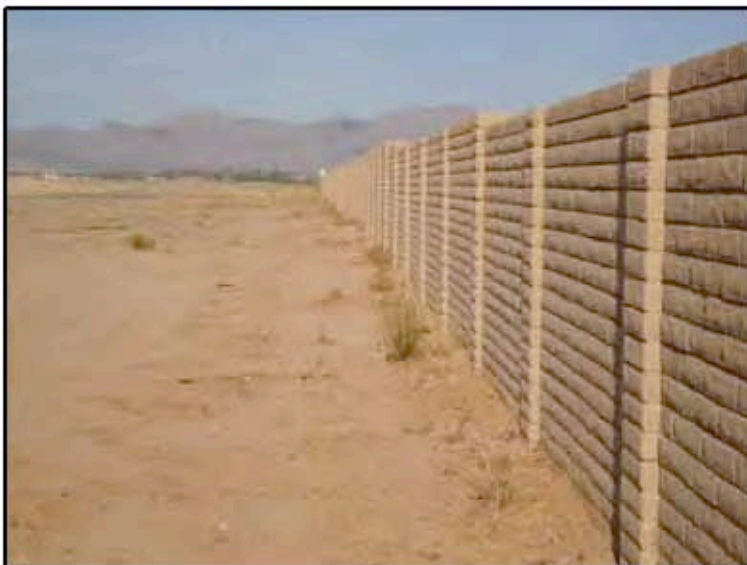
LF-14: Looking west
parallel to Northern
Avenue.

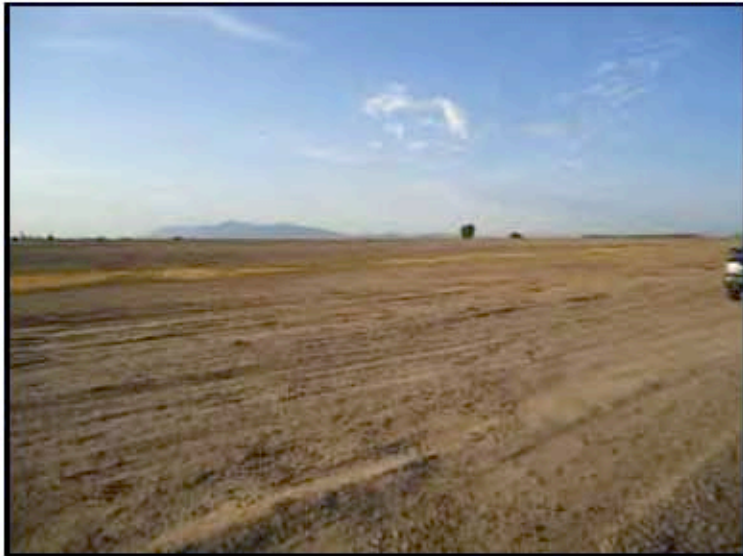
LF-25: Looking southwest, down dirt access road.

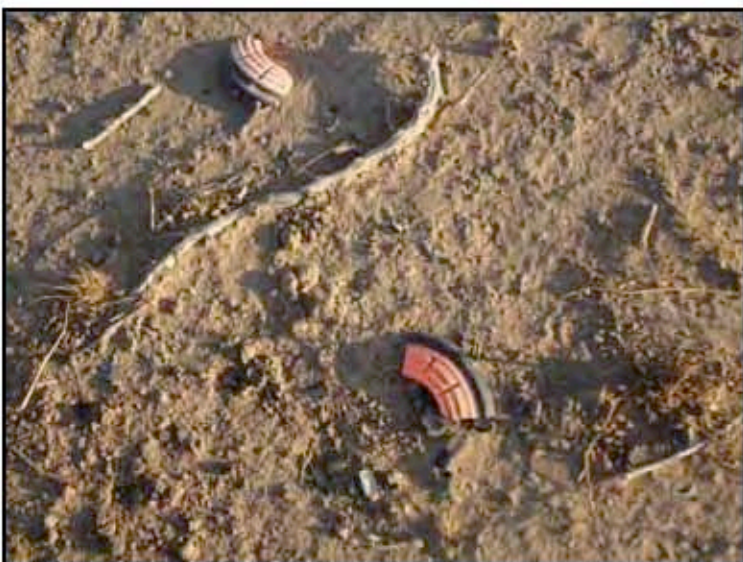
- **Ongoing Operations at Skeet Range Adjacent to LF-25:** Material from the adjacent skeet range continues to fall on LF-25. The remedy of ICs controls exist to control a worker's exposure during excavation at the site, not to prevent any ongoing impact to surface conditions from the adjacent skeet range. The remedy continues to be protective in controlling uncontrolled excavation at the site. However, the remedy was selected based on an assessment of surface conditions at LF-25 several years ago. During the next five-year review period, the Base will revalidate surface conditions at LF-25.

6. GENERAL SITE CONDITIONS	
Site is adjacent to active Base Skeet Shooting Range; some debris from range was observed during site inspection.	
7. LANDFILL COVERS	
Not applicable

LF-25: Example of material from adjacent Base Skeet Shooting Range.

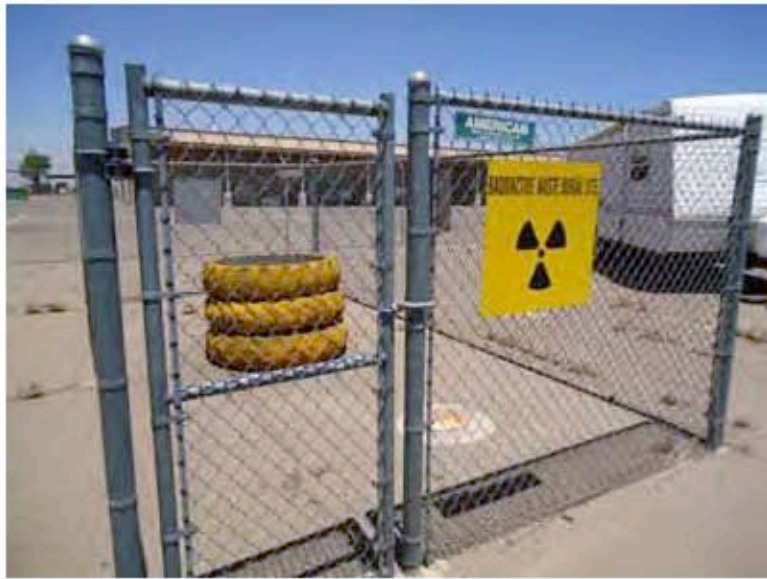
6. GENERAL SITE CONDITIONS	
Monitoring wells were replaced in 2008; fencing around low level radiological burial site and dry monitoring wells are in good shape; RV storage fencing has moved north; now access burial site through secured RV storage gate.

RW-02: Institutional controls at radioactive waste burial area.

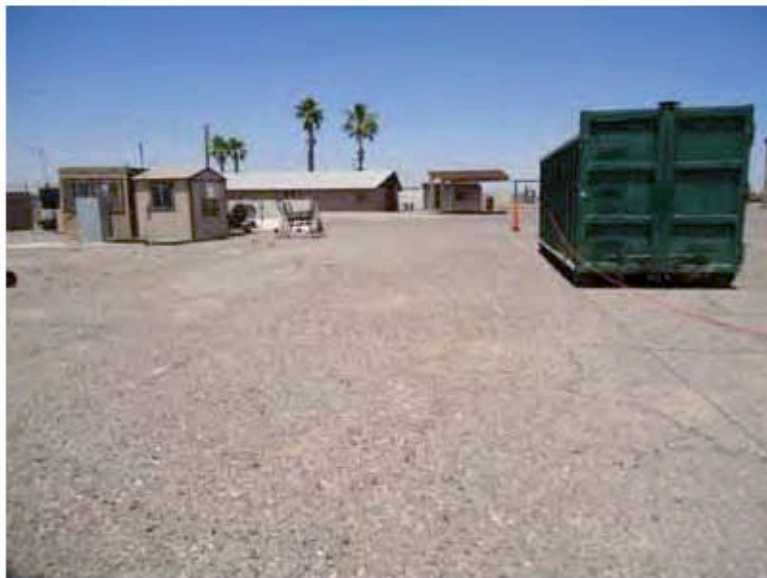
RW-02: Area near monitoring wells at RW-02

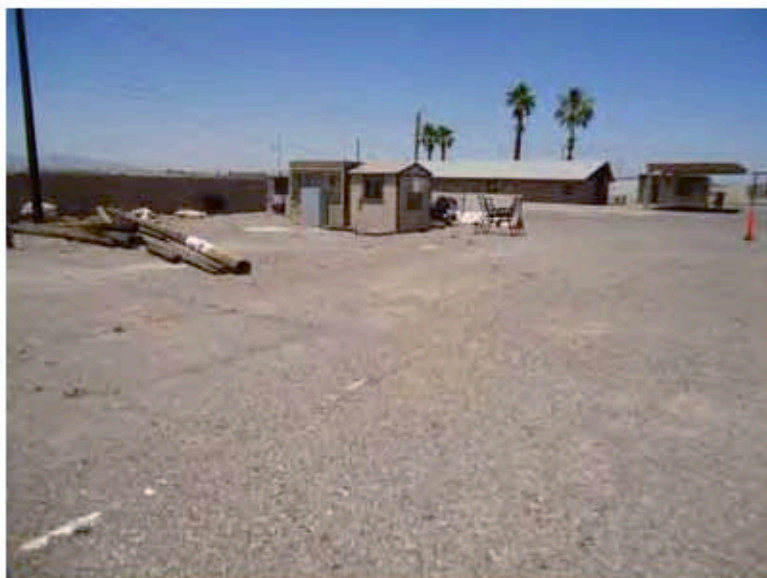
RW-02: Looking northwest at monitoring wells at RW-02

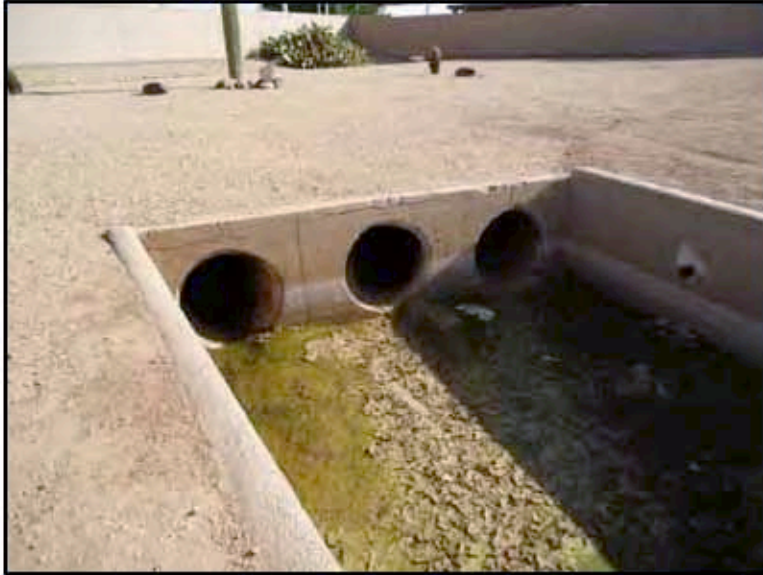
SD-20: Beginning of drainage channel, culvert on north side of Super Sabre.

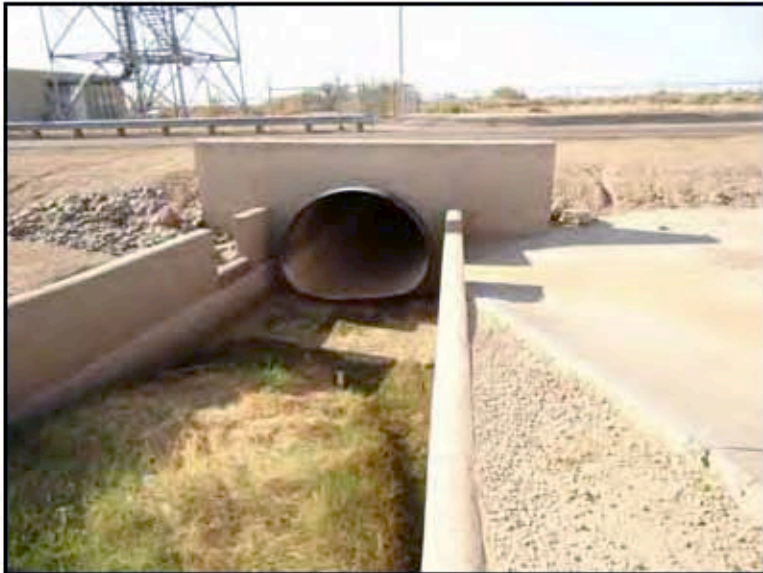
SD-20: Culvert on south side of Super Sabre.

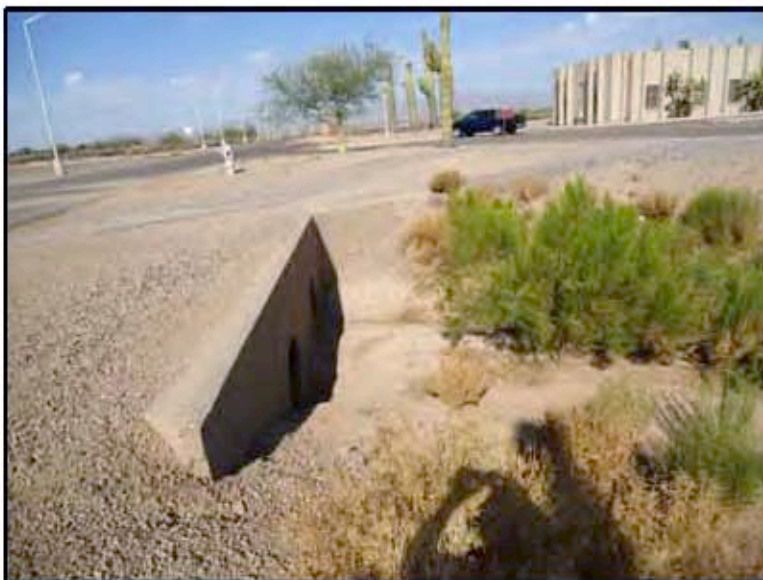
SD-20: Near Ammo Country administrative building.

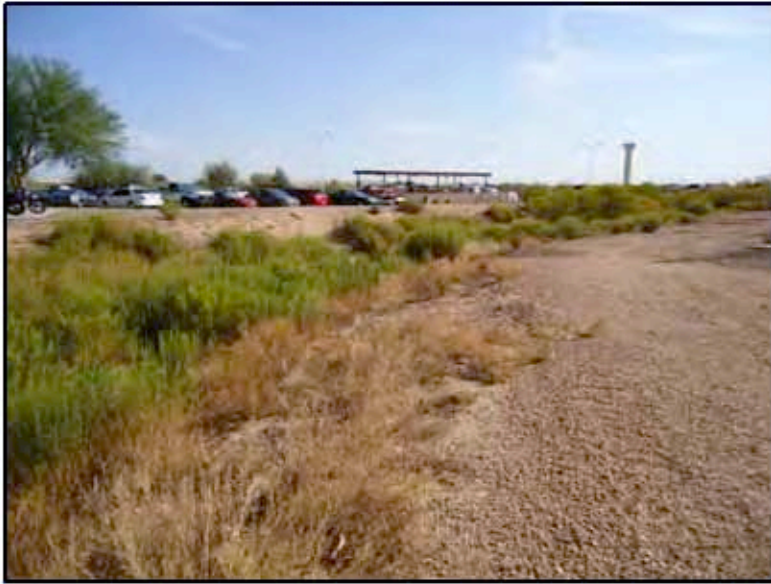
SD-20: North end of drainage channel

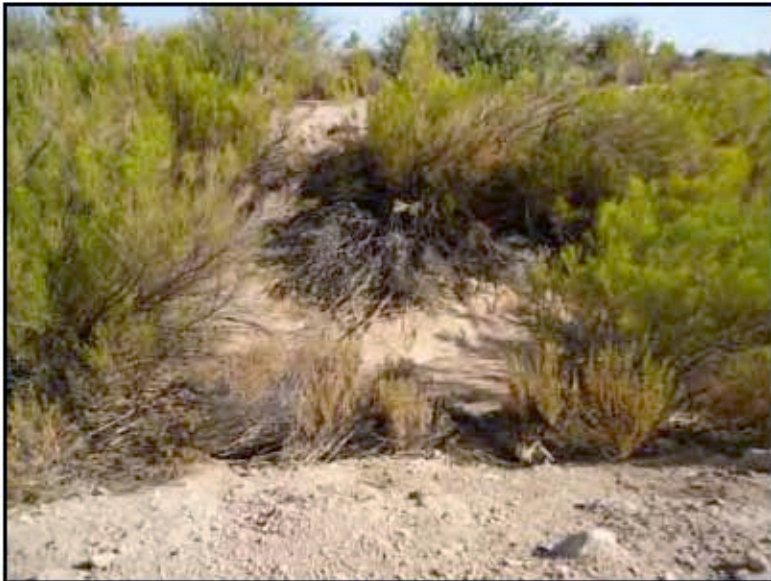
6. GENERAL SITE CONDITIONS	
Heavy vegetation located within drainage channel and surrounding monitoring wells; now monitoring wells were installed in 2008.

SD-20: Example of vegetation lining side of drainage channel

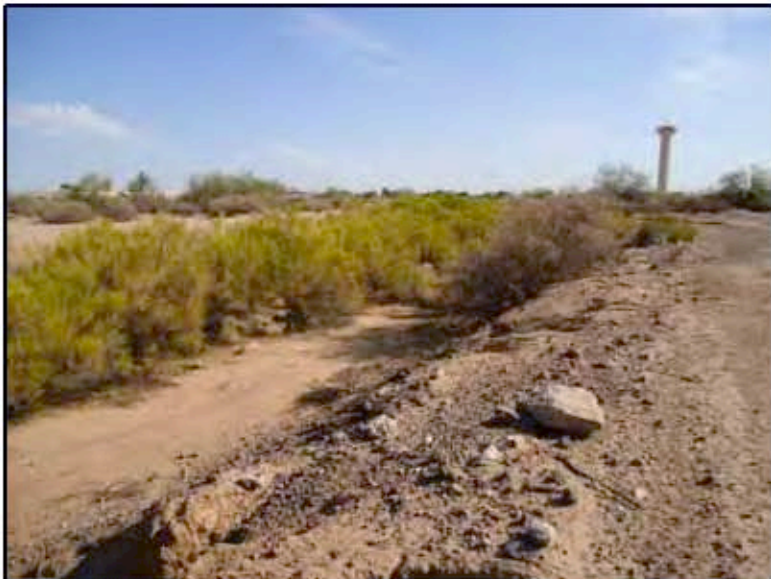
SD-20: Looking north towards Base

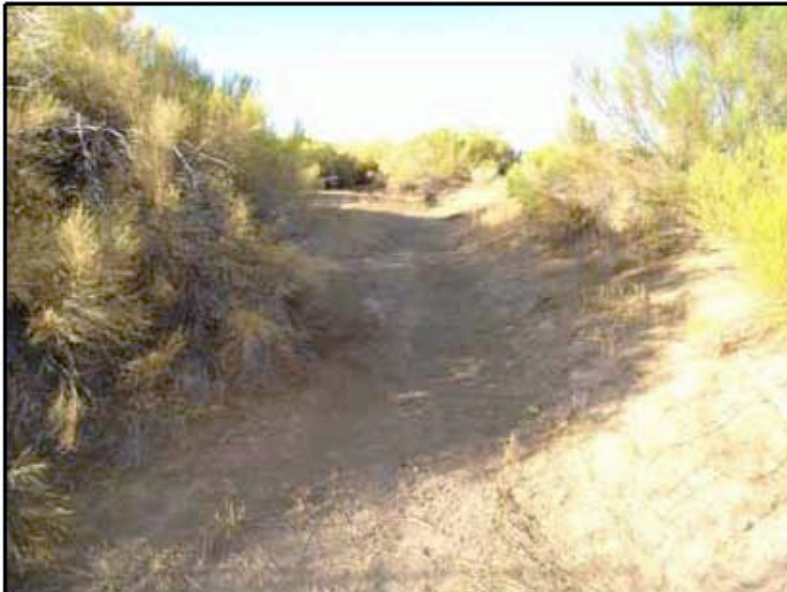
SD-20: Example of vegetation.

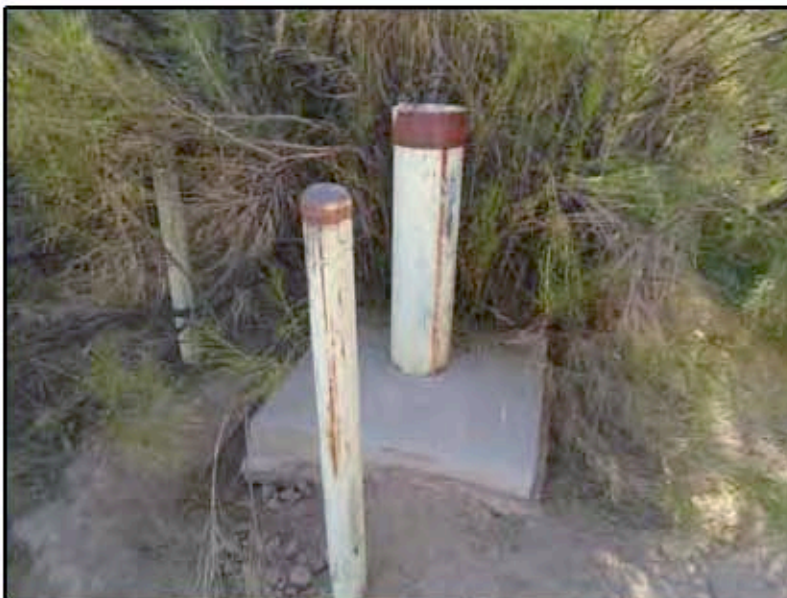
SD-20: Standpipe monitoring well and ballards

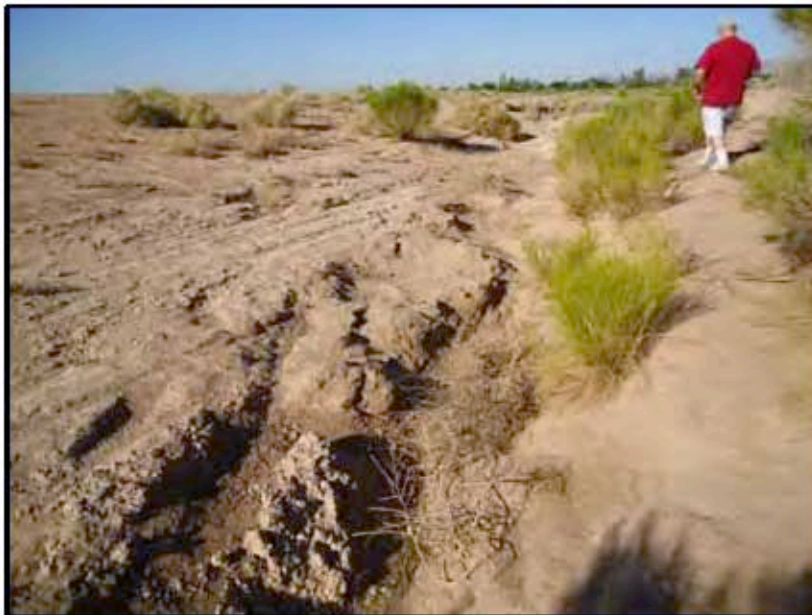
SD-20: Southern end of drainage channel

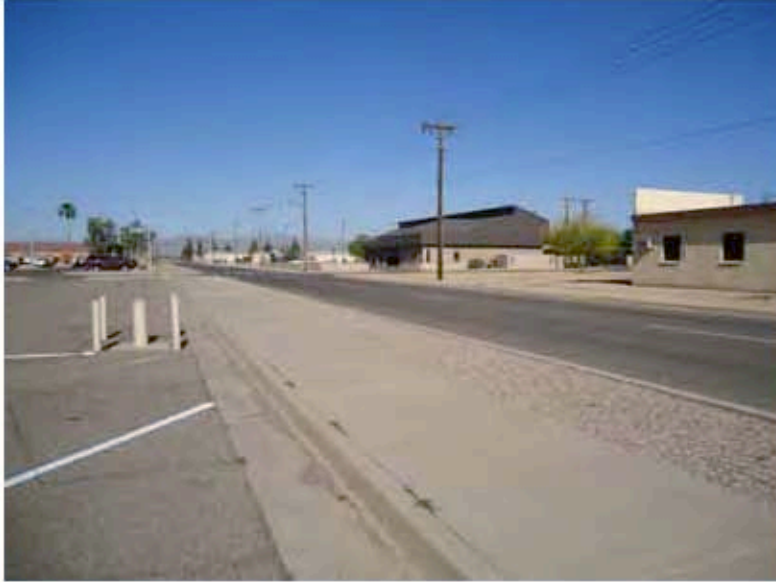
6. GENERAL SITE CONDITIONS	
Site is basically in middle of street where old Auto Shop used to be; oil/water separator was removed in 1991	
7. LANDFILL COVERS	
Not applicable

SD-38: Looking across street to location of the former auto body shop

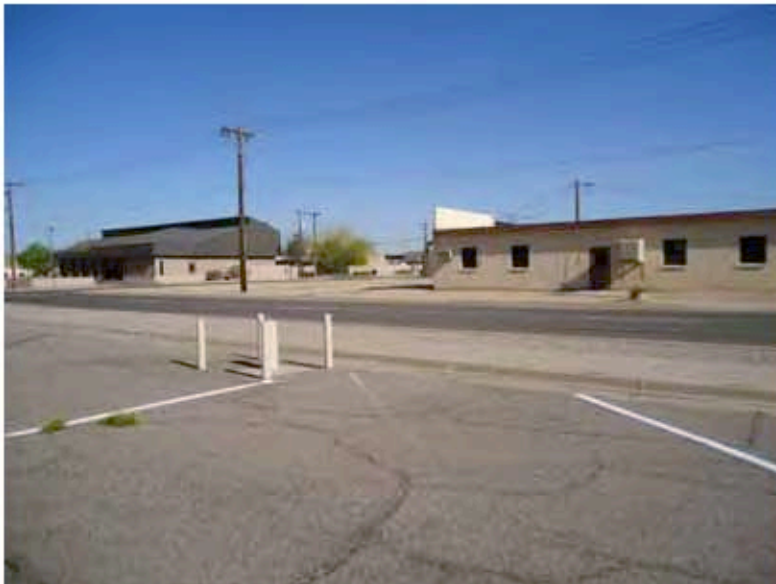
SD-38: Monitoring well by site SD-38.

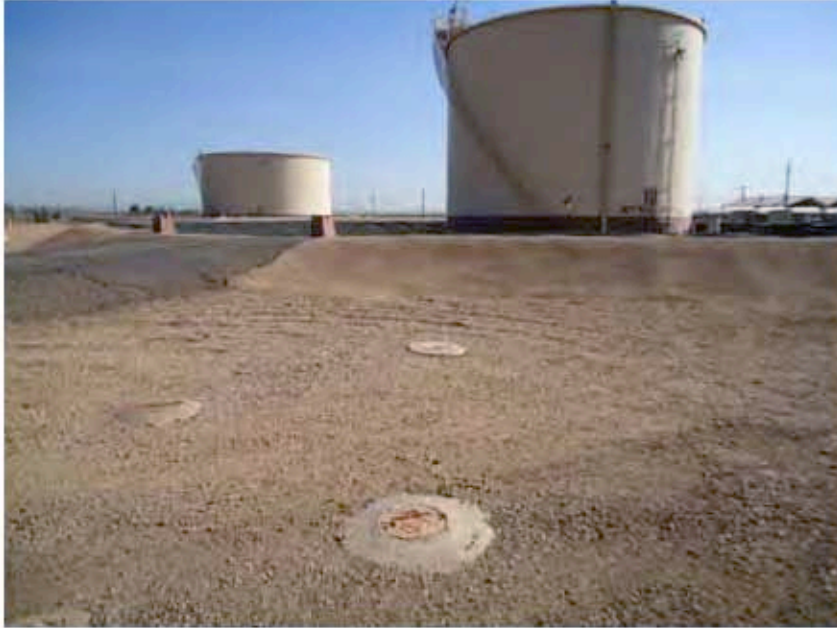
6. GENERAL SITE CONDITIONS	
Secondary containment around bulk storage tanks is in good shape; before sampling these monitoring wells, need to check in at administrative building and meet escort; new monitoring wells installed in 2008

SS-42: Bulk fuels storage facility with secondary containment around the aboveground storage tanks

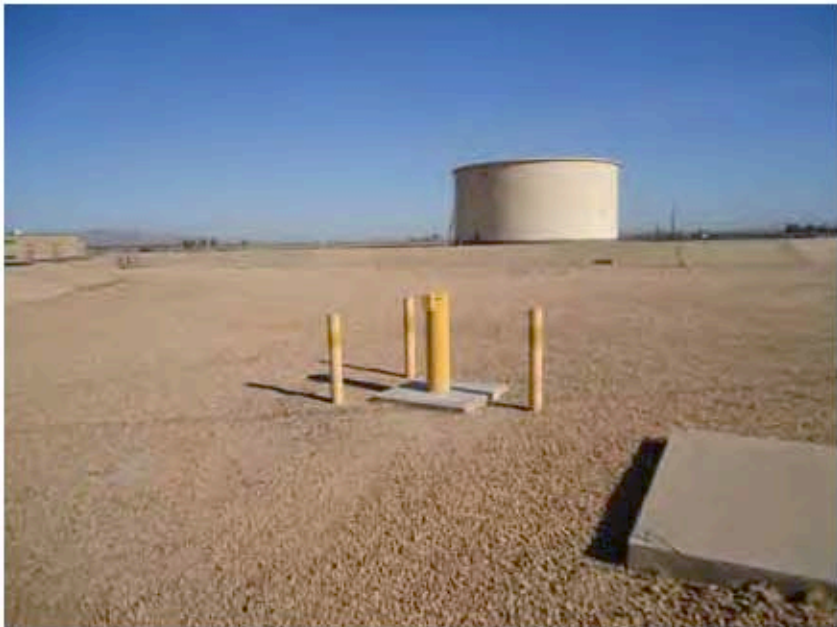
SS-42: Monitoring wells at site SS-42

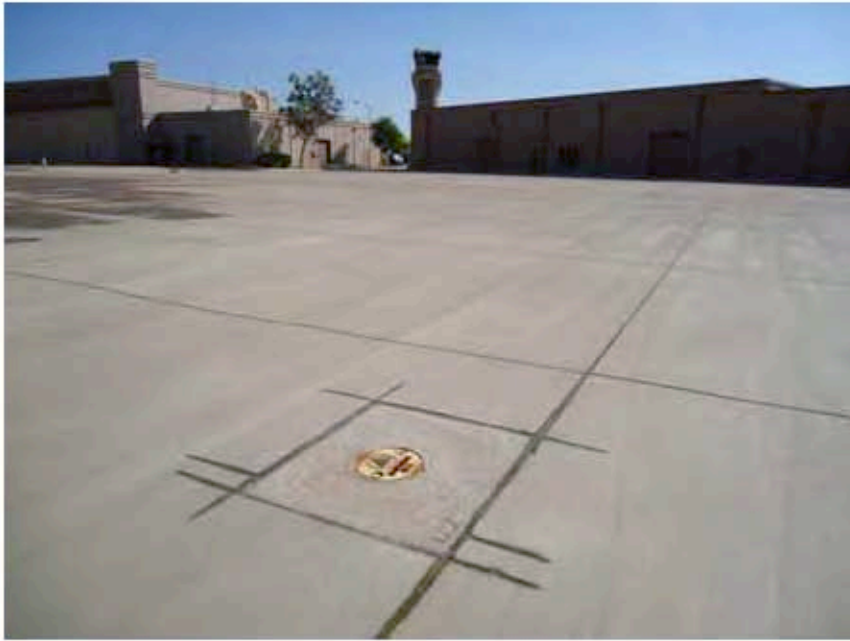
ST-18: Monitoring well at ST-18 area, looking towards Bldg 993

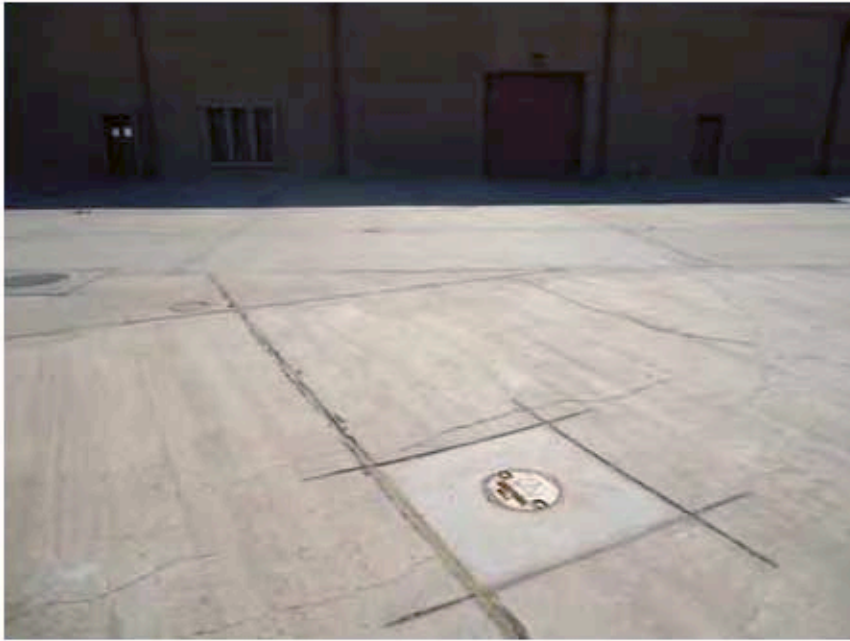
ST-18: Monitoring well by concrete cap at ST-18 area.

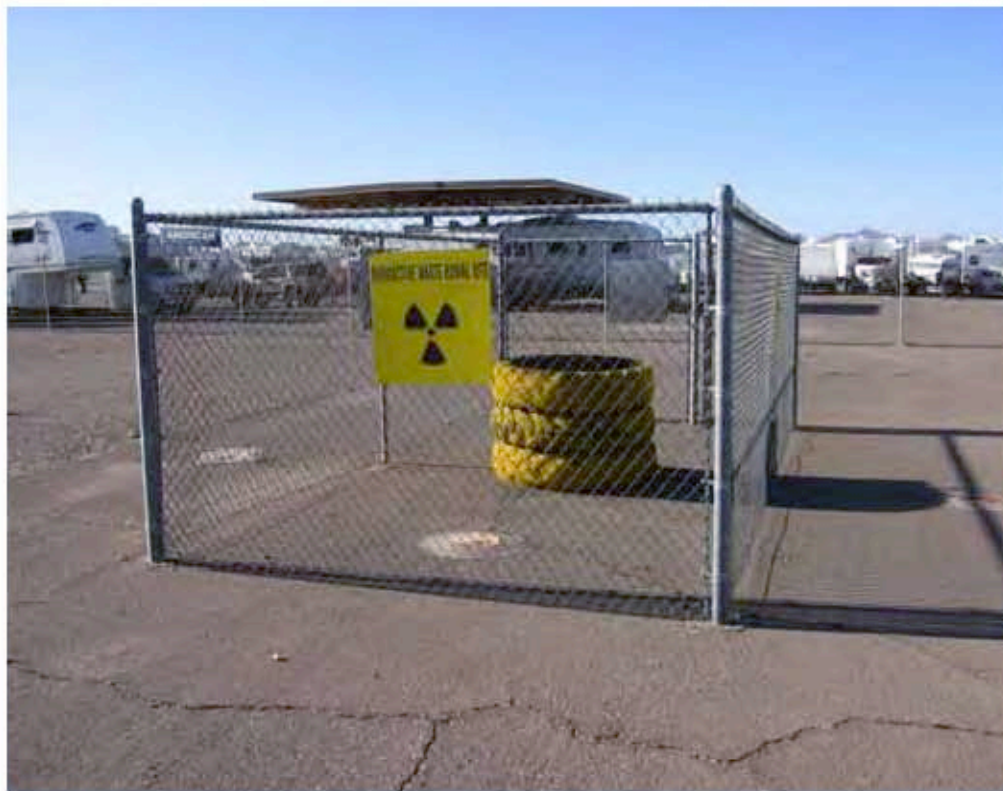
Photograph 1: Fencing and placard around radioactive burial site.
