Former Colvert's Dairy Ardmore, Oklahoma

Final Remediation Report

Prepared by:
Department of Environmental Quality
707 North Robinson
Oklahoma City, Oklahoma 73101

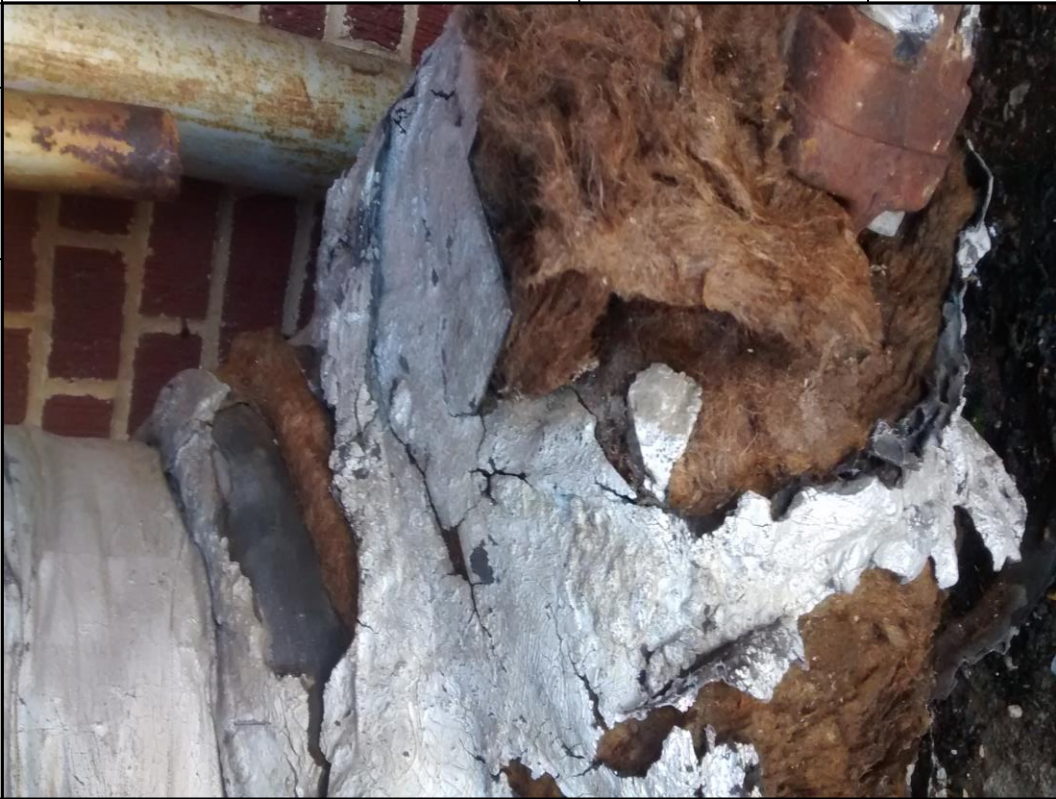
Photographer Bethany Scott 3			
Description Black Pipe Wrap, Exterior

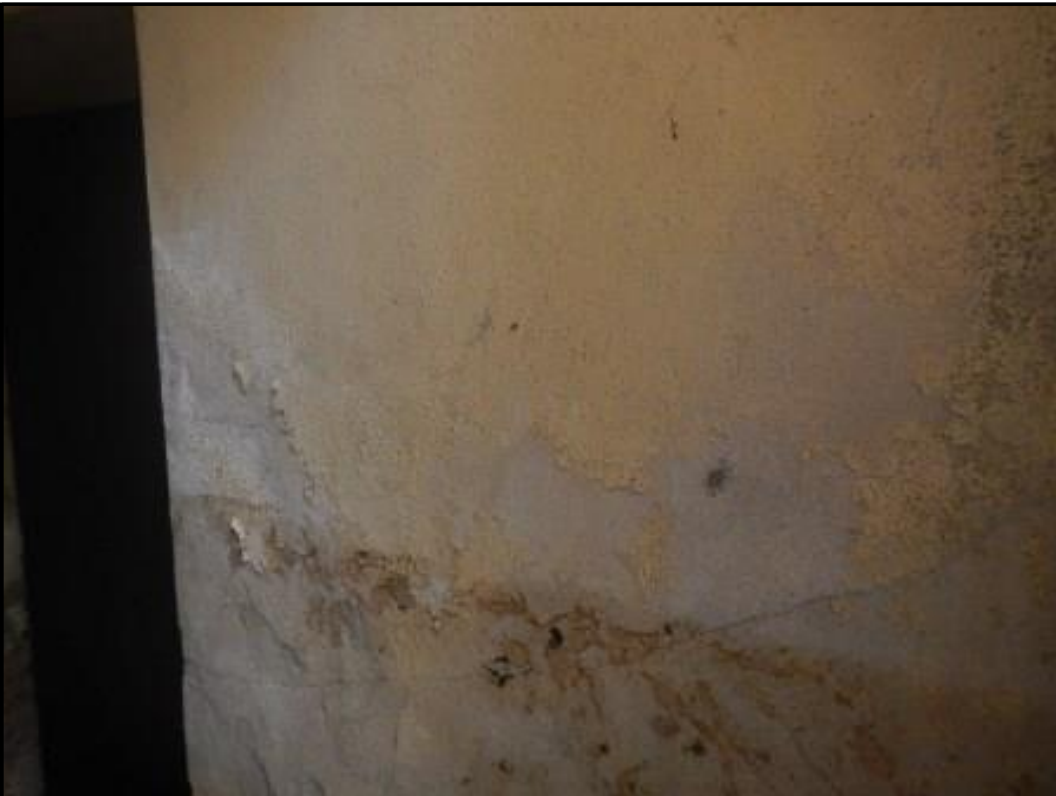
Photo No. 4			
Photographer Bethany Scott			
Description Grey/ Tan Wall Plaster, Basement

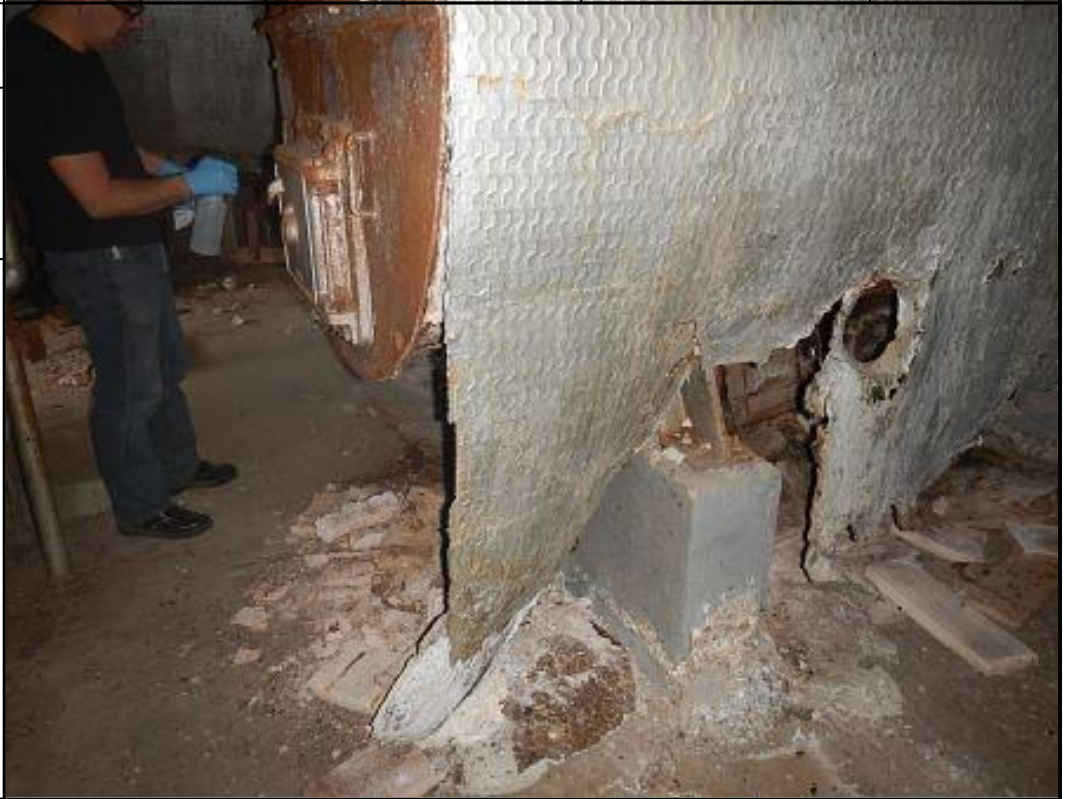
Photo No. 8

Description Boiler 1, first floor boiler room

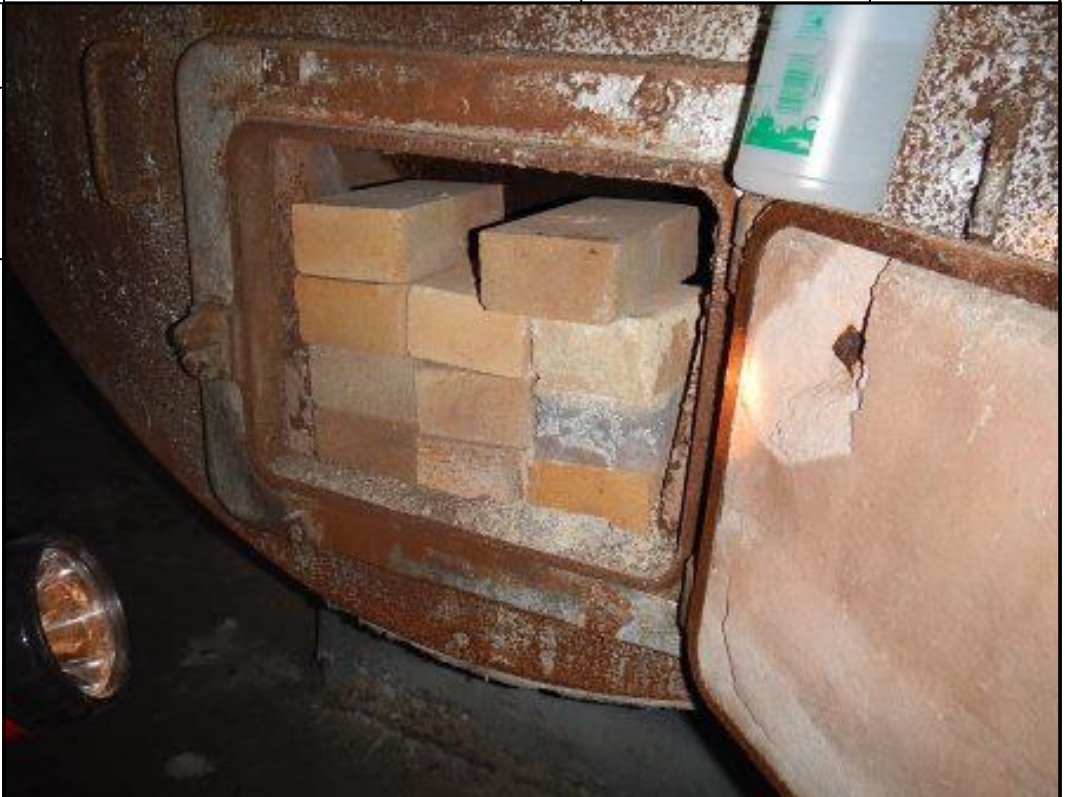
Photographer Bethany Scott			
Description Boiler 3, first floor boiler room

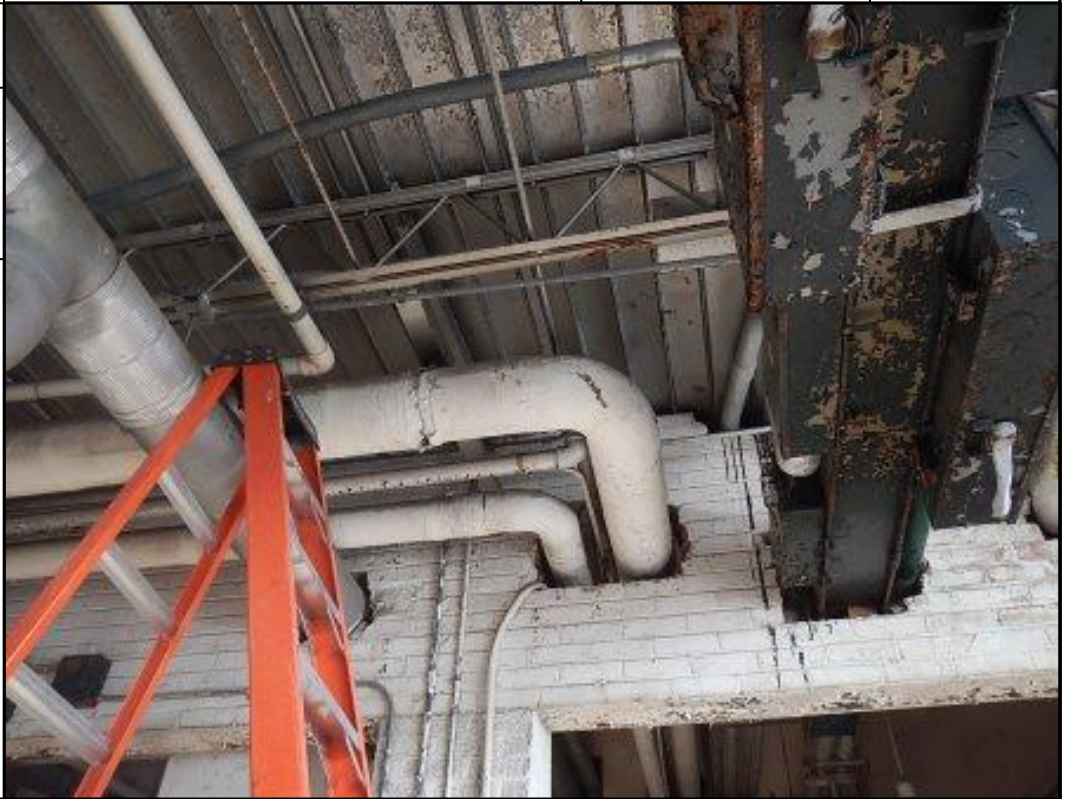
Photographer Bethany Scott			
Description 6 inch, 3 inch, and 1 inch pipe insulation, first floor boiler room			
Photo No. 12

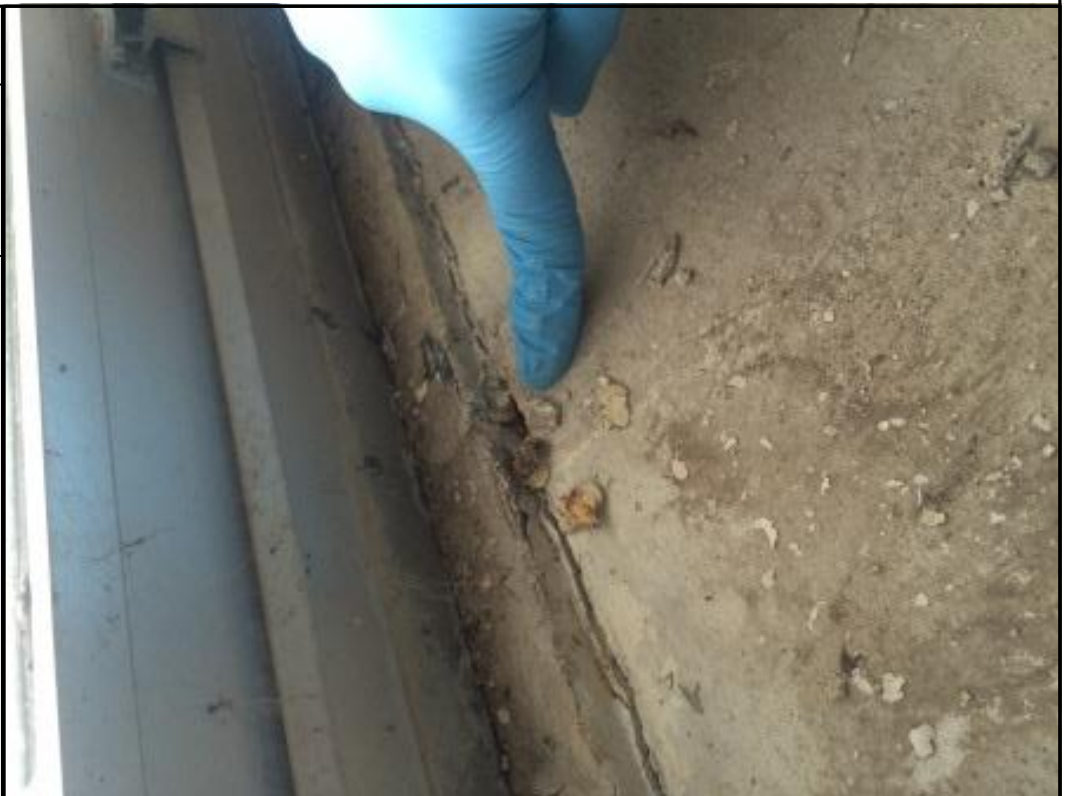
Photographer Bethany Scott			
Description Tan window putty, First Floor

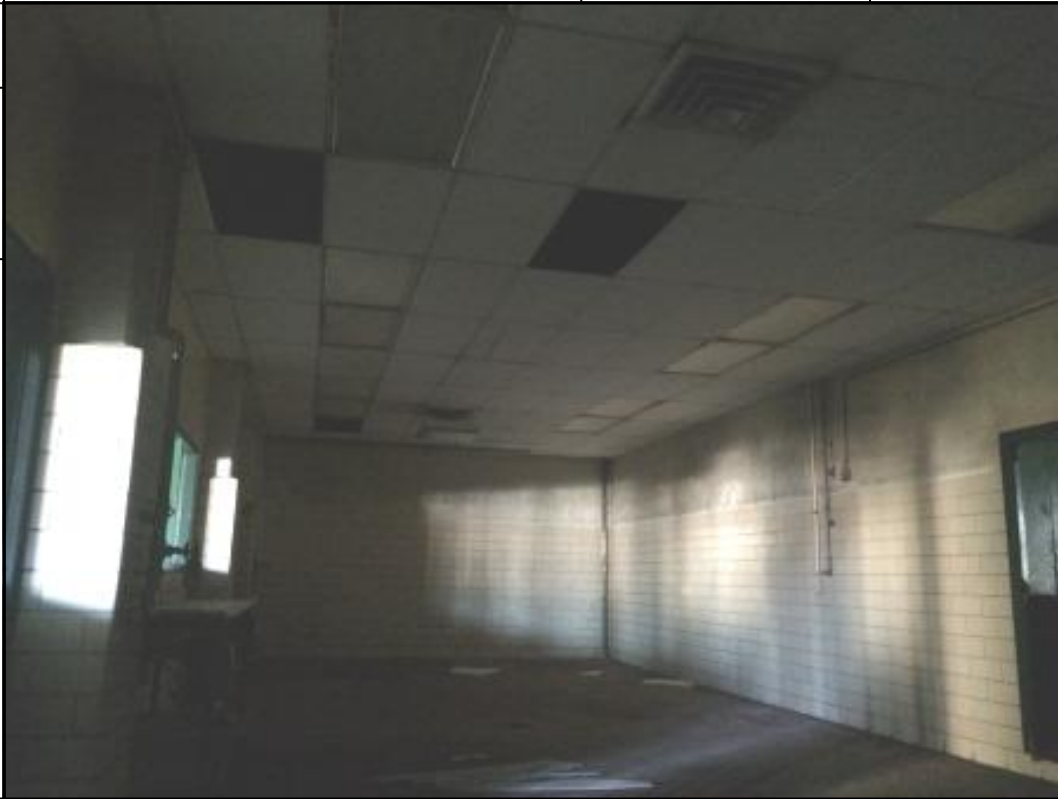
Photographer Bethany Scott			
Description Transite like 2x4 ceiling tiles, first floor, room 5			
Photo No. 14

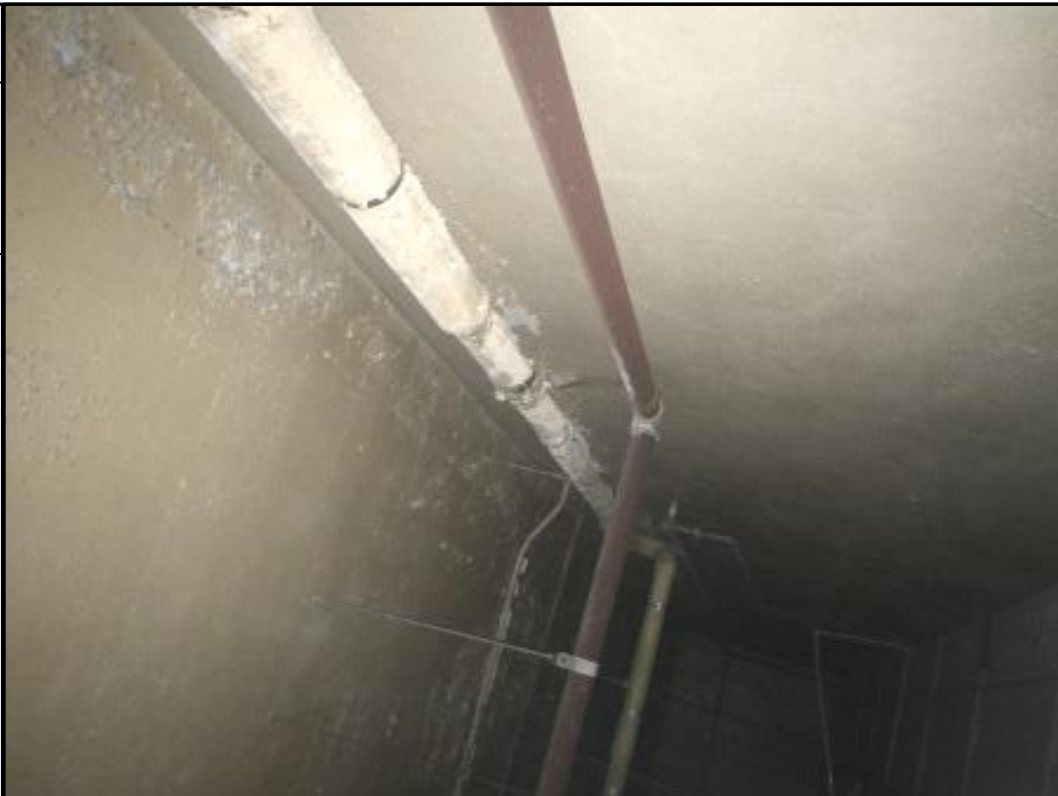
Photographer Bethany Scott			
Description 3 inch pipe insulation, first floor room

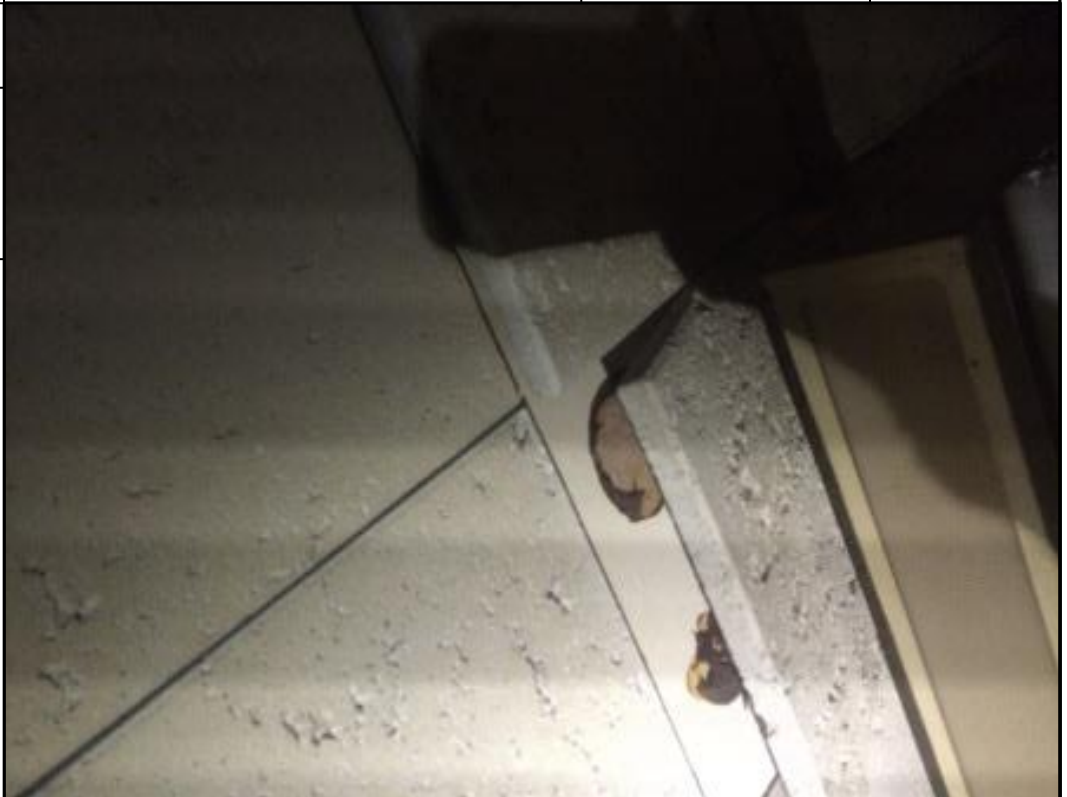
Photo No. 16

Description Tan floor tile with black mastic, First Floor

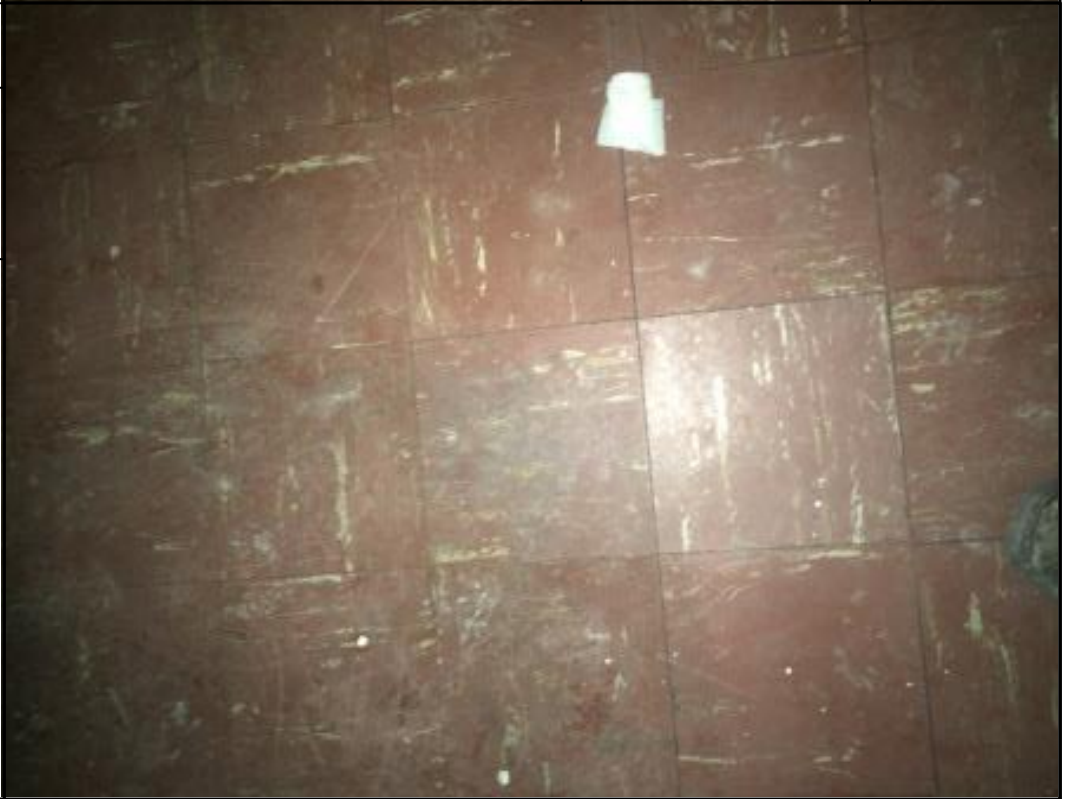
Photographer Bethany Scott			
Description Red floor tile black mastic, Mezzanine			
Photo No. 18

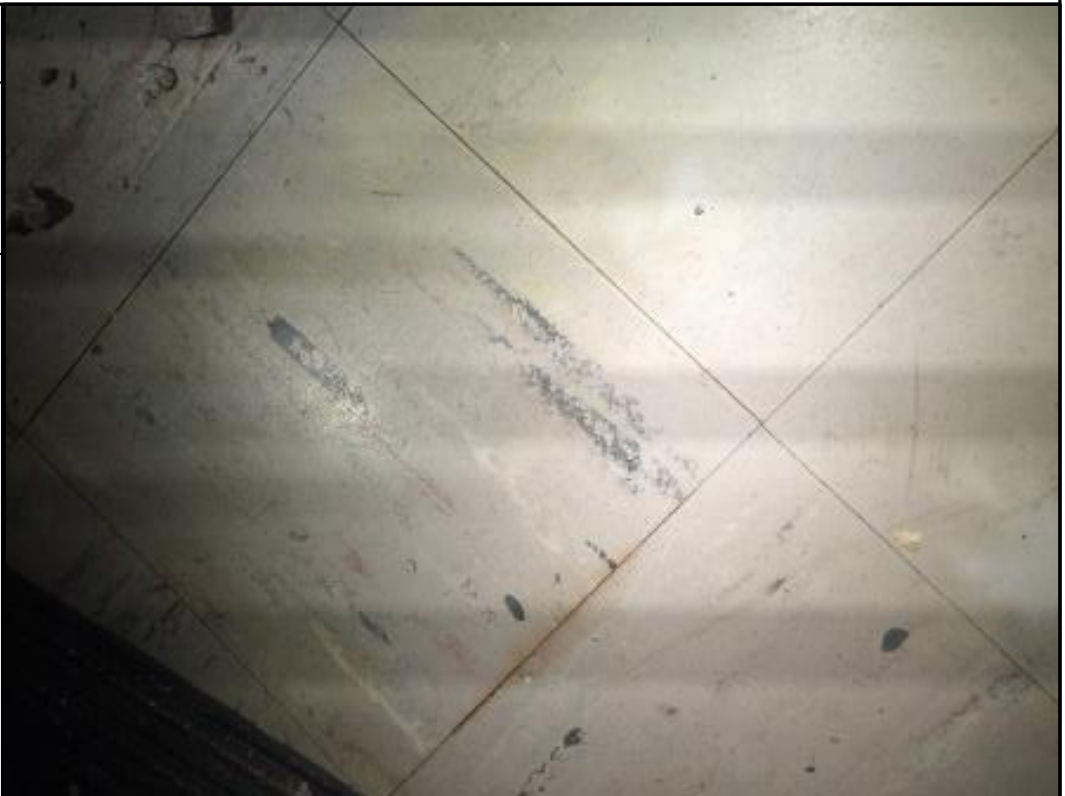
Photographer Bethany Scott			
Description Grey floor tile with black mastic, First Floor Offices

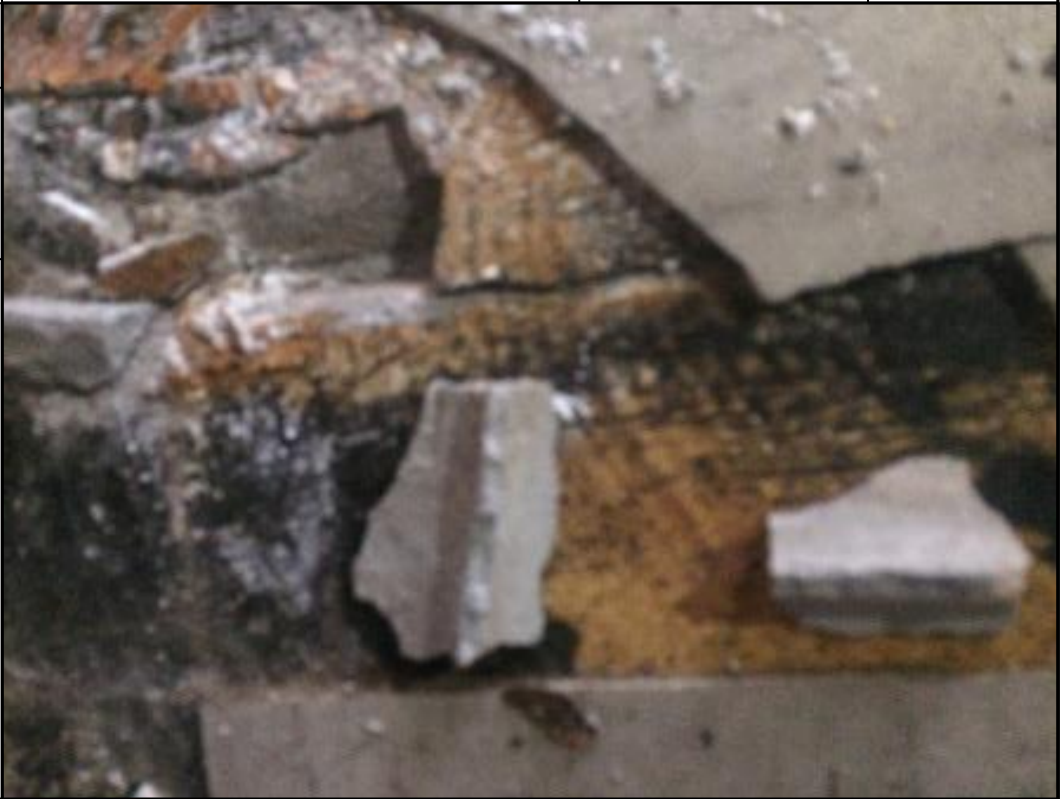
Photographer Bethany Scott			
Description Tan floor tile with black mastic, First Floor Offices			
Photo No. 20

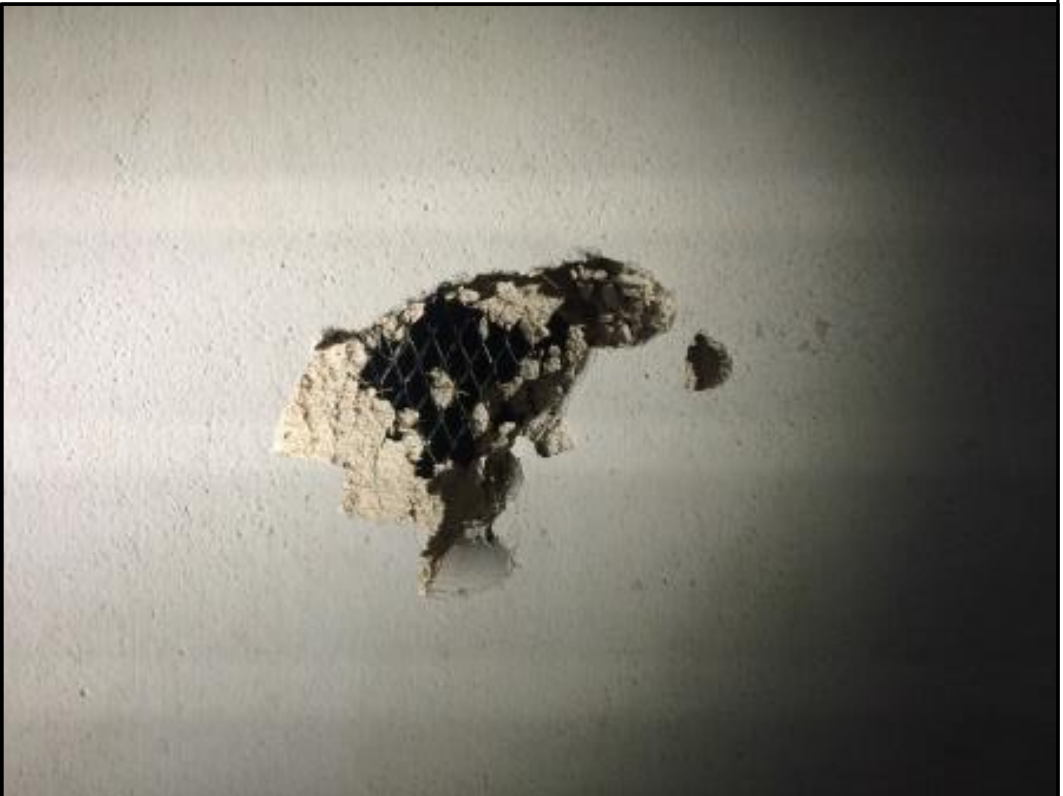
Photographer Bethany Scott			
Description White skim coat, First Floor Offices

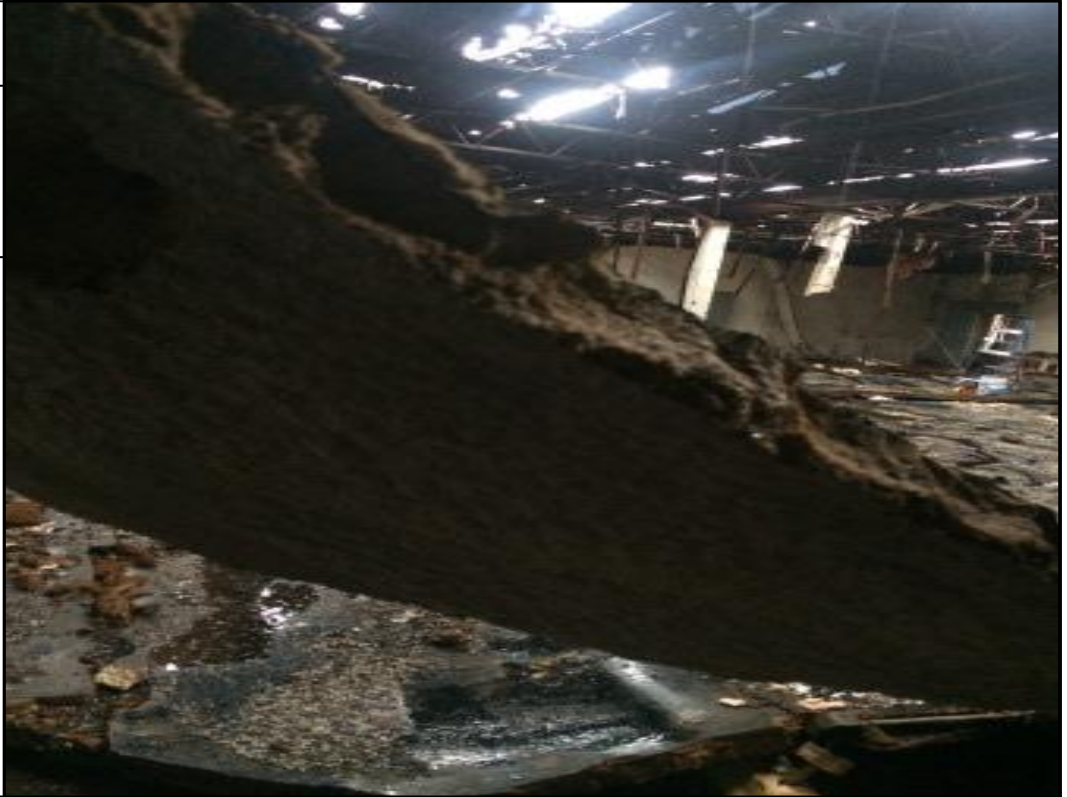
Silver and black coating over brown insulation, First Floor

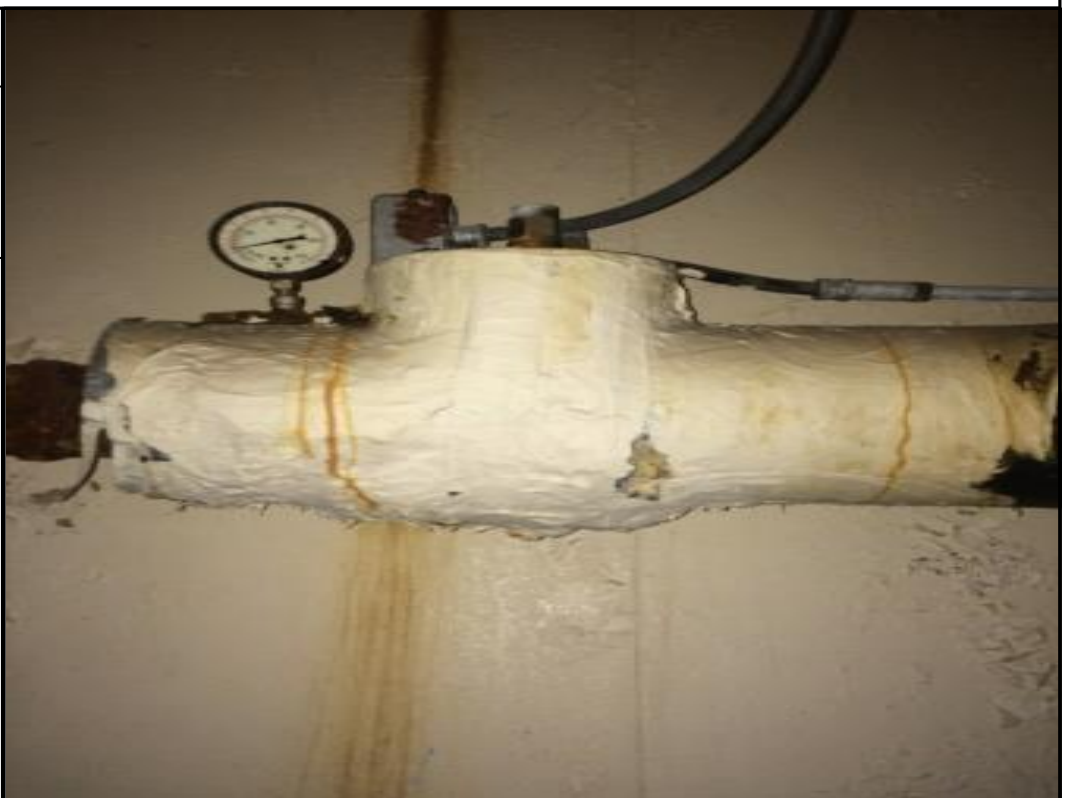
Pipe elbow insulation, First Floor

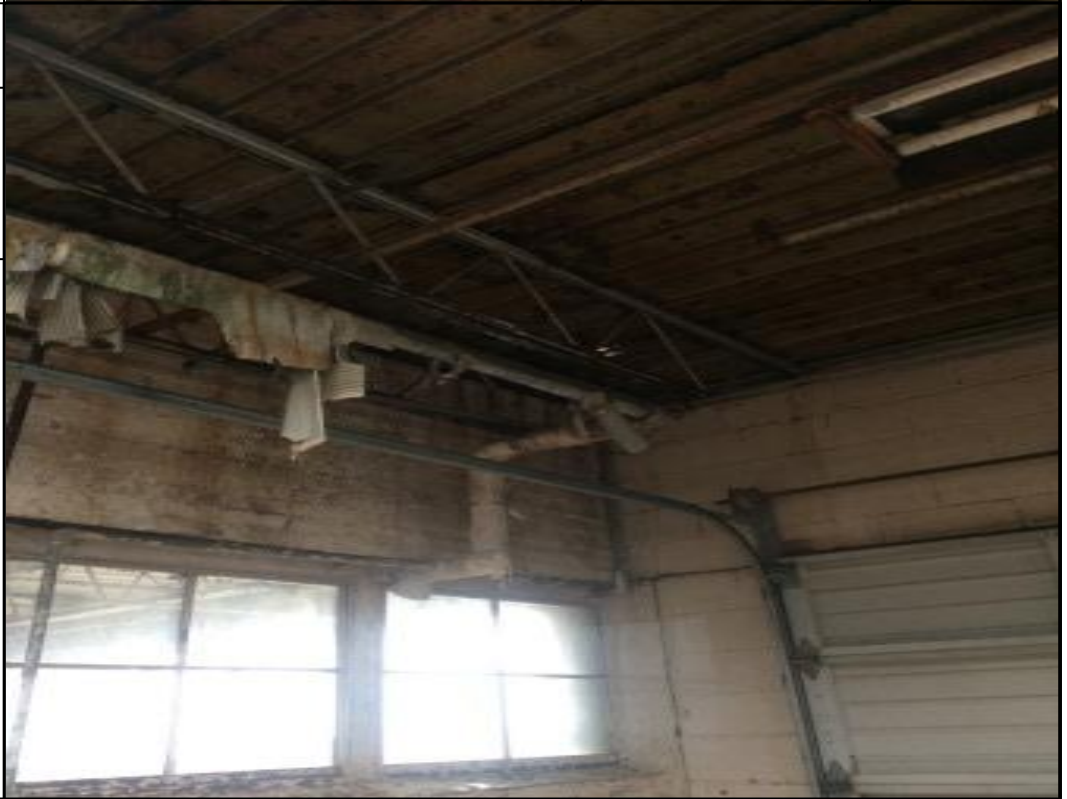
Photo No. 23

Description Grey Pipe Insulation, First Floor

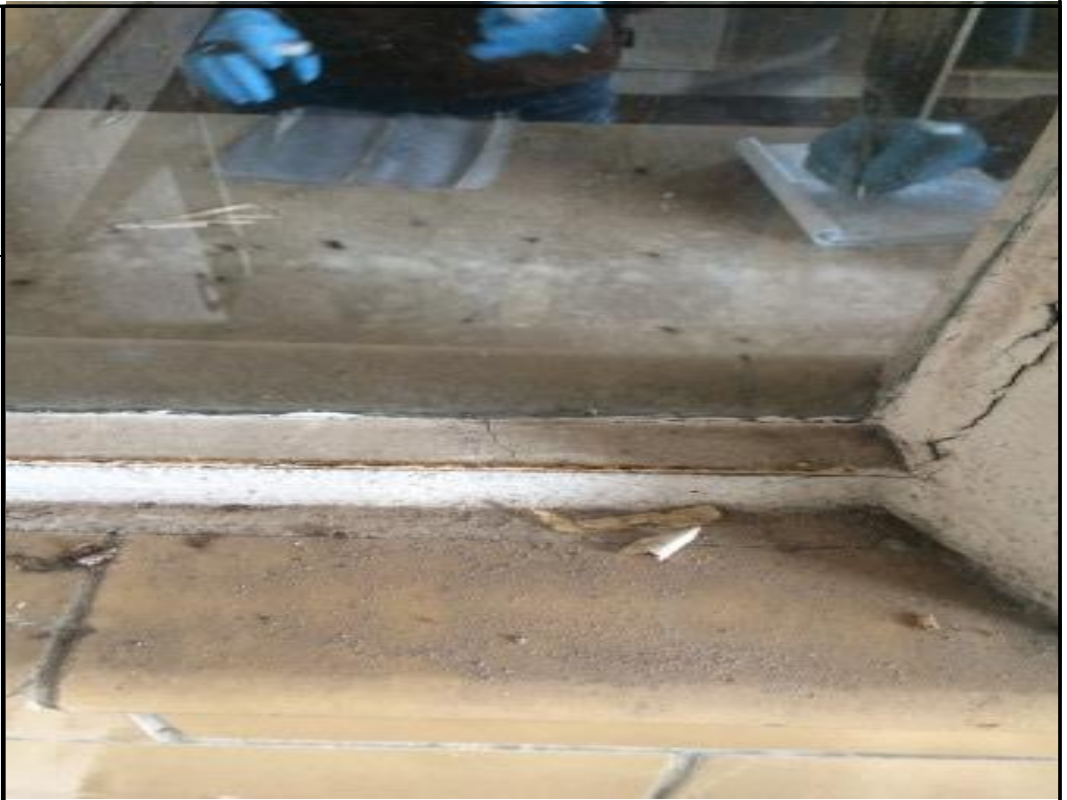
Photo No. 24

Description Cream window grout, First Floor

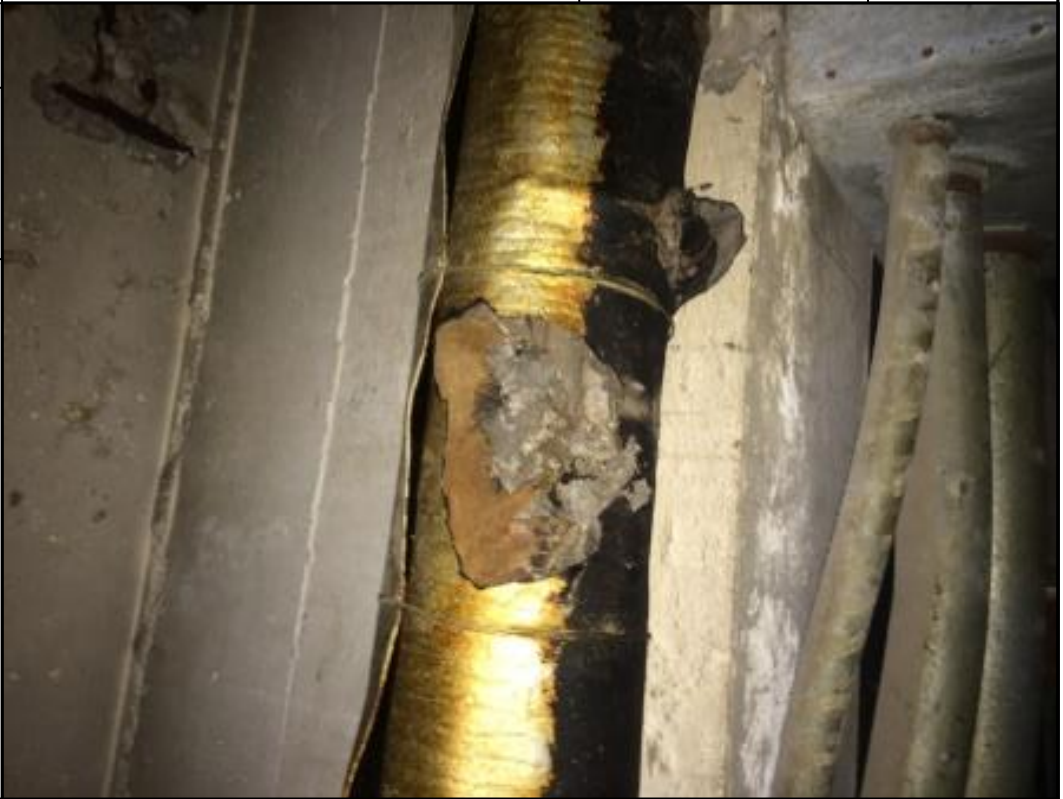
Photographer Bethany Scott			
Description 4-inch Pipe Insulation, First Floor			
Photo No. 28

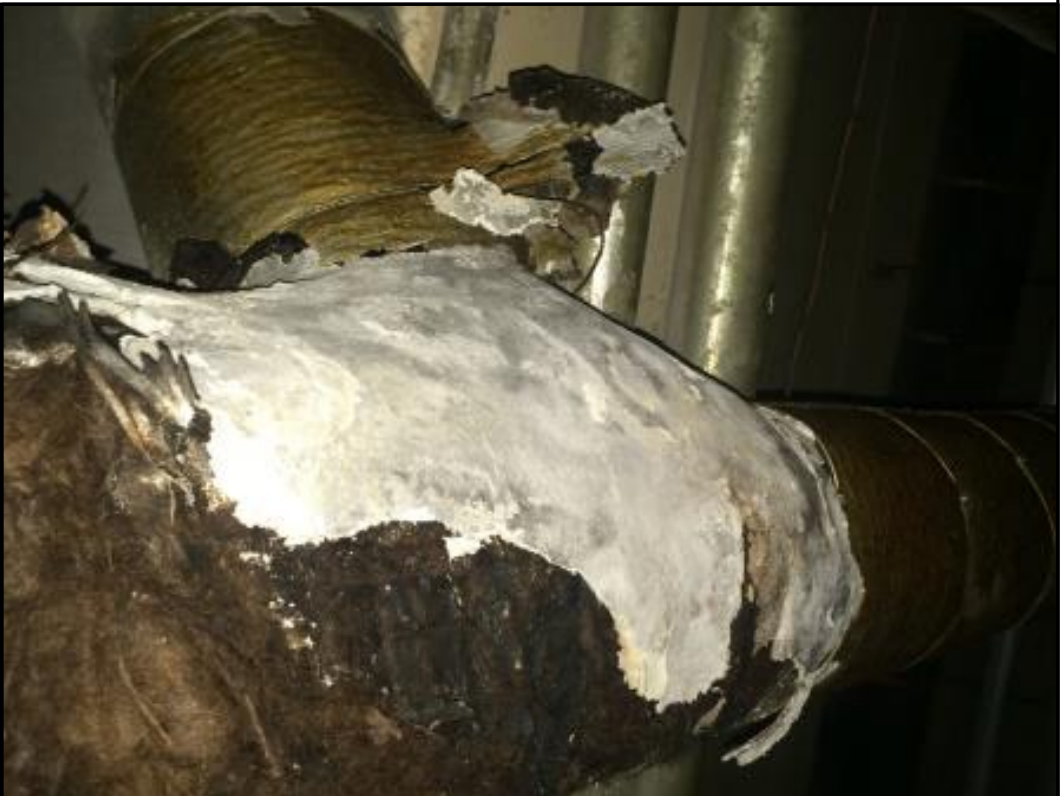
Photographer Bethany Scott			
Description Grey Pipe Elbow Insulation, First Floor

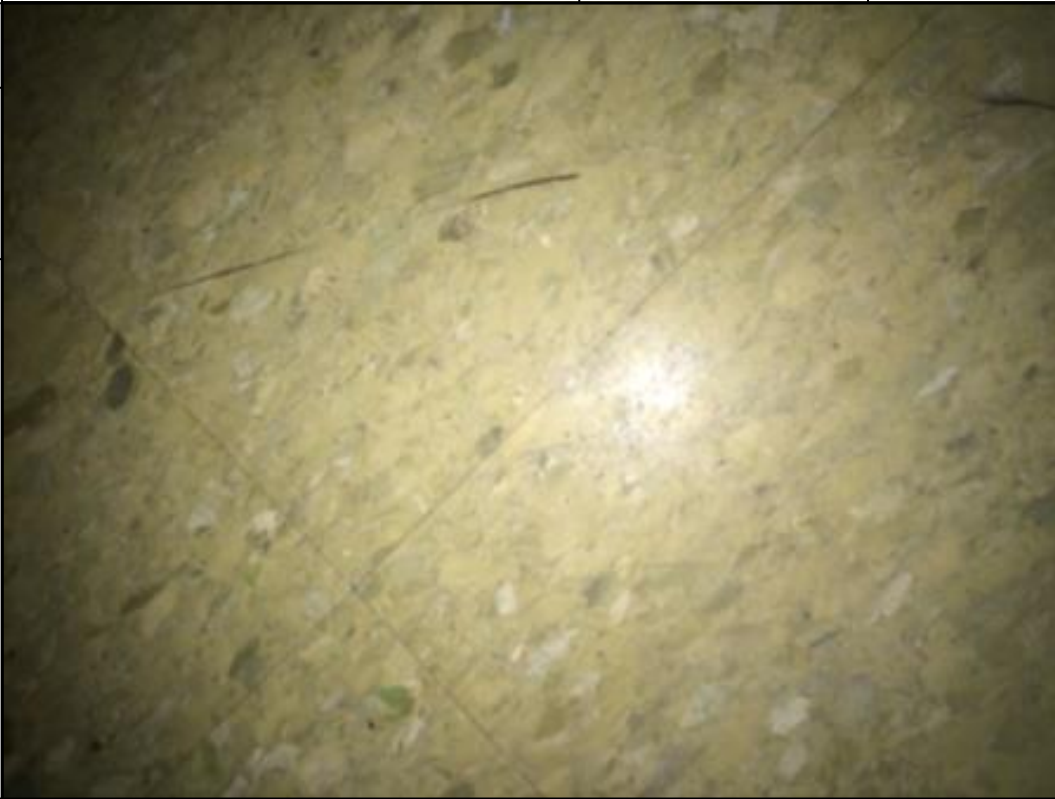
Client Name ODEQ	Site Location: 135 South Washington Street Ardmore, Oklahoma	Project Dates February 23, 24 and 25, 2016	Project No. ODEQ007
Photo No. 29

Photographer Bethany Scott			
Description Yellow Floor Tile with Black Mastic, First Floor			
Photo No. 30

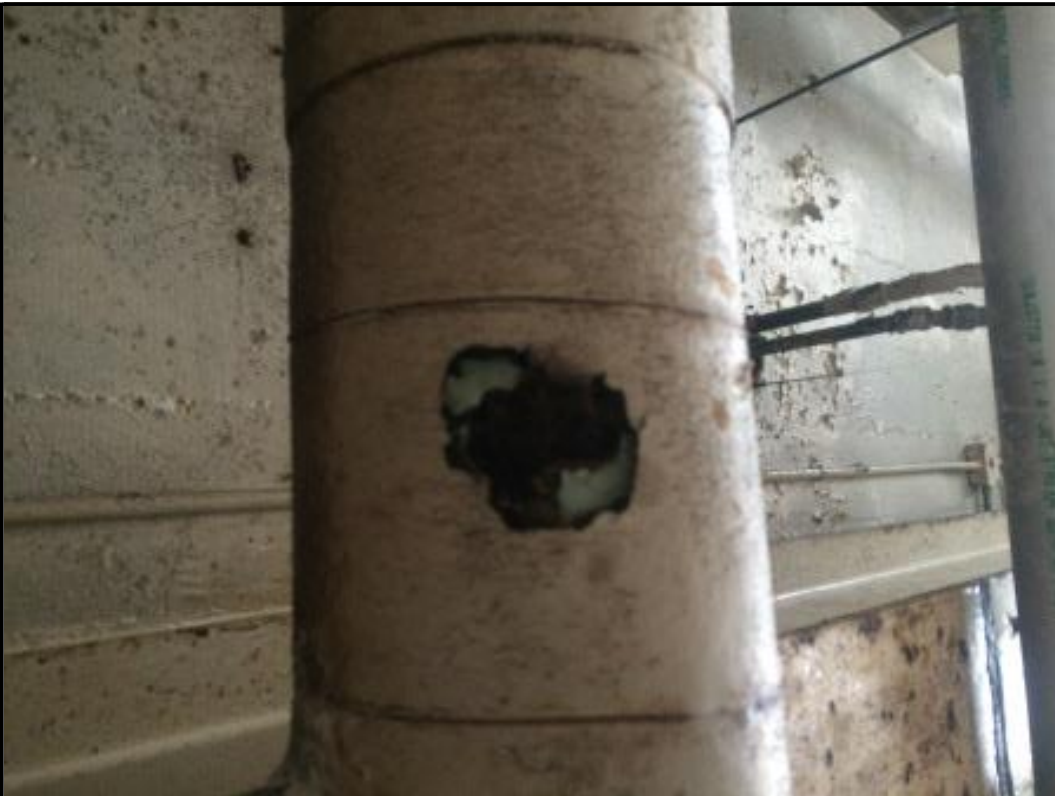
Photographer Bethany Scott			
Description 3 inch Pipe Insulation, First Floor

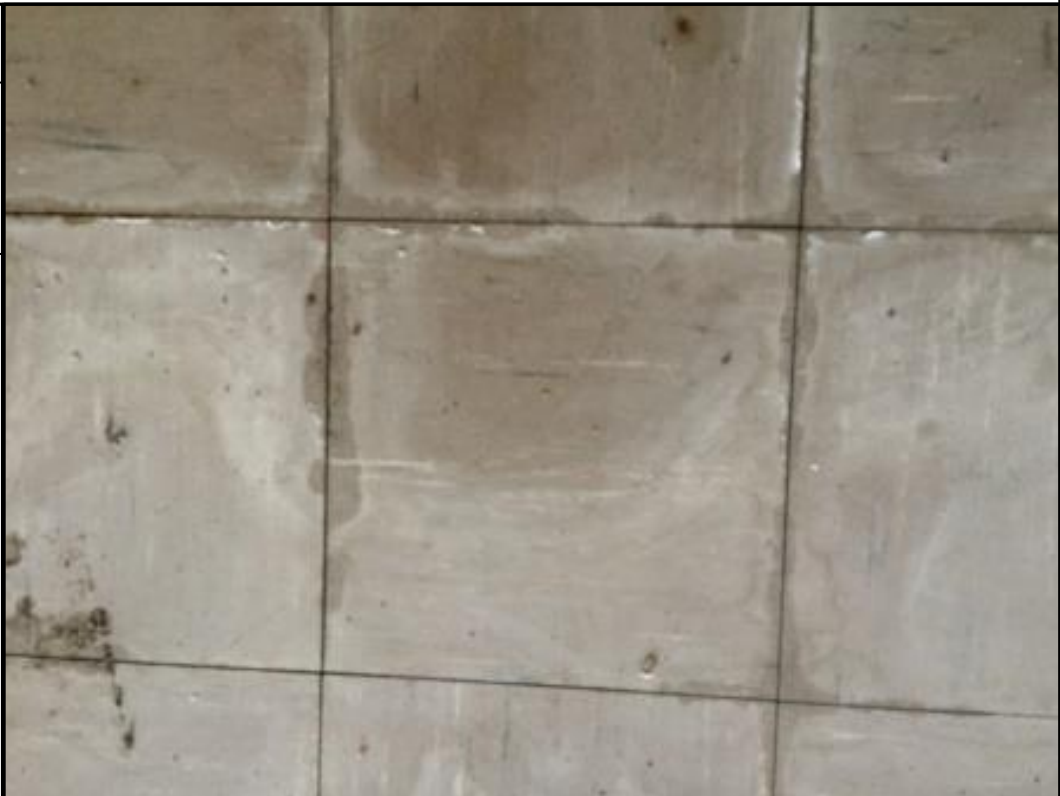
Photographer Bethany Scott			
Description Grey Floor Tile with Black Mastic, Second Floor

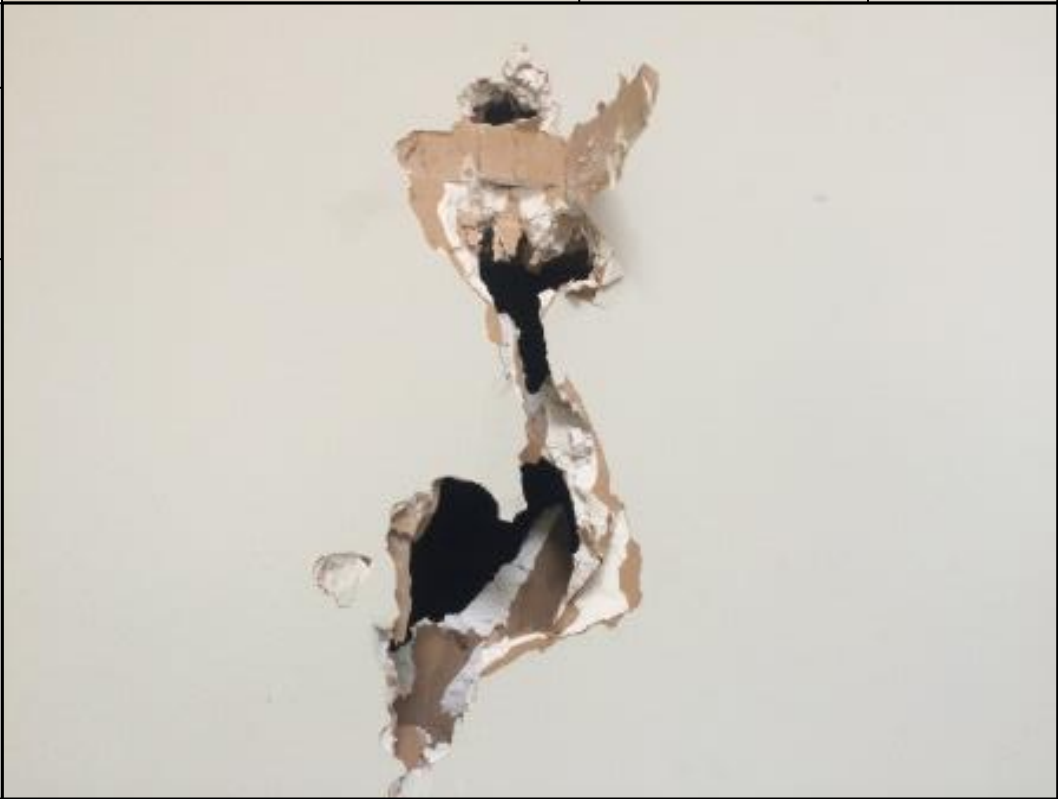
Client Name ODEQ	Site Location: 135 South Washington Street Ardmore, Oklahoma	Project Dates February 23, 24 and 25, 2016	Project No. ODEQ007
Photo No. 33

Photographer Bethany Scott			
Description White Joint Compound, Second Floor			
Photo No. 34

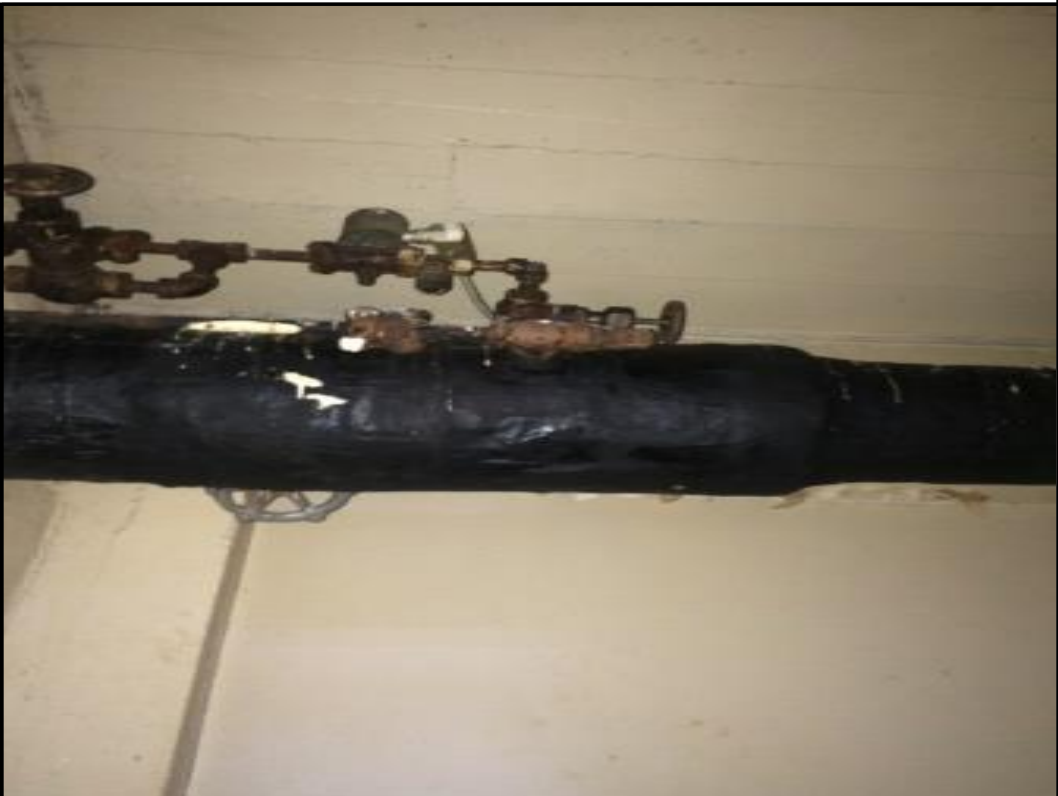
Photographer Bethany Scott			
Description Black Pipe Wrap, Second Floor

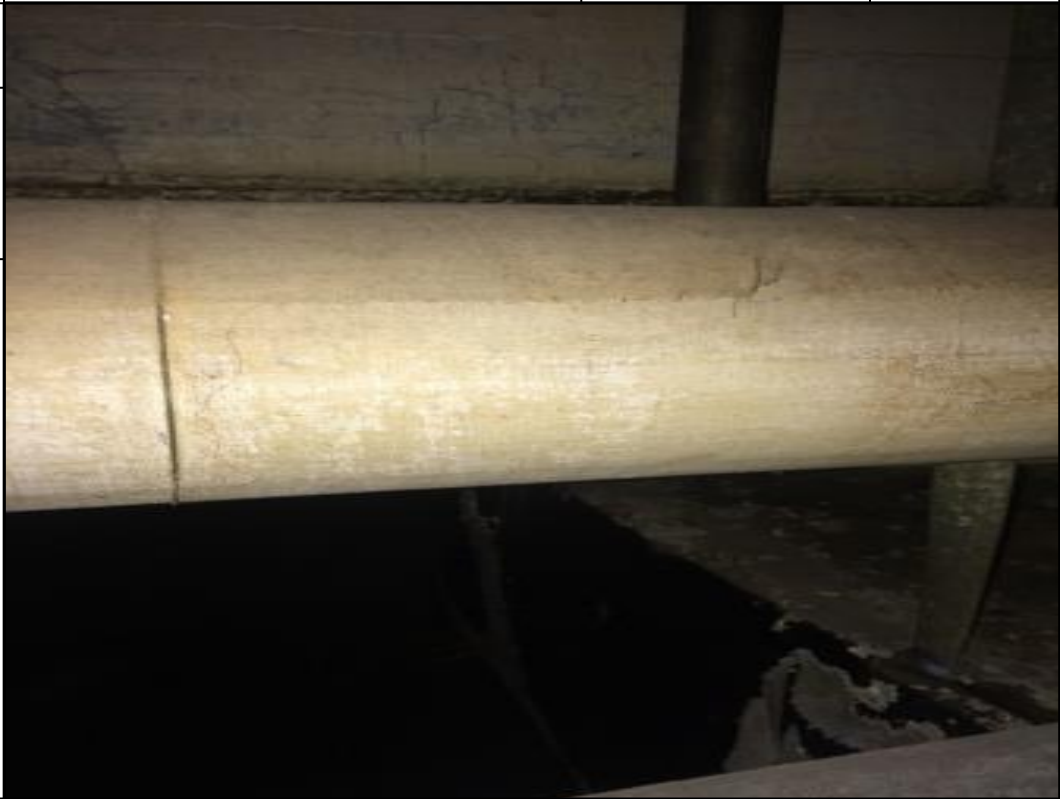
Client Name ODEQ	Site Location: 135 South Washington Street Ardmore, Oklahoma	Project Dates February 23, 24 and 25, 2016	Project No. ODEQ007
Photo No. 35

Photographer Bethany Scott			
Description 3 inch Pipe Insulation, Second Floor			
Photo No. 36

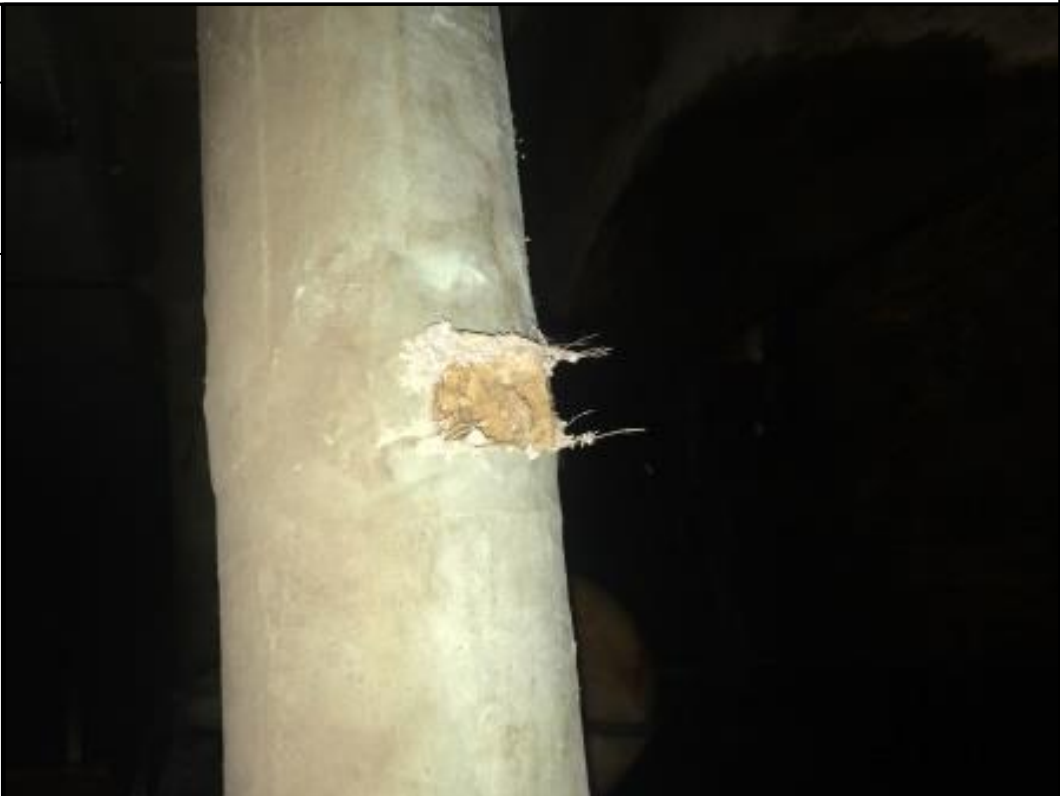
Photographer Bethany Scott			
Description 2 inch Pipe Insulation, Second Floor
