Former Colvert's Dairy Ardmore, Oklahoma

Final Remediation Report

Prepared by:
Department of Environmental Quality
707 North Robinson
Oklahoma City, Oklahoma 73101

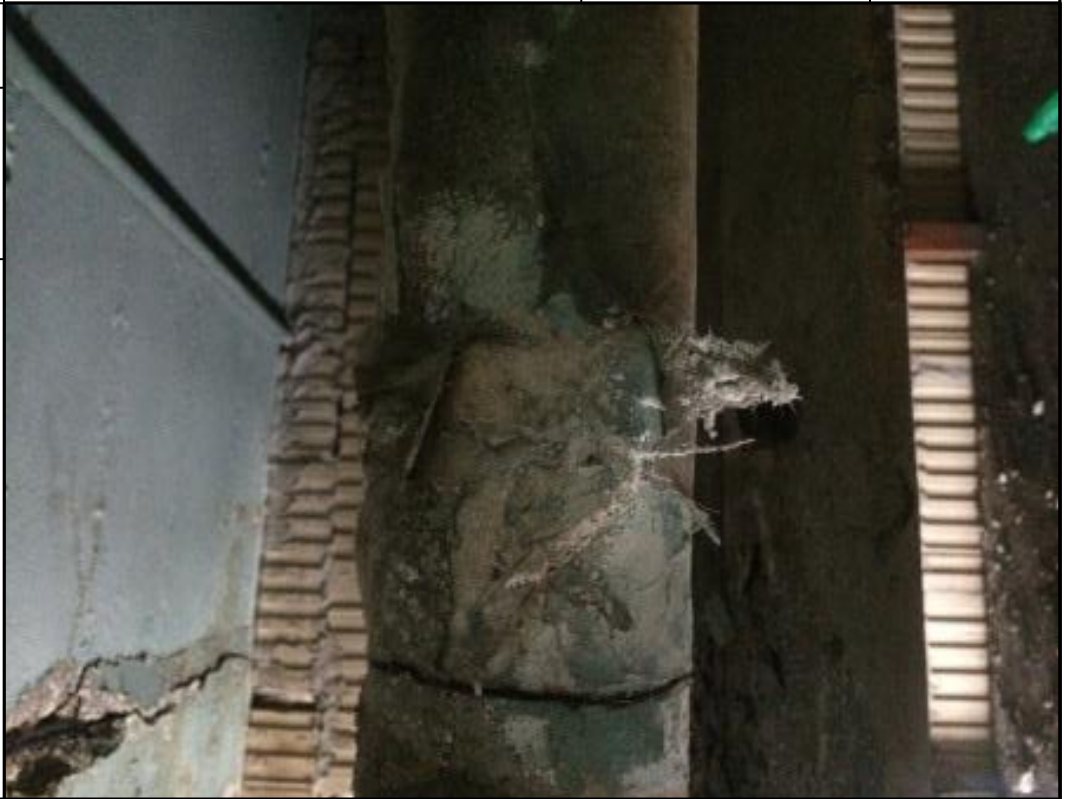
Client Name ODEQ	Site Location: 135 South Washington Street Ardmore, Oklahoma	Project Dates February 23, 24 and 25, 2016	Project No. ODEQ007
Photo No. 37

Photographer Bethany Scott			
Description 4 inch Pipe Insulation, Second Floor			
Photo No. 38

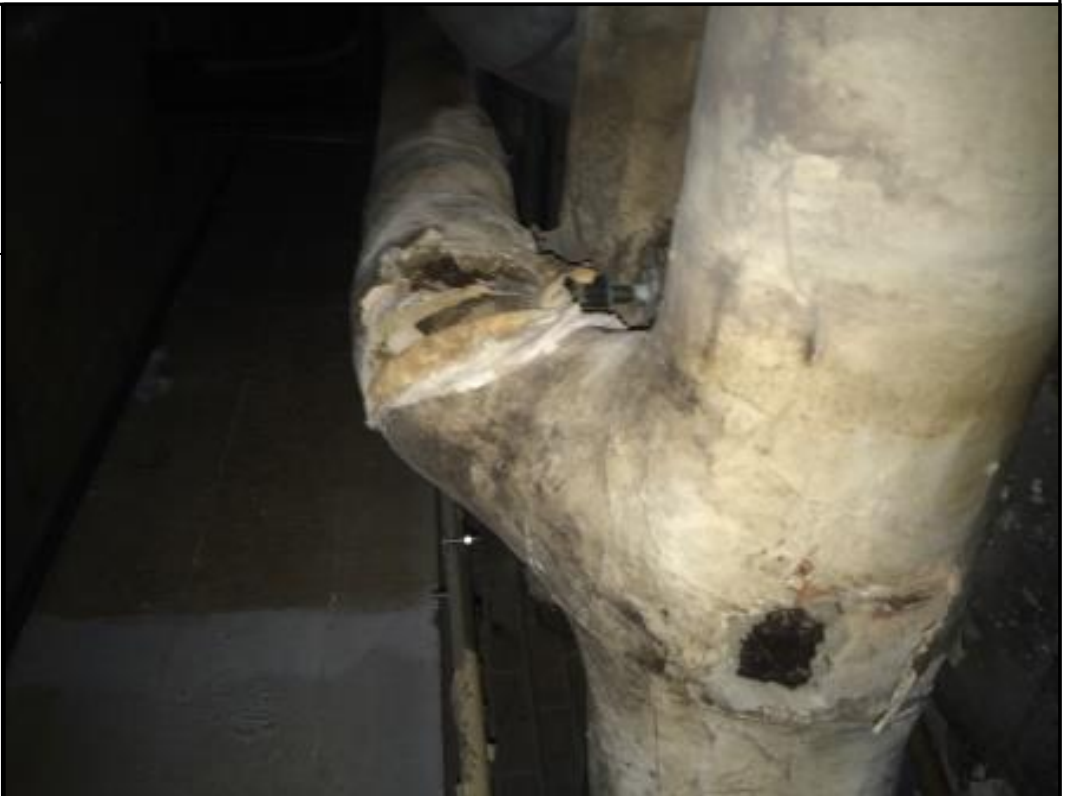
Photographer Bethany Scott			
Description Pipe Elbow Insulation, Second Floor

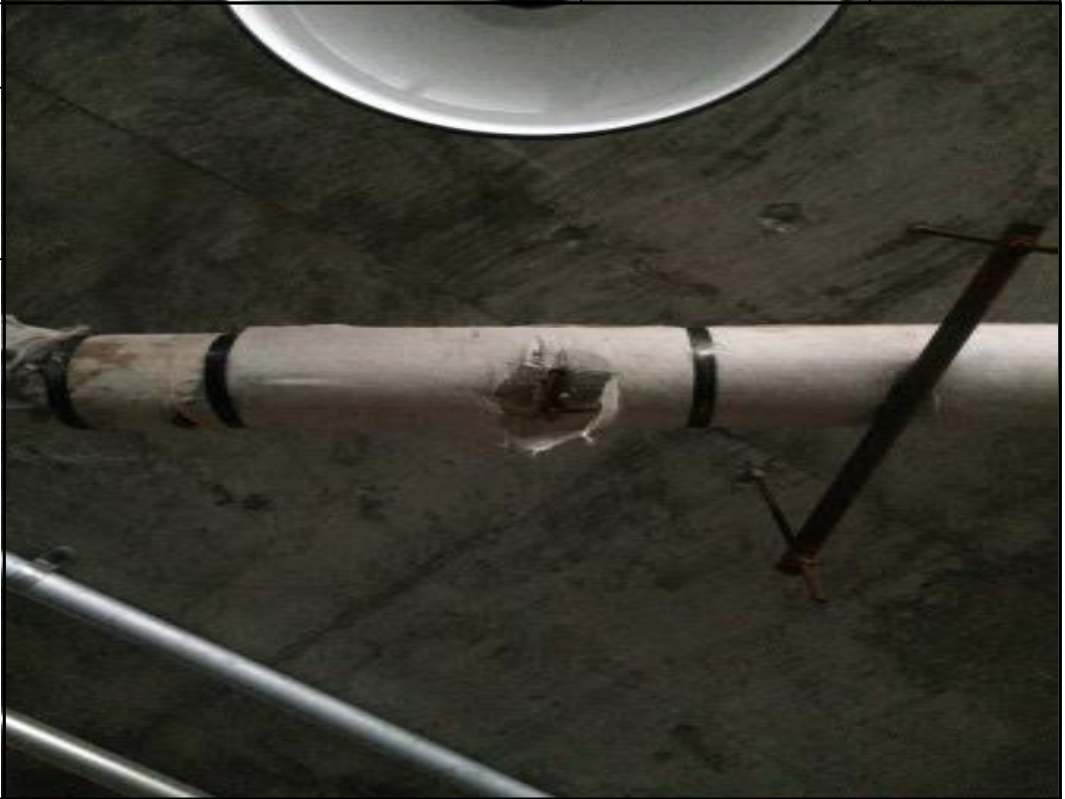
Client Name ODEQ	Site Location: 135 South Washington Street Ardmore, Oklahoma	Project Dates February 23, 24 and 25, 2016	Project No. ODEQ007
Photo No. 39

Photographer Bethany Scott			
Description 2 inch Pipe Insulation, Second Floor

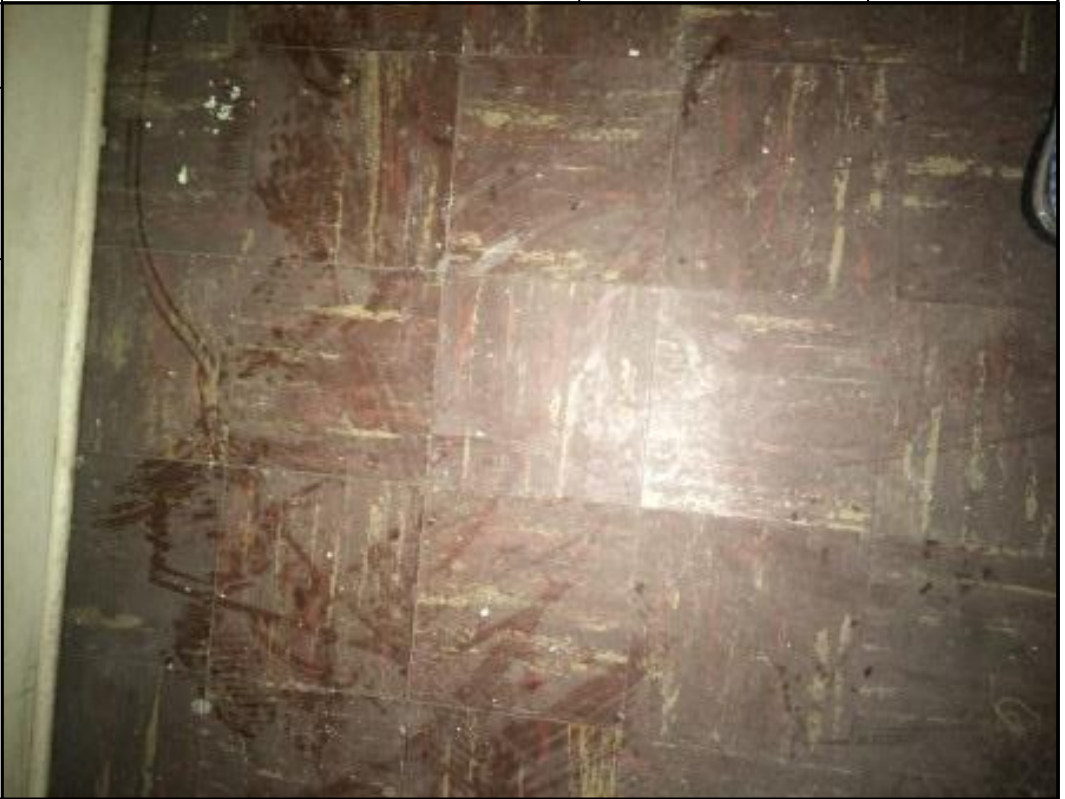
Photo No. 41

Photographer Bethany Scott	
Description Red Floor Tile, Second Floor

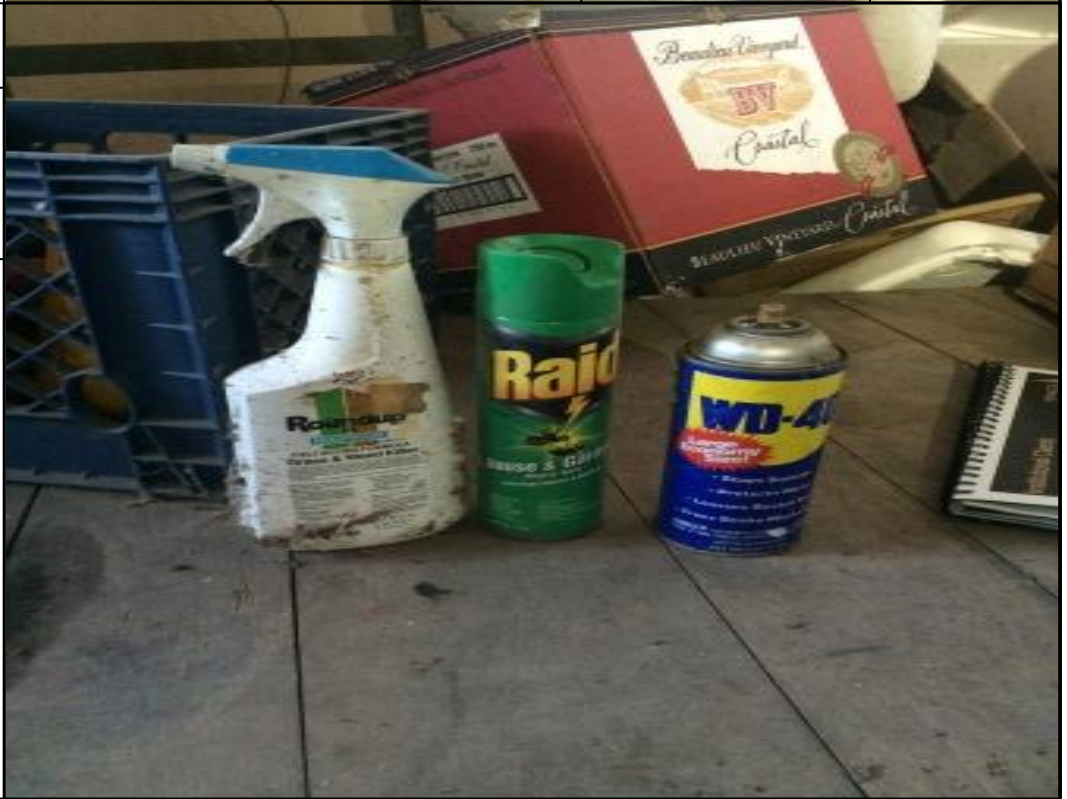
Photo No.
4

Typical hazmats
located in Room
10

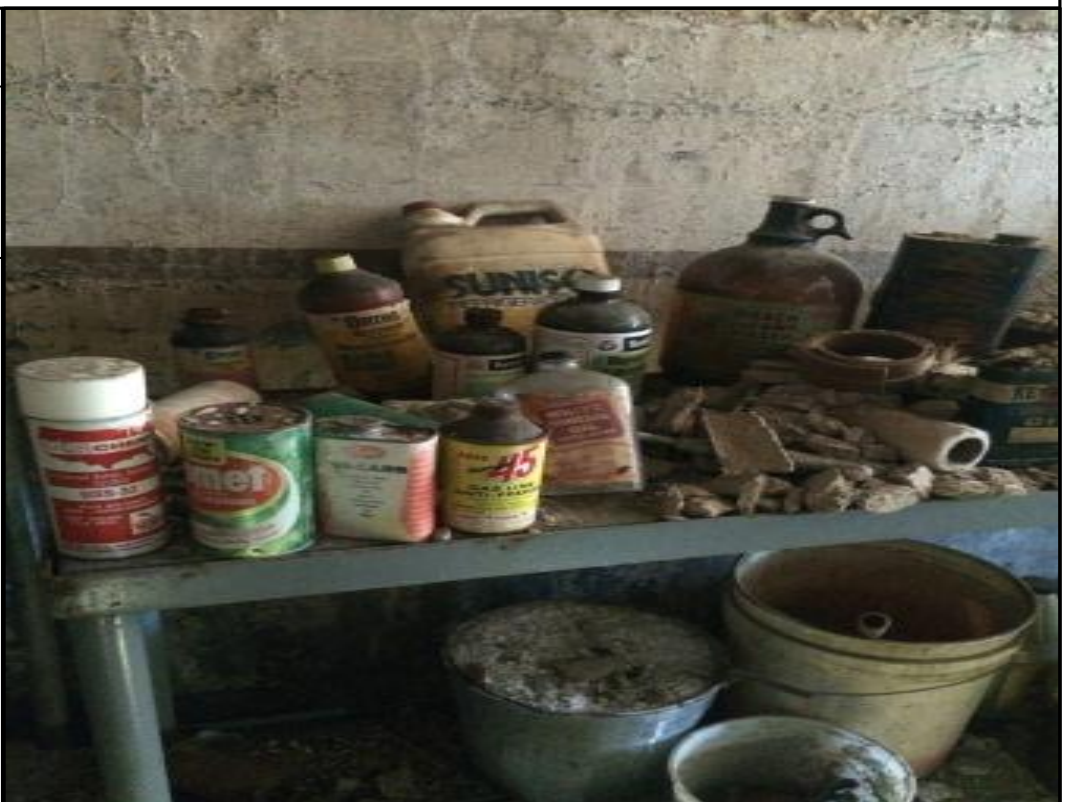
Photo No.
5

Typical hazmats
located in Room
10

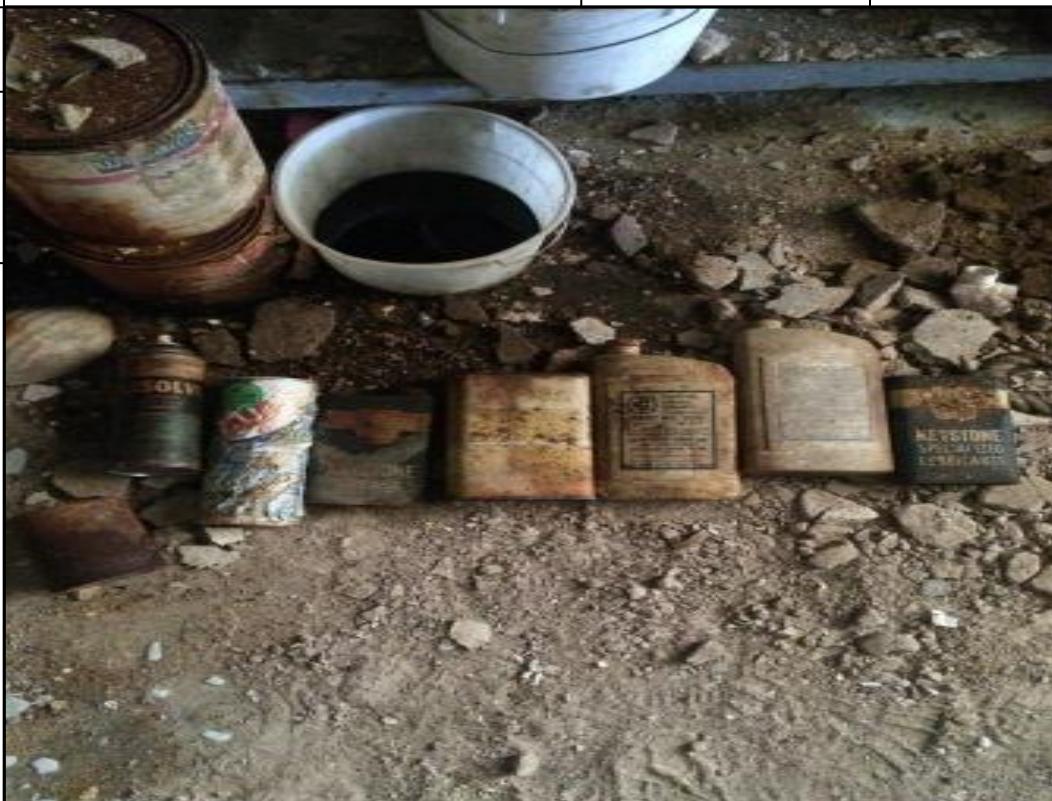
Photo No.
6

Bottles of
unmarked
gasoline located
in Room 8

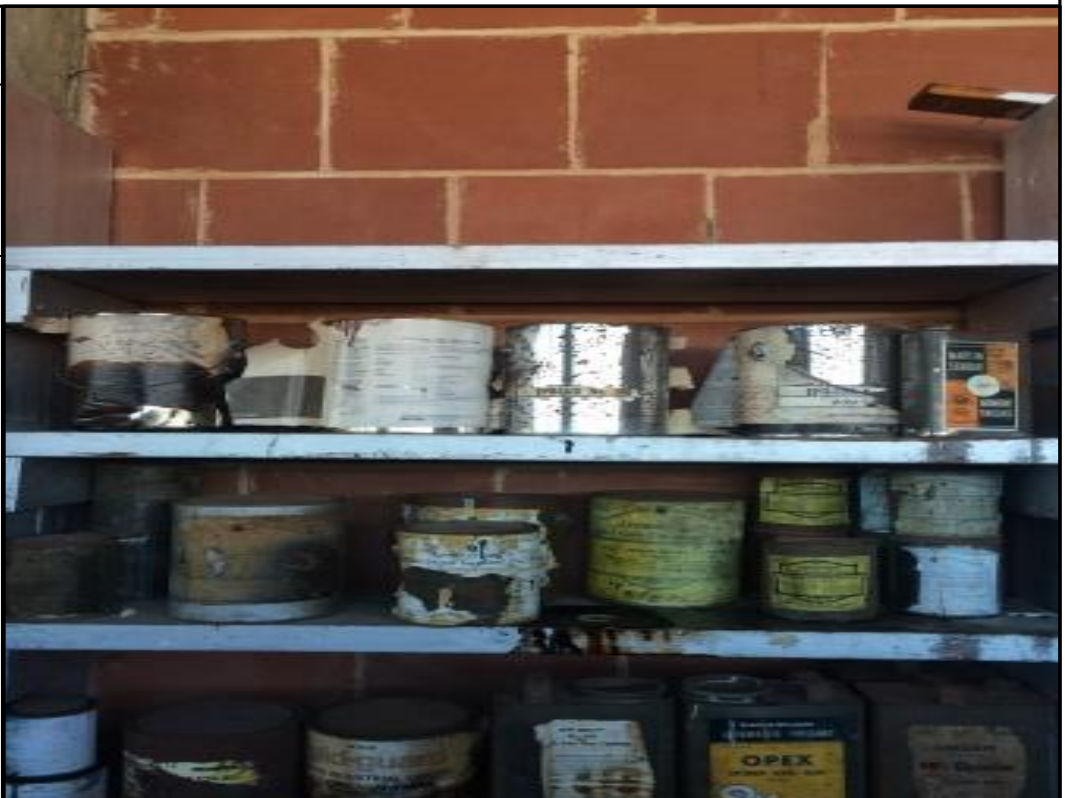
Client Name ODEQ	Site Location: 135 South Washington Street Ardmore, Oklahoma	Project Dates February 23, 24 and 25, 2016	Project No. ODEQ007
Photo No. 9

Photographer Bethany Scott			
Description Typical hazmats located in Room 51			
Photo No. 10

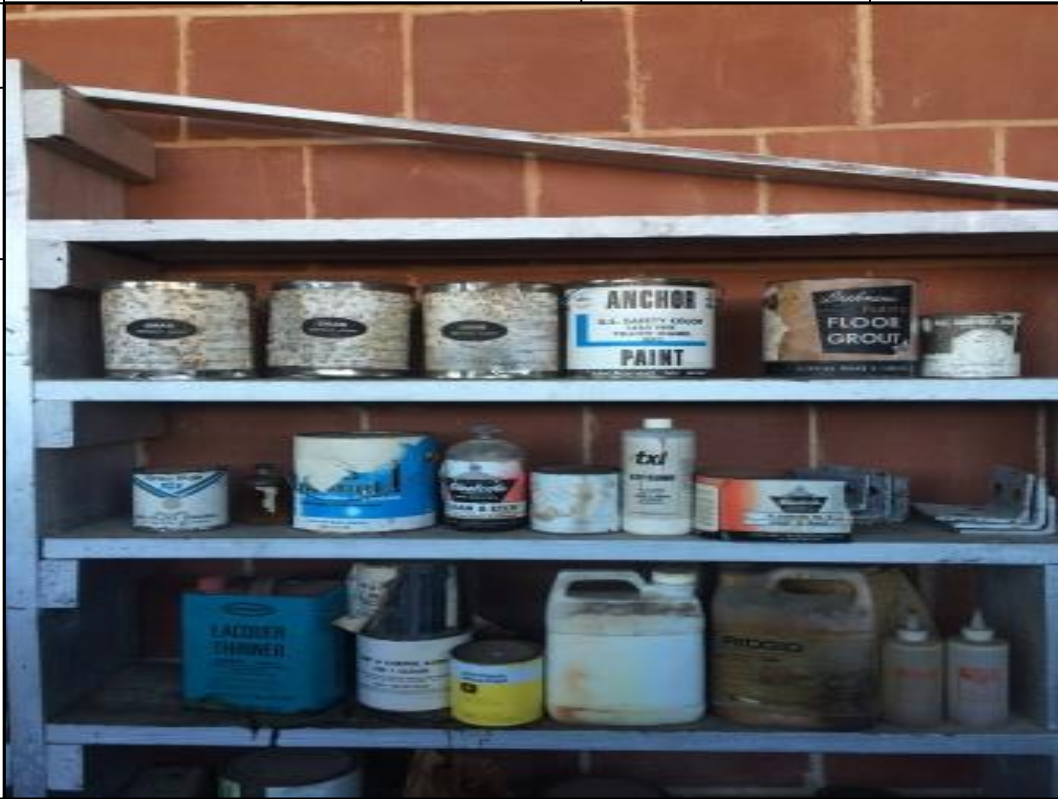
Photographer Bethany Scott			
Description Typical hazmats located in Room 51

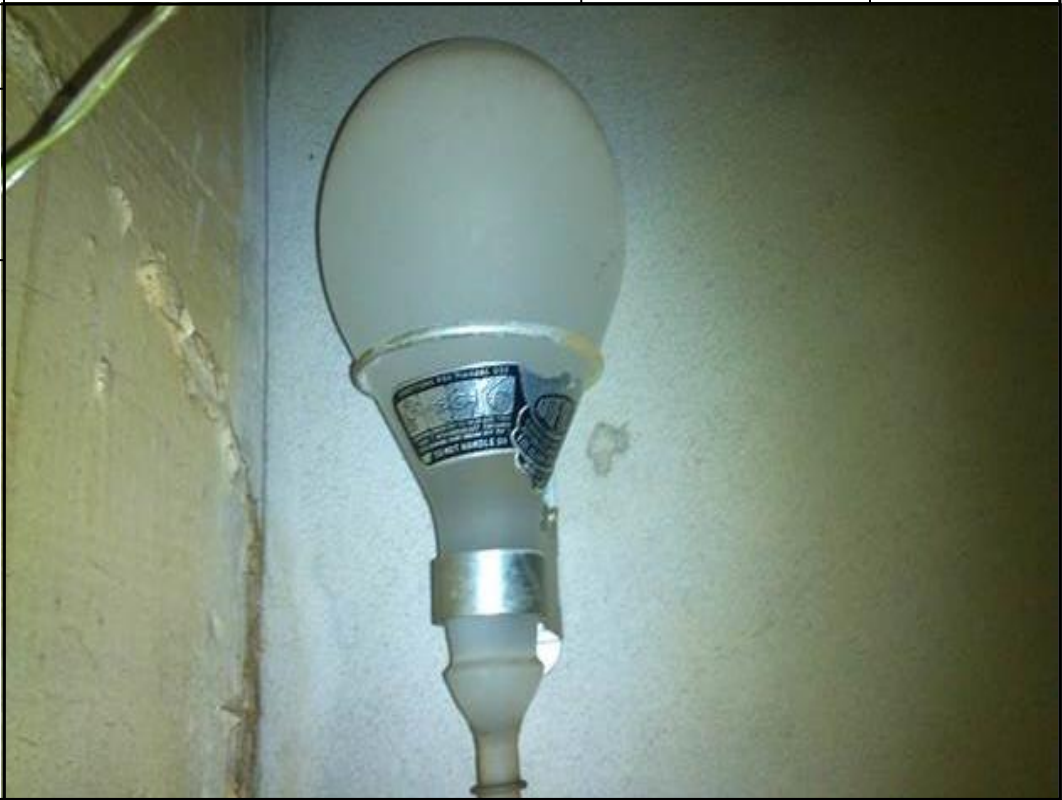
<p>Client Name ODEQ</p>	<p>Site Location: 135 South Washington Street Ardmore, Oklahoma</p>	<p>Project Dates February 23, 24 and 25, 2016</p>	<p>Project No. ODEQ007</p>
<p>Photo No. 15</p>

<p>Photographer Bethany Scott</p>			
<p>Description Gas filled glass fire extinguishing bulb</p>
